**MITIGATED NEGATIVE DECLARATION**

| <b>Project Title:</b> | Lundquist |
| <b>File Number:</b> | PLN110114 |
| <b>Project Location:</b> | 3224 17-Mile Drive, Pebble Beach |

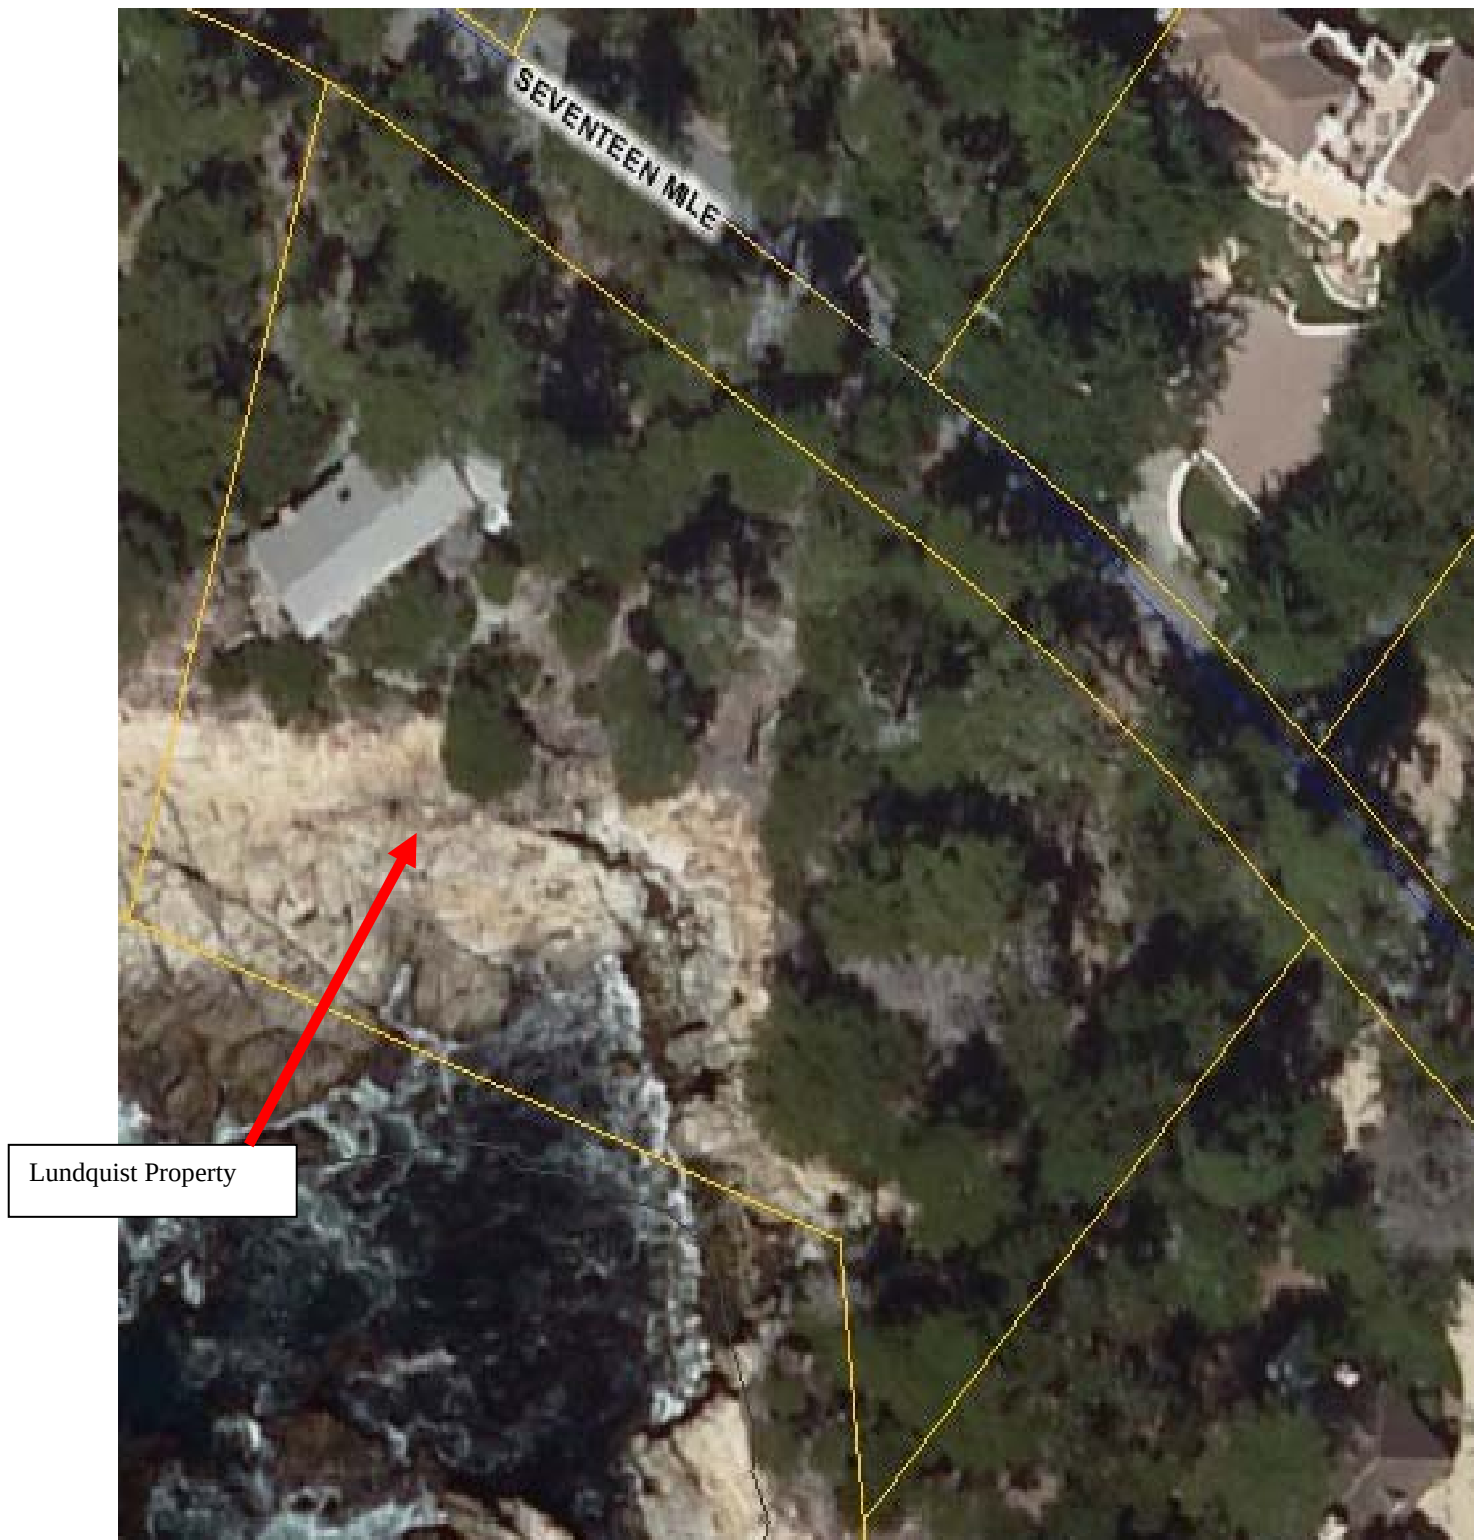
Figure 1: Aerial Site Plan of Lundquist property

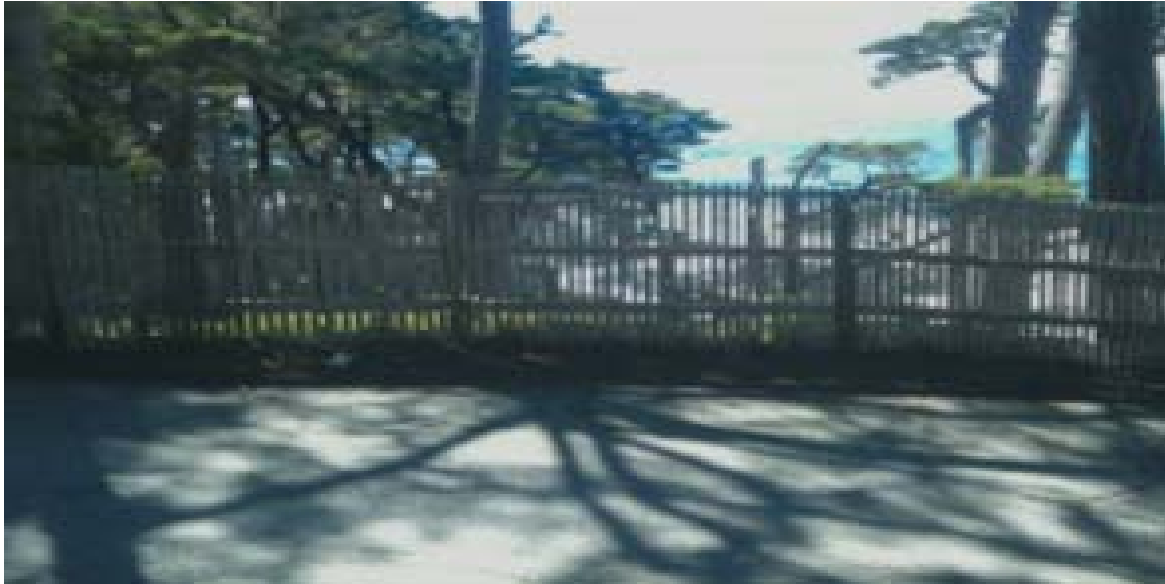
**Figure 2: Portion of Existing View from 17-Mile Drive (northwest portion)**

The project site is identified on the LUP Visual Resources Map (Map 2C) as part of the view area from 17-Mile Drive. The site of the Lone Cypress which is a designated scenic vista, is located immediately east of the site. Views from 17-Mile Drive are considered to be valuable scenic and visual resources that are protected within the Del Monte Forest Plan. LUP Policy No. 122 (Public Access) states that existing visual access from 17-Mile Drive and from major turnouts along the Drive shall be permanently protected as an important component of shoreline access and public recreational use. The policy guidance statement for Scenic and Visual Resources in the LUP recognizes the value of the areas magnificent scenic and visual resources and states that the objective of the plan is to "encourage improvements which complement the natural scenic assets and enhance the public enjoyment of them". LUP Policy 59 specifically requires that "New development, including ancillary structures such as fences constructed between 17-Mile Drive and the sea . . . be designed and sited to minimize obstruction of views from the road to the sea. Examples of methods to reduce obstruction include, but are not limited to the following: height limits, use of see-through materials for fences, limitations on landscape materials which would block views."

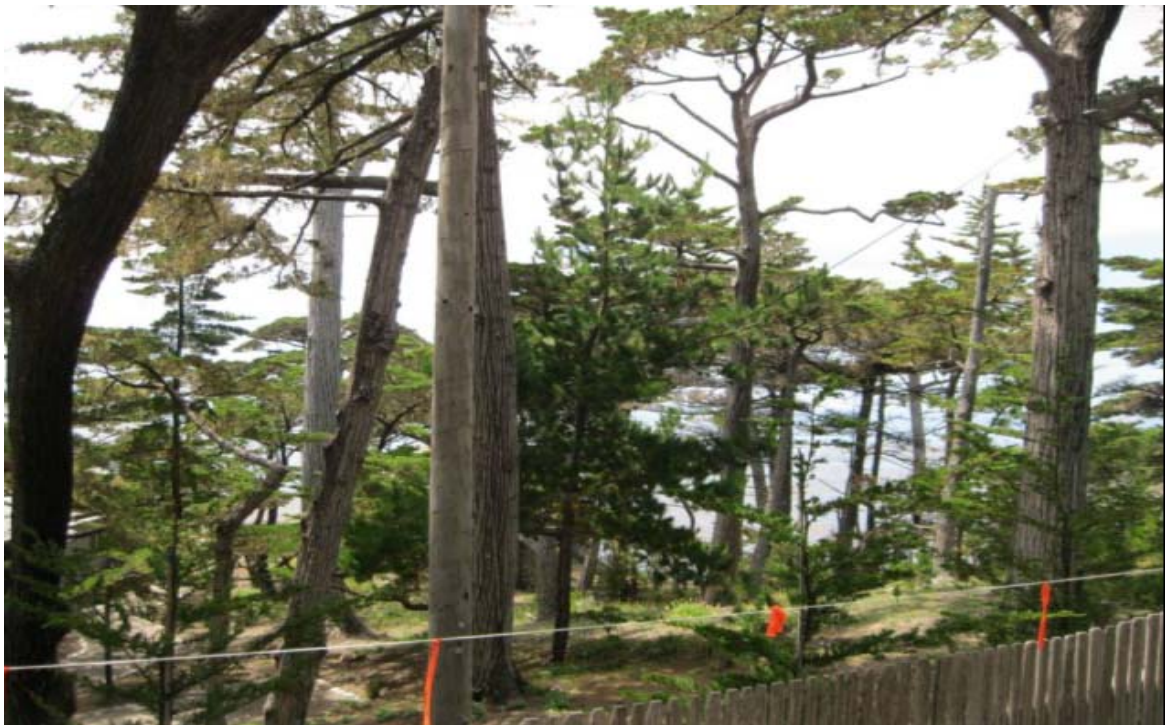
**Figure 3: Portion of Existing View from 17-Mile Drive (northeast portion)**

There is an existing approximately 4.5 to 6 foot tall wood “grapestake” fence at the front of the property along 17-Mile Drive, with an approximately 35 foot long section of shorter wire fence along the northeastern end. The view of the ocean from 17-Mile Drive varies as you drive along 17-Mile Drive passing the residence, but the ocean is visible through the Monterey cypress forest along almost the entire frontage. The existing wood fence design is such that, due to the spacing

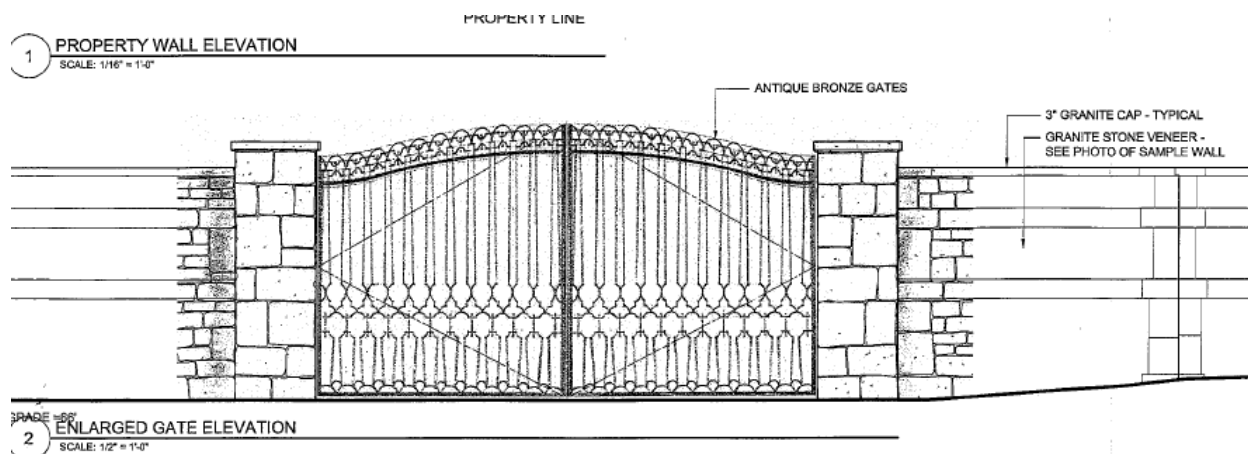
**Figure 4: Fence design at entrance**

**Mitigation Measure No. 1:** In order to prevent adverse impacts to the existing scenic vista and to the scenic character of the site due to the replacement of the existing fence and to ensure that the project complies with the Visual Resources and Public Access policies of the Del Monte Forest Land Use Plan, the proposed wall/fencing along 17-Mile Drive shall be designed and sited to minimize obstruction of views from the road to the sea. The proposed wall/fencing shall be designed so as to not impair views from 17-Mile Drive over the existing condition. Prior to the issuance of a building or grading permit, the applicant/owner shall submit revised plans for the wall/fencing to the RMA-Planning Department for review and approval that are consistent with the visual simulation provided to the County on June 21, 2012 including: 1) the top of the wall/fencing in Section A (between new driveway entrance and neighboring property to the northeast) as shown on the visual simulation shall be one foot lower than shown on the plans that were recommended for approval by the Del Monte Forest Land Use Advisory Committee on July 7, 2011; 2) the number of antique bronze fenced sections shall be increased from 5 to 6, with the additional section being located between the new driveway entrance and the neighboring property to the northeast; and 3) the open design fenced openings shall be increased from 9 feet long to 12.5 feet long.

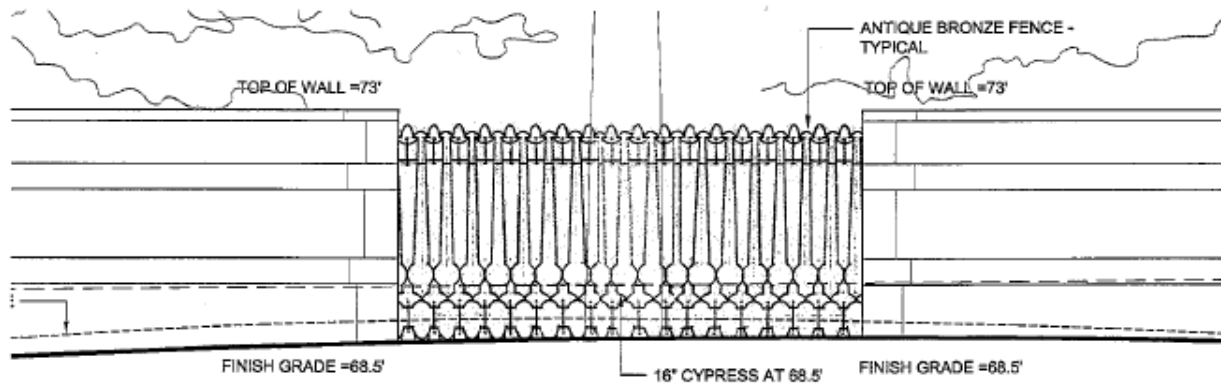
**Figure 5: Fence design at opening**

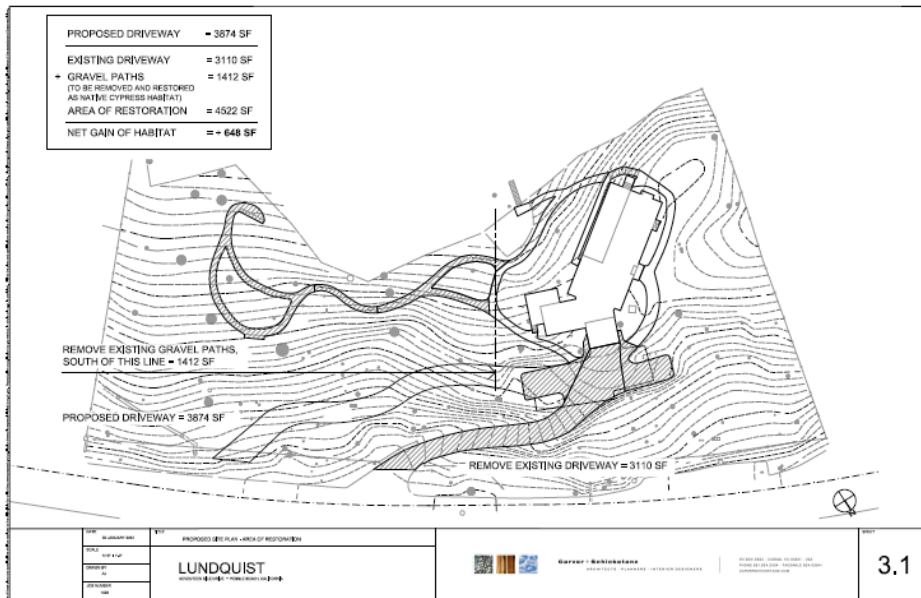
**Figure 6: Proposed Cypress Habitat Restoration Areas**

To mitigate for the removal of native Monterey cypress habitat, the applicant/owner shall prepare and implement a Monterey Cypress Habitat restoration plan for the existing asphalt driveway and the existing gravel paths and parking areas and all other areas that will be disturbed due to construction. The restoration plan shall be prepared by a qualified biologist in consultation with a qualified arborist and shall include measures to protect adjacent Monterey cypress trees during the restoration. Installation of the restoration plan shall be done under the supervision of a qualified biologist. The restoration plan shall also include a planting plan that includes mulching, the installation of Monterey cypress trees propagated from trees indigenous to Pebble Beach, appropriate Monterey cypress forest understory plants and a plan for the eradication of non-native species. Plants and seeds shall consist of appropriate local ecotypes of plant species and site-specific seed and/or cuttings shall be utilized. It is not expected that restoration to native Monterey cypress habitat will require excessive plantings. The removal of non-native species and installation of mulch and minimal appropriate native plantings to allow native understory plants to regenerate in areas that do not require erosion control plantings is preferable. The applicant/owner shall submit a monitoring report prepared by the project biologist documenting the success of the restoration to the RMA-Planning Department 6 months after the initial planting and then annually for 2 years. The restoration shall be considered successful when 95 percent of replanted trees, 85 percent of other planted native vegetation have survived and are evaluated by the project biologist and project arborist as being in good health, and 100 percent of non-native invasive plants within the restoration areas have been eradicated. In the event of loss of plant materials due to mortality, the plants shall be replaced and the monitoring shall begin again.

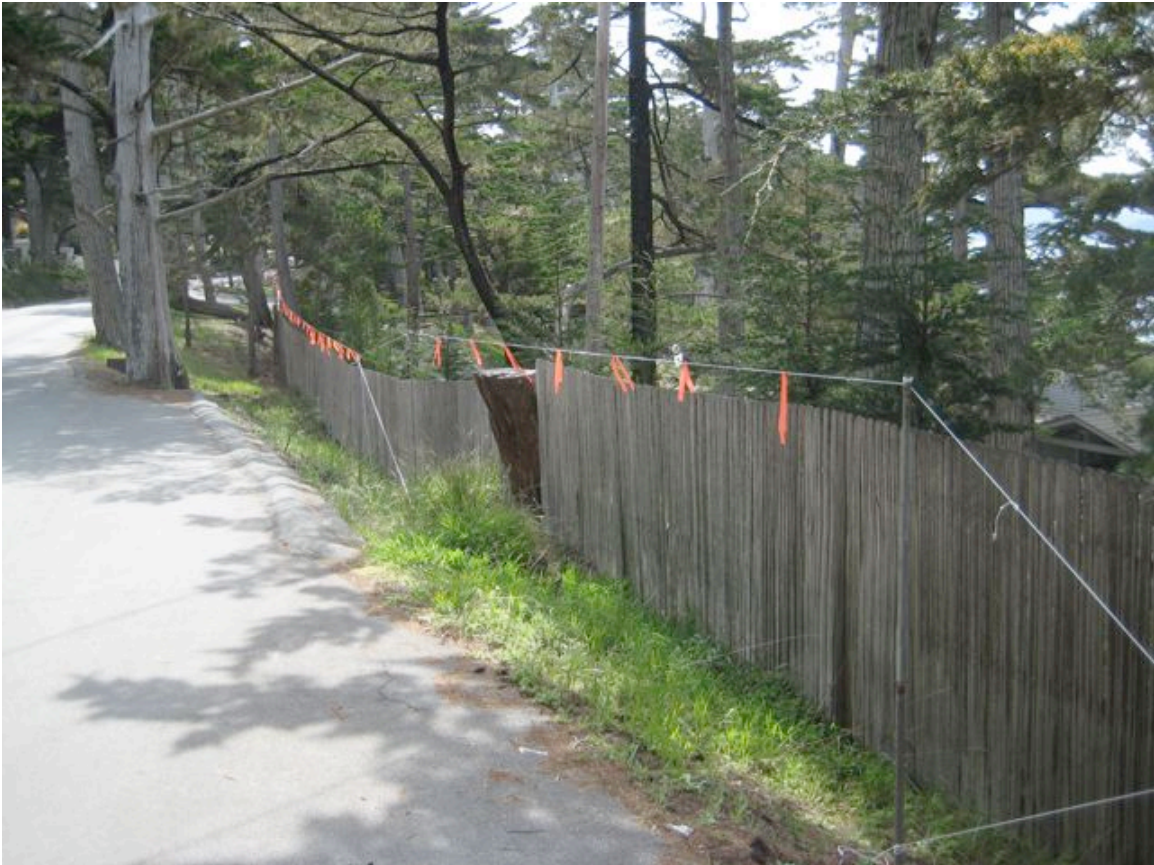
1. Existing fence and proposed (flagged) privacy wall location. NW corner facing south.

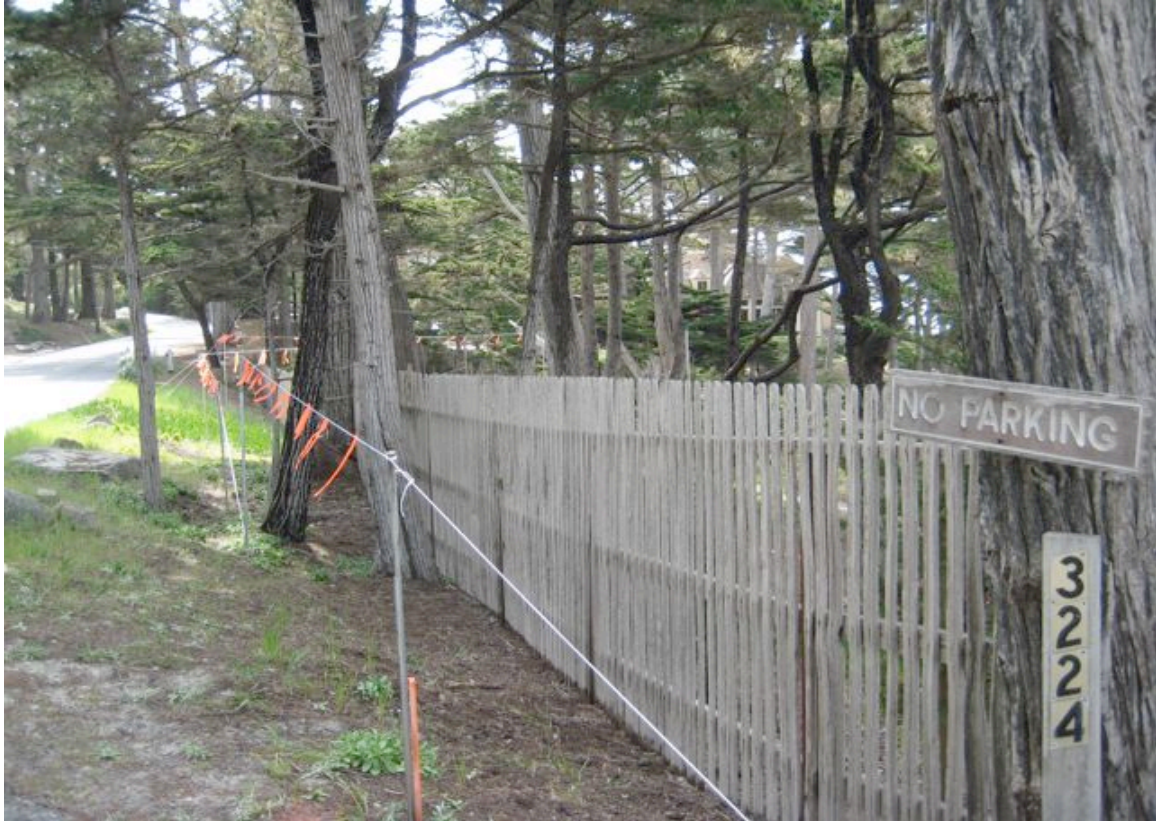
2. Existing fence and proposed (flagged) privacy wall location. NW corner of existing driveway entry facing east.

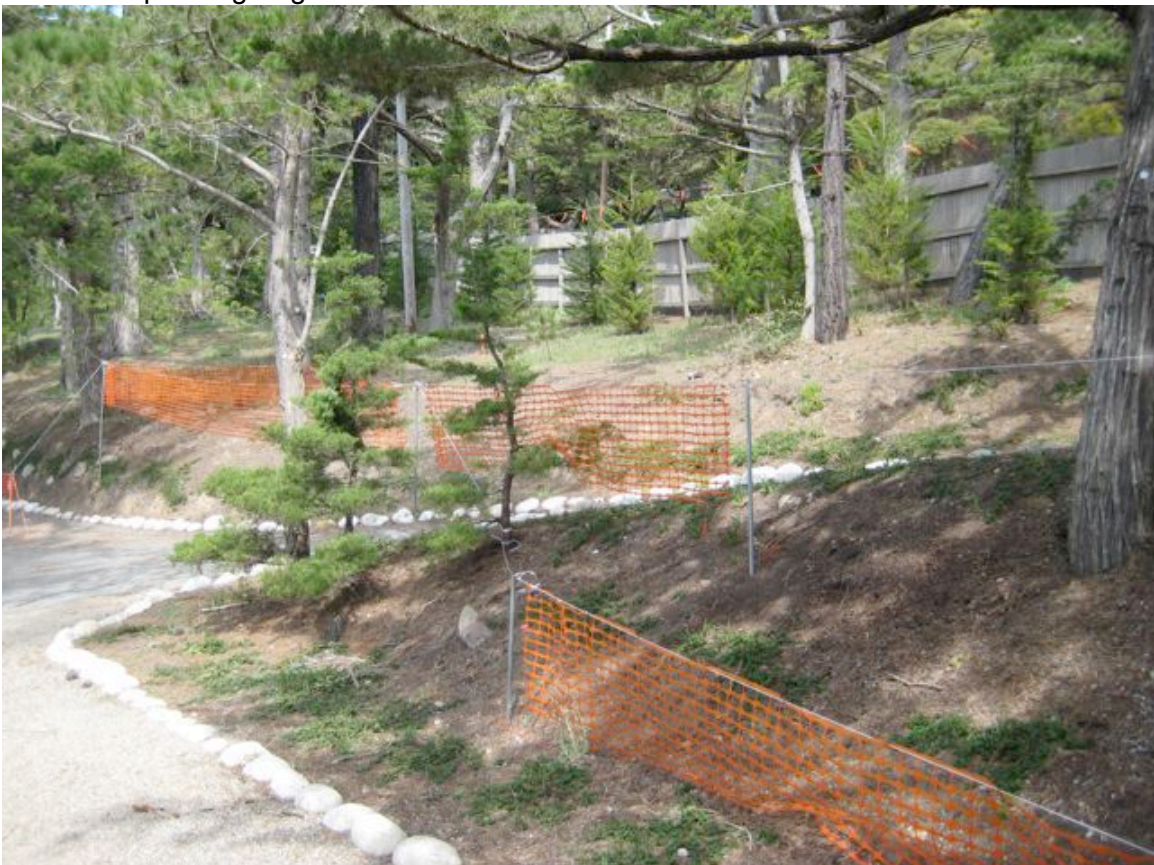
5. Proposed garage area.

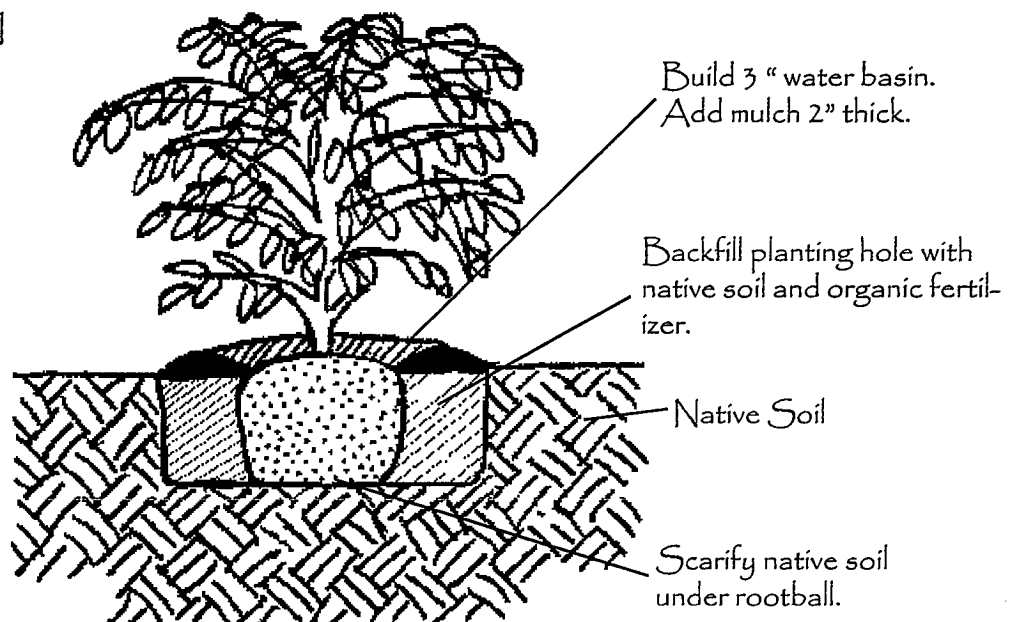
### Planting Detail

- Success is defined as 80% survival at the end the year, with new growth evident on the understory species and survival of the cypress seedling, showing good vigor and growth. The results shall be reported to County of Monterey, Planning Department. Failure to meet the success criteria will require the replanting, maintance and monitoring until success is achieved.

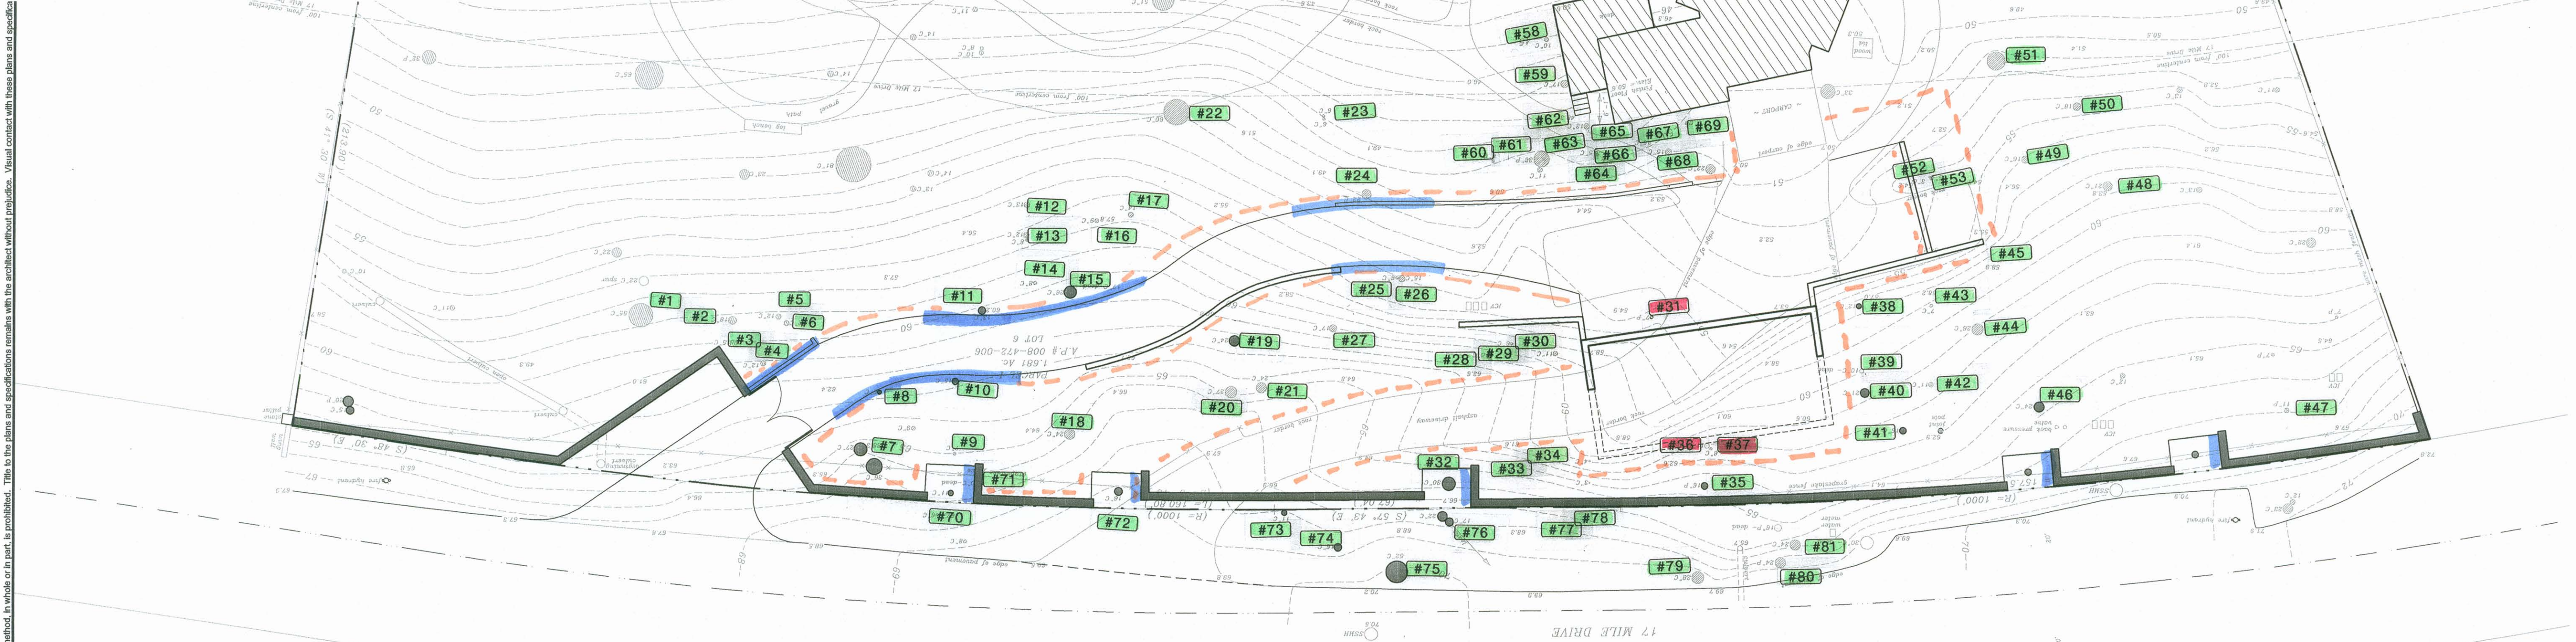
TREE LOCATION & PROTECTION PLAN  
3224 17 MILE DRIVE, PEBBLE BEACH  
April 2011

- PROTECT IN PLACE
- REMOVE OR RELOCATE
- SPECIAL CONSTRUCTION AREA
- EXCLUSIONARY FENCING AND STRAW BALE BARRICADES

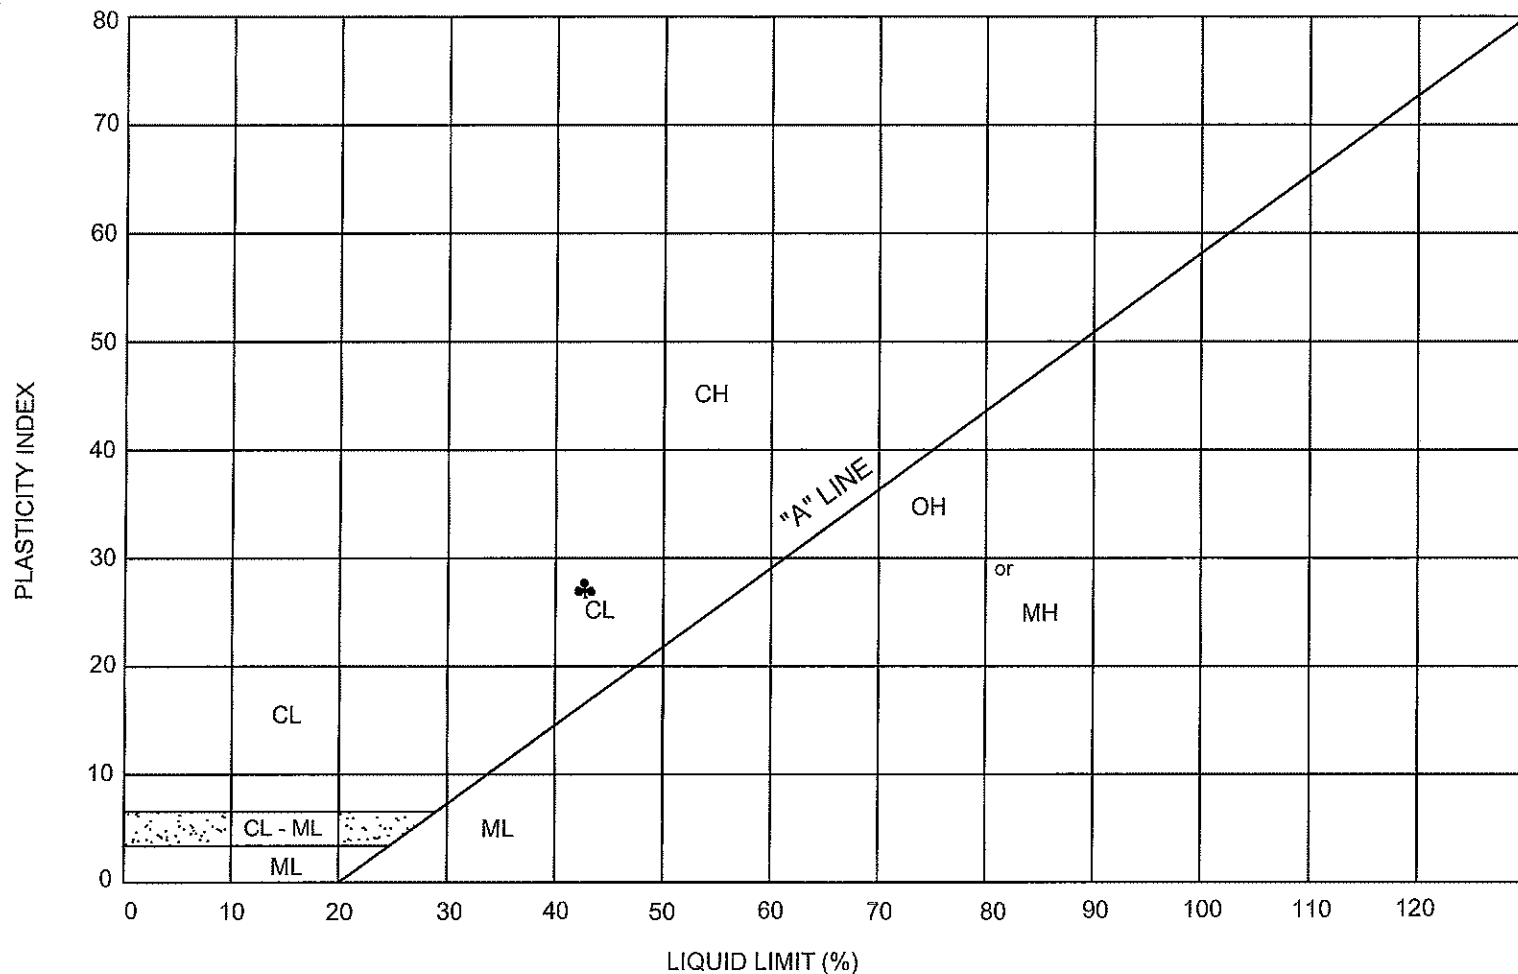
FIGURE NO. 12

# PLASTICITY CHART

## PLASTICITY DATA

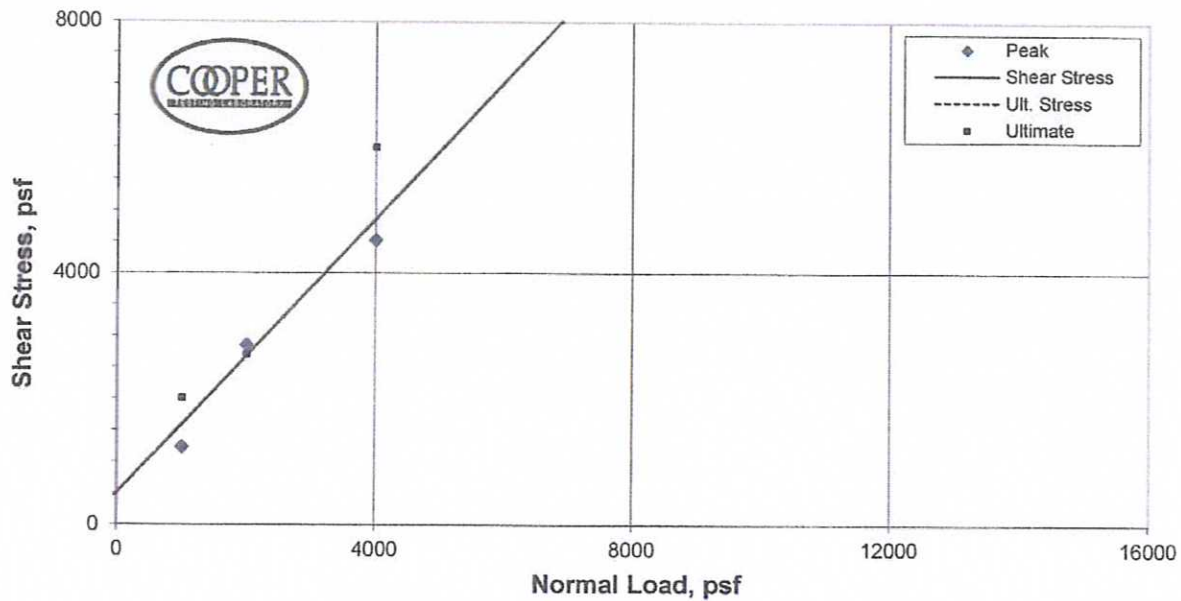
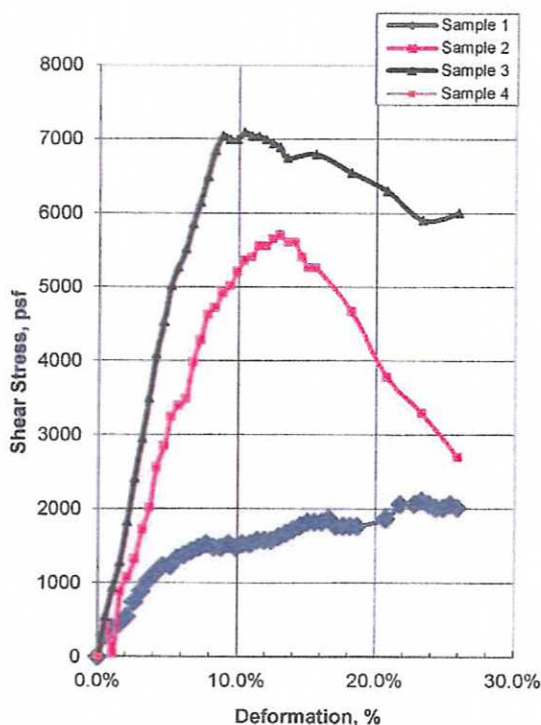
# Direct Shear

(Consolidated-Undrained)

| P. Phi (degrees) | 46 | Ult. Phi (degrees) | |
| P. Cohesion (psf) | 500 | Ult. Cohesion (psf) | |

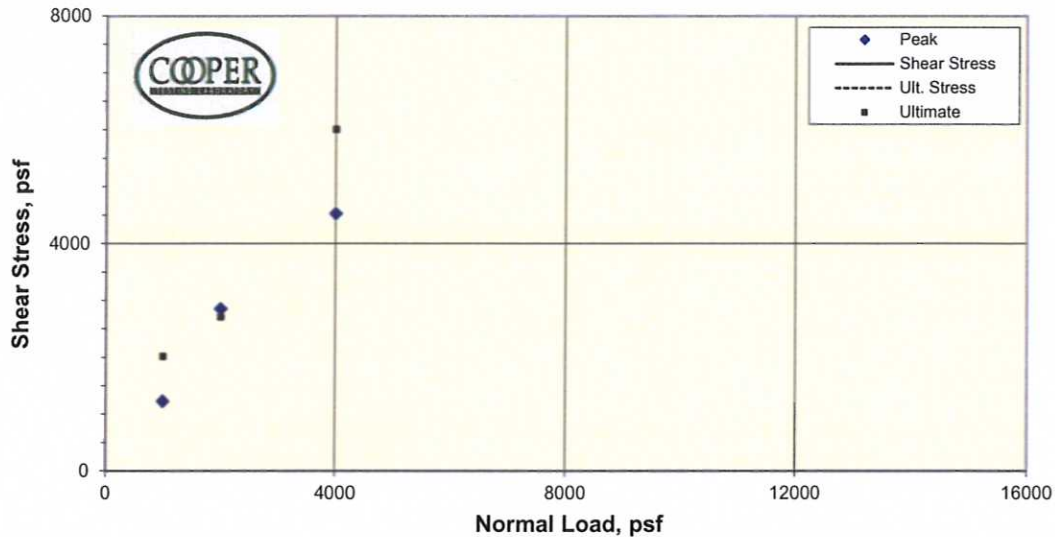
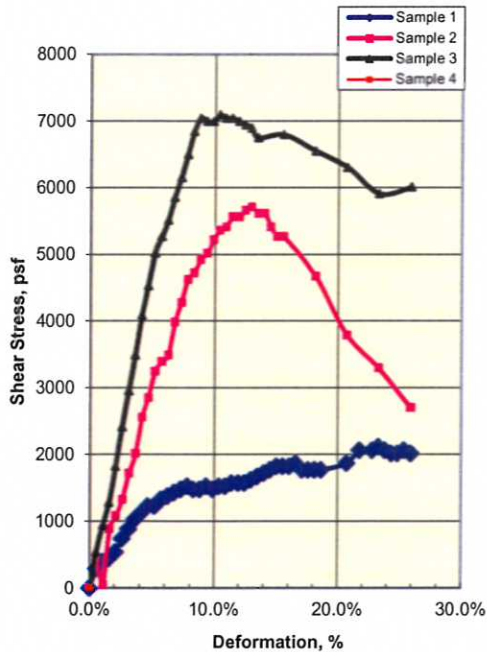
# Direct Shear

## (Consolidated-Undrained)
