INITIAL STUDY

Project Title: Raiser House Combined Development Permit

File No.: PLN100396

Project Location: 30650 Aurora Del Mar, Carmel, CA 93923

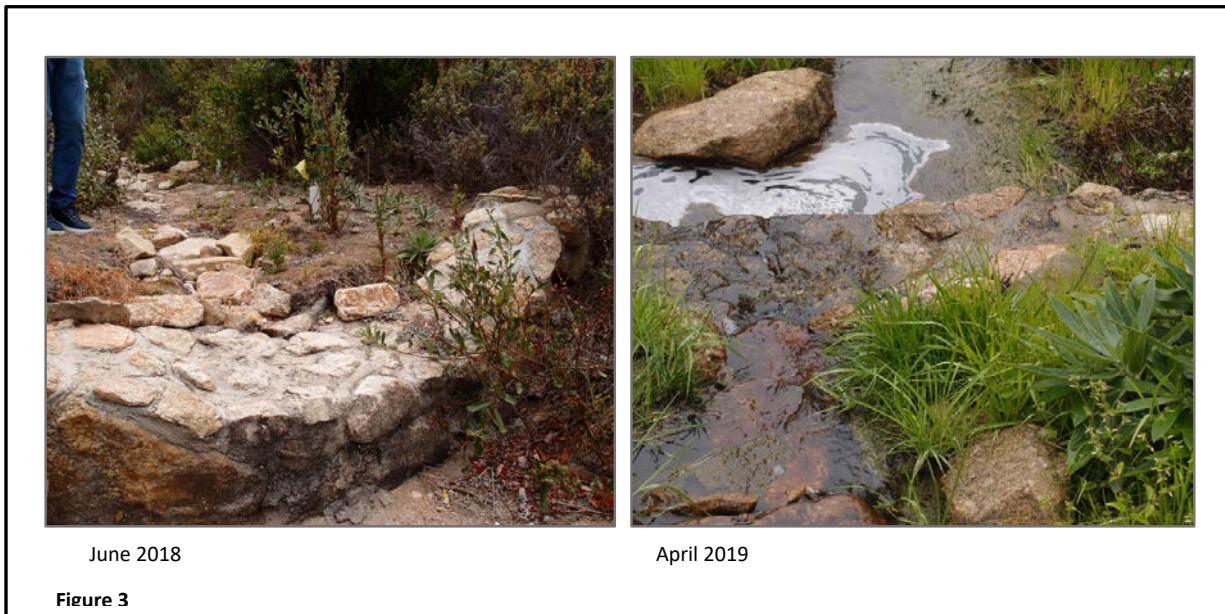
Figure 3

The County of Monterey is requiring Coastal Development Permits as a follow-up to the previously issued Emergency Coastal Development Permit for the project. The follow up permits constitute a Combined Development Permit (CDP) for: retaining wall construction, development on slopes in excess of 30 percent, drainage improvements, and development in an environmentally sensitive habitat area with archaeological sensitivity. As part of the CDP, the County, the California Coastal Commission (CCC), and the California Department of Fish and Wildlife (CDFW) required that dry-weather and stormwater flows up to the 2-year storm event are restored to the channel in order to maintain habitat and ephemeral stream function. The storm water inlet at the eastern reach of the arroyo is designed to allow surface flow during rain events. The weir tops within the arroyo are flush with the arroyo bottom so as not to impede surface flows. Refer to **Figure 3** below.

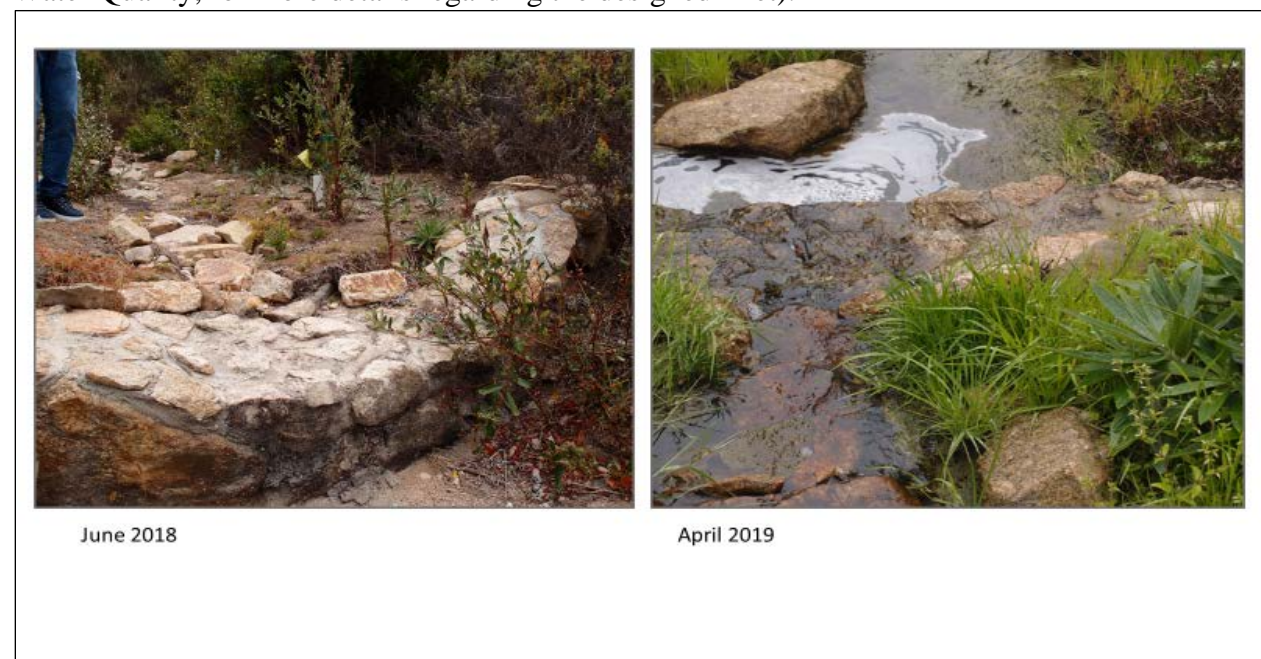
Figure 3

Allowing low-flow volumes, up to a two-year storm event, in the drainage channel and replanting the channel bed, the channel banks, and the Hilfiger wall with native species has improved the riparian and coastal bluff scrub habitats compared to the conditions that existed prior to the high-flow event that scoured the banks of the arroyo. **Figure 3** above shows the arroyo bottom and a

weir with water flowing in the April 2019 photograph. **Figure 4** below shows surface water flow and the restored habitat of the arroyo during April 2019.
