**Biotic assessment for the Stormwater Detention Pond
for Agricultural Runoff at Packard Ranch**

BIOTIC REPORT

July 5, 2023
Revised 11/7/2023

Stormwater Detention Pond for Agricultural Runoff

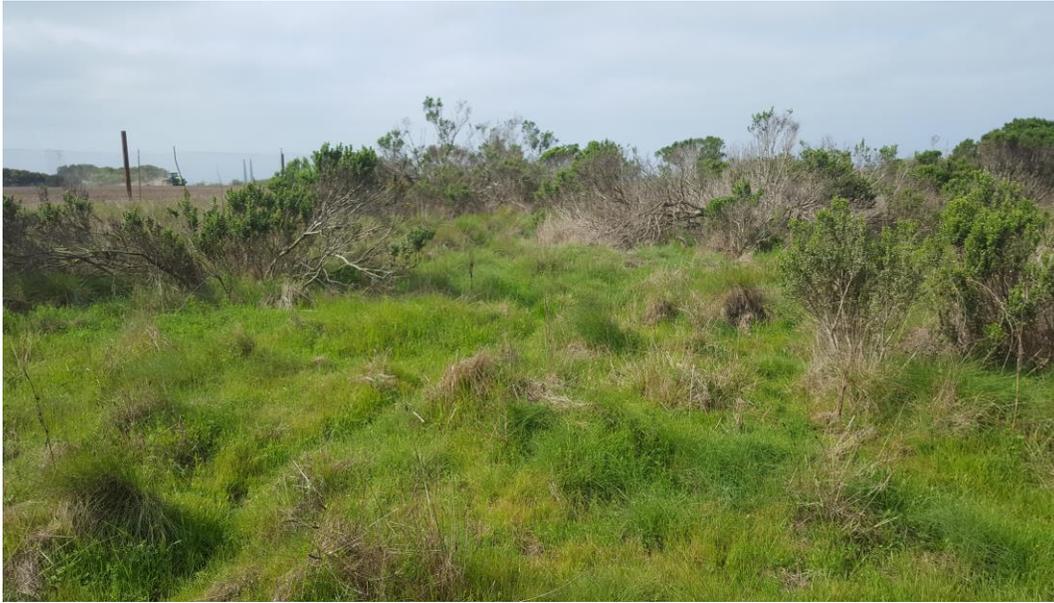
The majority of the vegetation in the project area is classified as coyote brush scrub. This portion of the property was retired from agriculture production and restored by the landowner pre- 2004. It is dominated by coyote brush (*Baccharis pilularis*) and a groundcover of native perennial grasses including tufted hairgrass (*Deschampsia caespitosa*) and red fescue (*Festuca rubra*). The character of the coastal scrub, which dominates the project area, is depicted in Photo 1.

Photo 1. Coastal Scrub Habitat Dominated by Coyote Brush

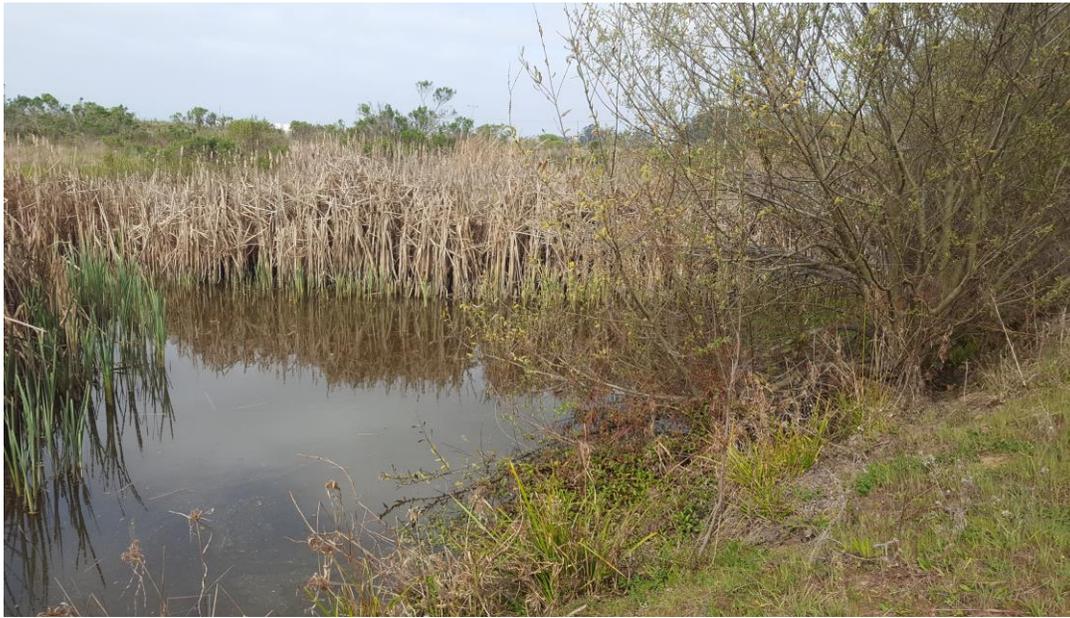
The existing pond consists of predominantly open water habitat with surrounding marsh, dominated by broadleaf cattail (*Typha latifolia*), willow (*Salix* sp), and yellow nutsedge (*Cyperus esculentus*). The character of the marsh is depicted in Photo 2.

Photo 2. Open Water and Marsh Habitat

The wildlife value of the marsh at this site is low because of its size. Cattails provide nesting sites for red-winged blackbirds, ducks and geese. However, the steep side slopes limit the growth of seed-bearing species, such as swamp timothy, which is critical for migrating bird species. Limited open water habitat limits the use by the California red-legged frog and the lack of basking habitat limits use by the Western pond turtle. A comprehensive list of birds observed in November 2017, documented nearly 80 bird species on the property (<https://ebird.org/checklist/S40306484>). Many of these could use this marsh for nesting and cover. However, the project will improve the quality and quantity of habitat for these species.

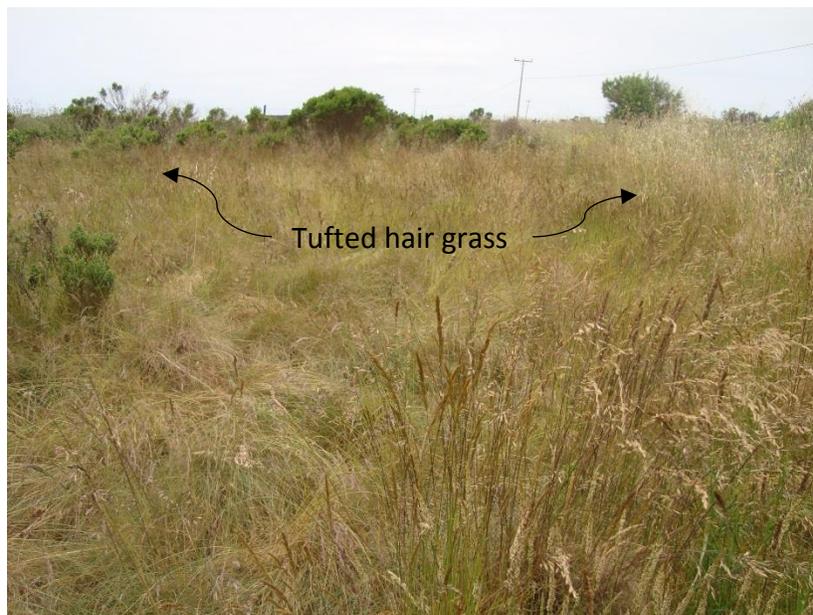
The coyote brush scrub is the dominate vegetation type; it is comprised of scattered coyote brush shrubs intermixed with native and non-native grasses and forbs. At the June 2023 site visit, tufted hair grass, non-native wild oat (*Avena sp.*), non-native soft chess (*Bromus hordeaceus*), and non-native Italian thistle (*Carduus pycnocephalus*) provided the most cover. Other plant species include red fescue (*Festuca rubra*), Italian ryegrass (*Lolium [Festuca] multiflorum*), spring vetch (*Vicia sativa*), poison hemlock (*Conium maculatus*), and bull thistle (*Cirsium vulgare*). There were scattered occurrences of blue wild rye (*Elymus glaucus*) and purple needlegrass (*Stipa pulchra*). Shrubs of lizard tail (*Eriophyllum staechadifolium*) and blue elderberry (*Sambucus nigra*), were observed near the access road. The stands of native grasses (primarily tufted hair grass) range in their percent cover. Some stands exhibited dense cover of hairgrass (i.e., 80% cover); however, most stands were in the 40-50% cover range, with non-native wild oat, soft chess, and Italian thistle being the other species. The character of a dense stand of tufted hair grass (80% cover) is depicted in **Figure 1**.

Figure 1. View westerly of dense stand of tufted hairgrass (occurrence #12), June 2023

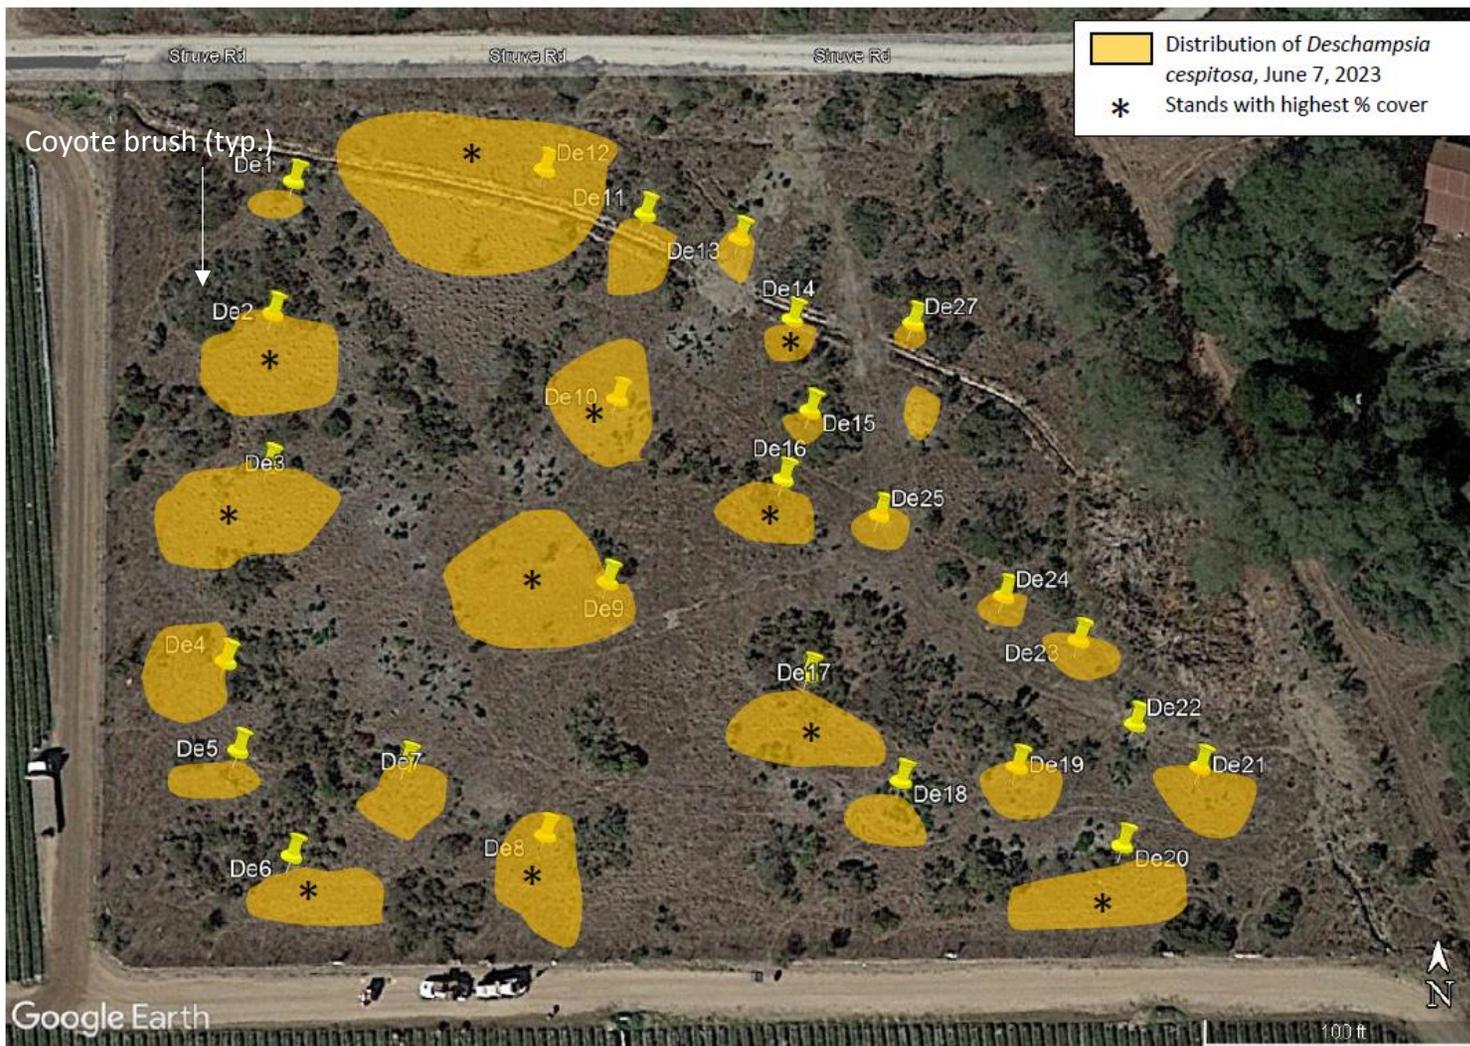
Twenty-seven stands of tufted hairgrass were documented on site. Eleven of these stands had cover values of over 50%. The distribution of these occurrences is depicted on **Figure 2**.

Figure 2. Distribution of *Deschampsia cespitosa*, June 2023

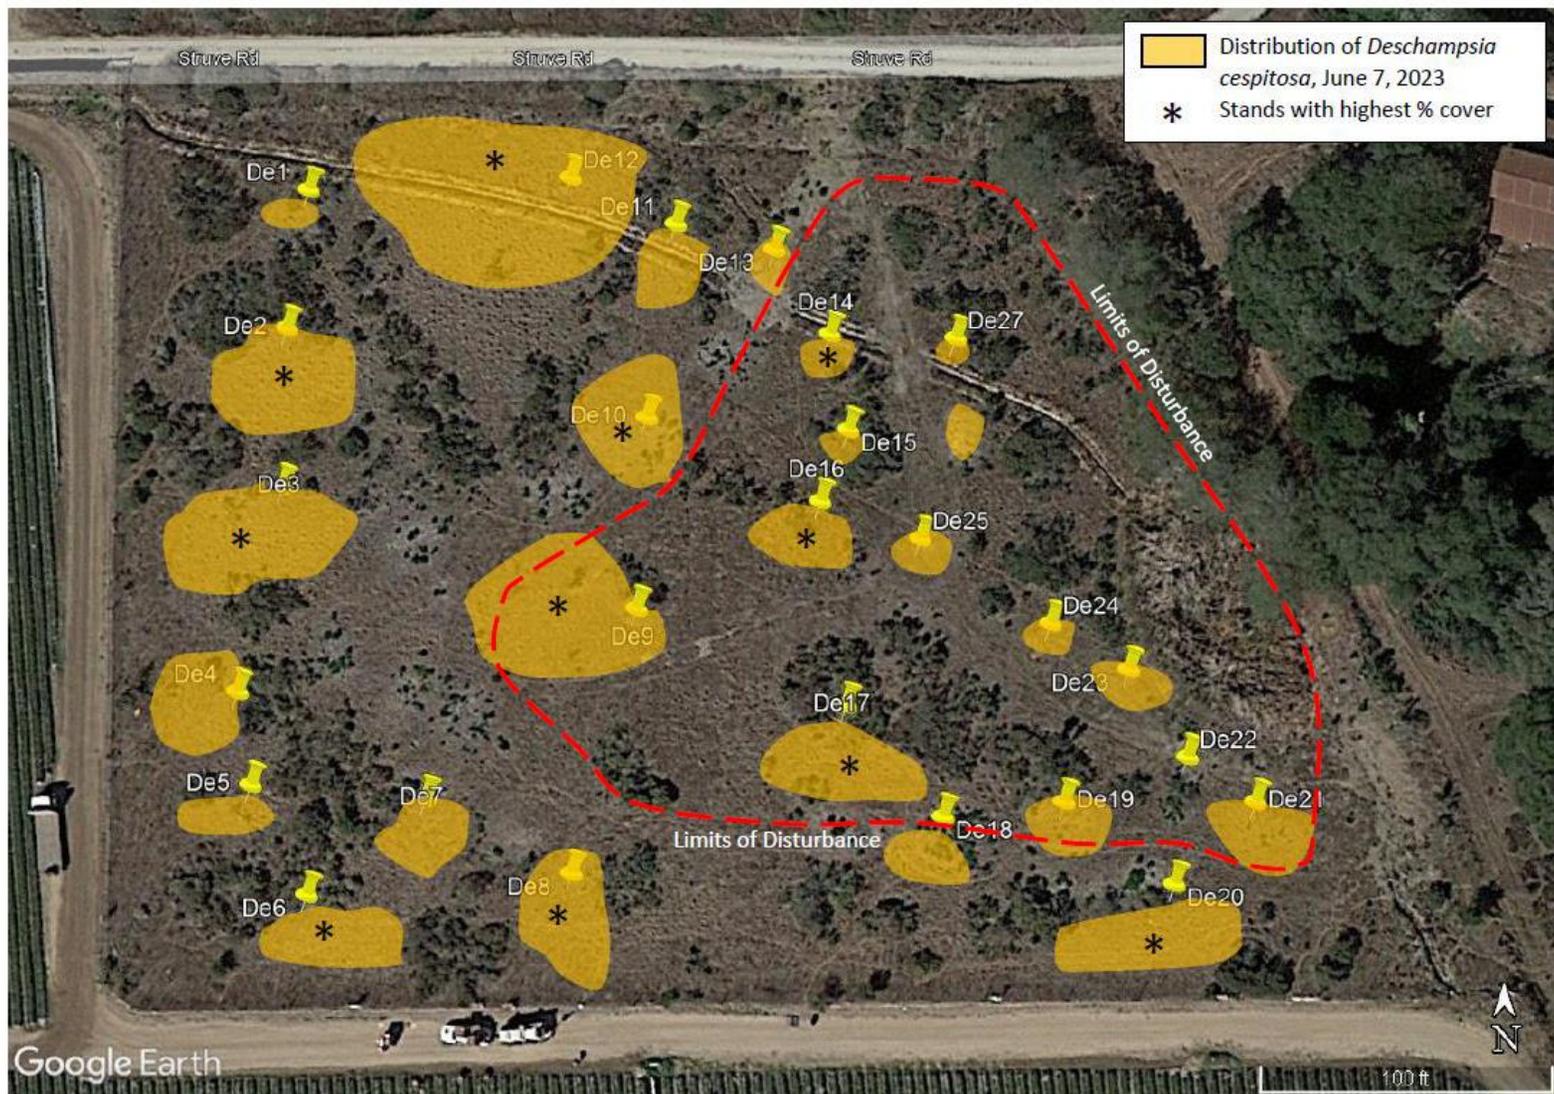
Figure 3. Limit of Disturbance Line and distribution of *Deschampsia cespitosa*, June 2023

Recommendation: *The applicant shall implement a tufted hairgrass salvage and re-planting plan. Plants shall be salvaged from the impact area and re-planted on-site outward of the new detention basin in areas temporarily impacted by construction, or other areas, if needed. Each salvaged plant shall have a minimum root/soil thickness of four inches. The transplants shall be kept moist and cool; the salvage and transplant are recommended in 1 day; however, if plants need to be held over, plants shall be covered with wet burlap or equivalent until they are installed.*
