# **SPRING FLOW MONITORING, RAIN WATER HARVESTING & WATER QUANTITY/QUALITY REPORT**

**April 16, 2018**

**Prepared For:**  
**Theo Maehr**  
**38059 Palo Colorado Rd.**  
**(Long Ridge)**  
**Carmel, Ca 93923**

**Prepared By:**  
***Bierman Hydrogeologic***  
***A Professional Corporation***

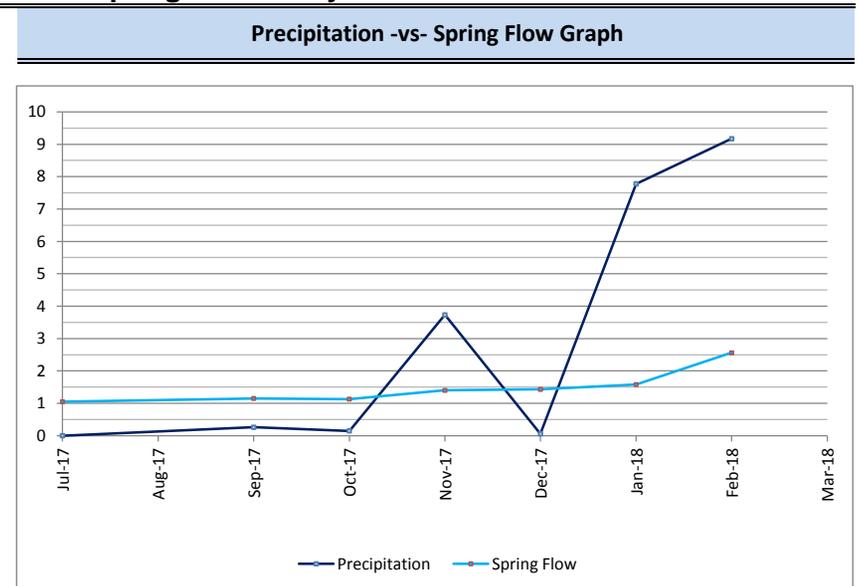
Precipitation -vs- Spring Flow Data		
Date	Precipitation (in)	Spring flow (gpm)
Jul-17	0	1.05
Sep-17	0.26	1.15
Oct-17	0.15	1.13
Nov-17	3.73	1.4
Dec-17	0.06	1.43
Jan-18	7.78	1.58
Feb-18	9.17	2.56

#1: Only 50% capture obtained due to lack of spring box, underflow and plant uptake

In a comparison of the precipitation versus the spring flow data obtained to date (Table 2) it is noted that the spring-flow does not appear to be directly related to precipitation. Specifically, as shown on the Graph of Figure 2, the amount of precipitation in November-2017 shows a significant increase and in December-2017 a significant decrease. Whereas, the spring flow tends to only increase and decrease slightly relative to precipitation values/amplitudes. Generally, if springs are directly connected to precipitation and precipitation percolated as recharge, spring flow curves and amplitude would be very similar to that of the precipitation curve/amplitude which is not necessarily observed, suggesting a lag-time of percolated precipitation to emerge as spring flow. The lag-time for percolated recharge as precipitation has not been thoroughly determined.

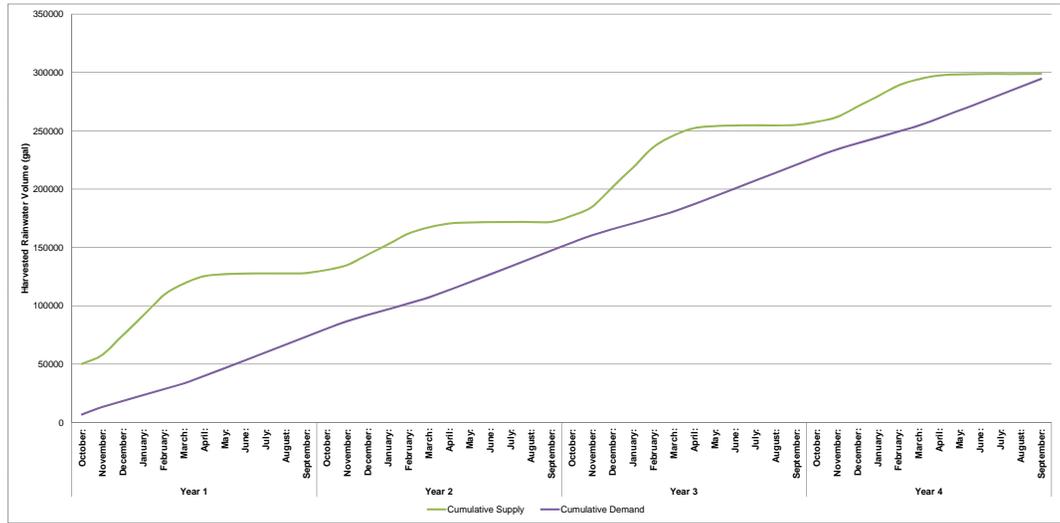
Calculated Output Values		
Existing Storage Capacity(gal):	56,940	
Recommended Tank Capacity based on Year 1-4 Precipitation Analysis(gal):	85,594	
Recommended Increase in Storage Volume (gal):	14,327	
Minimum volume observed (gal):	4,344	
Months below desired minimum volume for Fire Protection:	3

May:	872	6499	298376	267412	30964	0
	June:	324	6789	298700	274201	24499	0
Year 4	July:	11	6789	298711	280990	17721	1
	August:	11	6789	298722	287779	10943	1
	September:	190	6789	298912	294568	4344	1

- <sup>1</sup> Indoor Water Demand (afy and gals/yr) derived from MPWMD interior use factors and is sum of Main Residence (Table 3) & Accessory Structure (Table 4) demands divided by 12 months.
- <sup>2</sup> Exterior Demand derived from MPWMD Water Use Factors (Table 5) and divided by 8 months.
- <sup>3</sup> Winter exterior demand is zero except on for use with farm animals.
- <sup>4</sup> Remaining 1/3 of exterior demand (after farm animal use) is used in Spring.
- <sup>5</sup> Remaining 2/3 of exterior demand (after farm animal use) is used in Summer.
- <sup>6</sup> As of 2/28/18 there was approximately 45,000 gallons of storage - Personal Communication with Applicant.

In summary, assuming drought and most-probable reoccurrence interval water years occur over the next 4-years, and, if the water demand is accurate (which it appears to be slightly elevated to actual use especially since the system survived the worst drought in recent history and was able to survive the fire) the RWH supply may be less than demand in year #4 and therefore, as a back-up, the spring water may be needed to offset water supply. It is therefore recommended that either the spring be incorporated into the water supply for the existing structures or, additional storage is added to the RWH system to maximize storage in a average and above average precipitation years and retain extra volume in drought years especially for fire protection.

- 2) It is recommended that the RWH system increase storage by roughly 14,970 gallons (three, 4,990-gallon tanks) to maximize storage in average and above average water-years and, to offset fire protection and retain water during drought conditions in less than average water-years.

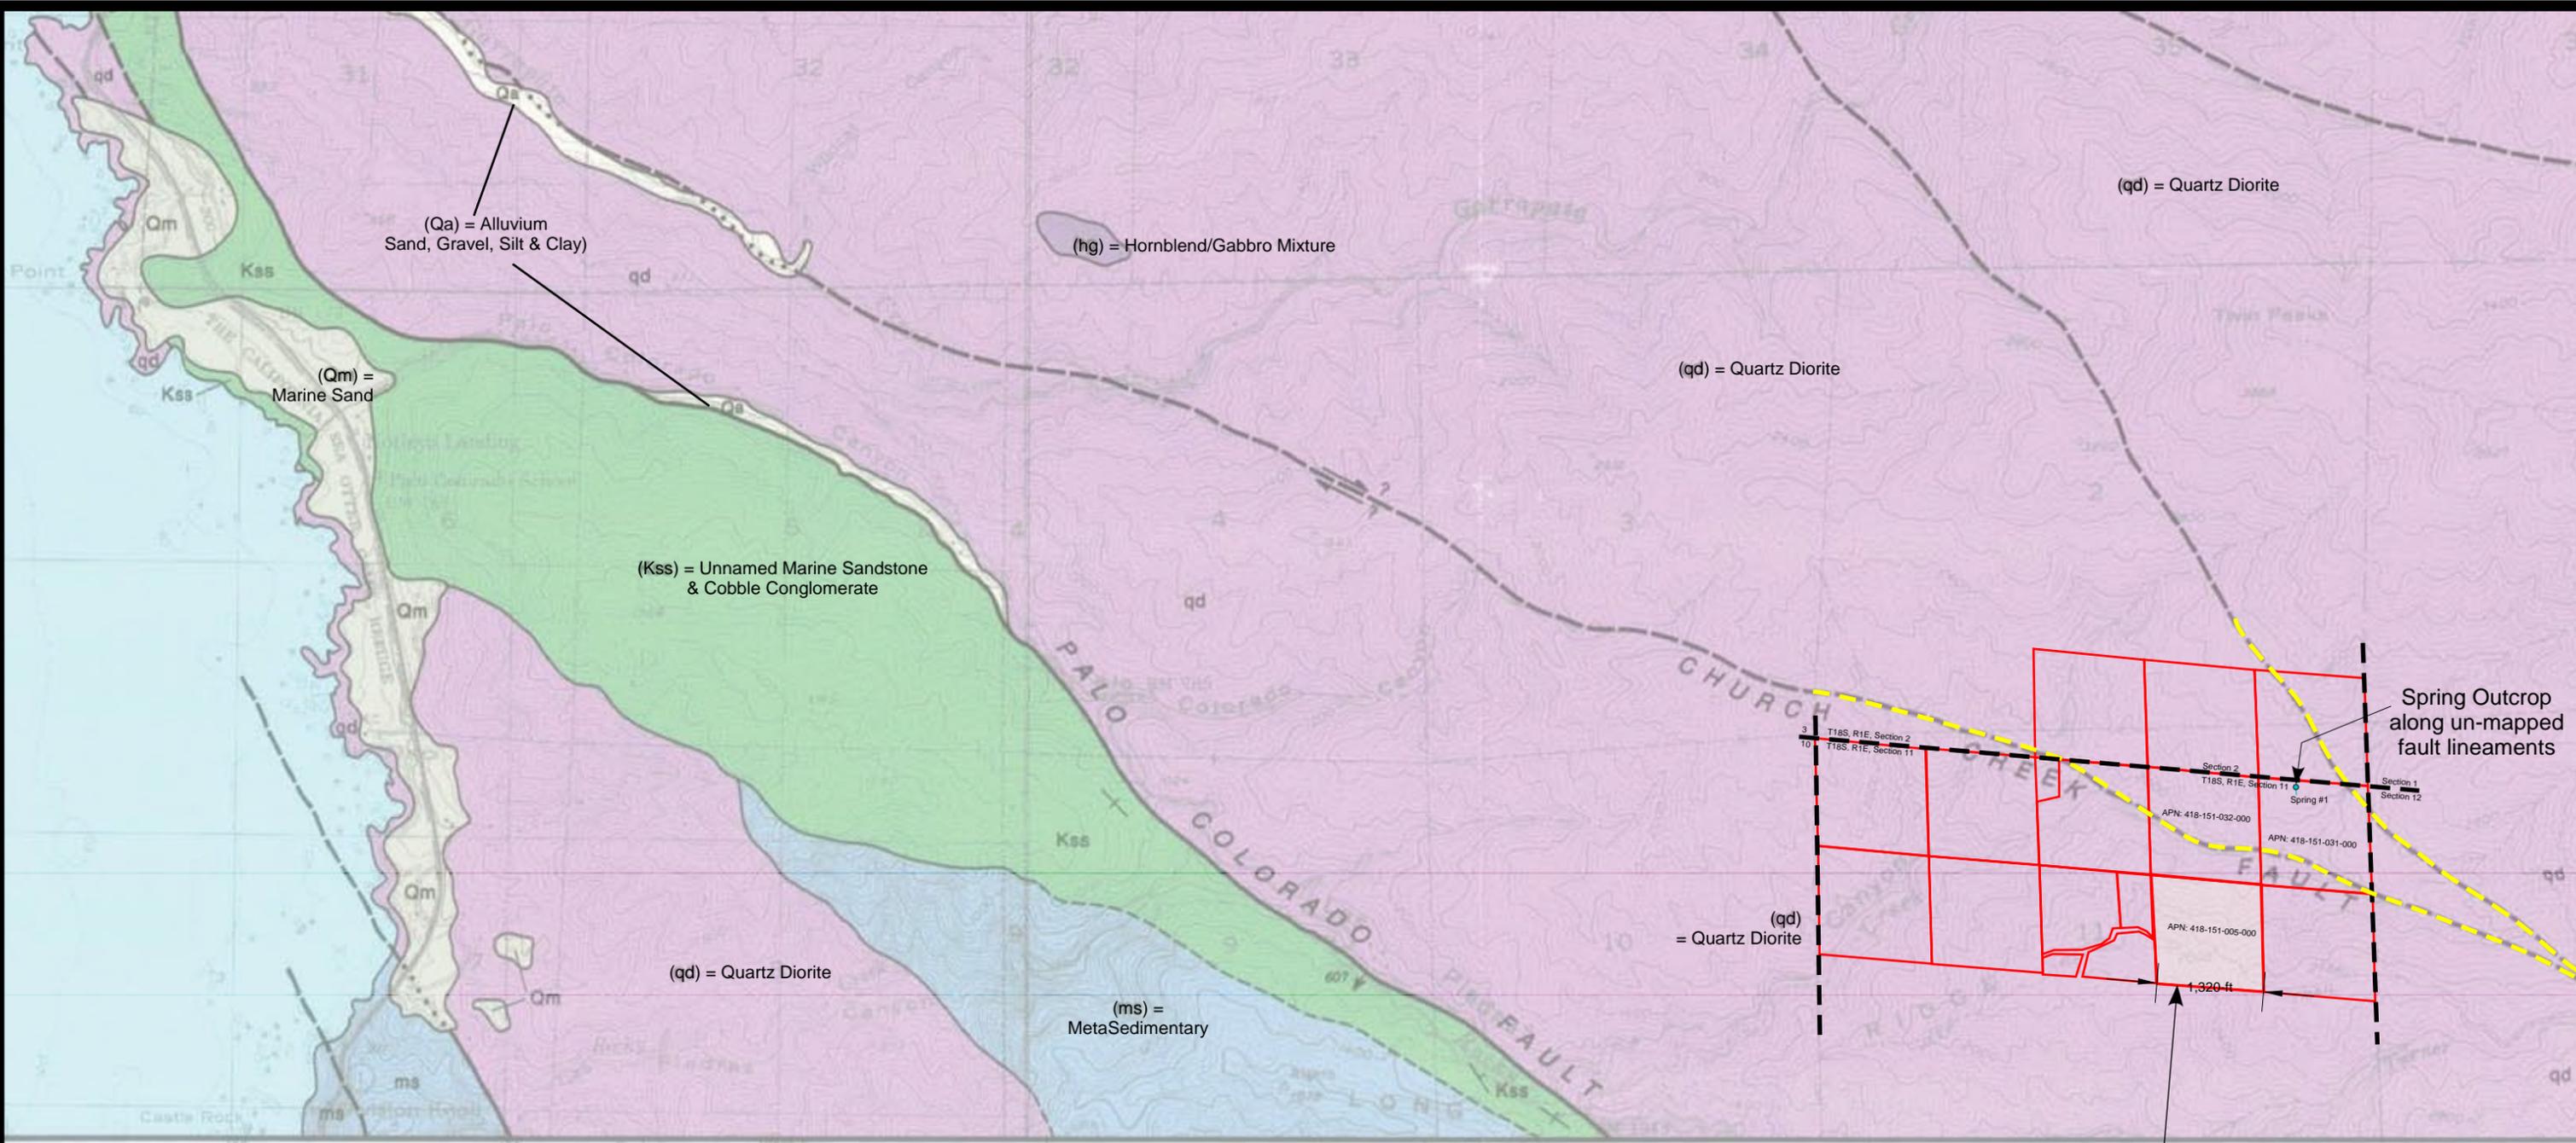
**FIGURE 3**

Basemap from USGS Soberanes Point and Mt. Cramel Quadrangles, Dibblee Jr., 2007

**GEOLOGIC MAP**  
APN: 418-151-005-000  
MONTEREY COUNTY, CALIFORNIA

Geologic Map, Figure 3, shows the regional related faults in the area which trend northwest-southeast offsetting sedimentary, meta-sedimentary and granitic rocks, resulting in steep, narrow canyons with friable regolith and thus prone to landslides. Stream canyons frequently follow fault splays, hence, most canyons, near-parallel the coast rather than descend directly in to it. The highest peaks are generally granitic rock because they are more resistant to erosion, although, they may also be marble (metamorphosed limestone). In areas where stream erosion is minor, there are still exposures of sandstone and siltstone sediments that have been tilted and/or folded and lay atop more rigid bedrock.

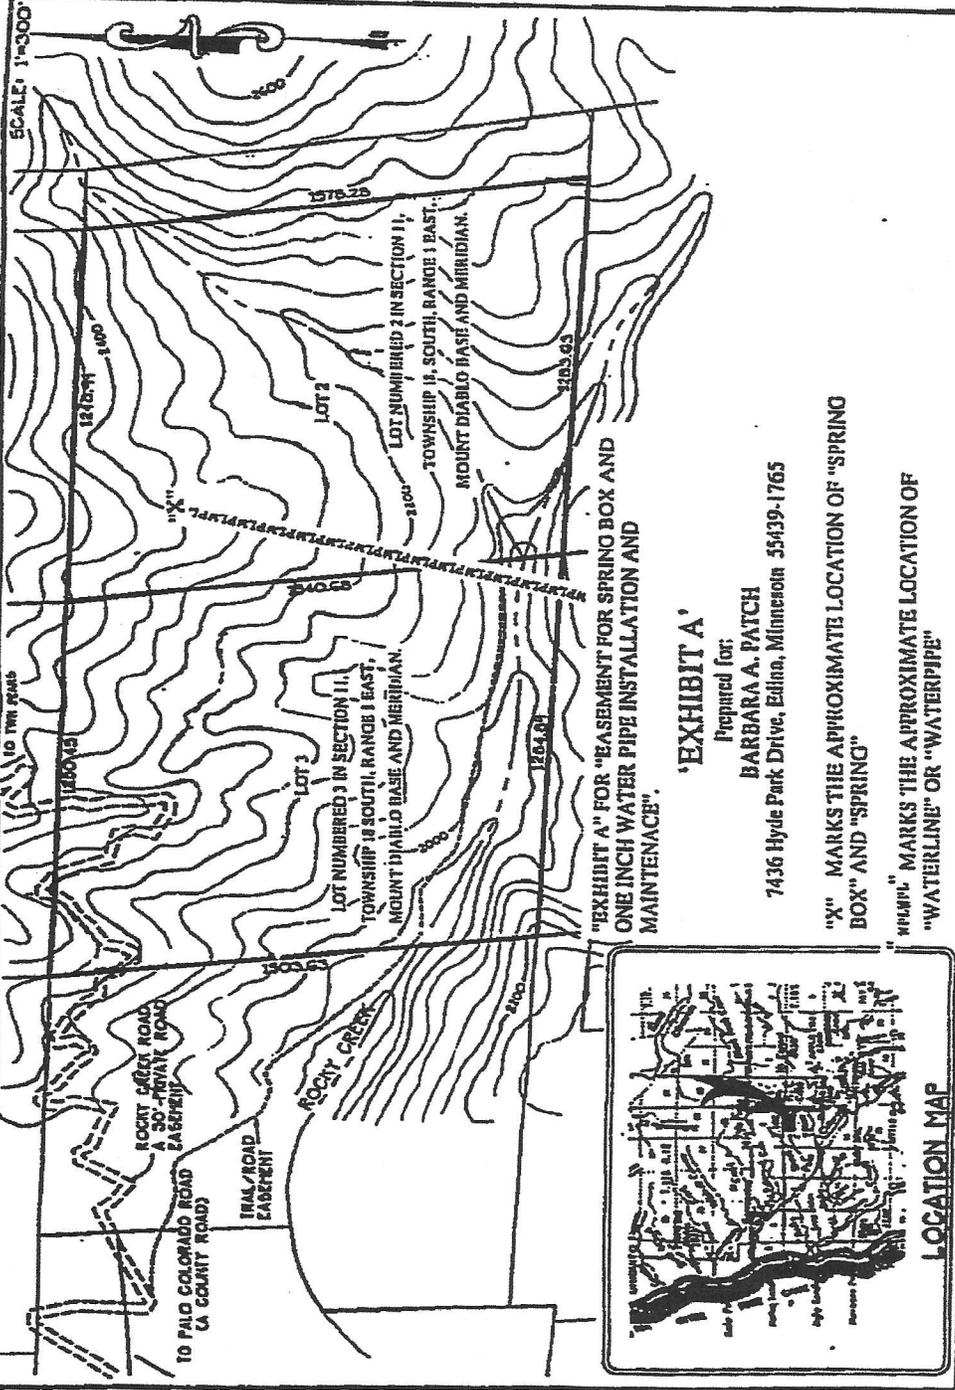
"EXHIBIT A" FOR "EASEMENT FOR SPRING BOX AND ONE INCH WATER PIPE INSTALLATION AND MAINTENANCE".

"X" MARKS THE APPROXIMATE LOCATION OF "SPRING BOX" AND "SPRING"

"#P#P#" MARKS THE APPROXIMATE LOCATION OF "WATERLINE" OR "WATERPIPE"

WHEREAS, GRANTOR has agreed to convey a perpetual easement  
to Grantee for the installation and exclusive use of a "spring" and "spring  
box" to be located in that approximate location as identified and noted on the  
attached "Exhibit A".

WHEREAS, Grantor has agreed to convey a perpetual easement to Grantee for the installation and use of a water pipe not to exceed one inch in diameter. Said water pipe to be located along the approximate line as identified and noted on the attached "Exhibit A".

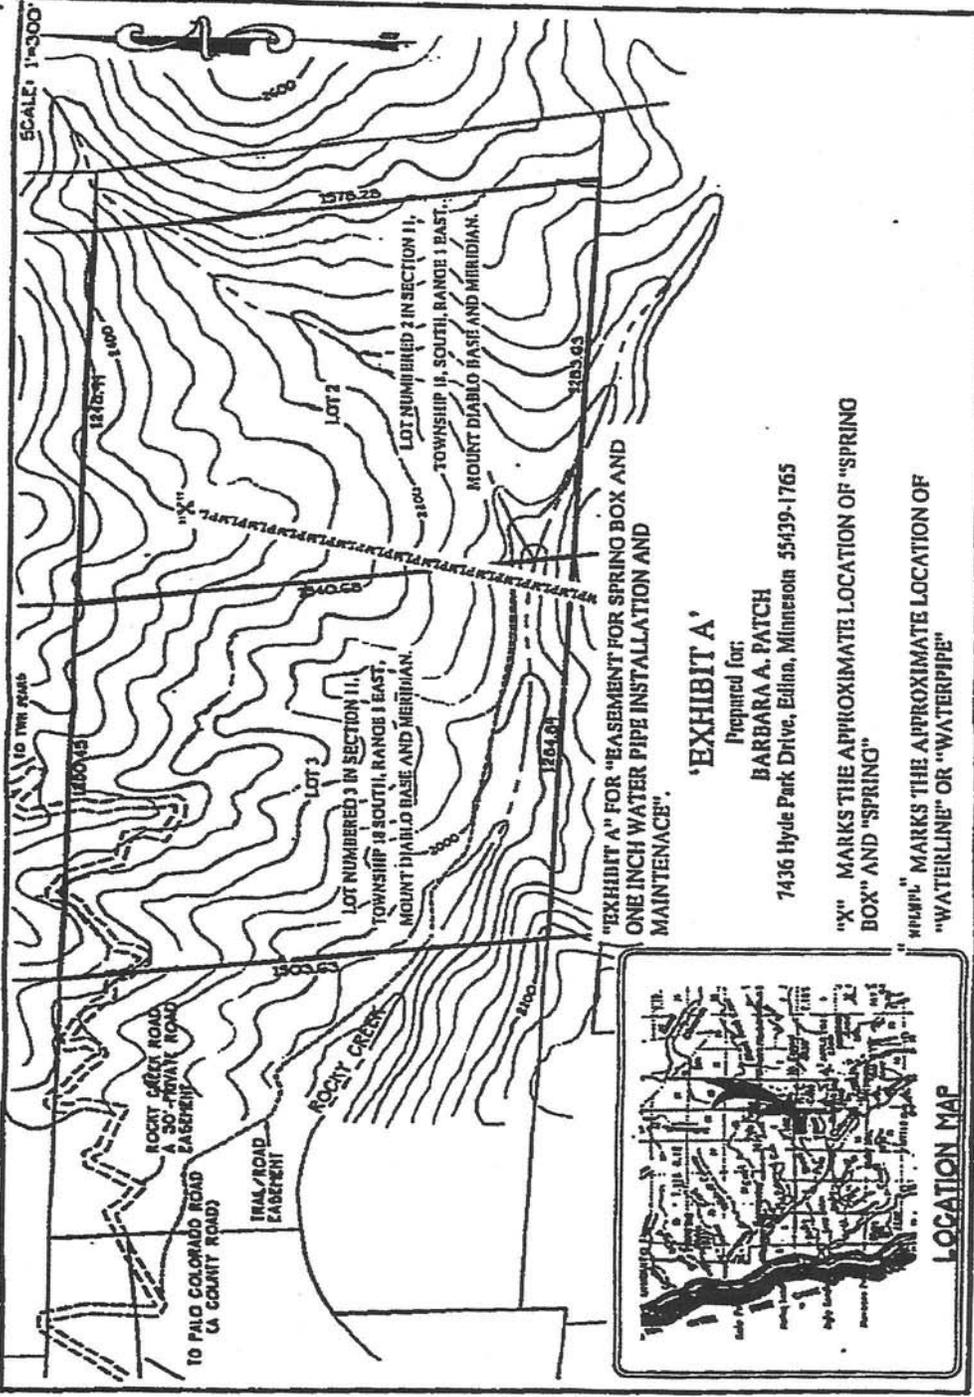
"EXHIBIT A" FOR "EASEMENT" FOR SPRING BOX AND ONE INCH WATER PIPE INSTALLATION AND MAINTENANCE".

"X" MARKS THE APPROXIMATE LOCATION OF "SPRING BOX" AND "SPRING"

"WATERLINE" MARKS THE APPROXIMATE LOCATION OF "WATERLINE" OR "WATERPIPE"
