Elkhorn Battery Energy Storage System

Monterey County Board of Supervisors December 13, 2022

Event Summary

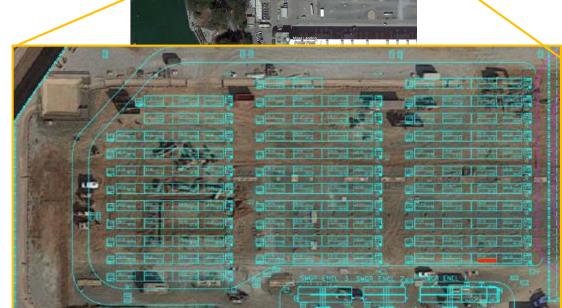
Outline drawing of the 256 Megapacks at Elkhorn BESS NOTE: Red rectangle designates the thermal event Megapack

- We have preliminarily identified the likely root cause of the incident as related to an equipment installation issue.
 - Corrective actions including performing an extent of condition and inspection of all other Megapacks on site, additional causal analysis, physical modifications and testing are required before the system is safely returned to operations.

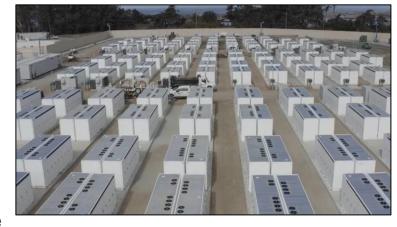
- Located at PG&E's Moss Landing electric substation in Moss Landing, CA
- Owned and operated by PG&E
- Enough electricity to meet the instantaneous demand of nearly 275,000 homes
 - Maximum discharge rate of 182.5 megawatts (MW)
 - Capacity to store and dispatch up to 730 megawatt hours (MWh) of energy for four hours
- Approved by the California Public Utilities Commission (CPUC) in November 2018 to support local capacity requirements and reliability.
- Approved by the Monterey County Planning commission in February 2020.
- Site construction began in July 2020 and the system began operation in April 2022.
- The system was designed, constructed, and is maintained in collaboration with Tesla, and is one of the largest utility-owned, lithium-ion battery energy storage systems.
