# **CARMEL VALLEY MANOR MASTER PLAN PHASE TWO HISTORIC ASSESSMENT REPORT**

Jay Zimmer, President & CEO  
Carmel Valley Manor  
8545 Carmel Valley Rd.  
Carmel, CA 93923

PAST Consultants, LLC  
P.O. Box 721  
Pacific Grove, CA 93950  
February 10, 2025

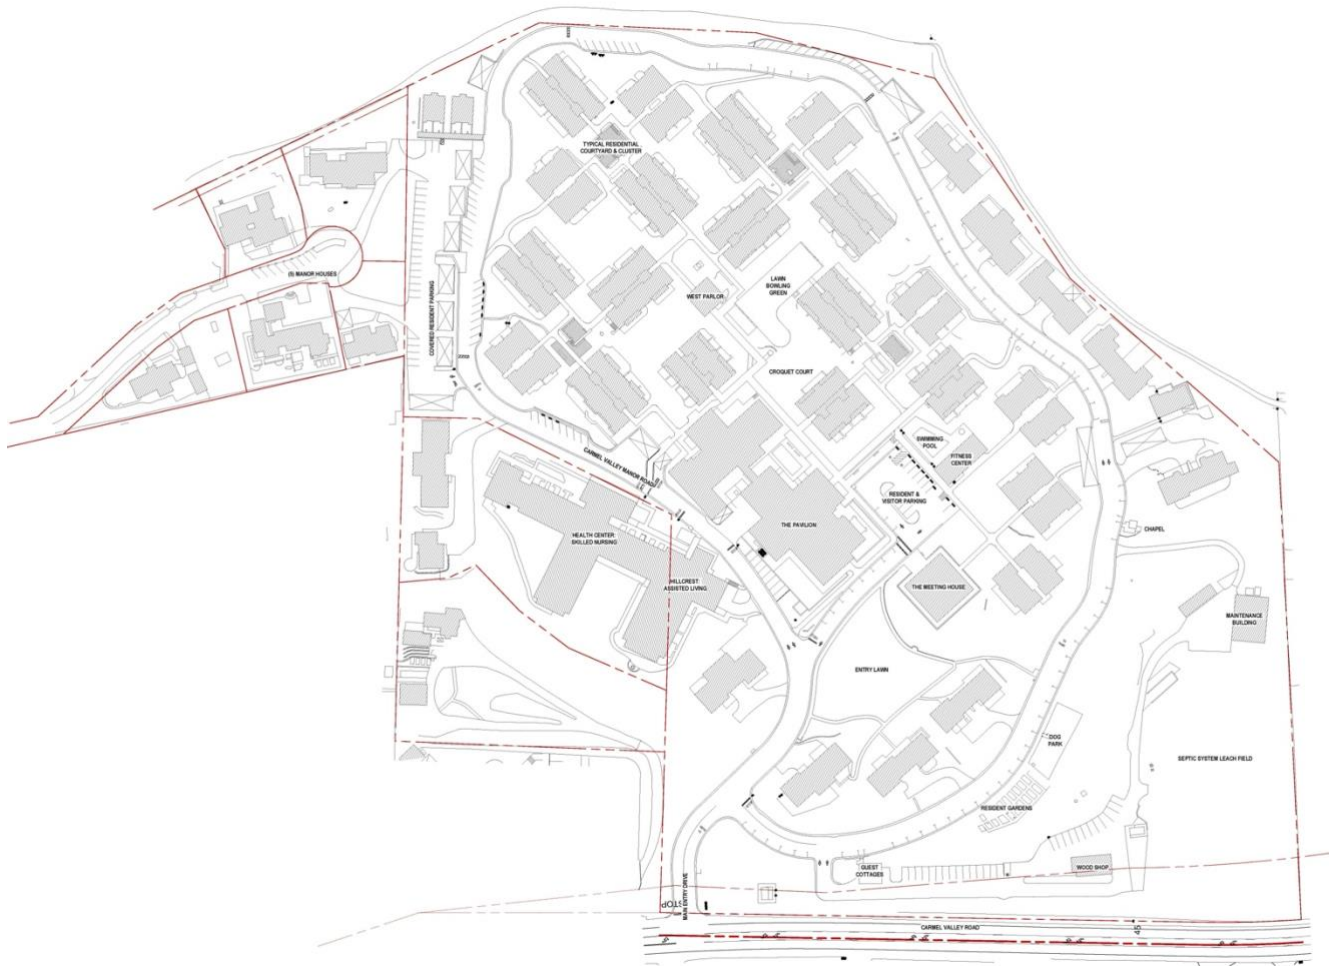
The following shows the existing arrangement of buildings at Carmel Valley Manor (**Figure 2**).

**Figure 2.** Site Plan showing existing buildings (*Courtesy: Perkins Eastman, 2025*).

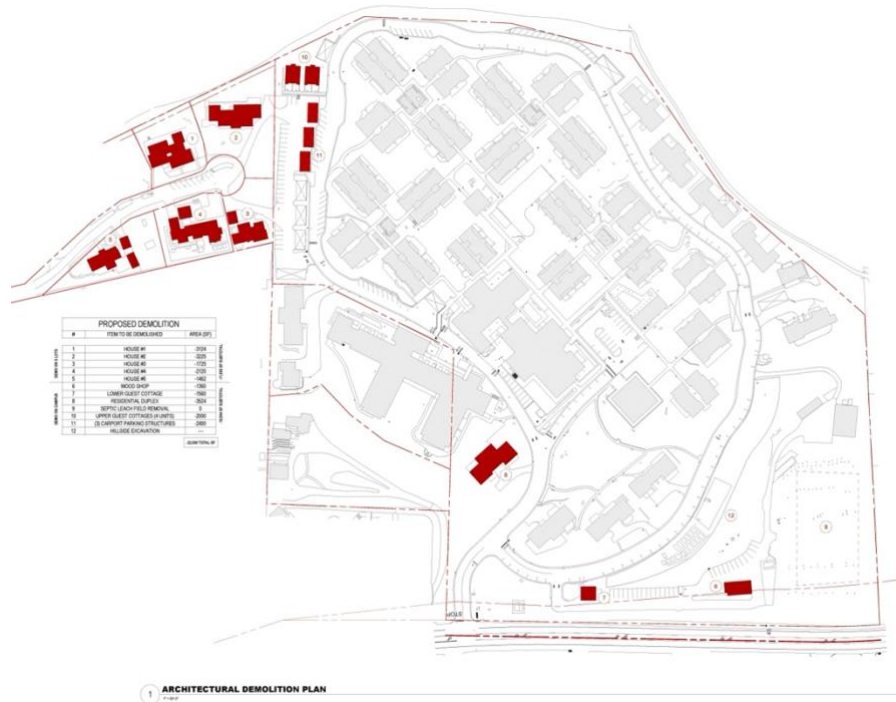
The proposed project is presented on the design drawings, *Carmel Valley Manor Master Plan*, by Perkins-Eastman, dated January 9, 2025. The demolition plan indicates buildings to be removed (**Figure 3**).

**Figure 3.** Site Plan showing buildings to be removed in red (*Courtesy: Perkins Eastman, 2025*).

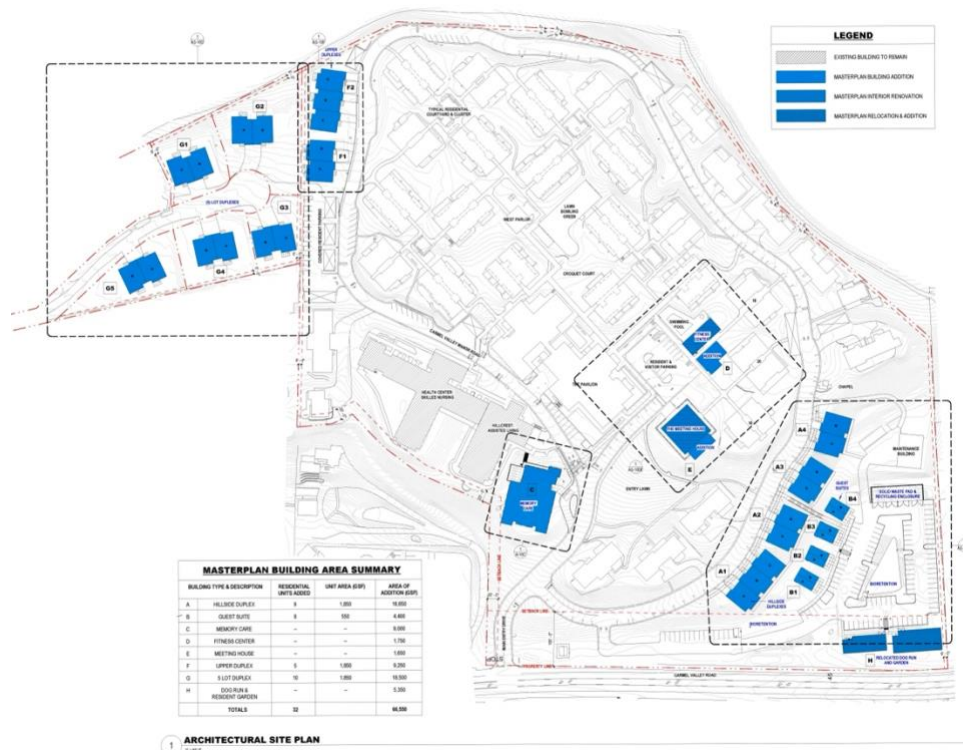
The site plan showing new construction appears below (**Figure 4**).

**Figure 4.** Site Plan showing buildings to be constructed in blue (Courtesy: Perkins Eastman, 2025).

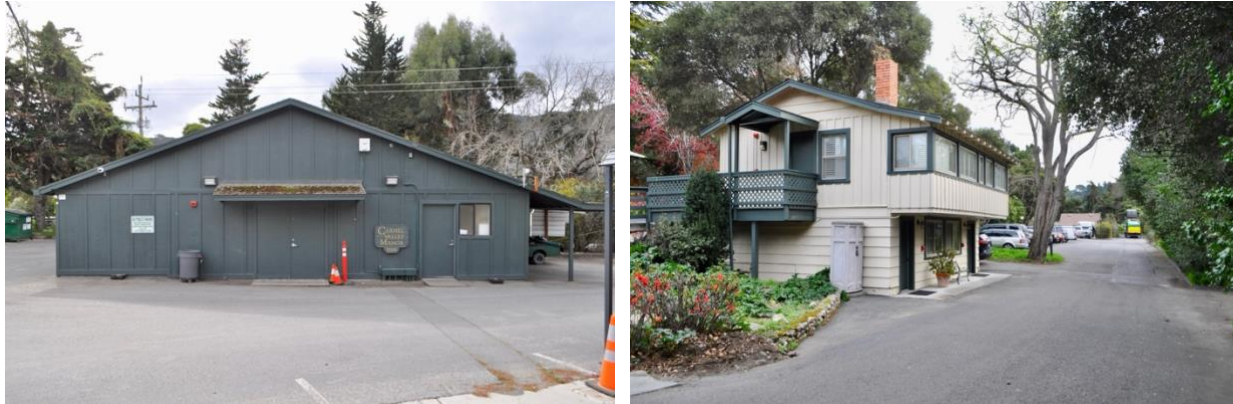
The Wood Shop/Maintenance Shed and the Lower Guest Cottage will be removed (**Figures 6 & 7**).

**Figures 6 and 7.** Left: north elevation of the Wood Shop/Maintenance Shed. Right: south and west elevations of the Lower Guest Cottage.

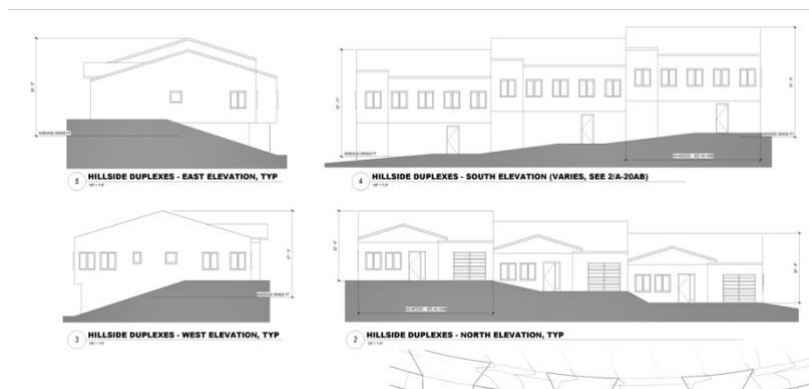
The proposed addition of the four residential duplexes appears below (**Figure 8**).

**Figure 8.** Elevations of proposed hillside duplexes, taken from Sheet A-10A of the Carmel Valley Master Plan design submittal.

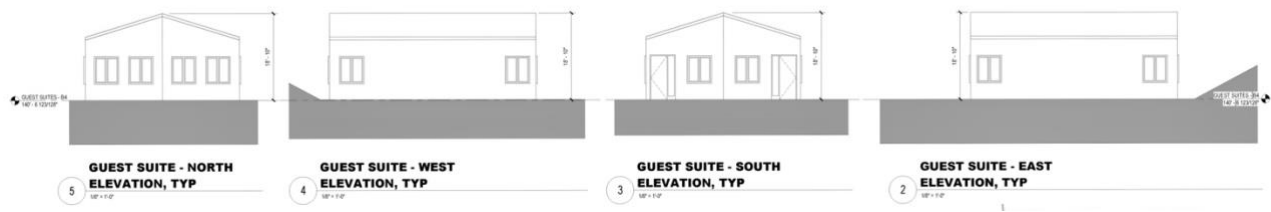
Similarly, the hillside guest cottages (**Figure 9**) utilize the SOM-designed forms of gable rooflines with flush eaves but will be differentiated from the Core Campus designs by a variation of stucco finish.

**Figure 9.** Elevations of proposed guest cottages, taken from Sheet A-10B of the Carmel Valley Master Plan design submittal.

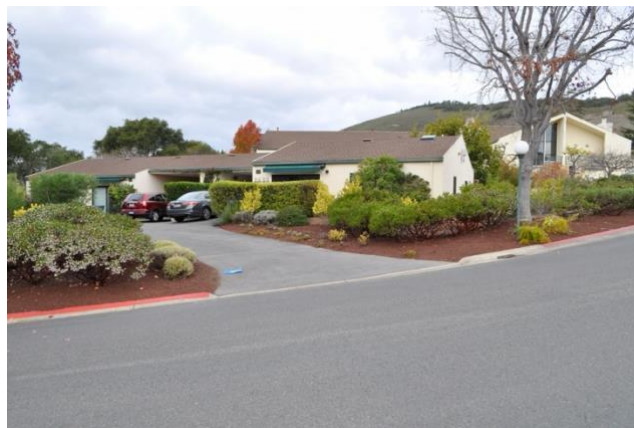
The construction of the proposed Memory Care facility adjacent to and southeast of the Hillcrest Assisted Living Facility will remove one duplex that was part of the 1963 SOM design (**Figure 10**). The removal of this duplex will not impact the historic integrity of the site substantially, as this building form is repeated in other locations on the Campus.

**Figure 10.** Site of proposed Memory Care Facility.

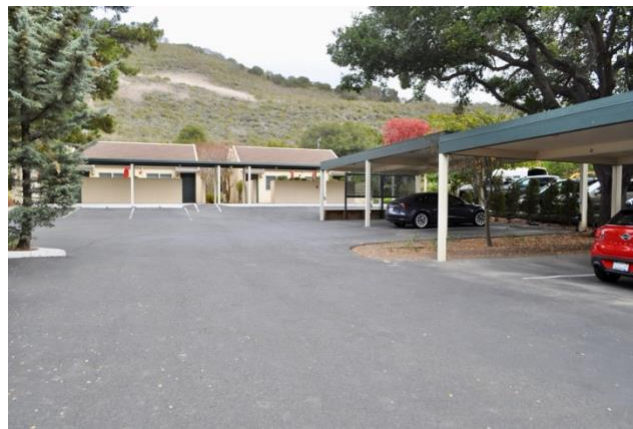
Two guest cottages and three carport parking structures will be removed for the construction of new duplexes in this location (**Figure 12**). Removal of these buildings is acceptable, as they are not part of the original 1963 SOM design.

**Figure 12.** View of upper guest cottages and carport structure to be removed.

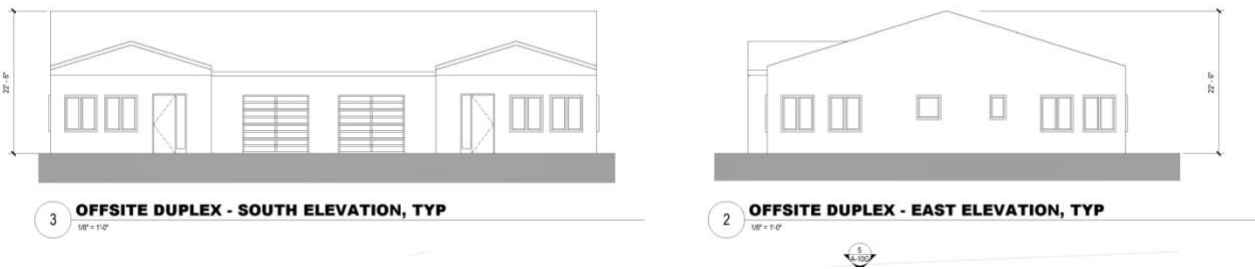
The proposed design of the duplexes appears below (**Figure 16**).

**Figure 16.** Elevations of the proposed Los Arboles Drive duplexes taken from Sheet A-10G of the Carmel Valley Master Plan design submittal.

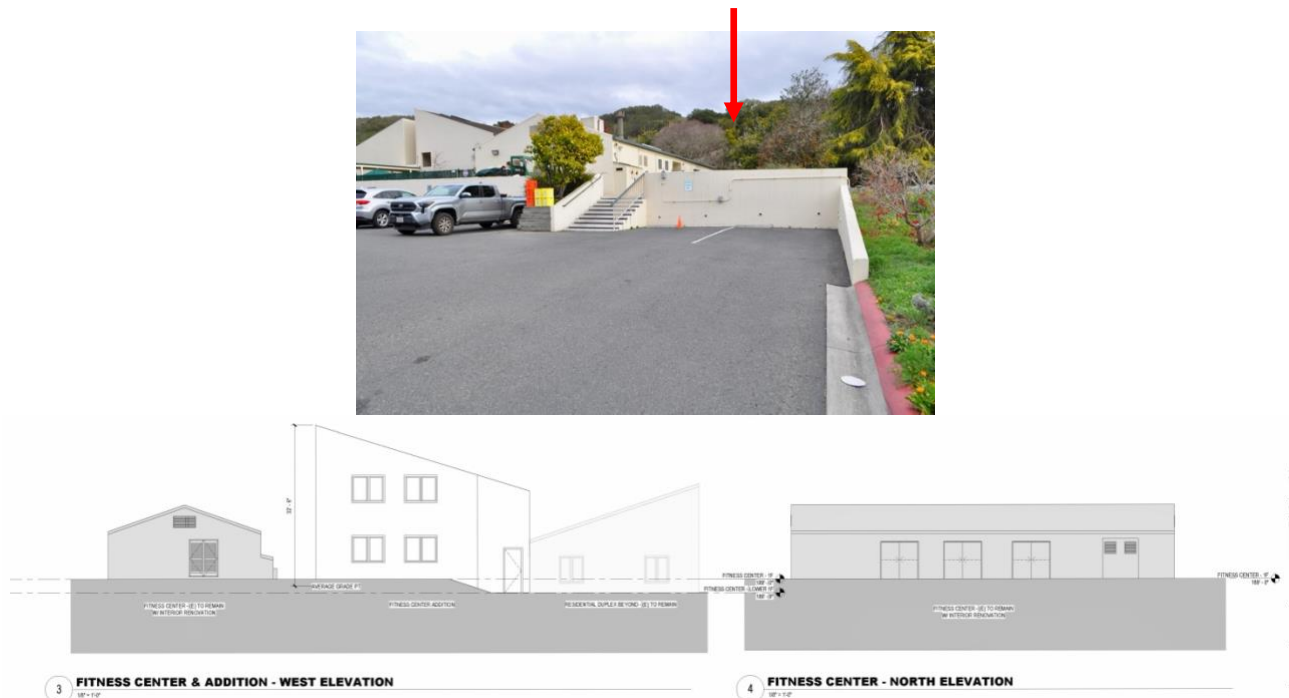
A two-story addition is proposed adjacent to and south of the existing Fitness Center. This building utilizes similar shed-roofed forms as the SOM-designed historic buildings but will be differentiated from the historic buildings in detailing and stucco finish (**Figures 17 and 18**).

**Figures 17 and 18.** Top image shows the proposed location of new Fitness Center building. Bottom image shows the elevations of the proposed Los Arboles Drive duplexes taken from Sheet A-11D of the Carmel Valley Master Plan design submittal.

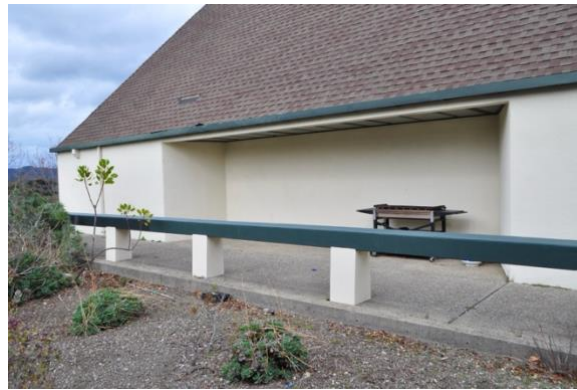
A rear (south elevation) addition is proposed for the Meeting House. The addition is of minimal size, on the least visible elevation of the building and will be differentiated from the historic building by using a flat roof and a different stucco finish, which satisfies *Standard 9* (**Figures 19 and 20**).

**Figures 19 and 20.** Top image shows the Meeting House's south elevation and the location of the rear addition. This elevation faces open space and is the least visible elevation of the building. Bottom image shows the elevations of the proposed Meeting House rear addition taken from Sheet A-11E of the Carmel Valley Master Plan design submittal.

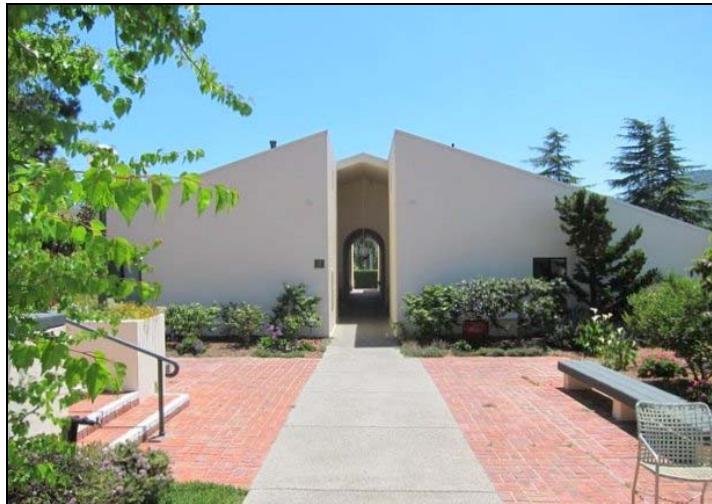
A unique feature of the SOM design is the pass-through feature of all residential buildings, linking them with the network of paved pathways. All buildings have this central pass-through design element, an example shown on **Figure 18** below.

**Figure 18.** Typical pass-through feature of residential buildings.

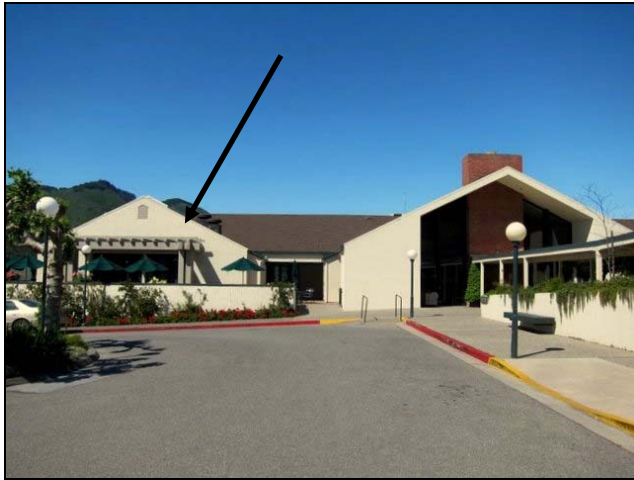
**Figure 19.** Front elevation of the Pavilion Building.  
Dining room addition to front façade shown with arrow.

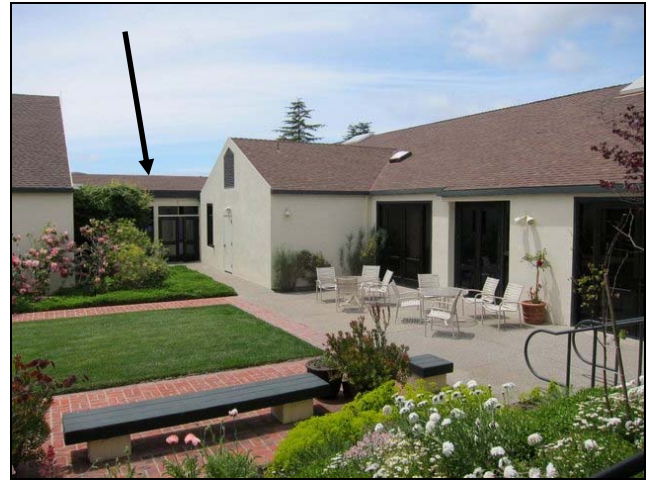
**Figure 20.** The highly-modified Infirmary, now the Resident Activity Center. Arrow indicates the connecting structure.

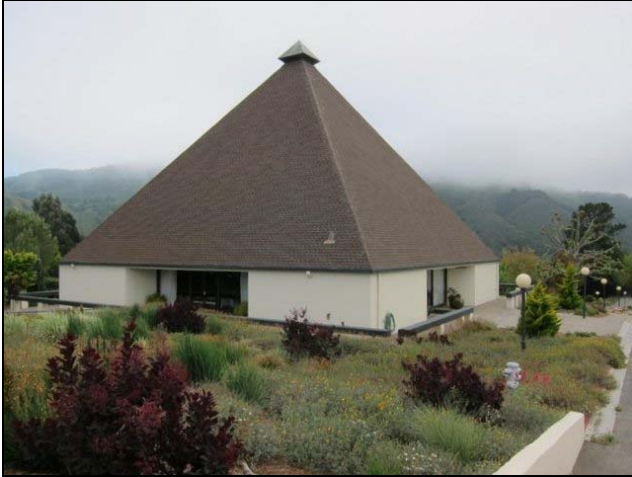
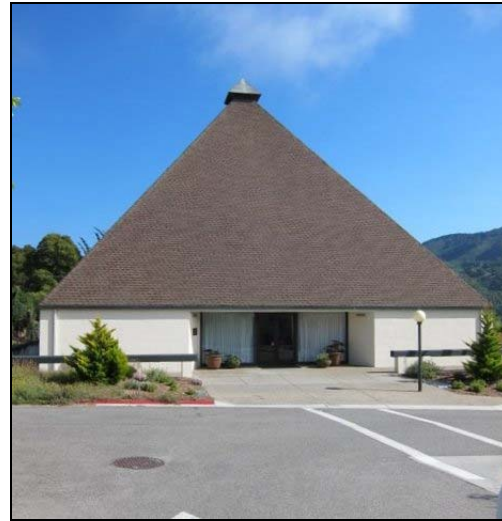
**Figure 21.** Side (east) elevation of Meeting House.

**Figure 22.** Front (north) elevation of Meeting House.

The most prominent building on the site, the Meeting House is square in plan with a tall pyramidal room. It features symmetrical elevations with a recessed pair of anodized aluminum entry doors on every elevation except the south. Fixed glazing with thick aluminum frames flanks the entry doors. A concrete post and rail surrounds the building. With the exception of roofing material replacement from wood shake to asphalt shingle, the building is largely unaltered.

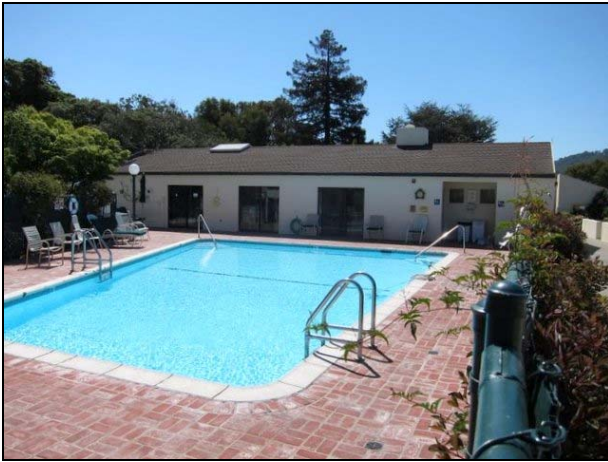
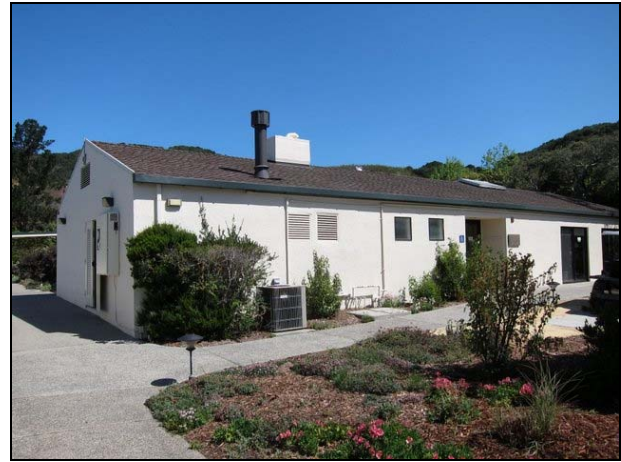
**Figure 23.** Front (north) elevation of the Fitness Center.

**Figure 24.** Rear (south) elevation of the Fitness Center.

Originally the Library, the building was highly altered when it was converted into the Fitness Center in 2001. It is a simple gable-roofed structure with an off-center chimney, a central rear entrance and modified openings containing paired sliding glass aluminum doors. Like all buildings on the campus, the Fitness Center has the same replaced asphalt shingle roof and box gutters painted green.

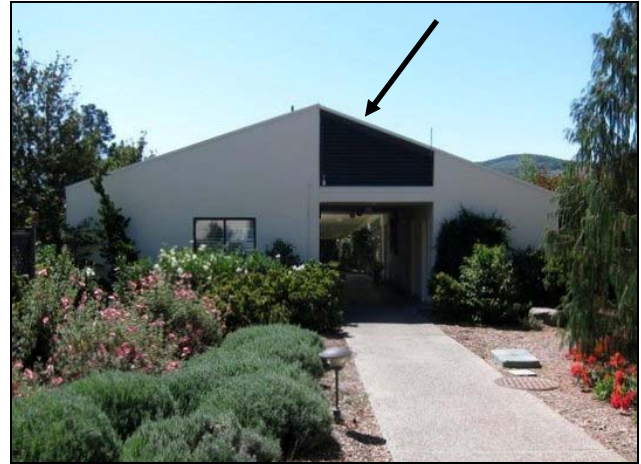
**Figure 26.** Rear (north) elevation of the West Parlor.  
Connection of two shed roofs shown with an arrow.

A subsequent alteration includes the connection of the shed roofs and placement of large louvered vents at each building end, apparently to improve ventilation (**Figure 26**). The vent carries the same roof pitch as the two sheds, making the massing appear as a gable end, rather than individual shed forms. Other alterations common to buildings on campus include the in-kind replacement of aluminum slider windows and patio doors; and replacement of original shake roof with asphalt shingles.

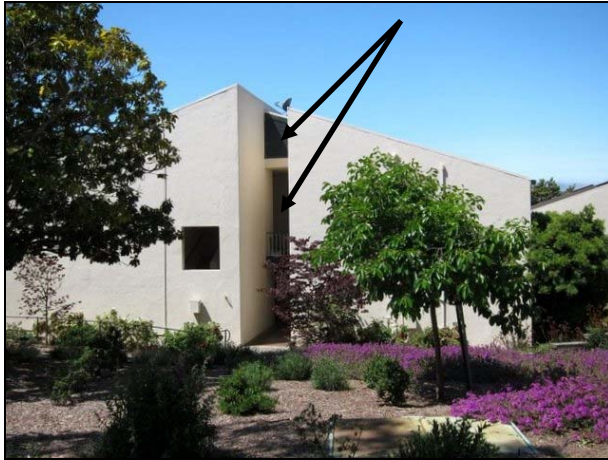
**Figure 27.** Rear (east) elevation of the Bldg. 17.  
Louvered vent and glazing alteration shown with arrows.

A subsequent alteration includes the connection of the two roof forms and placement of large louvered vents at each building end, apparently to improve ventilation. The vent's roof carries the same roof pitch as the two sheds, making the massing appear as a gable end, rather than individual shed forms. The alteration is less prominent on this building type, as the vent is inset from the outer shed walls (**Figure 27**). Glazing is placed below the vents on the second floor to protect upstairs residents from the wind. Other alterations common to buildings on campus include the in-kind replacement of aluminum patio doors; replacement of original shake roof with asphalt shingles; the installation of retractable awnings over the sliding glass doors; and the installation of skylights and a satellite dish to the roof. Individual apartments have been combined on many of the buildings to provide more living space.

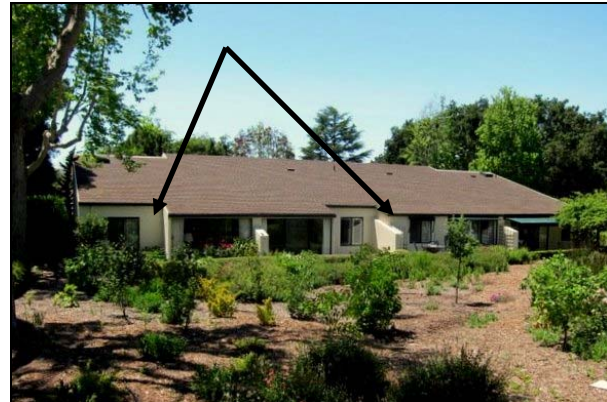
**Figure 30.** Bldg. 3 outer wall extensions shown with arrows.

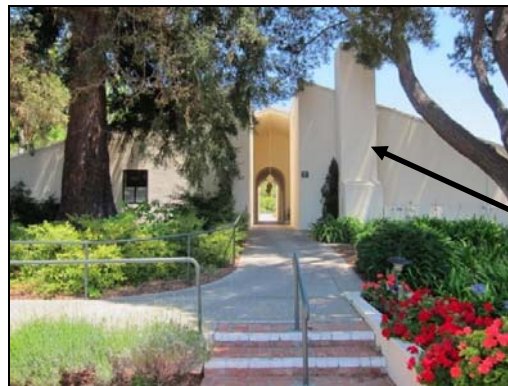
**Figure 31.** Front (west) elevation of Bldg. 2. Note chimney (arrow) and window in left shed end.

An alteration common to this building type consists of the addition of windows in the shed ends on most of the buildings. Chimneys for furnaces are installed on some of the shed ends. This feature does not appear on the SOM drawings, indicating that this may have been an early design change or is a subsequent alteration (**Figure 31**). Another common alteration is the extension of side façade outer building walls into the patio areas to provide greater living space. This has been done to most units (**Figure 30**). In-kind replacement of aluminum windows and patio doors, awnings, skylights and satellite dishes are also common.

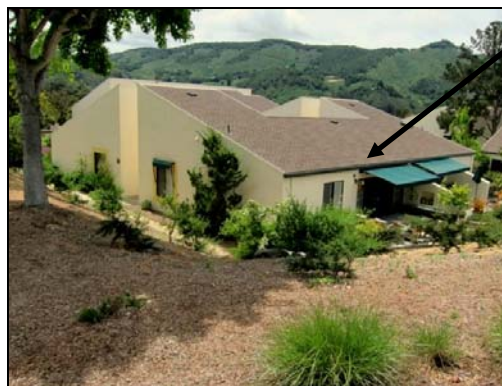
**Figure 34.** Overall view of Bldg. 18 with full outer wall extension (arrow).

An alteration common to this building type consists of moving the outer wall into the patio area, extension of the roofline, and installation of a window in the shed end. This has been done to most units (**Figure 34**). In-kind replacement of aluminum windows and patio doors, awnings, skylights and satellite dishes are also common alterations.

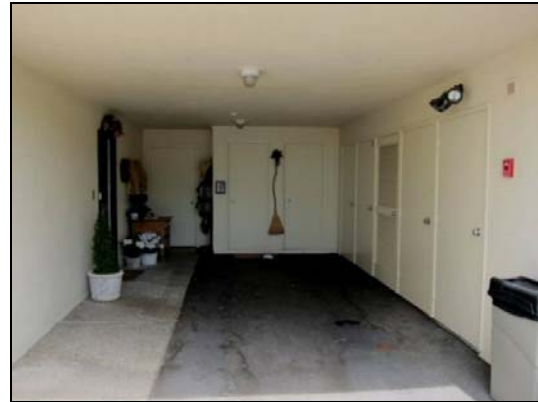
**Figure 36.** Typical garage design seen on Bldg. 22.

Building Type D is a symmetrical duplex design separated by a garage. The building features gable roof massing with two aluminum slider windows in the gable end. Front and rear fenestration consists of a single aluminum slider window and aluminum sliding patio doors. Rear additions have been installed to several of the units. Original garages have multiple closets (**Figure 36**).

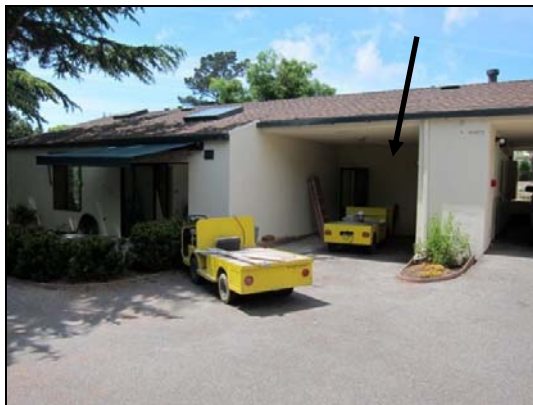
**Figure 37.** Bldg 29 conversion of garage to study.

A handful of units have undergone removal of the closets in the garage and conversion of the space into an additional room (**Figure 37**). A wide aluminum slider window is installed in the rear façade of units with the garage conversion (**Figure 38**). In-kind replacement of aluminum windows and patio doors, awnings and skylights are also common alterations.

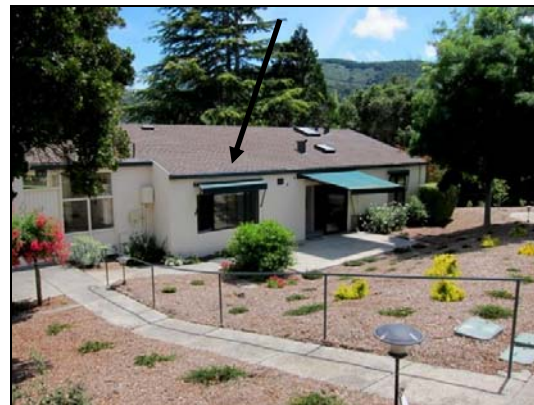
**Figure 38.** Rear of Bldg. 29 showing garage conversion.

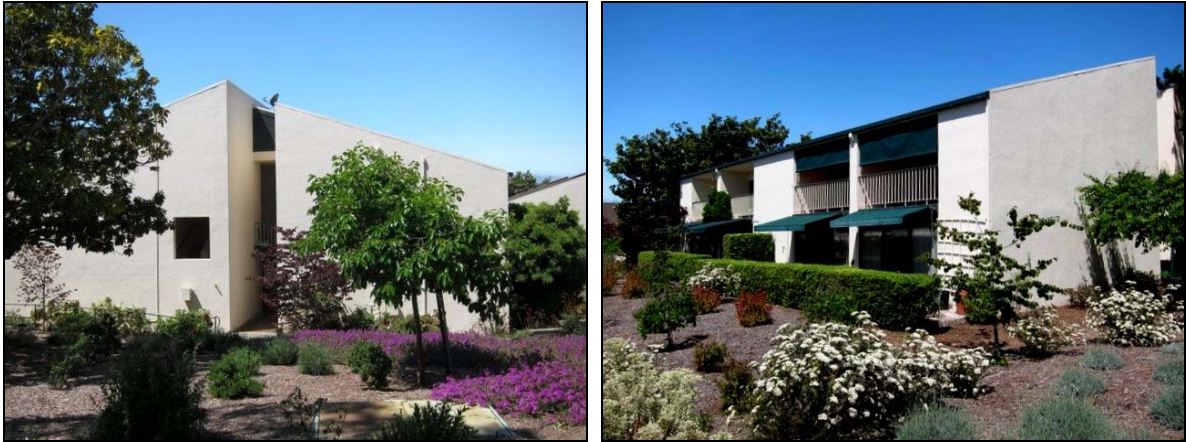
**Figures 2 and 3.** Typical front and side elevations of Building Type A.

1. Installation of fixed-pane glazing on second floor of shed ends for wind protection.
2. Extension of first-floor patio walls out to a maximum limit of the face of outer building wall. This alteration has been performed for all units on all three buildings.
3. In-kind replacement of black anodized aluminum patio doors and windows.
4. Installation of retractable green window awnings matching other campus buildings.
5. Installation of replacement asphalt shingle roofing to matching other campus buildings.

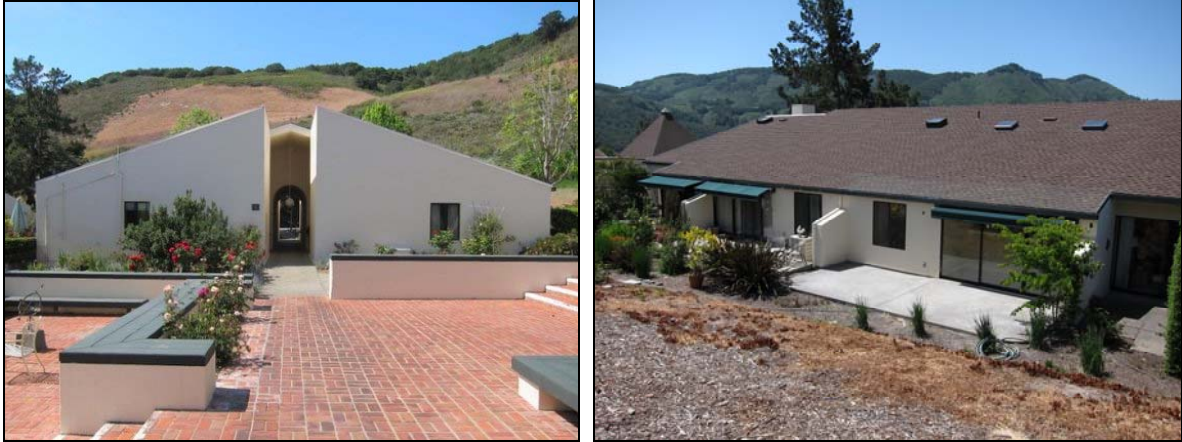
**Figures 4 and 5.** Typical front and side elevations of Building Type B.

1. Extension of patio walls outward. Original roof plane extended to meet new wall.
2. Original roof pitch maintained to meet the newer outer building wall
3. In-kind replacement of black anodized aluminum patio doors and windows.
4. Addition of black anodized aluminum slider window in shed ends matching the existing type, size and design found on other campus buildings.
5. Installation of retractable green window awnings matching other campus buildings.
6. Installation of replacement asphalt shingle roofing to match other campus buildings.

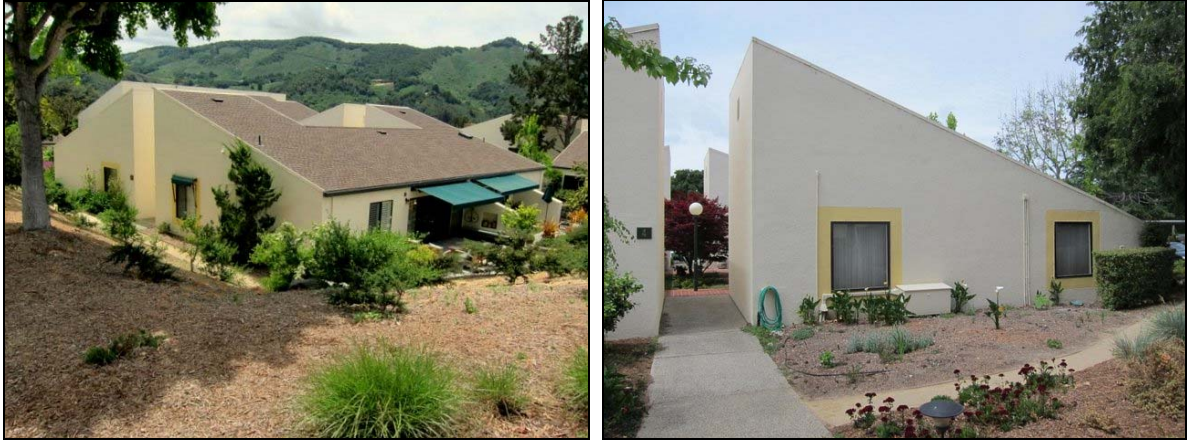
**Figures 6 and 7.** Typical front and side elevations of Building Type C.

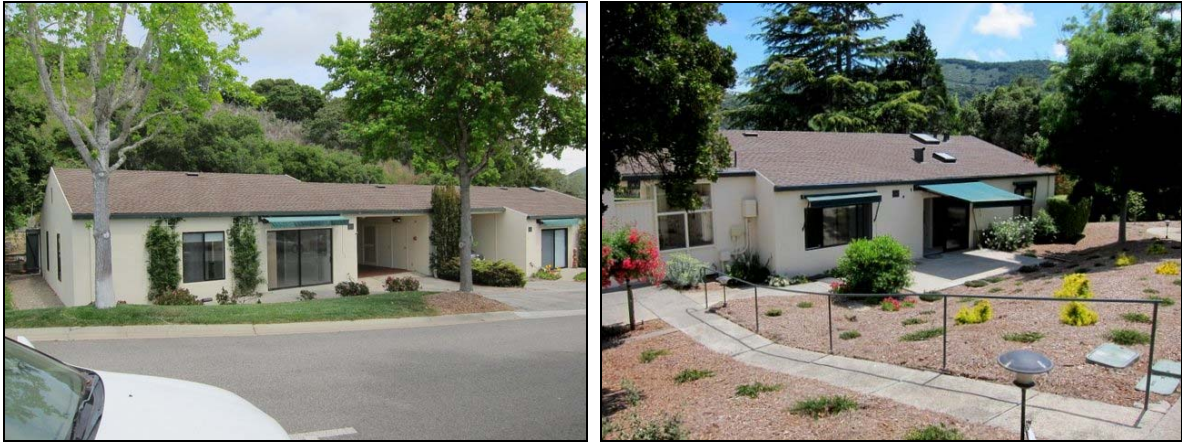
**Figures 8 and 9.** Typical front and rear elevations of Building Type D. Right image shows window added to rear wall as part of typical carport conversion.

1. Partial carport alteration: construction of solid wall within the carport and installation of in-kind black anodized aluminum slider window to rear elevation.
2. Construction of rear addition to back of building. Roofline and addition are not visible from the street.
3. In-kind replacement of black anodized aluminum patio doors and aluminum windows.
4. Installation of retractable green window awnings matching other buildings on the campus.
5. Installation of replacement asphalt shingle roofing to matching other campus buildings.
