# Monterey County

## Board Report

(Appeal from the Monterey County Historical Resources Review Board's recommendation to the Monterey County Building Official regarding the Mothball Protection Plan for the "Connell House" - REF150089/1170 Signal Hill Road, Pebble Beach, Del Monte Forest Land Use Plan)

**See attached 3 drawings from Taluban Engineering, Inc.: 1) Site Plan, 2) Lower Level Protection Plan, and 3) Main Level Protection Plan**

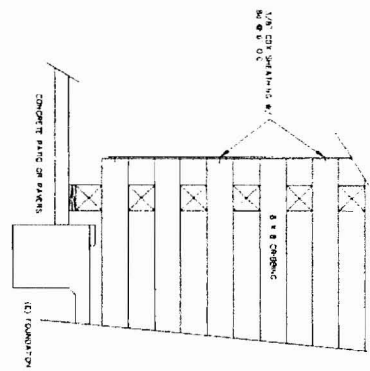
1 CRIBBING & FOUNDATION  
NOT TO SCALE

WEATHERPROOF CRIBBING

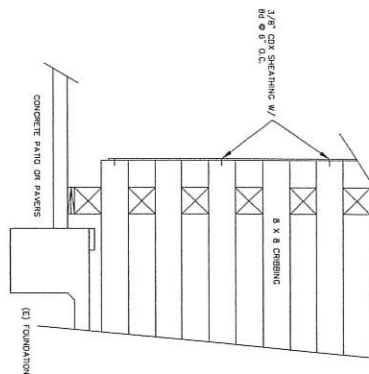
## 1 CRIBBING & FOUNDATION NOT TO SCALE

## WEATHERPROOF CRIBBING

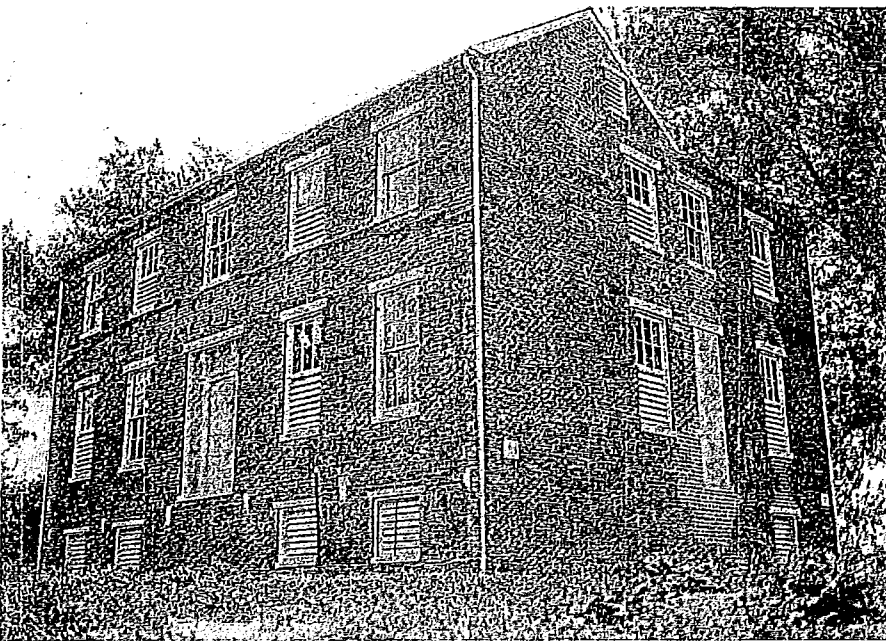
Figure 1. Proper mothballing treatment: This building has been successfully mothballed for 10 years because the roof and walls were repaired and structurally stabilized, ventilation louvers were added, and the property is maintained. Photo: Charles E. Fisher, NPS.

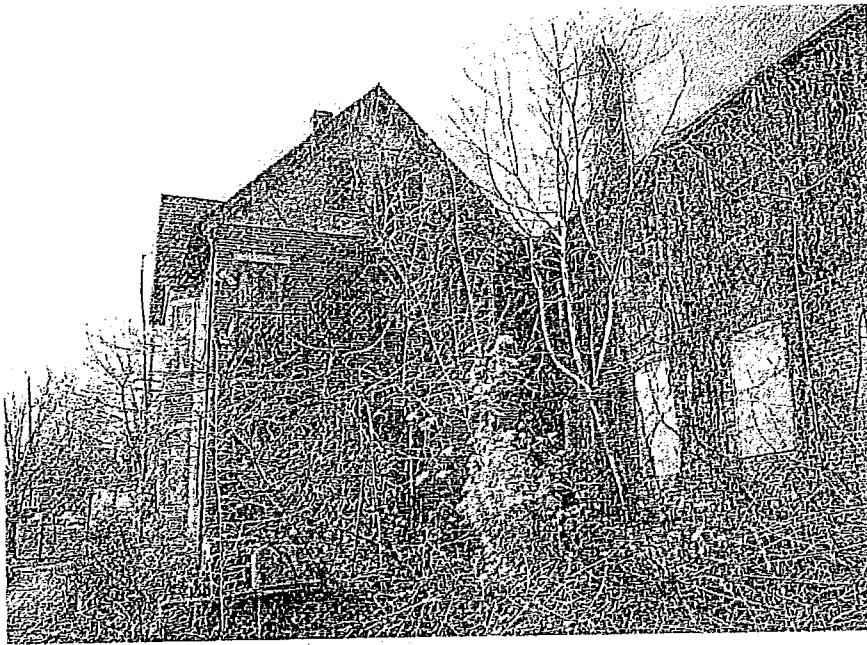
Figure 2. Improper treatment: Boarding up without adequate ventilation, lack of maintenance, and neglect of this property have accelerated deterioration. Photo; NPS file.

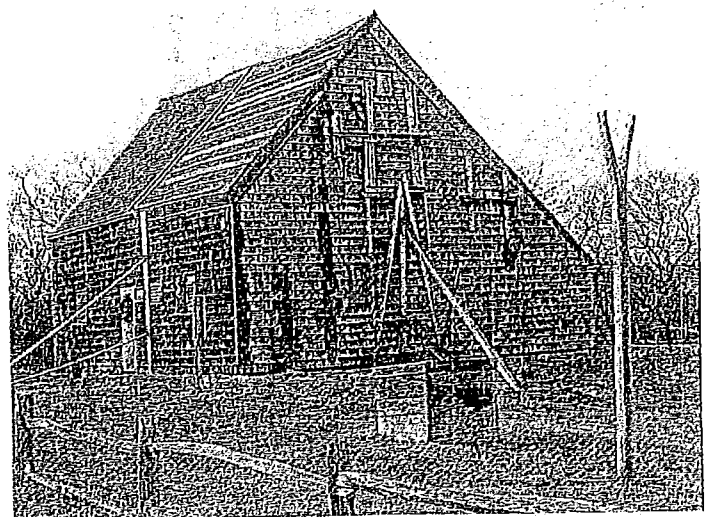
Figure 3. Buildings seriously damaged by storms or deterioration may need to be braced before architectural evaluations can be made. Jethro Coffin House. Photo: John Milner Architects.

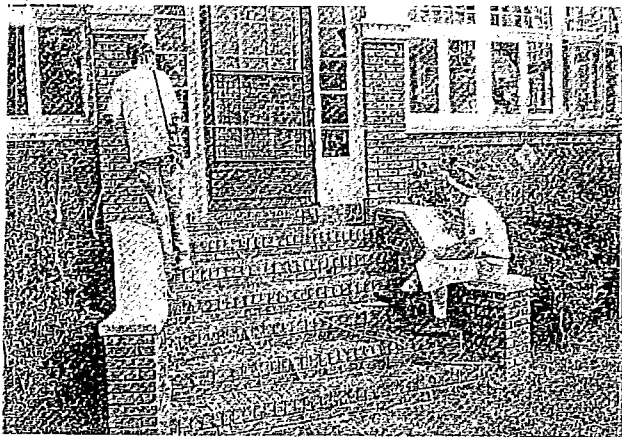
*Figure 4. Documenting the building's history, preparing schematic plans, and assessing the condition of the building will provide necessary information on which to set priorities for stabilization and repair prior to securing the building. Photo: Frederick Lindstrom, HABS.*

Old photographs can be helpful in identifying early or original features that might be hidden under modern materials. On a walk-through, the architect, historian, or preservation specialist should identify the architecturally significant elements of the building, both inside and out (see fig.4).

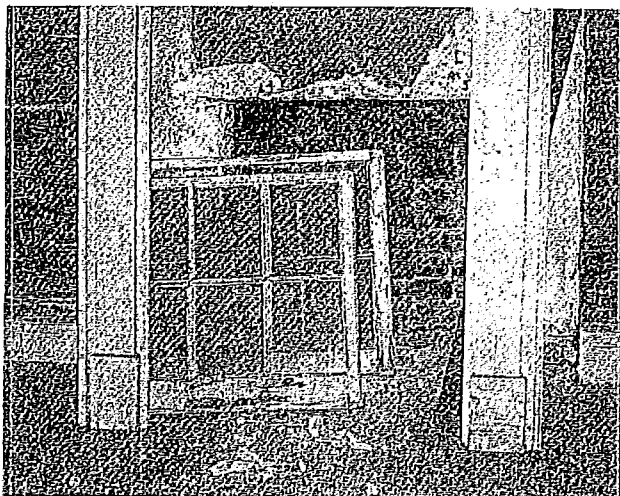
*Figure 5. Loose or detached elements should be identified, tagged and stored, preferably on site. Photo: NPS files.*

By understanding the history of the resource, significant elements, even though deteriorated, may be spared the trash pile. For that reason alone, any materials removed from the building or site as part of the stabilization effort should be carefully scrutinized and, if appearing historic, should be photographed, tagged with a number, inventoried, and safely stored, preferably in the building, for later retrieval (see fig. 5).

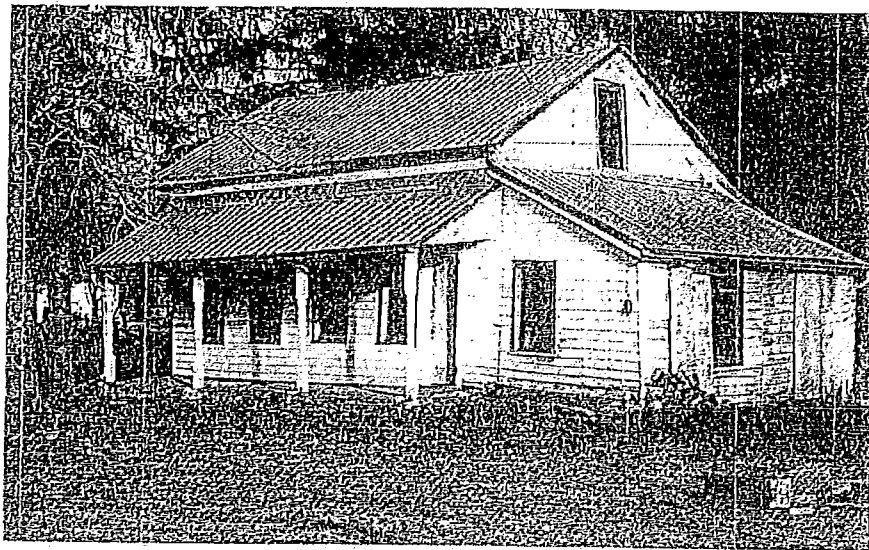
Figure 7. Non-historic materials are appropriate for mothballing projects when they are used to protect historic evidence remaining for future preservation. This lightweight aluminum channel frame and roofing covers the historic wooden shingle roof. Galvanized mesh panels secure the window openings from intrusion by raccoons and other unwanted guests. Photo: Williamsport Preservation Training Center, NPS.

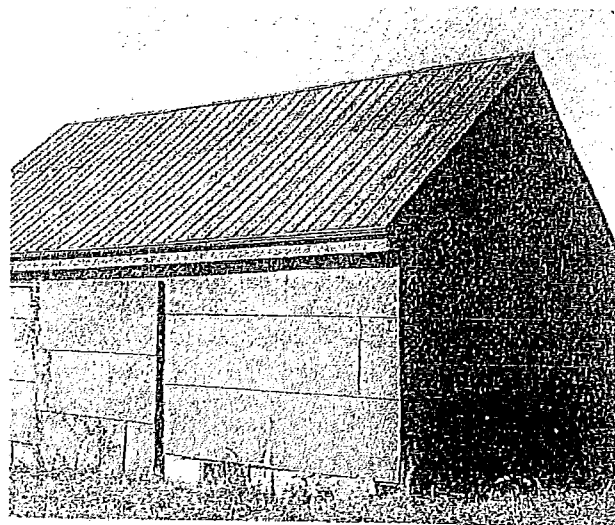
Figure 9. Severely deteriorated wooden siding on a farm building has been covered over with painted plywood panels as a temporary measure to eliminate moisture penetration to the interior. Foundation vents and loose floor boards allow air to circulate inside.

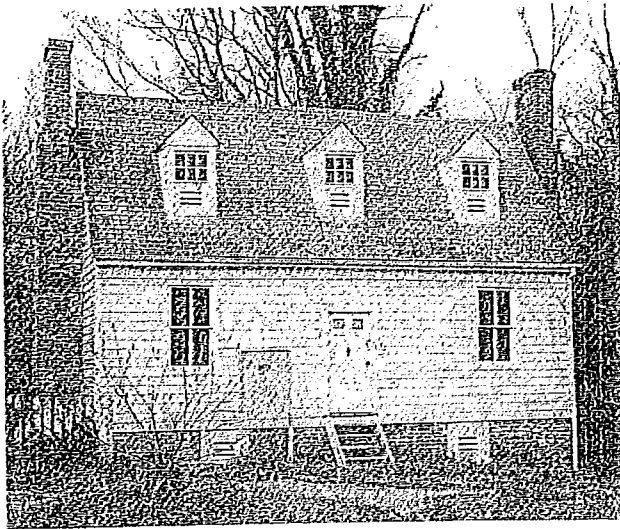
Figure 10. Regrading around the Booker Tenement at Colonial Williamsburg has protected the masonry foundation wall from excessive damp. This building has been successfully mothballed for over 10 years. Note the attic and basement vents, the temporary stairs, and the informative sign interpreting the history of this building.

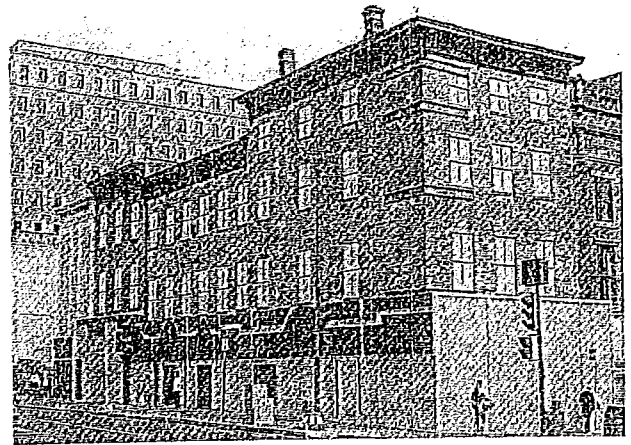
Figure 11: Urban buildings often need additional protection from unwanted entry and graffiti. This commercial building uses painted plywood panels to cover expansive glass storefronts and chain link fencing is applied on top of the panels. The upper windows on the street sides have been covered and painted to resemble 19th century sash. Photo: Thomas Jester, NPS.

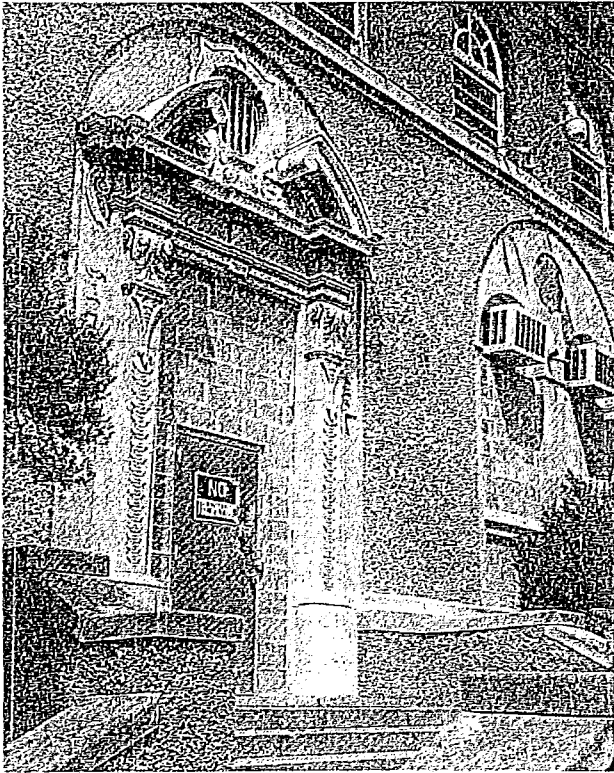
Figure 12. First floor openings have been filled with cinderblocks and doors, window sash and frames have been removed for safe keeping. Note the security light over the windows and the use of a security metal door with heavy duty locks. Photo: H. Ward Jandl, NPS.

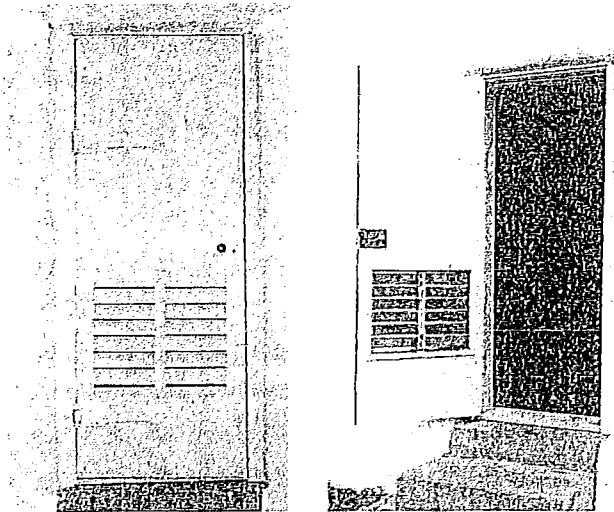
Figure 13. If historic doors would be damaged by adding extra locks, they should be removed and stored and new security doors added. At this lighthouse, the historic door has been replaced with a new door (seen both inside and outside) with an inset vent and new deadbolt locks. The heavy historic hinges have not been damaged. Photo: Williamsport Preservation Training Center, NPS.

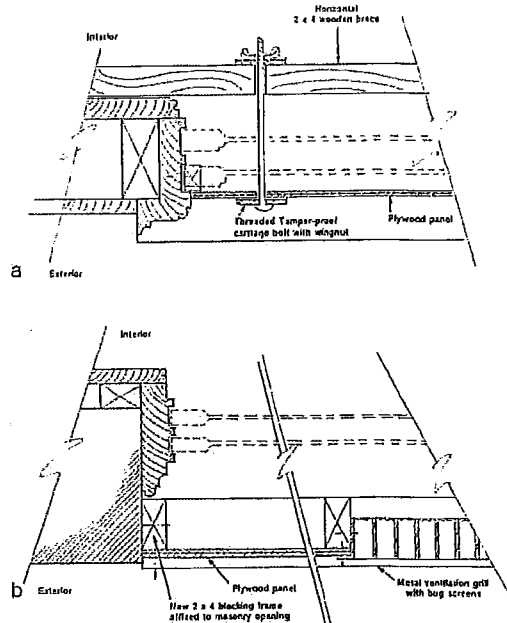
Figure 14. A: Plan detail showing plywood security panel anchored with carriage bolts through to the inside horizontal bracing, or strong backs. B: Plan detail showing section of plywood window panel attached to a new pressure treated wood frame set within the masonry opening. Ventilation should be included whenever possible or necessary.

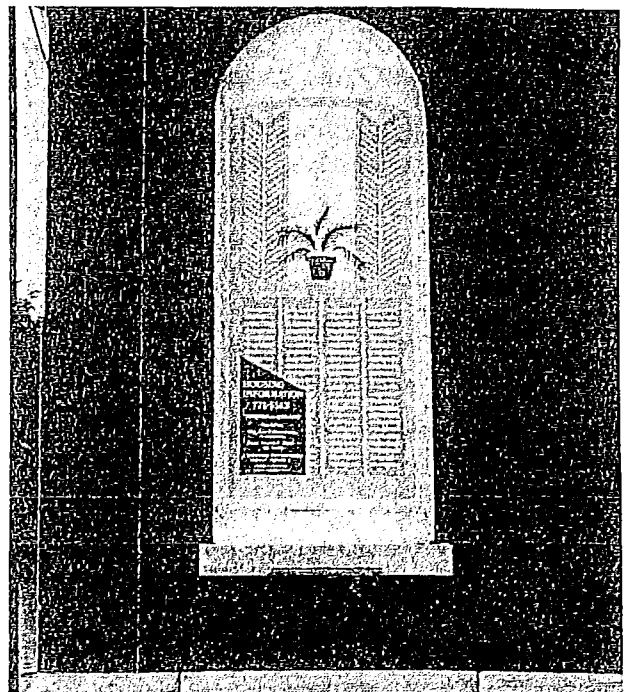
Figure 15. Painting trompe l'oeil scenes on plywood panels is a neighborhood friendly device. In addition, the small sign at the bottom left corner gives information for contacting the organization responsible for the care of the mothballed building. Photo: Lee H. Nelson, FAIA.

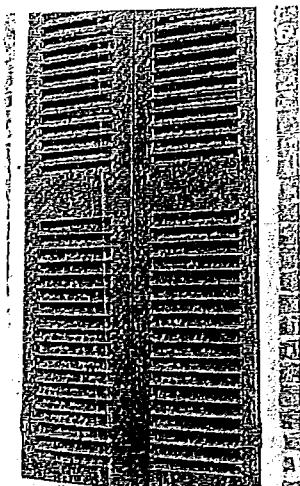
Figure 16. Historic louvered shutters make excellent security closures with passive ventilation.

If the building has shutters, simply close the shutters and secure them from the interior (see fig. 16). If the building had shutters historically, but they are missing, it may be appropriate to install new shutters, even in a modern material, and secure them in the closed position. Louvered shutters will help with interior ventilation if the sash are propped open behind the shutters.

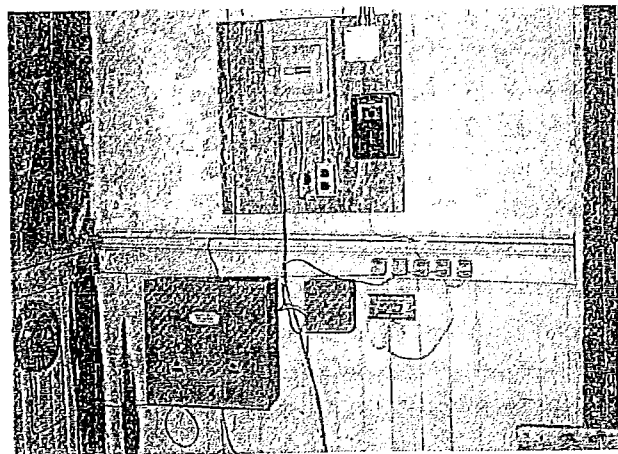
Figure 17. Security systems are very important for mothballed buildings if they are located where fire and security services are available. A temporary electric service with battery back-up has been installed in this building. Intrusion alarms and ionization smoke/fire detectors are wired directly to the nearby security service.

If at all possible, new temporary electric service should be provided to the building (see fig. 17). Generally a telephone

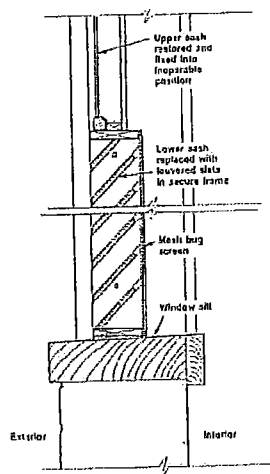
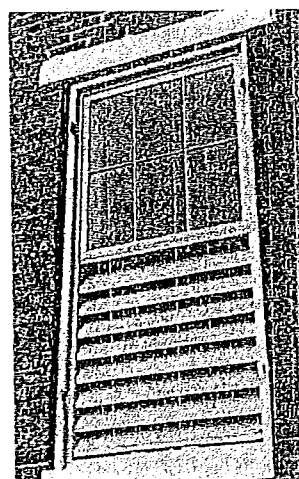
Figure 18. Heavy duty wooden slated louvers were custom fabricated to replace the deteriorated lower sash. The upper sash were rebuilt to retain the historic appearance and to allow light into this vacant historic building. Refer back to Fig. 1 for a view of the building. Photo: Charles E. Fisher, NPS. Drawing by Thomas Vitanza.

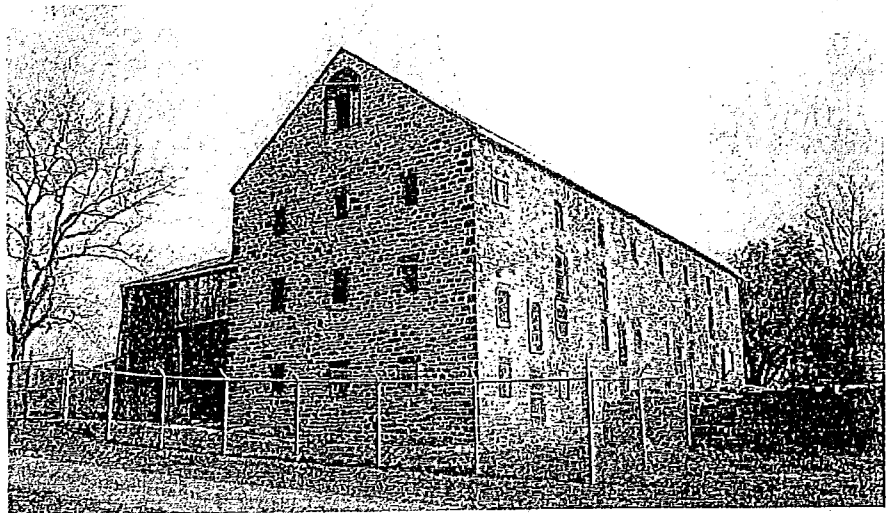
Figure 24. Once mothballed, a property must still be monitored and maintained. The openings in this historic barn has been modified with a combination of wood louvers and metal mesh panels which require little maintenance. The grounds are regularly mowed, even inside the chain link security fence. Photo: Williamsport Preservation Training Center, NPS.

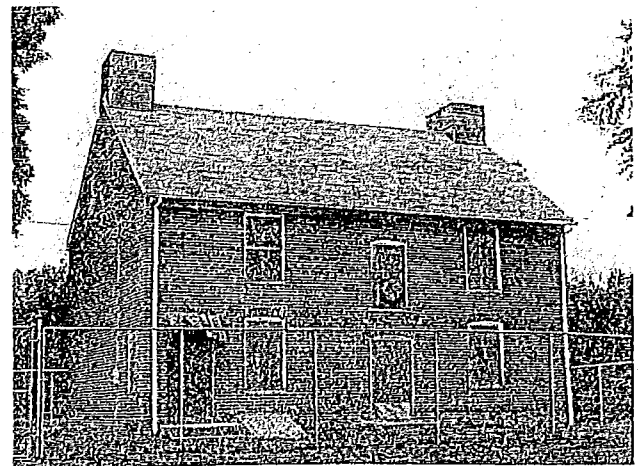
a. A view showing the exterior of the house in its mothballed condition.

Figure 25. Above is a summary of the tasks that were necessary in order to protect this significant property while restoration funds are raised. Photographs: Michael Mills; Ford Farewell Mills Gatsch Architects.

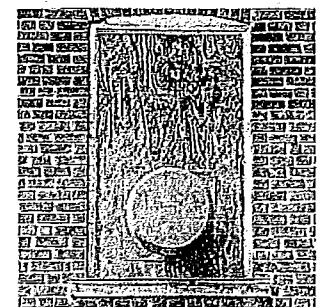
c. The exhaust fan has tamper-proof housing.
