Project: 1030 Marcheta/Garibaldi

Phase: Root Investigation

Root System Excavation and Inspection

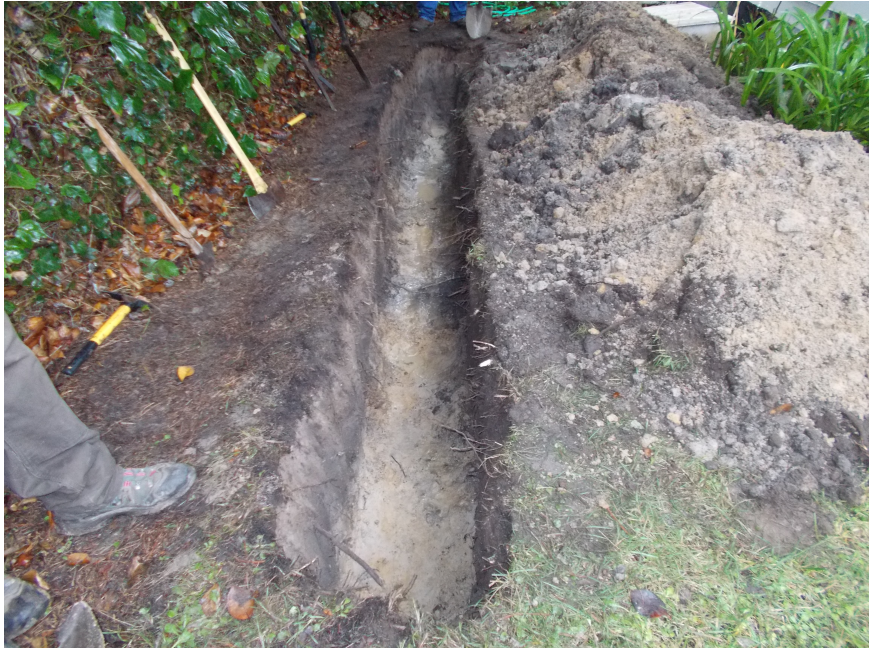
An initial 12-inch wide trench was dug approximately seven feet from the base of the tree. No entry into the adjacent property occurred during the excavation.

The excavation was done in stages to a depth of two feet, then four feet. The soil transitioned from a dark loam at the soil surface to a mix of rock and clay type material.

At four feet in depth the soil was predominately dense rock. The rock layer was penetrated using a steel probe to a depth of six feet.

No roots were unearthed in the initial trench.

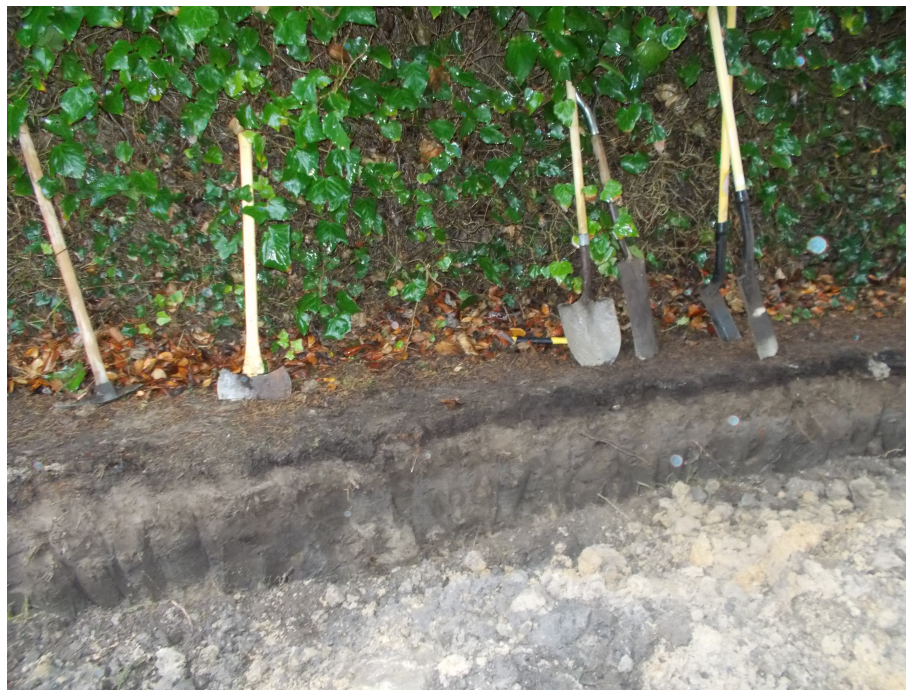
A secondary trench was dug to expand the width to 24 inches and meet the same depth of four feet. As with the initial trench the length was probed to locate any roots within the rock layer. No roots were located in the wider trench, approximately five feet from the base of the tree.

A third excavation that expanded the trench to 36 inches in width was excavated using the same methods; no roots were located.

The careful manual excavation adjacent to the neighboring tree did not reveal any structural root development.

Although the excavation was limited to four feet in depth it is unlikely that any roots have developed in the lower soil profile.

The excavation required to construct the driveway as proposed will not impact structural roots or destabilize the tree.
