BIOTIC REPORT & CONSERVATION PLAN  
FOR  
**THE VIRNIG RESIDENCE, "SPY & SEA"**  
1154 SILVER TRAIL, PEBBLE BEACH,  
MONTEREY COUNTY, CALIFORNIA 93953  
**PLN#160144**

**BIOTIC REPORT & HABITAT RENOVATION PLAN FOR THE VIRNIG RESIDENCE  
1154 SILVER TRAIL, PEBBLE BEACH, CALIFORNIA 93953  
MONTEREY COUNTY / APN 008-012-013**

**PLN#160144**

In accordance with your authorization, Landset Engineers, Inc. has completed a soil-engineering investigation for the proposed additions to your residence located off of Silver Trail in the Pebble Beach area of Monterey County, California. This report presents the results of our field investigation, laboratory testing, along with our preliminary conclusions and recommendations for site development.

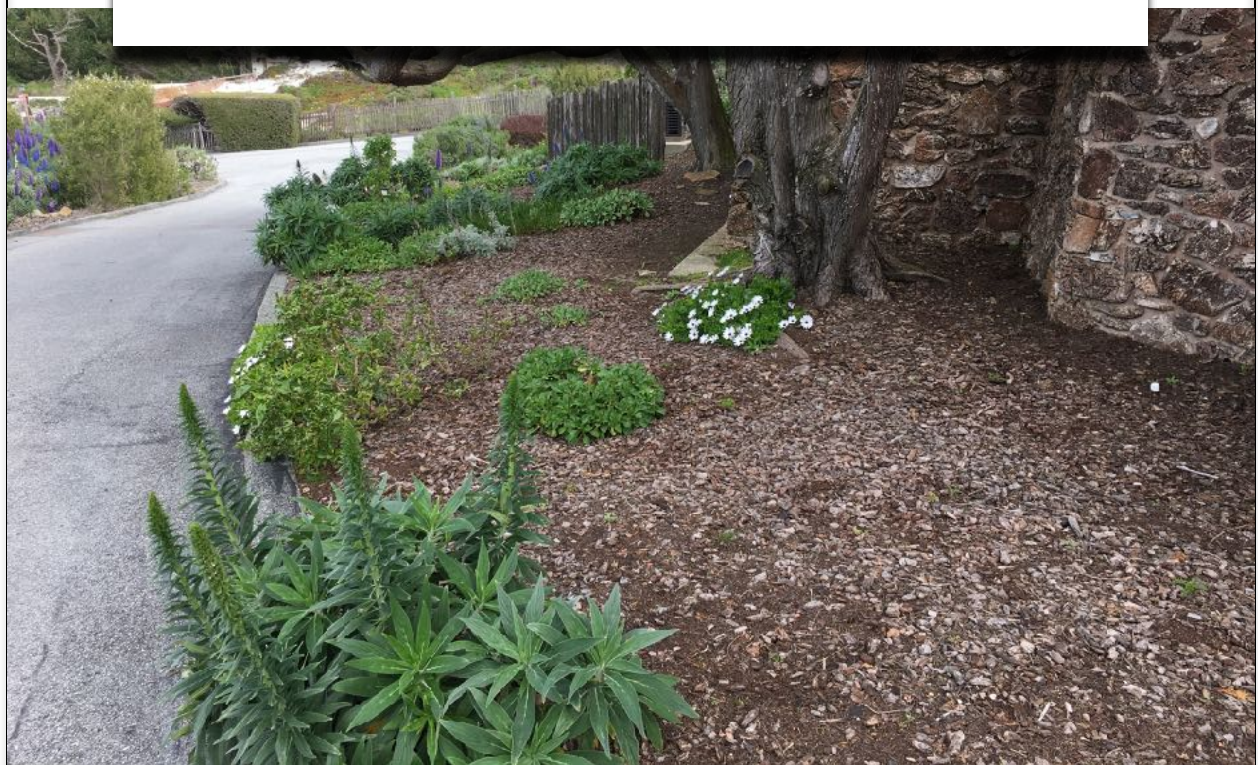
**FIGURE 3.** *Continued.*

Existing Residential/Dooryard Landscape

The majority of the property is covered with *bordered ornamental plantings* around the residence and *escaped and ruderal plantings* on the graded pad and slope between the driveway and downslope dunes (Figures 3, 4). In both settings, Iceplant, Pride-of-Madeira, and Myoporum are predominant (see *Plant Taxa*, below). Significantly, there is a 3/4-inch irrigation line with impact sprinklers that was installed by the previous owner along the lower edge of the non-dune slope to irrigate the uphill planted area<sup>2</sup>, but that was deactivated (by the current owner) about nine (9) years ago.

As previously explained, the Virnig property incorporates a contiguous area of sand dune that is covered by native dune vegetation, as well as a discrete section of the dune that is covered exclusively by a continuous mat of Iceplant. Figure 3 zeroes-in on the total on-property dune formation and cover stands. Neither the existing residence nor the proposed remodeled version of the residence are contiguous with or otherwise directly affect the on-property sand dunes. The dunes are separated from the residence by a paved driveway and a substantial fill-slope that is covered with planted and invasive/escaped nonnative vegetation.

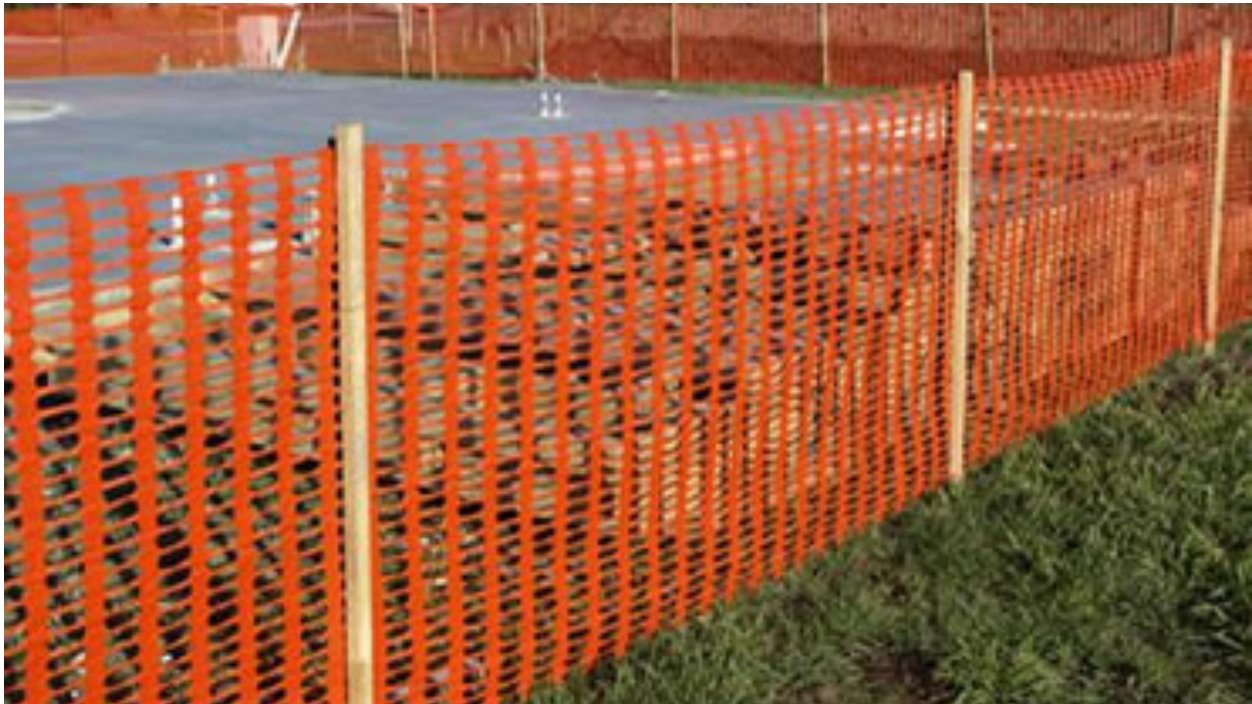
6. Project BMP — A Best Management Practice for the residence remodeling project will ensure separation of the fill-slope and dunes (combined conservation areas) from of all work elements including, e.g., those associated with materials storage, equipment operation and parking, and construction. The BMP to enforce the separation should include a strong-line of construction fencing (safety-barrier fencing; orange @ minimum 48-inches) that is staked (@ minimum 60 inches) along the outboard (W) edge of the existing asphalt driveway curb. The following insert illustrates appropriate application of correct fence material.
