# Inspection Report

**Property Address:**  
58 Brooklyn St A & B  
Royal Oaks ca 95076

**Santa Cruz County Home Inspections**

<b>Date:</b> 5/10/2017	<b>Time:</b> 03:30 PM	<b>Report ID:</b> 171005 - Brooklyn ct
<b>Property:</b> 58 Brooklyn St A & B Royal Oaks ca 95076	<b>Customer:</b>	<b>Real Estate Professional:</b>

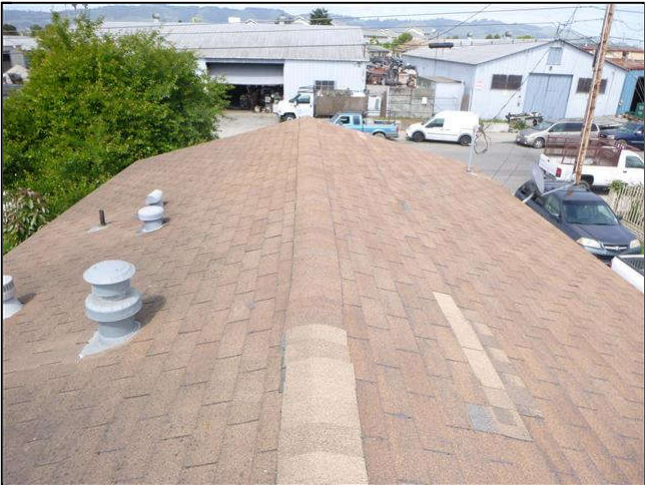
1.0 Item 1(Picture)

1.0 (1) Unit A: The roof is a single layer of composition shingles. The roof shows normal to moderate ware and I would age this roof at 15 to 20 years old. Missing or damaged shingles noted in several areas. A hole was also noted in the roof at the back left corner. Further evaluation then repair or replacement by a qualified local tradesman is recommended. No signs of leaking noted at time of inspection.

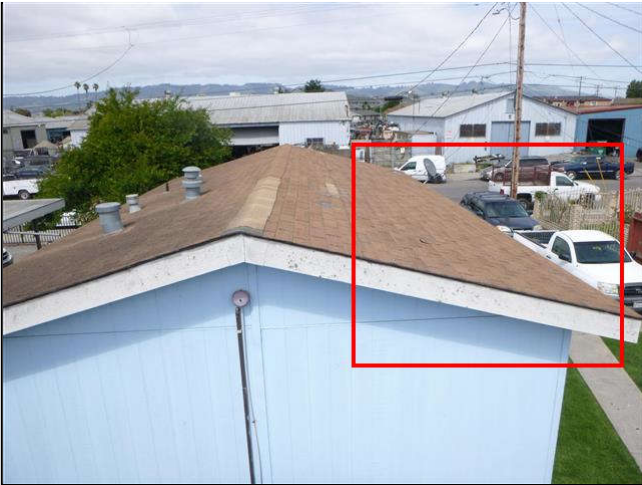
1.1 Item 1(Picture)

**1.1** No gutters found on unit A or B. Gutters are recommended because they control the flow of run off away from the home and it's foundation. Adding gutters to both units is recommended.

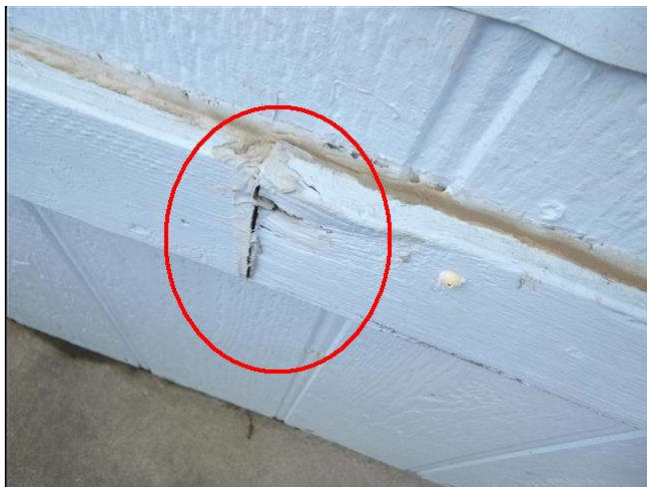
2.0 Item 1(Picture)

**2.0 (1) Unit A:** Damage noted to the skirt and skirt trim around the home at the left side, left and right back corners. Further evaluation by a qualified local pest inspector is recommended.

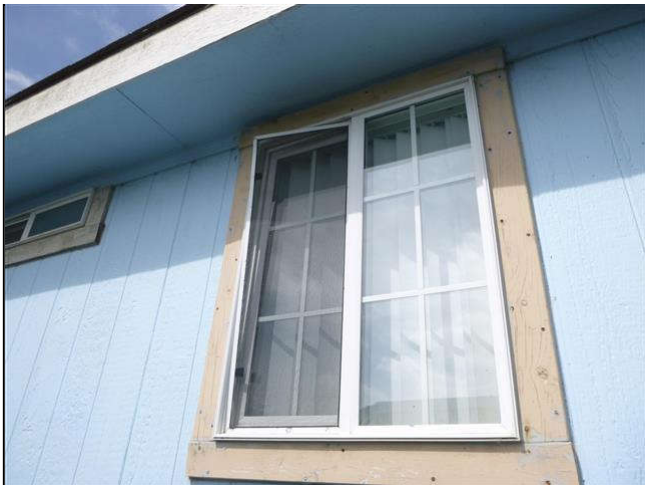
2.0 Item 6(Picture)

(3) Unit B: Exposed wood noted at the back and left side of the home around the windows. Proper prep and paint recommended to increase the life span of the material.

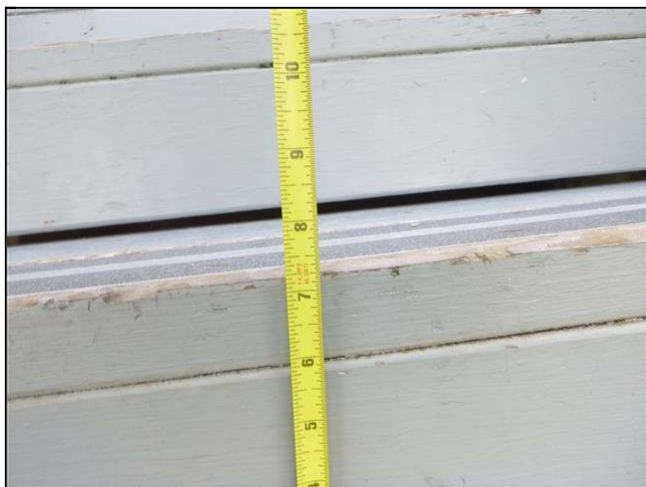
2.3 Item 1(Picture)

**2.3** Stairway height varies more than 3/8 of an inch. Noted at all stairs on unit A & B. Improper rise or run was noted at the stairs. This means that one or more of the stairs was higher or longer than the others or that the length of the stairs does not meet current standards. This should be considered a tripping hazard. Recommend correction be made by a qualified local tradesman.

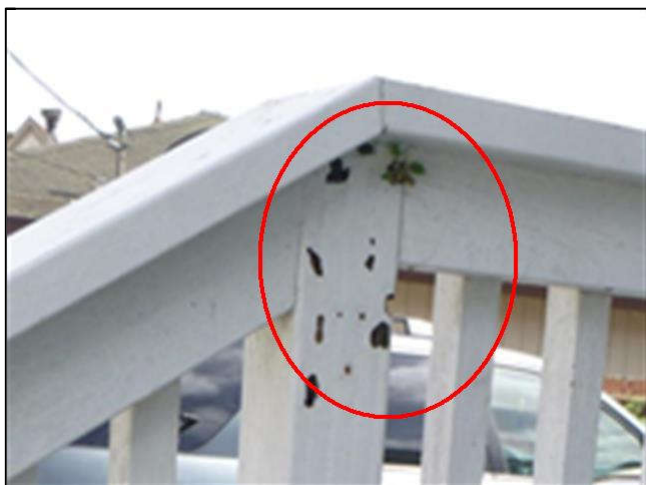
2.4 Item 1(Picture)

**2.4** Unit A: Wood damage noted at front stairs. Further evaluation by a qualified local pest inspector is recommended.

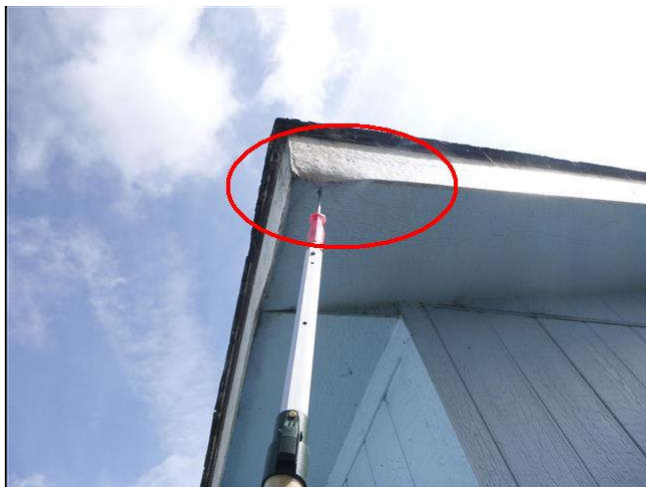
2.6 Item 1(Picture)

**2.6 Unit B:** Damage noted at the front left corner of the home. Further evaluation by a qualified local pest inspector is recommended.

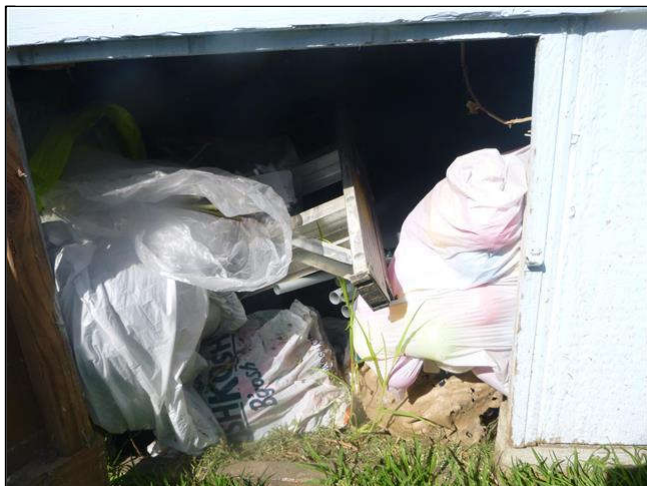
3.0 Item 1(Picture)

**3.0** Crawl spaces for unit A & B where inaccessible due to lots of stored items under the home. I view what I could through the items and surrounding foundation vents. No negative signs noted at time of inspection but further evaluation when access to crawlspace is provided is recommended.

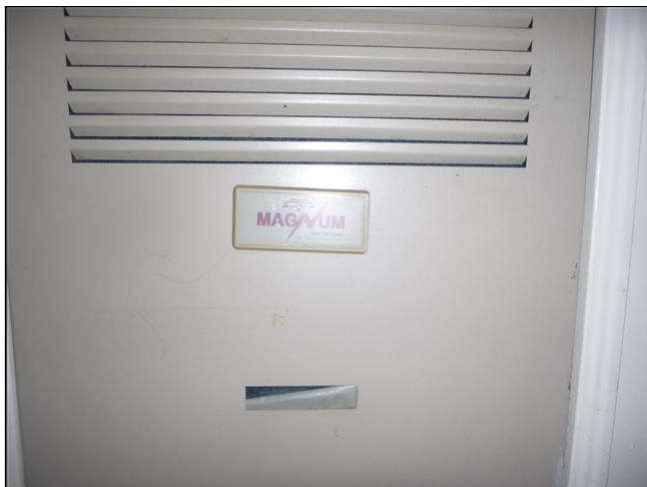
4.0 Item 1(Picture)

**4.0** The unit is older but in good shape and clean for unit A & B. Functionality for both units was verified at each vent with thermal imaging.

It is recommended by the manufacturer that all heating units be serviced annually by a qualified local tradesman to improve there life span and efficiency.

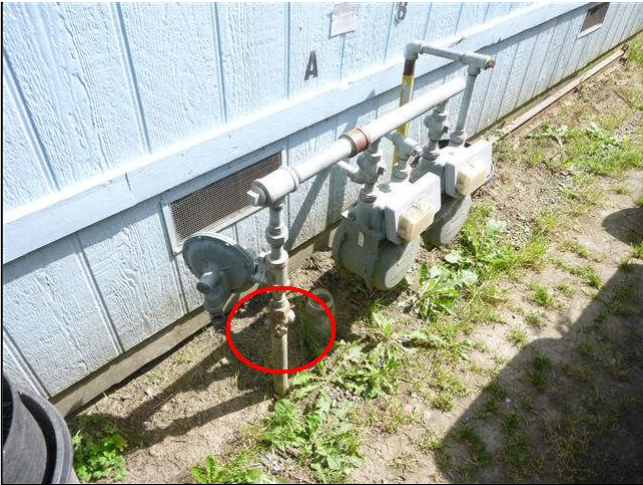
5.1 Item 1(Picture)

**5.1** Main fuel supply shut off is located outside on the right side of the home. Recommend adding a wrench for emergency shutoff.

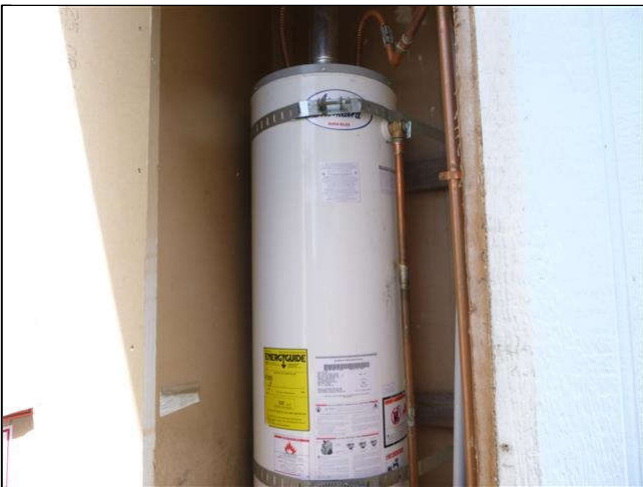
5.2 Item 1(Picture)

**5.2** Both water heaters are installed properly and on the newer side at time of the inspection. Unit A has a 30 gallon water heater manufactured in 2011. Unit B has a 40 gallon water heater manufactured in 2009. Both functioned well at time of inspection.

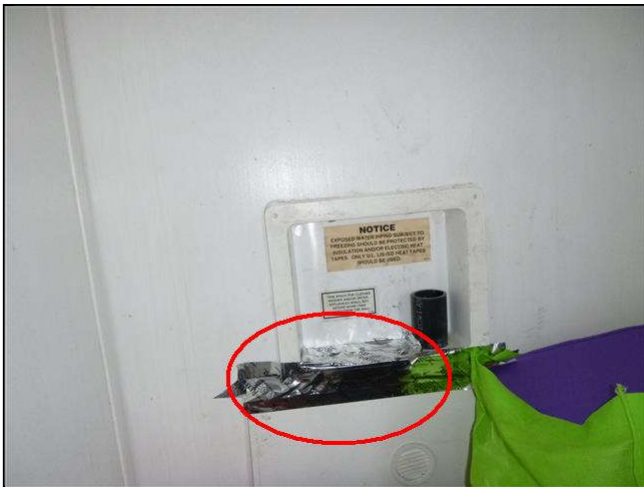
5.3 Item 1(Picture)

5.3 (1) Unit A: No water spigots noted for washing machine dryer combo.

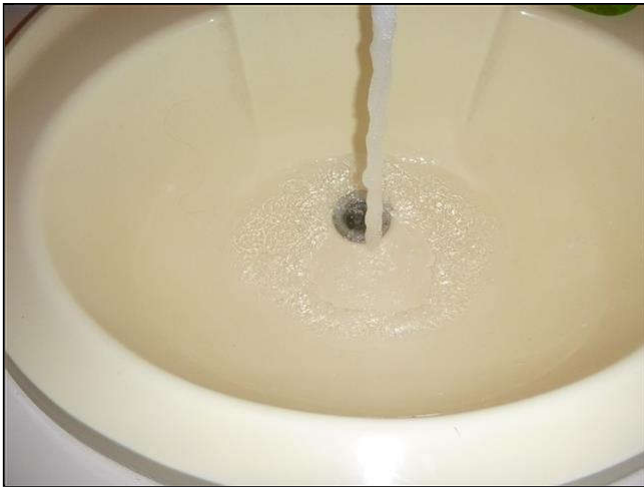
5.3 Item 2(Picture)

(2) Unit A & B: Drain stop not working or missing in the bathrooms. Recommend repair or replace as needed by a qualified local tradesman.

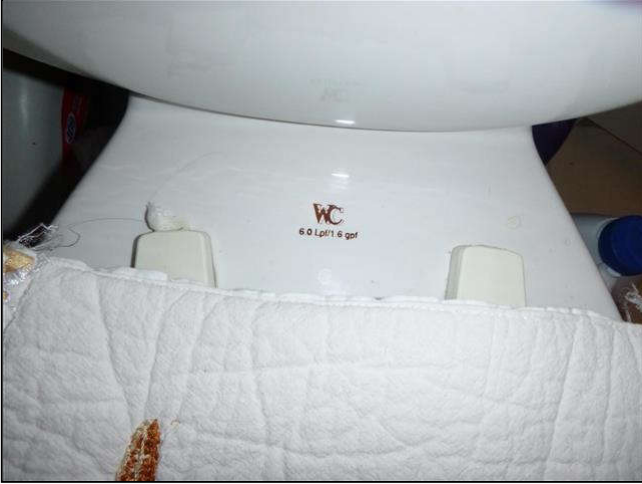
5.3 Item 5(Picture)

(4) The toilets and shower heads in the home are low flow. Santa Cruz city and county require low flow fixtures at time of sale in some cases. This home meets the low flow requirements.

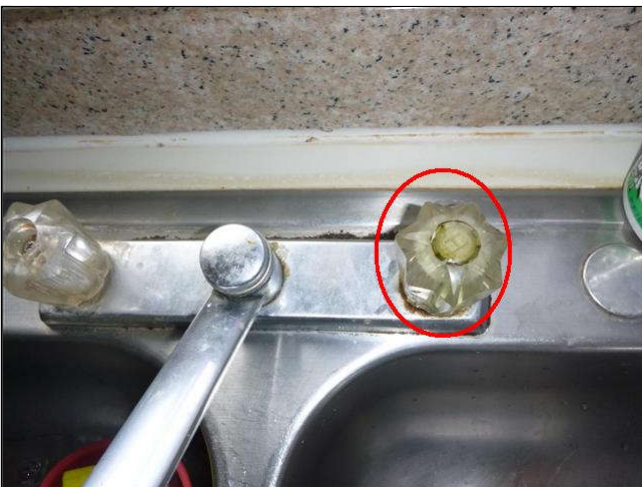
5.3 Item 7(Picture)

(6) Unit A: It is noted that the hot water label is on the wrong nob at the kitchen sink.

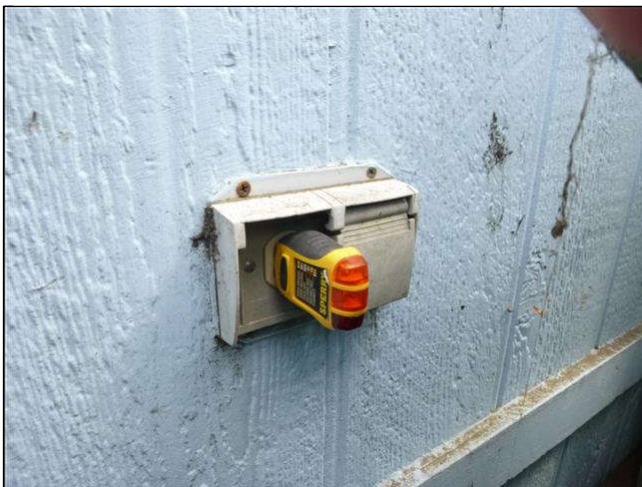
6.3 Item 1(Picture)

**6.3 (1) Unit B:** Receptacle at the back of the home is not energized. Repair as needed by a qualified local tradesman is recommended.

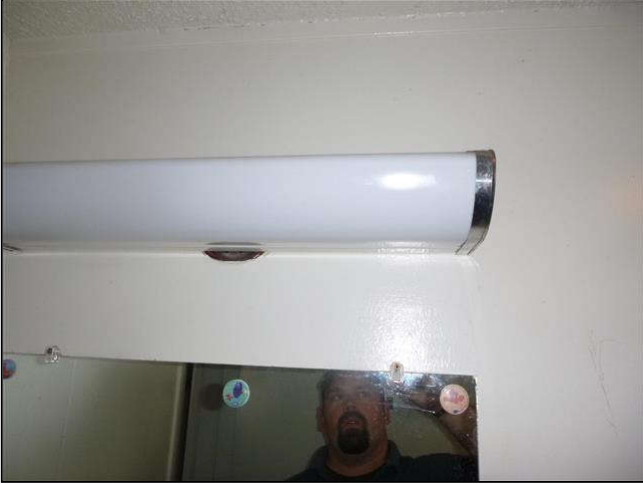
6.3 Item 2(Picture)

(2) Unit B: Light fixtures over both bathroom sink do not light. This could be a burnt out bulb. Further evaluation by a qualified local tradesman is recommended.

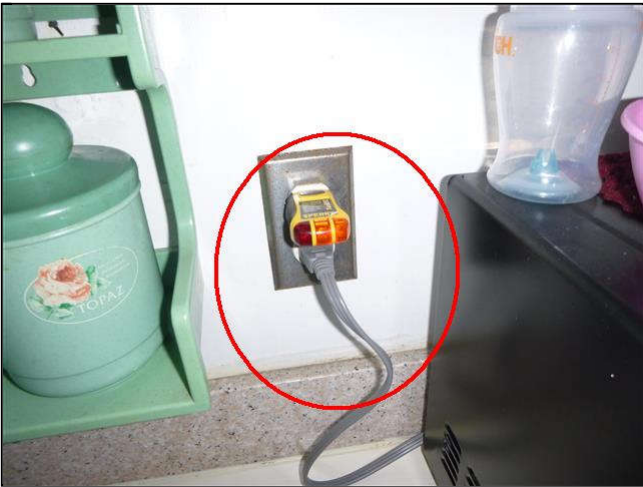
6.4 Item 1(Picture)

**6.4** GFCI protection not provided at exterior receptacles or one kitchen receptacle in unit A. As an extra precaution and for safety it is a recommended upgrade that this component be installed when possible. Recommend GFCI type outlets that are within 72 inches of the sinks / damp areas be installed. Modification or addition is generally considered an upgrade which should improve safety or efficiency. The opinion of a qualified local tradesman is recommended.

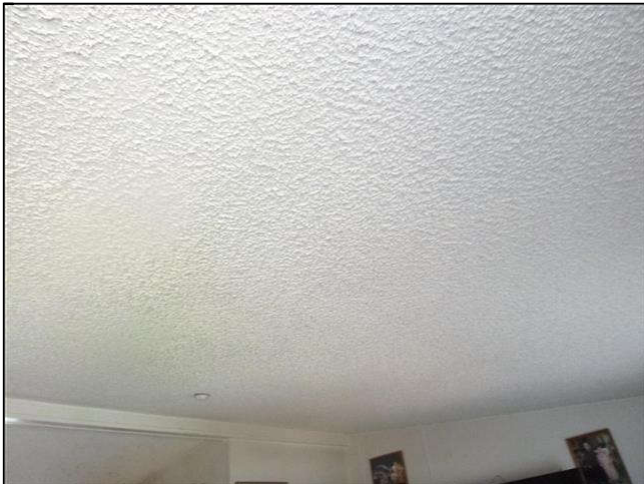
8.0 Item 1(Picture)

**8.0 Unit A:** No evidence of water intrusion below hole in roof at time of inspection.

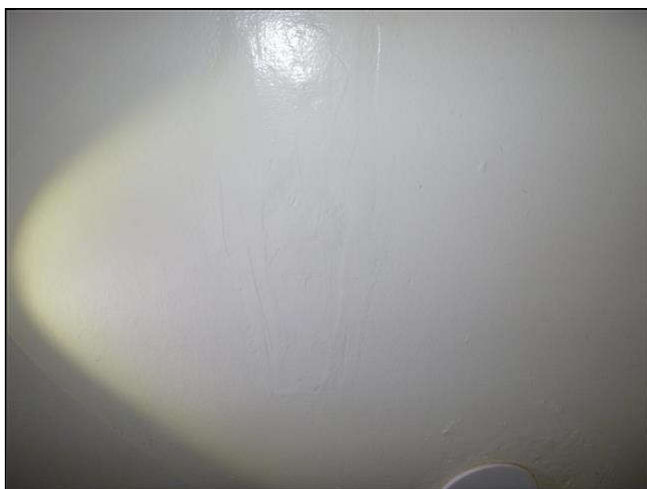
8.1 Item 1(Picture)

**8.1 Unit B:** Proper patching noted in the hall bathroom.

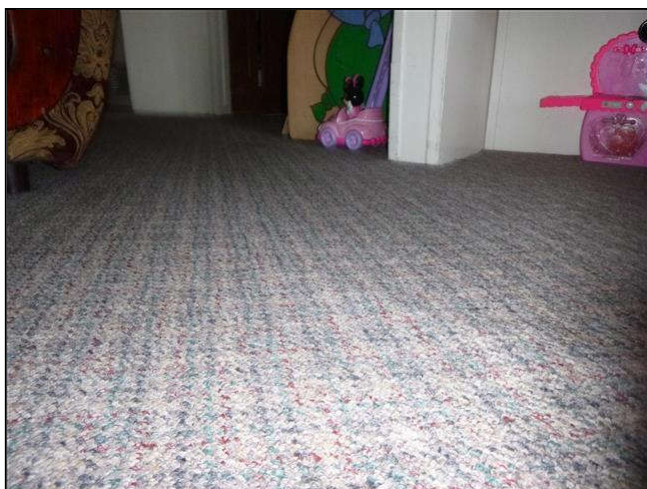
8.2 Item 1(Picture)

**8.2 Unit A:** Loose carpet noted in main living area. Repair or replacement as needed by a qualified local tradesman is recommended.

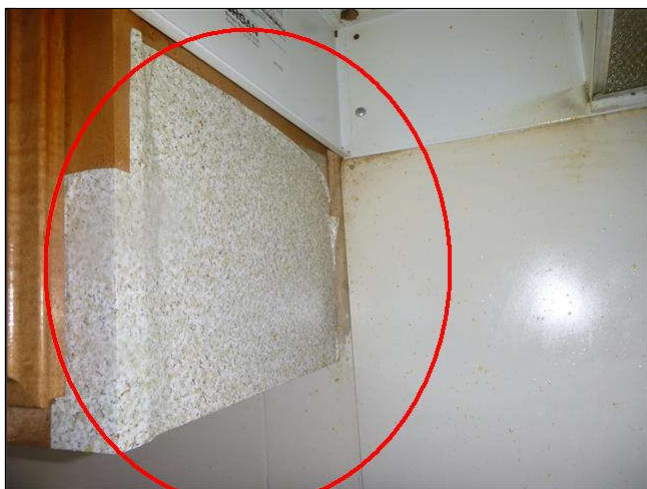
8.4 Item 1(Picture)

**8.4 Unit B:** Peeling wall paper on the side of one of the kitchen cabinets. Removal and repair as needed is recommended.

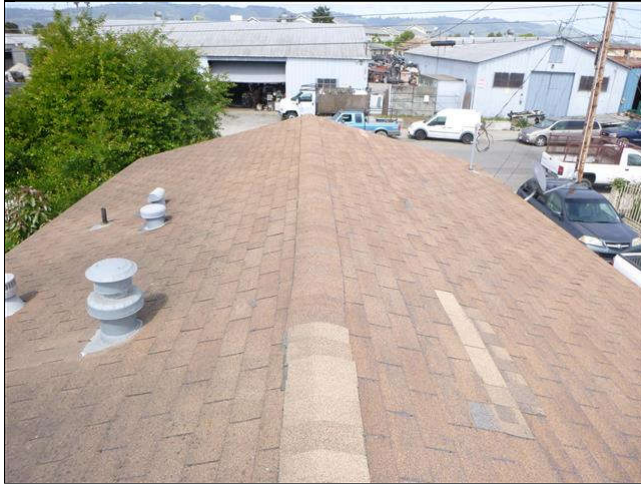
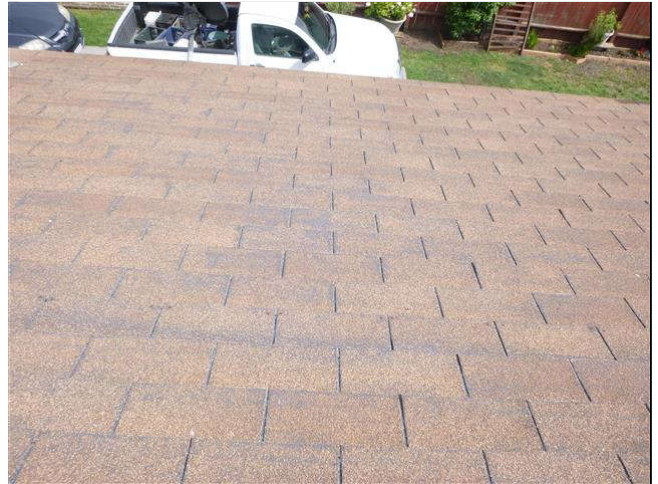
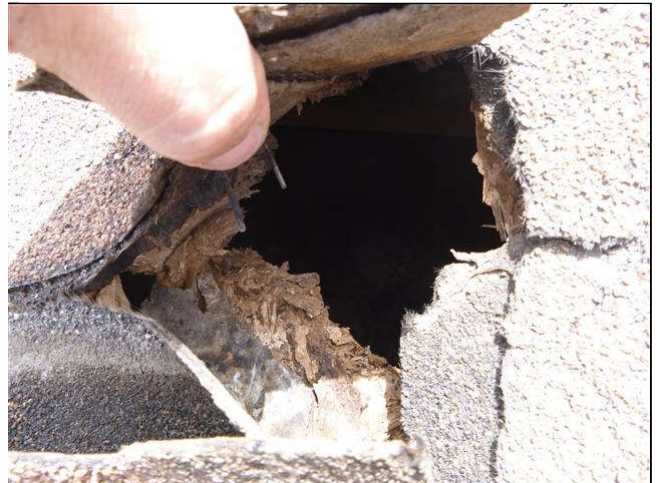
(1) Unit A: The roof is a single layer of composition shingles. The roof shows normal to moderate wear and I would age this roof at 15 to 20 years old. Missing or damaged shingles noted in several areas. A hole was also noted in the roof at the back left corner. Further evaluation then repair or replacement by a qualified local tradesman is recommended. No signs of leaking noted at time of inspection.

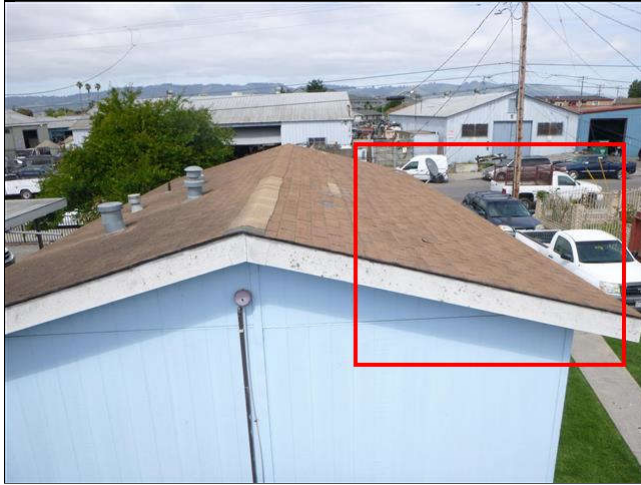
No gutters found on unit A or B. Gutters are recommended because they control the flow of run off away from the home and it's foundation. Adding gutters to both units is recommended.

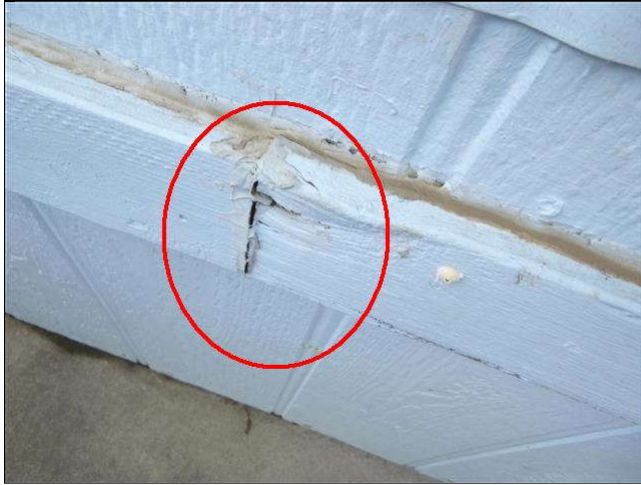
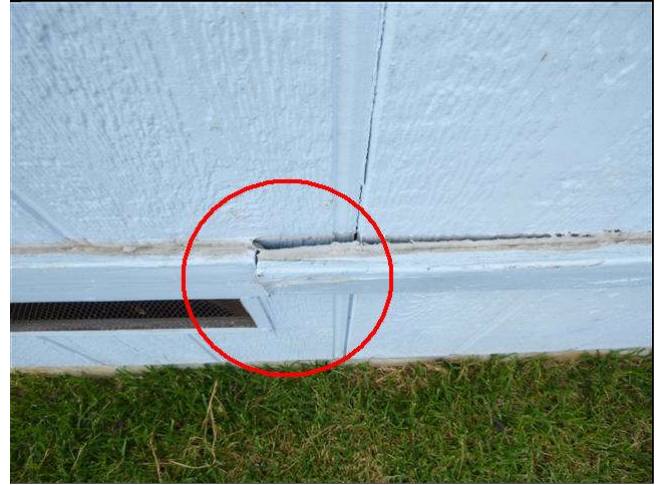
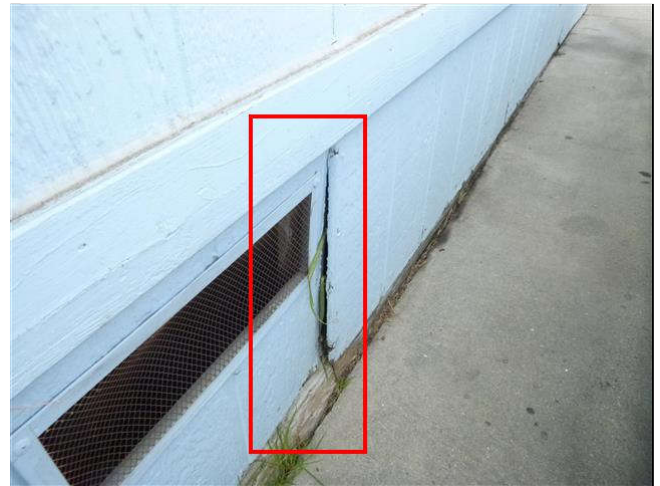
(1) Unit A: Damage noted to the skirt and skirt trim around the home at the left side, left and right back corners. Further evaluation by a qualified local pest inspector is recommended.

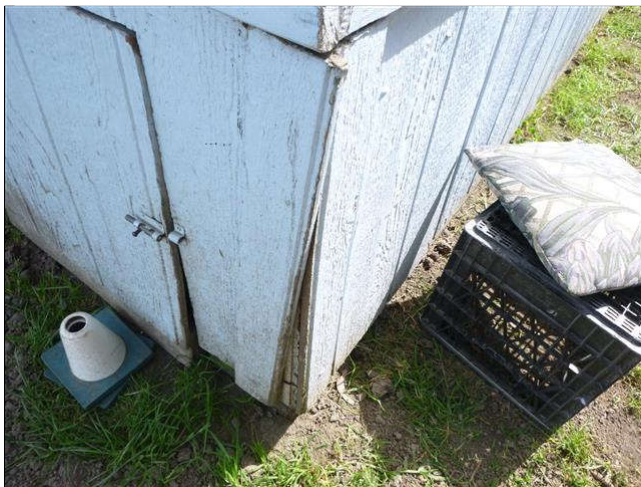
2.0 Item 5(Picture)

(2) Unit B: Loose trim noted at the front right corner of the home. Repair or replacement by a qualified local tradesman as needed is recommended.

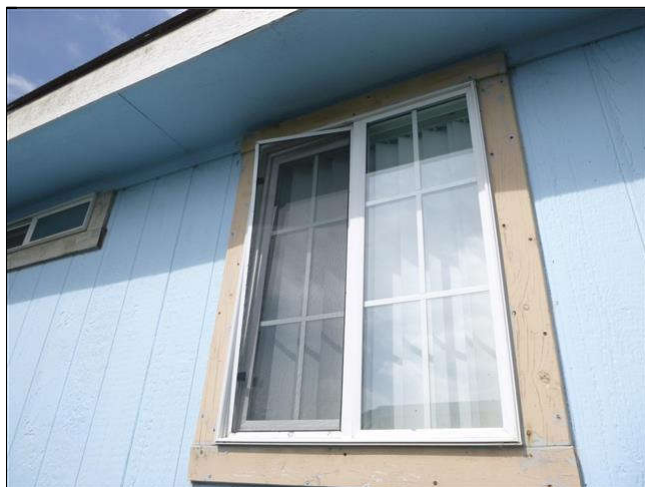
2.0 Item 6(Picture)

(3) Unit B: Exposed wood noted at the back and left side of the home around the windows. Proper prep and paint recommended to increase the life span of the material.

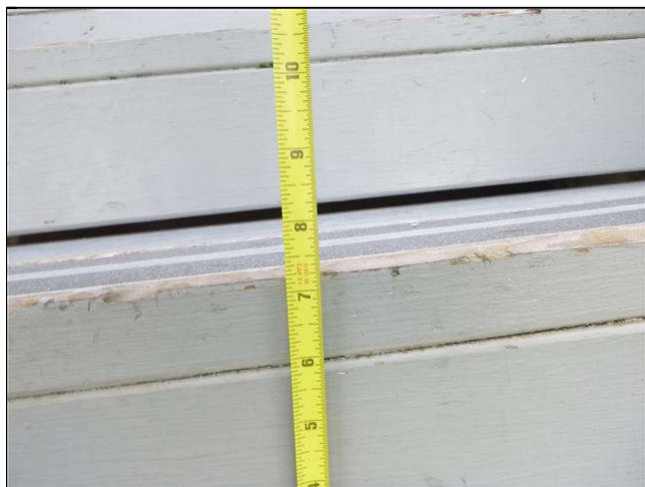
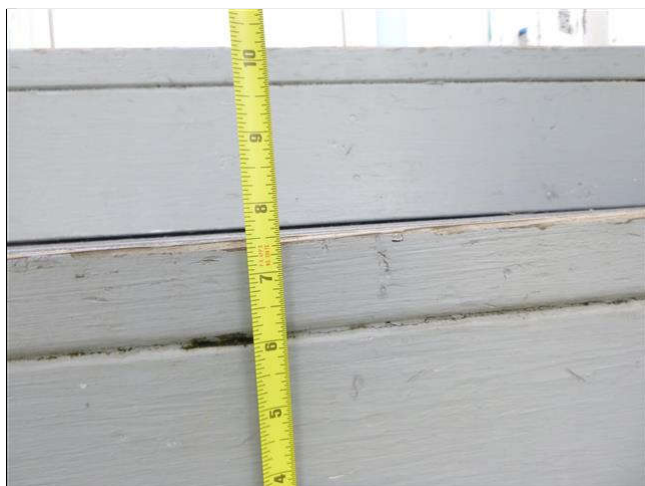
Stairway height varies more than  $\frac{3}{8}$  of an inch. Noted at all stairs on unit A & B. Improper rise or run was noted at the stairs. This means that one or more of the stairs was higher or longer than the others or that the length of the stairs does not meet current standards. This should be considered a tripping hazard. Recommend correction be made by a qualified local tradesman.

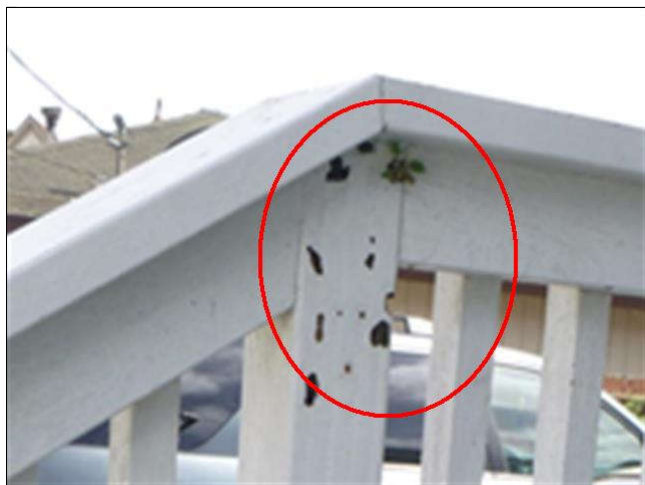
2.4 Item 1(Picture)

Unit A: Wood damage noted at front stairs. Further evaluation by a qualified local pest inspector is recommended.

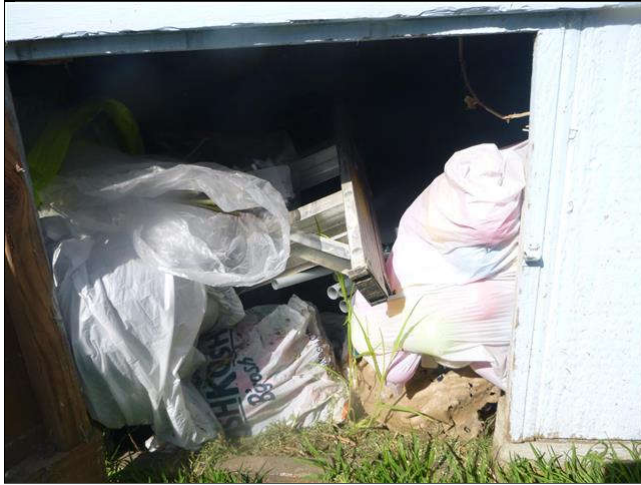
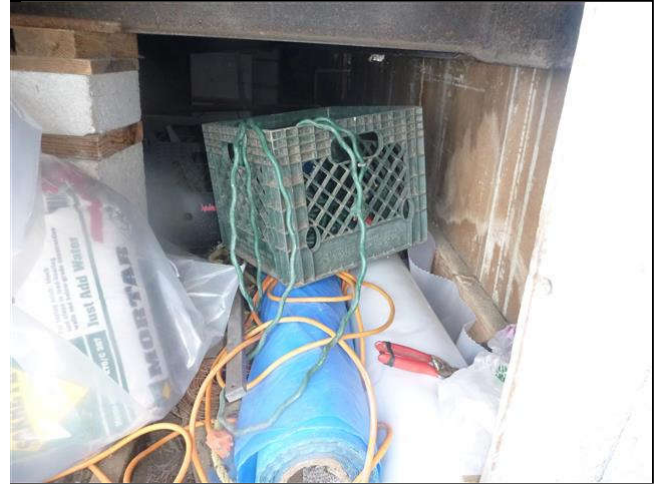
Crawl spaces for unit A & B where inaccessible due to lots of stored items under the home. I view what I could through the items and surrounding foundation vents. No negative signs noted at time of inspection but further evaluation when access to crawlspace is provided is recommended.

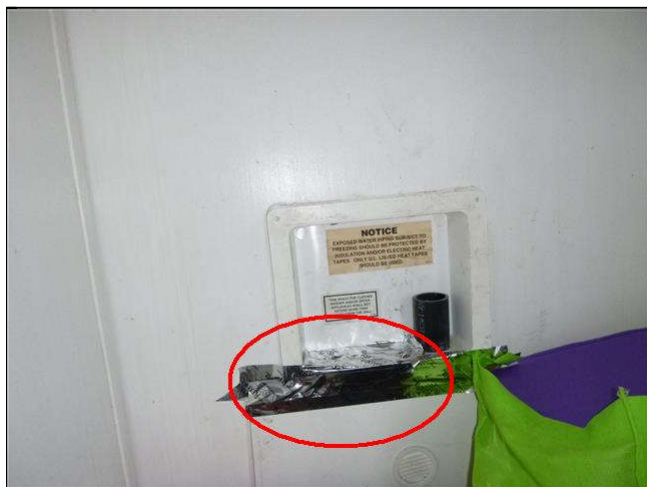
5.3 Item 1(Picture)

(1) Unit A: No water spigots noted for washing machine dryer combo.

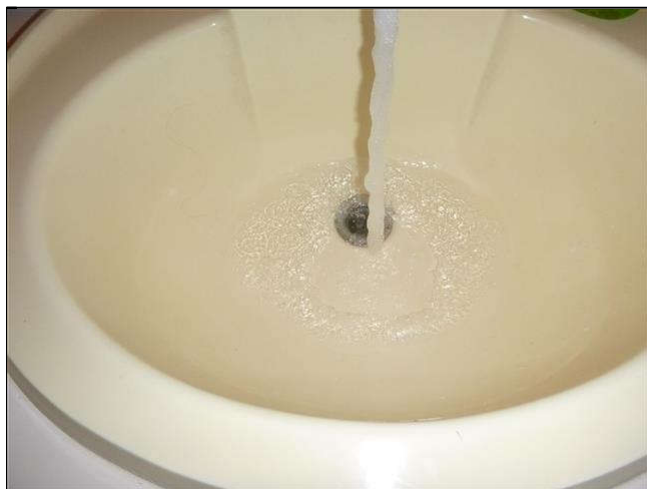
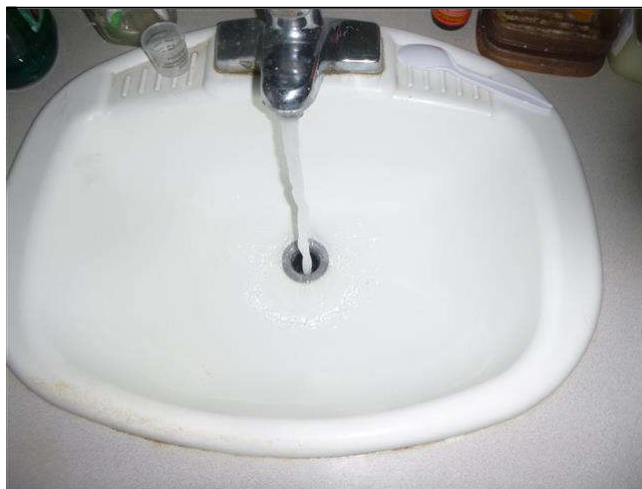
(2) Unit A & B: Drain stop not working or missing in the bathrooms. Recommend repair or replace as needed by a qualified local tradesman.

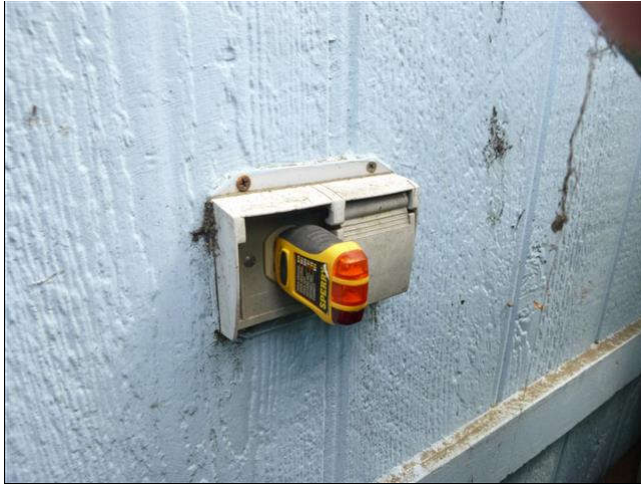
6.3 Item 1(Picture)

(1) Unit B: Receptacle at the back of the home is not energized. Repair as needed by a qualified local tradesman is recommended.

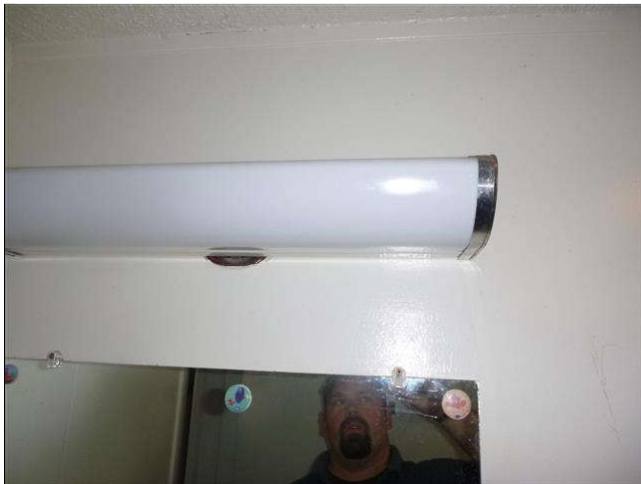
6.3 Item 2(Picture)

(2) Unit B: Light fixtures over both bathroom sink do not light. This could be a burnt out bulb. Further evaluation by a qualified local tradesman is recommended.

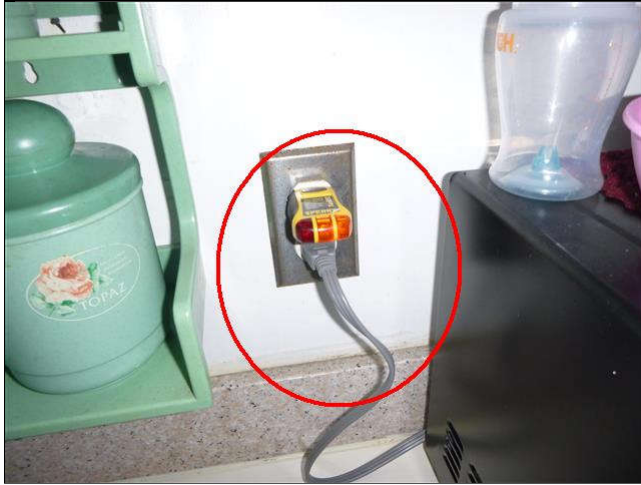
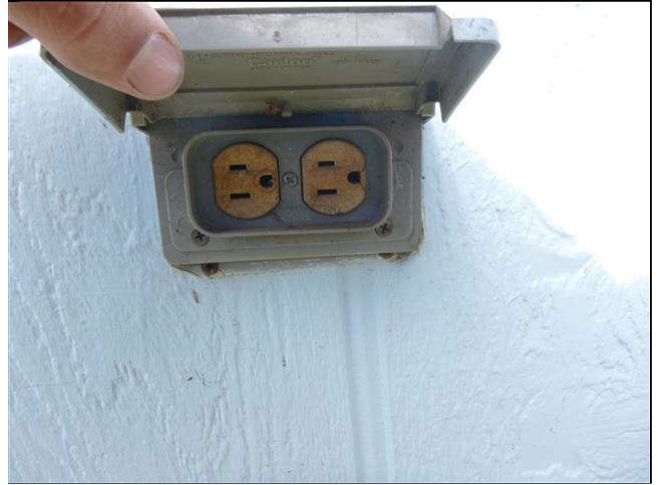
GFCI protection not provided at exterior receptacles or one kitchen receptacle in unit A. As an extra precaution and for safety it is a recommended upgrade that this component be installed when possible. Recommend GFCI type outlets that are within 72 inches of the sinks / damp areas be installed. Modification or addition is generally considered an upgrade which should improve safety or efficiency. The opinion of a qualified local tradesman is recommended.

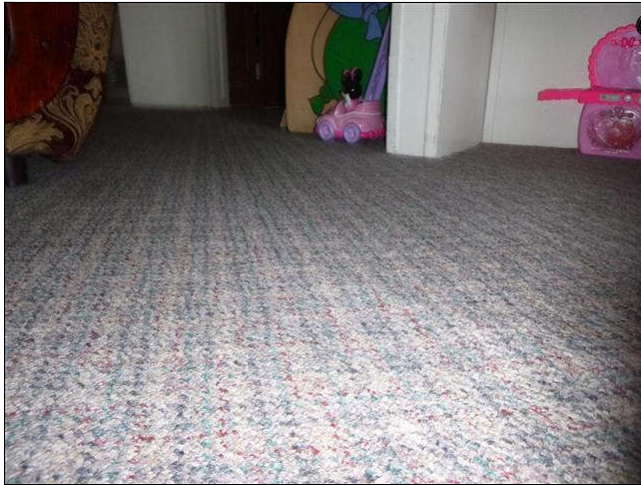
Unit A: Loose carpet noted in main living area. Repair or replacement as needed by a qualified local tradesman is recommended.

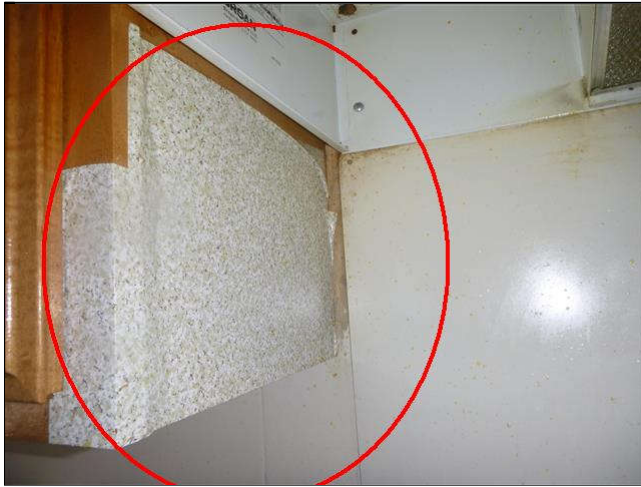
8.4 Item 1(Picture)

Unit B: Peeling wall paper on the side of one of the kitchen cabinets. Removal and repair as needed is recommended.
