Exhibit D

Subject: Supplemental Geologic Report for
Proposed Guest House
36150 Highway 1, Monterey
Monterey County APN 243-251-023

Subject: Supplemental Assessment of Slope
36150 Highway 1, Monterey
Monterey County APN 243-251-023

Subject: Response to County Comments
Proposed Accessory Dwelling Unit
36150 Highway 1, Monterey, California
Monterey County APN 243-251-023

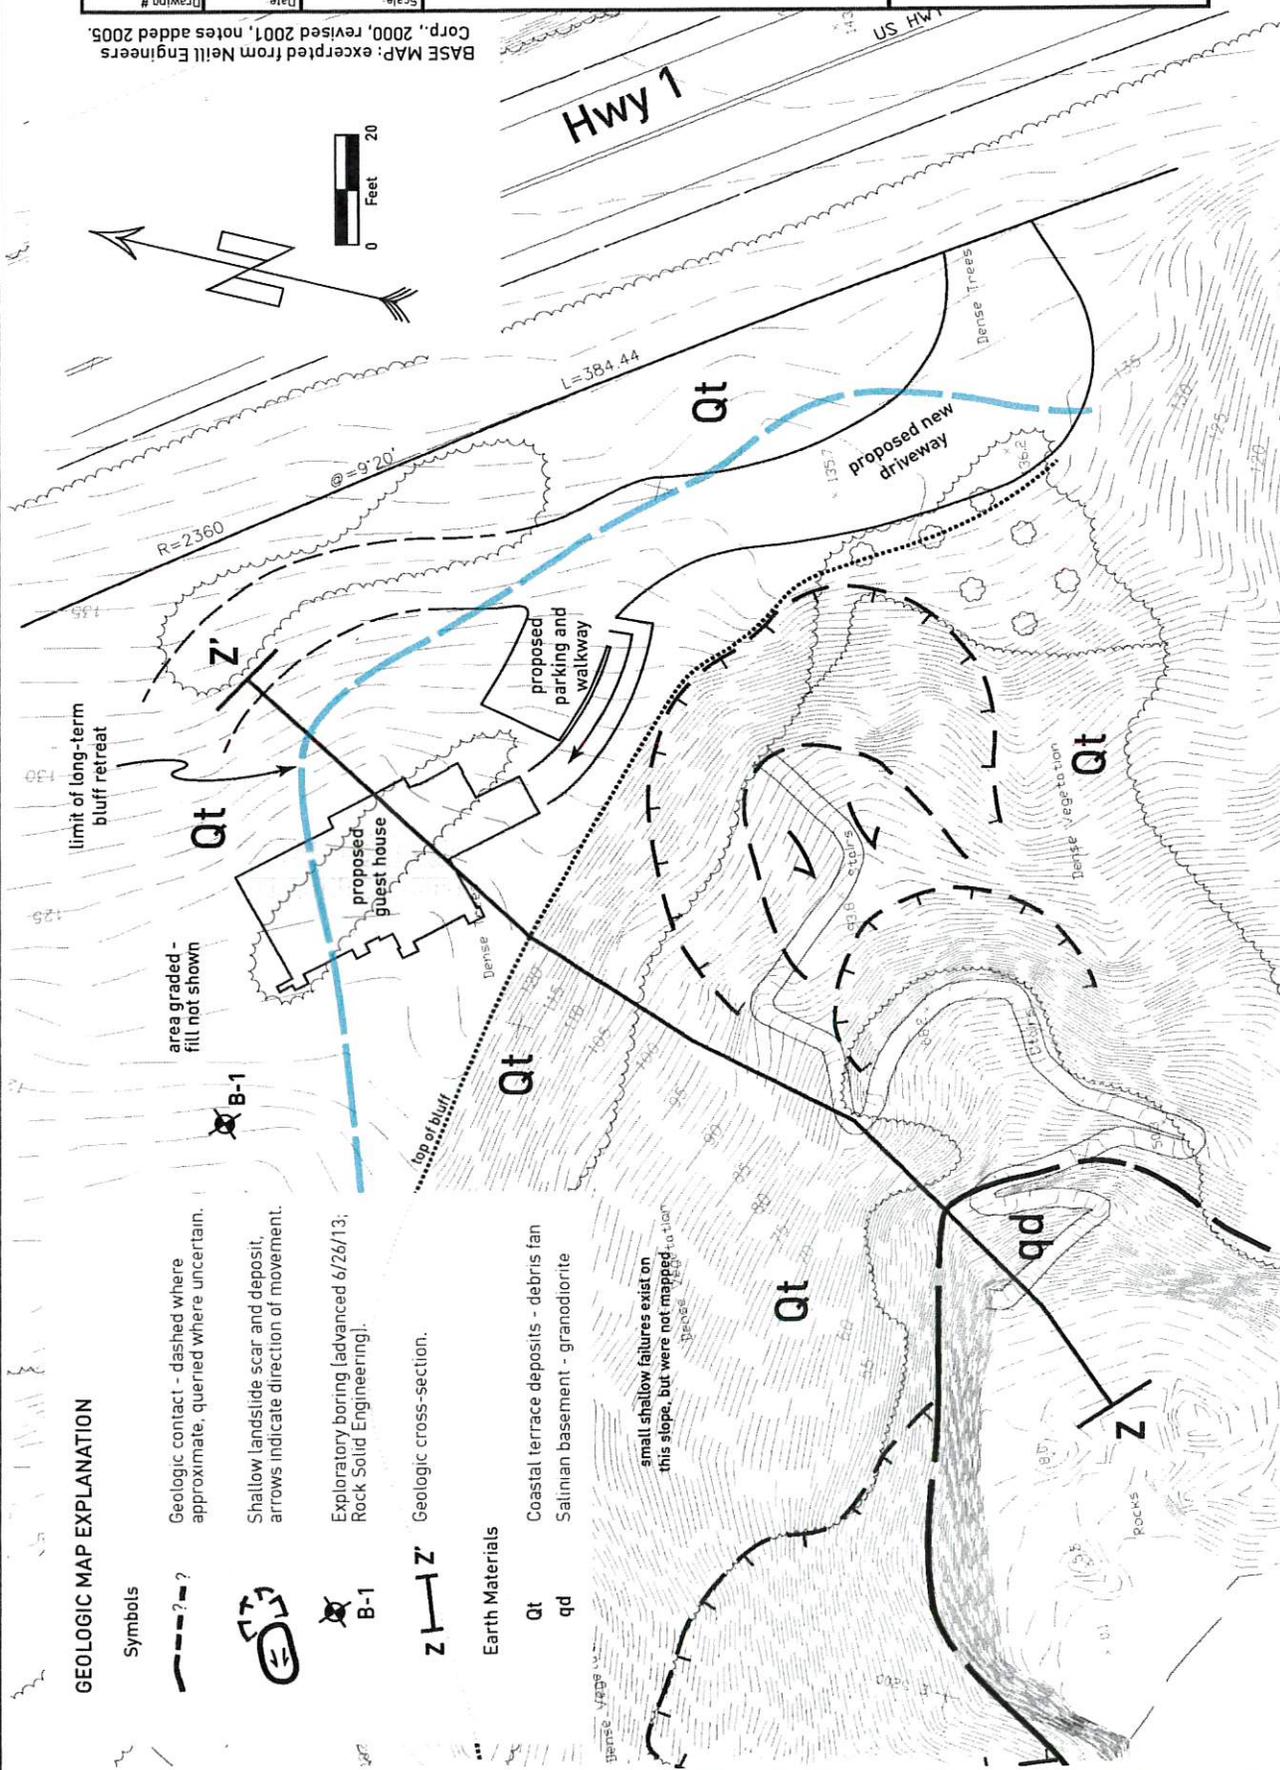
Scale: 1" = 20'	Date: 3/13/17	Project #: C16021
Drawn By: GFE	Revised:	Drawing #: Figure 1
EASTON GEOLOGY, INC. P.O. Box 3533 Santa Cruz, California 95063 831.247.4317		
GEOLOGIC MAP OF PROPOSED GUEST HOUSE LOCATION Chez Property 36510 Highway 1, Monterey, California Monterey County APN 243-251-023

The guest house is proposed atop an approximately 120 foot tall coastal bluff (Figures 1 & 2). Relatively young, noncemented terrace deposits comprise the upper 90 or so feet of the bluff. The lowermost 30 feet of the bluff consists of much older, erosion resistant granitic bedrock.

We mapped the proposed guest house site and surrounding area including the bluff below (Figures 1 & 2). The blufftop at the guest house site slopes gently seaward, and the dwelling situated about eight feet from the edge of the bluff. Grading in the area of the guest house site has created: 1) an

small shallow failures exist on this slope, but were not mapped on this map.

GEOLOGIC MAP

unimproved access road; 2) an adjacent generator building and fill pad; 3) a stockpile of excavated material from construction of the main house; and 4) minor cuts and fills associated with an access trail to the base of the bluff. From our mapping, we estimate that the stockpiled material overlying the ground surface at the site of the guest house is about five feet thick (Figure 2).

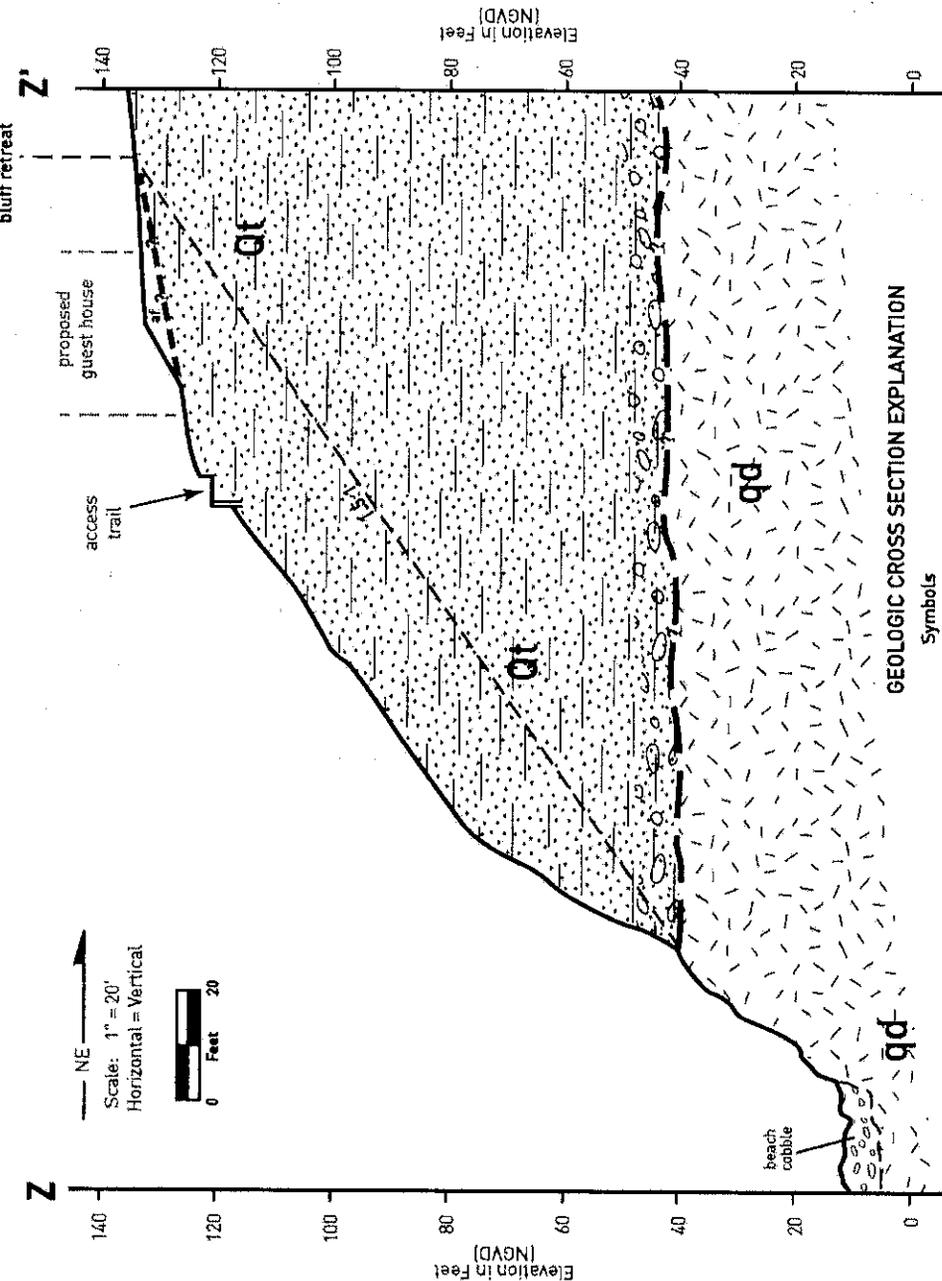
EASTON GEOLOGY, INC. P.O. Box 3533 Santa Cruz, California 95063 831.247.4317		GEOLOGIC CROSS SECTION 36510 Highway 1, Monterey, California Monterey County APN 243-251-023	
Scale: 1" = 20' H = V	Date: 3/13/17	Drawn By: GFE	Project #: C16021
Figure 2	Figure 2

To evaluate the current configuration of the bluff, we surveyed a geologic cross section across the proposed development site and down the bluff-face below (Figure 2). In general, the terrace deposits in the upper 50 feet of the bluff are steeply sloping (about 71% gradient). The lower portion of the terrace deposits and the granitic bedrock comprising the base of the bluff are very steep (over 100% gradient).

GEOLOGIC CROSS SECTION EXPLANATION

- af Stockpiled fill
- Qt Coastal Terrace deposits - debris fan
- qd Salinian basement - granodiorite

- a. Cross Section Z-Z' used for our analysis was provided by Easton Geology (Reference 3). The cross section extended from north of the proposed guest house to the base of the coastal bluff. The location of the cross section is shown on the Geologic Map **Figure 1** and the Geologic Cross Section is shown on **Figure 2**.
- b. In order to model the slope conditions in an earthquake, the pseudo-static analyses assumed a seismic coefficient of 0.36 with a required minimum Factor of Safety of 1.0 as provided by the Easton Geology (Reference 2).

- c. The Geologist has provided a projected long term bluff retreat line. The retreat line extends from base of the terrace deposits at an angle of 1.5:1 to the ground surface (**Figure 2**). To protect the structure from future cycles of repetitive shallow type failures, we are proposing that the structure be founded on augured piers which extend below the 1.5:1 projected line.

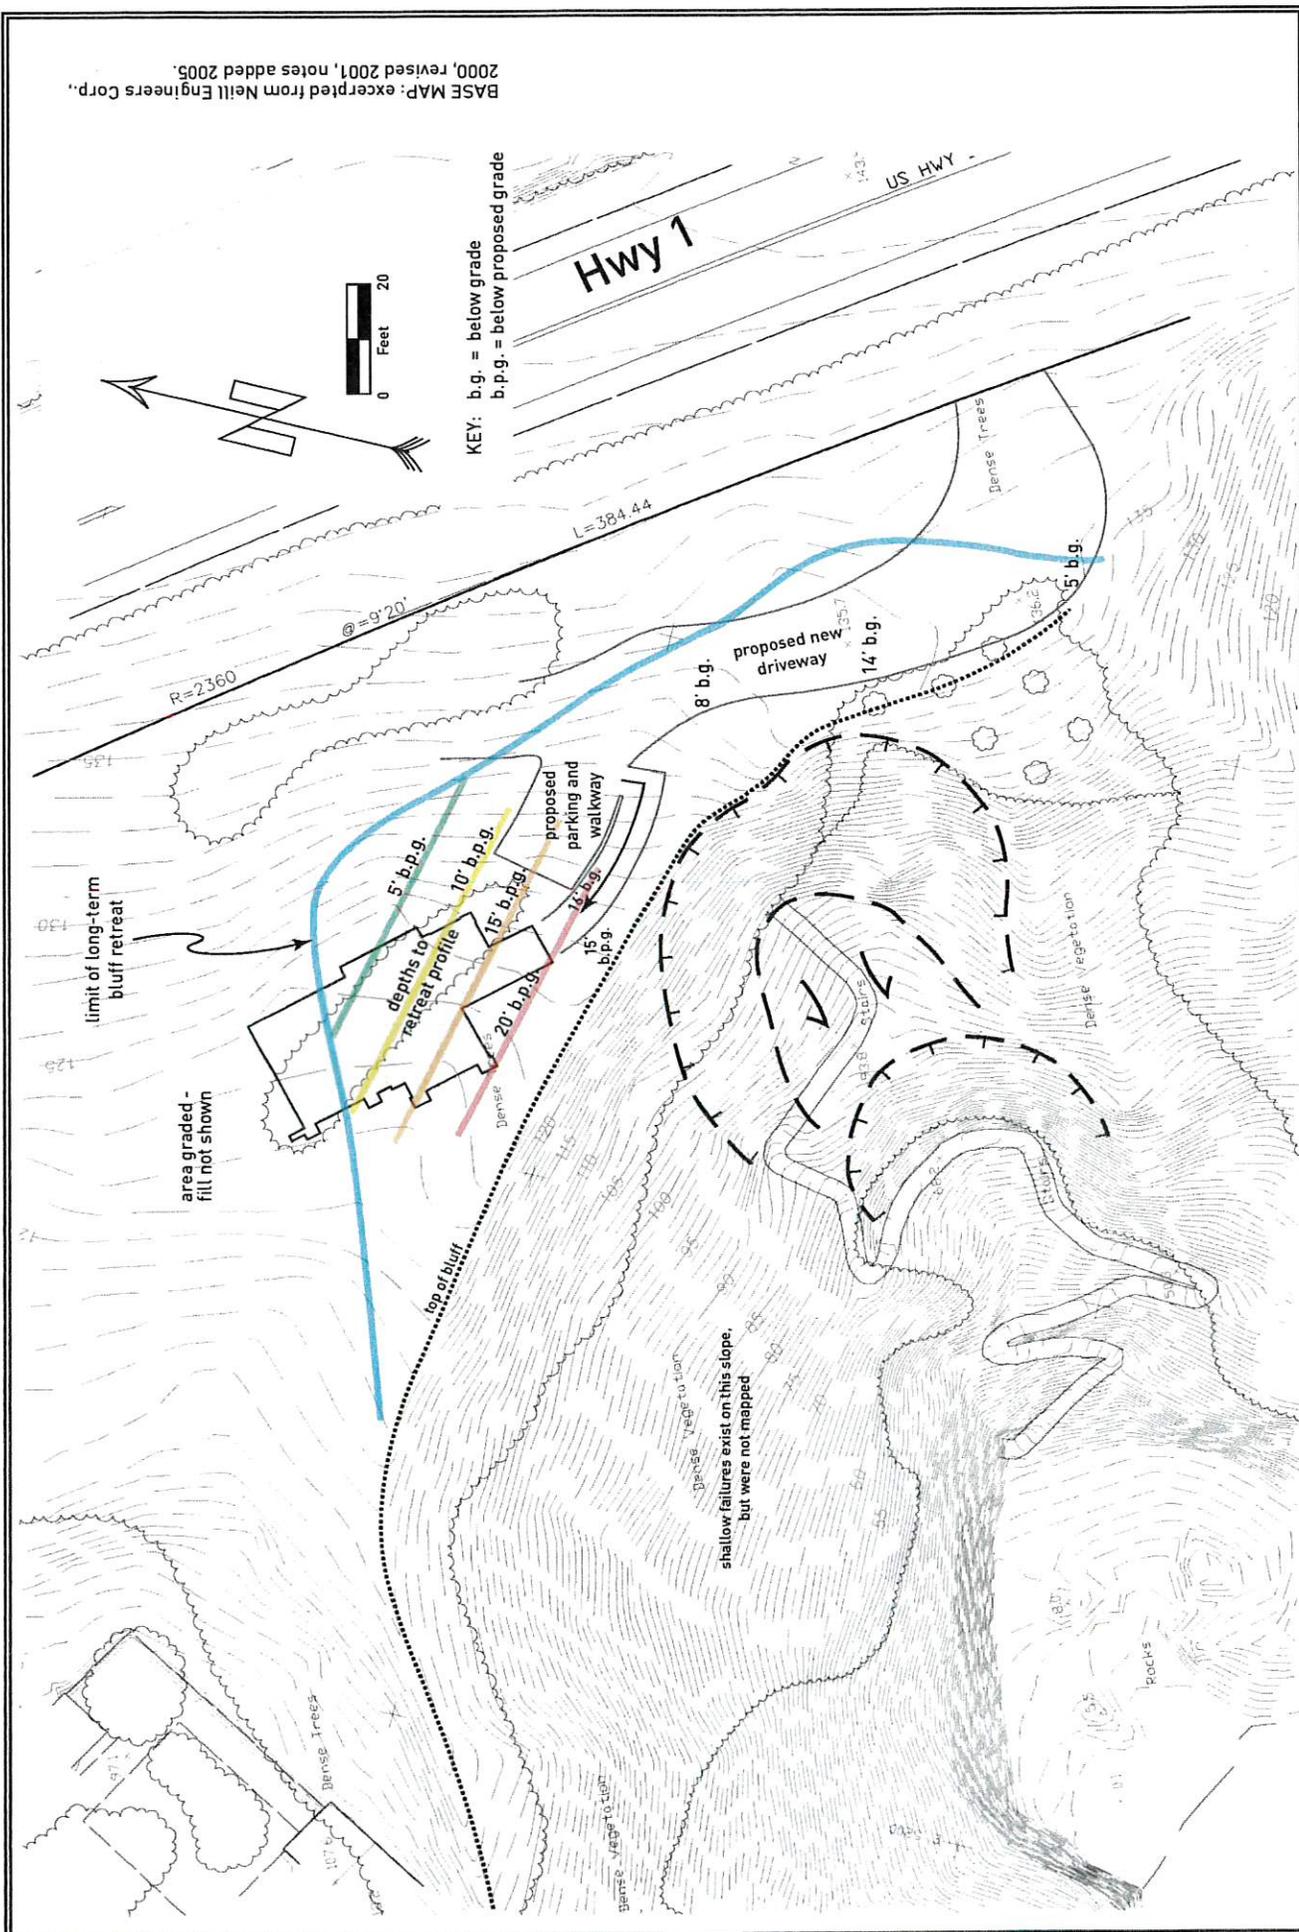
DEPTHS TO LONG TERM BLUFF RETREAT LINE

- c. The depth of embedment of the piers shall be the depth noted on **Figure 3** plus 5 feet. The depths may be interpolated between given numbers.
- d. The Project Geologist mapped a landslides downslope of the proposed driveway in 2013 (**Figure 1**). During the winter of 2015-2016, an additional slide occurred in the same vicinity. A 3 to 4 inch diameter pipe was noted in the area of the slide. This pipe appeared to be separated and was discharging water into the area of the slide. If not already completed, this pipe should be located and repaired to bring the discharge location further downslope.

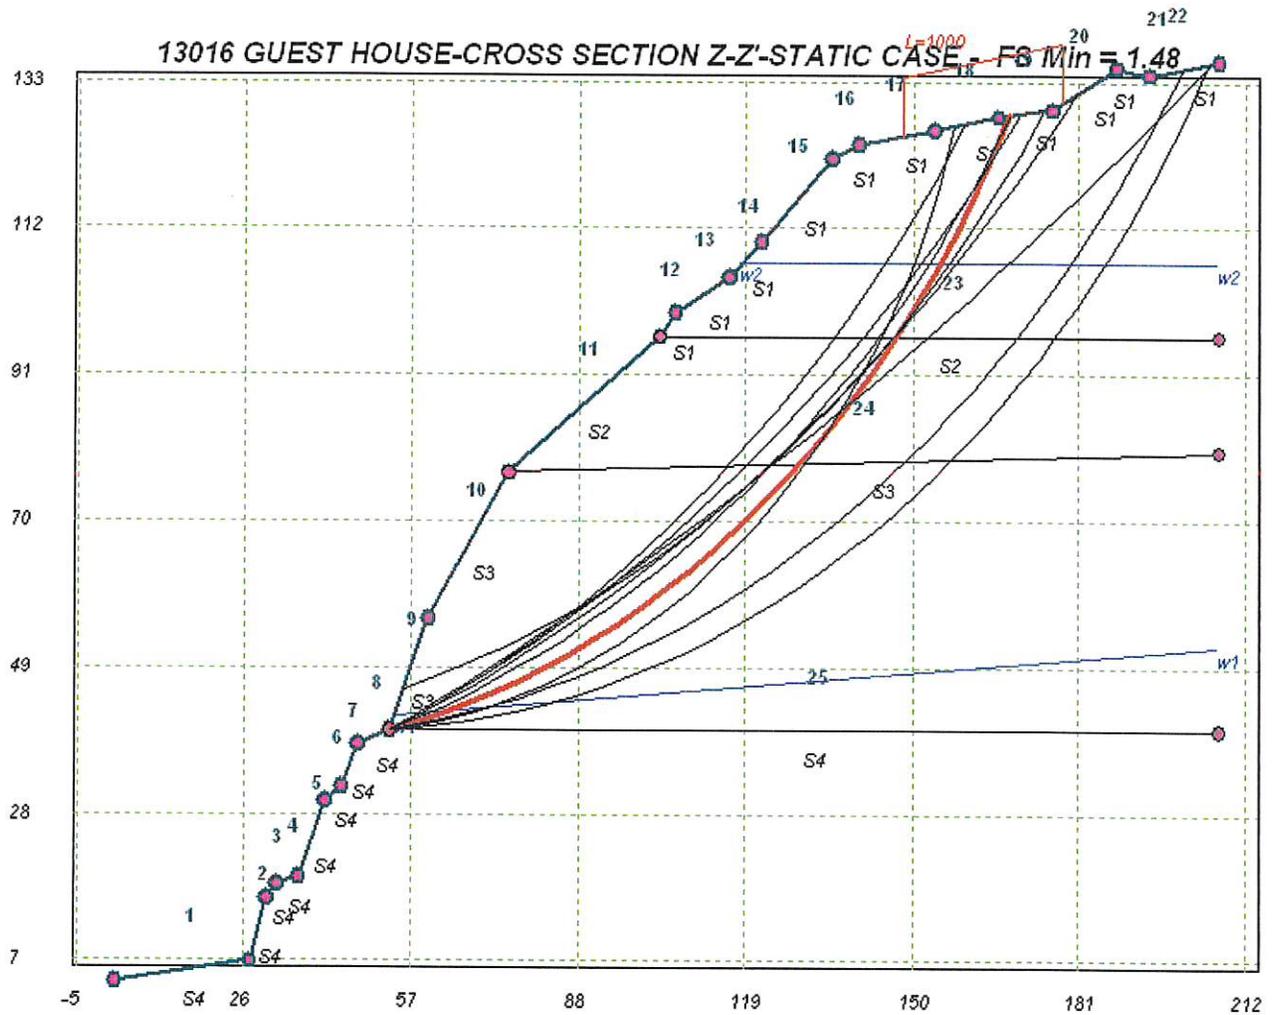
CROSS SECTION Z-Z' - STATIC CASE

- A-2. The stability of the slope at the subject site was analyzed using the program PCSTABL6 which utilized a limiting equilibrium method for determining the Factor of Safety against sliding on an assumed failure surface. The cross section analyzed, and the results of the analysis are presented below.

*** 1.480 ***

- a. The results of our analysis indicate that the minimum factor of safety of the slope, in the current configuration, for overall circular type failures is 1.5 for the static case and 1.0 for the pseudo-static case. These just **meet** the minimum factors of safety considered to be the industry standard.

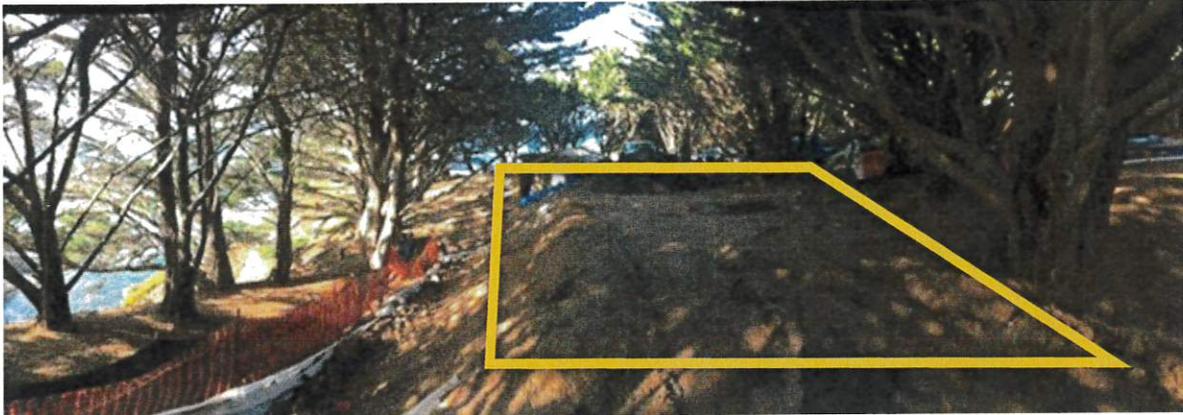
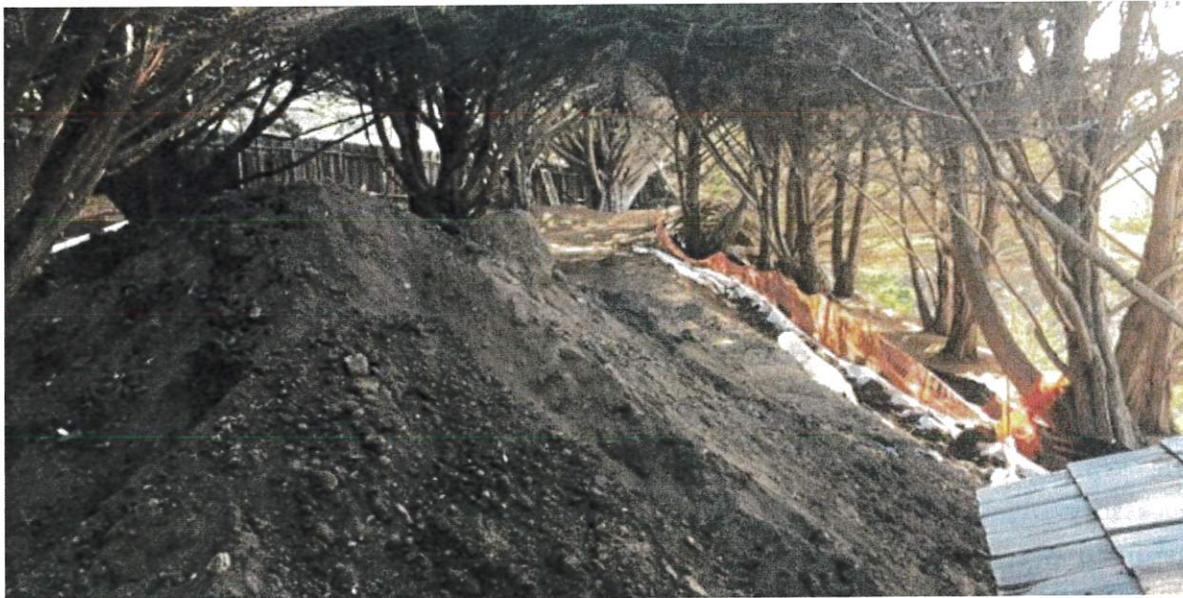
As the photographs indicate, the proposed site is a level area that currently is cleared of vegetation — which had been evaluated in 2013 — and covered with deposited earth excavated from the main building site. The site abuts several planted and nonnative Monterey Cypress trees, none of which will be removed as part of the proposed work.
