Soil Investigation Report (Design Phase) Based on CBC 2016

0 Hillcrest Rd, Watsonville, CA 9507 **APN 117-081-013-0006**

Ahmed Saba- Single Family Dwelling (831)-818-4077

SUBJECT: SOIL INVESTIGATION REPORT

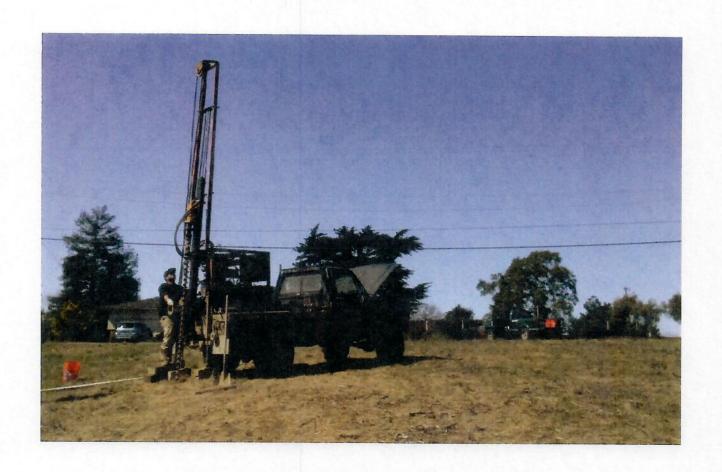
Boring #1 Drilling Operation on 8-31-2017 at 0 Hillcrest Rd Watsonville Ca 95076

We observed drilling of 2 borings and logged the subsurface conditions at each location. Boring locations are shown on Site Plan, Appendix. We retained a Mobile B24 drill rig and crew to advance the borings using 4-inch diameter solid flight auger methods. The boring drilled for this investigation encountered very stiff lean clay to sandy lean clay and sandy silt to a depth of approximately $8\frac{1}{2}$ feet. Below a depth of $8\frac{1}{2}$ feet, the boring encountered medium dense, silty sand with lean clay to 15 depth. Borings were advanced to depths ranging from 15 to 18 feet below existing grade. Borings were backfilled with drill cuttings. We obtained soil samples at various intervals using standard penetration tests and a California Modified Sampler (3-inch O.D. split spoon with 2.5-inch I.D. liners). The blow counts were obtained by dropping a 140-pound hammer through a 30-inch free fall. The sampler was driven 18 inches and the number of blows were recorded for each 6 inches of penetration. Unless otherwise indicated, the blows per foot recorded on the boring log represent the accumulated number of blows required to drive the last one foot of penetration; the blow counts have not been converted using any correction factors. When sampler driving was difficult, penetration was recorded only as inches penetrated for 50 hammer blows.

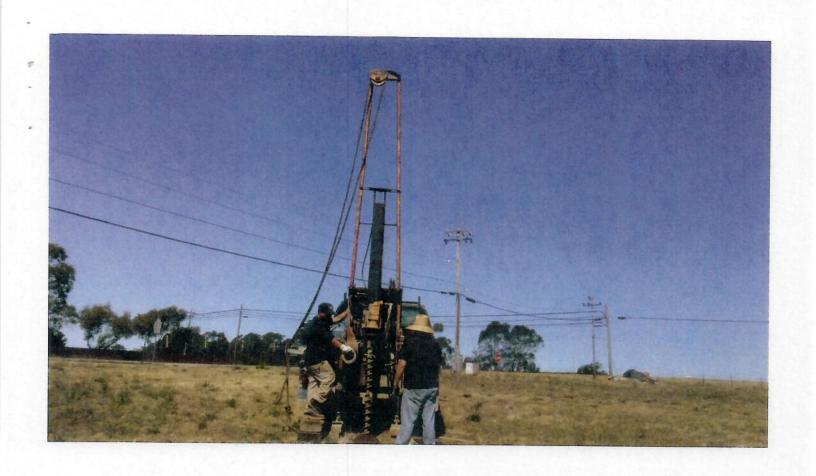
Boring #2 Drilling Operation on 8-31-2017 at 0 Hillcrest Rd Watsonville Ca 95076
