# Exhibit C

PROJECT FILE NO. PLN180198

PHOTOGRAPHS

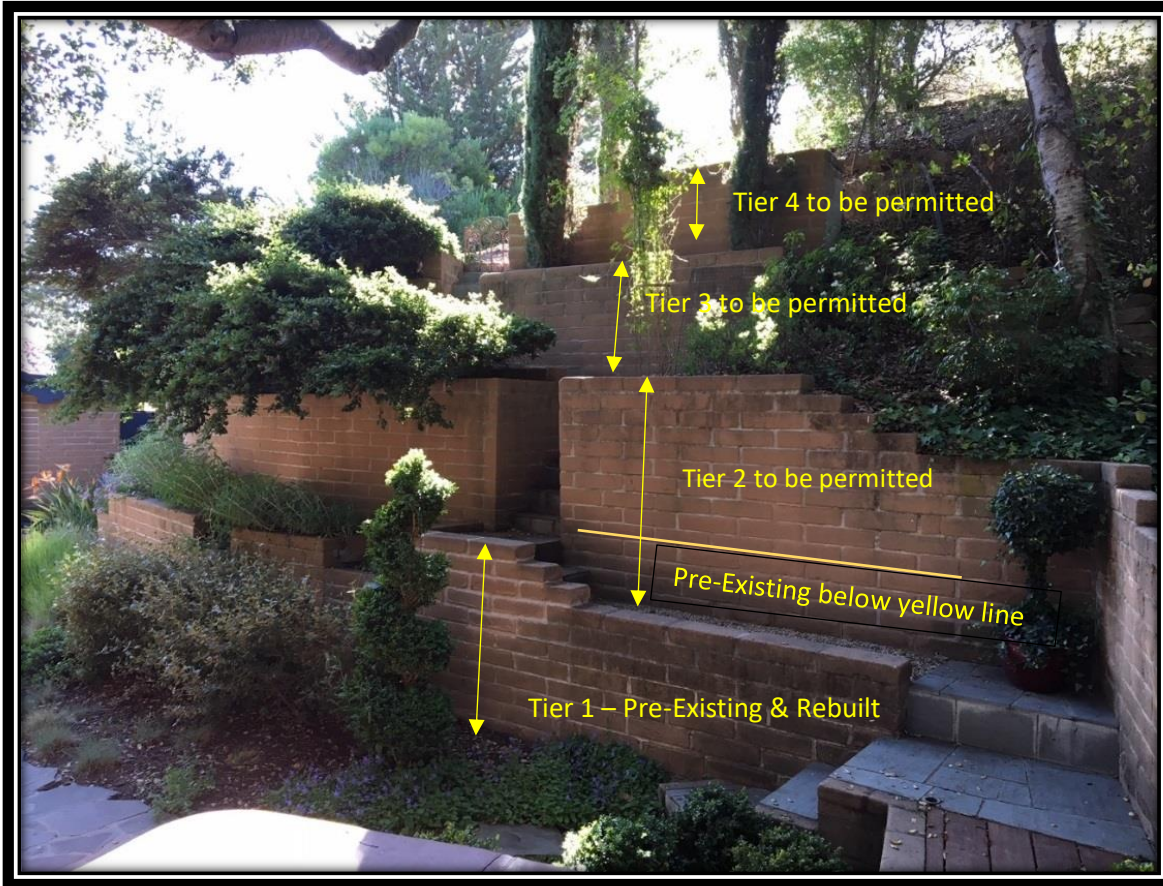
Picture 1

Heights of Walls:

Tier 1 = 3.8'

Tier 2 = 4.9'

Tier 3 = 3.5'

Tier 4 = 3.2'

DESCRIPTION: North retaining walls, showing Tiers 1, 2, 3, & 4 (picture 1). Tier 1 & part of Tier 2 pre-existed. The additional height of Tier 2, steps, and Tiers 3 & 4 are to be permitted. See "Work Area 1" on Plot Plan.

All other walls in picture pre-existed the scenic easement, and the addition of fascia to these walls as well as Tier 1 and part of Tier 2 were permitted in 1985 with the permit to add a master bedroom and bath.

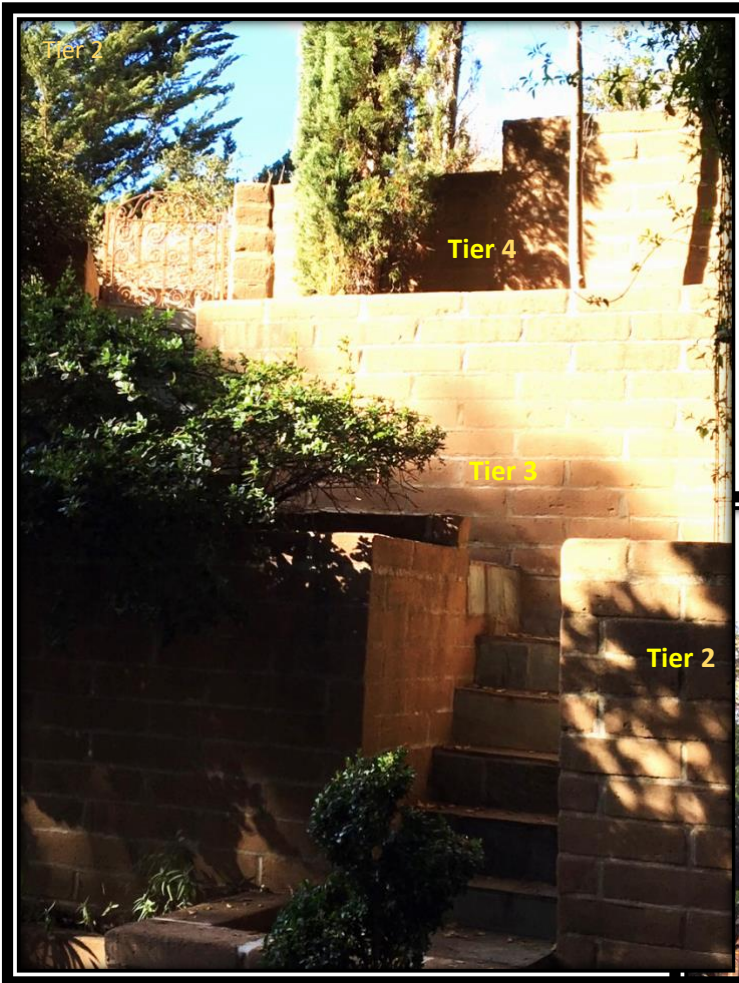
Picture 4

DESCRIPTION: North retaining walls, close-up of front of walls and steps (6" high) (picture 4) Close-up of landing. (picture 5) See "Work Area 1" on Plot Plan.

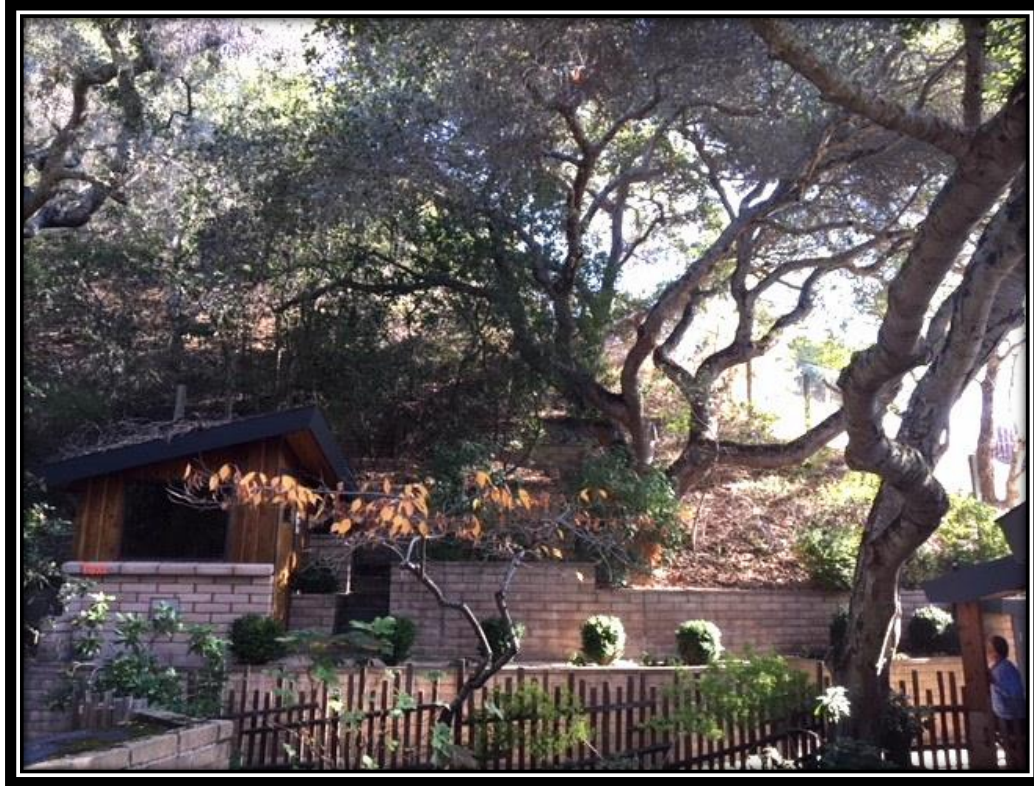
Picture 6

DESCRIPTION: East retaining walls, overall view with Tiers 1 and 2 visible and with sauna at left of Tier 2. (picture 6) Looking North to Sauna, Tier 1 & 2 (picture 7) with short wooden fence at left of path. See "Work Area 2" on the Plot Plan.

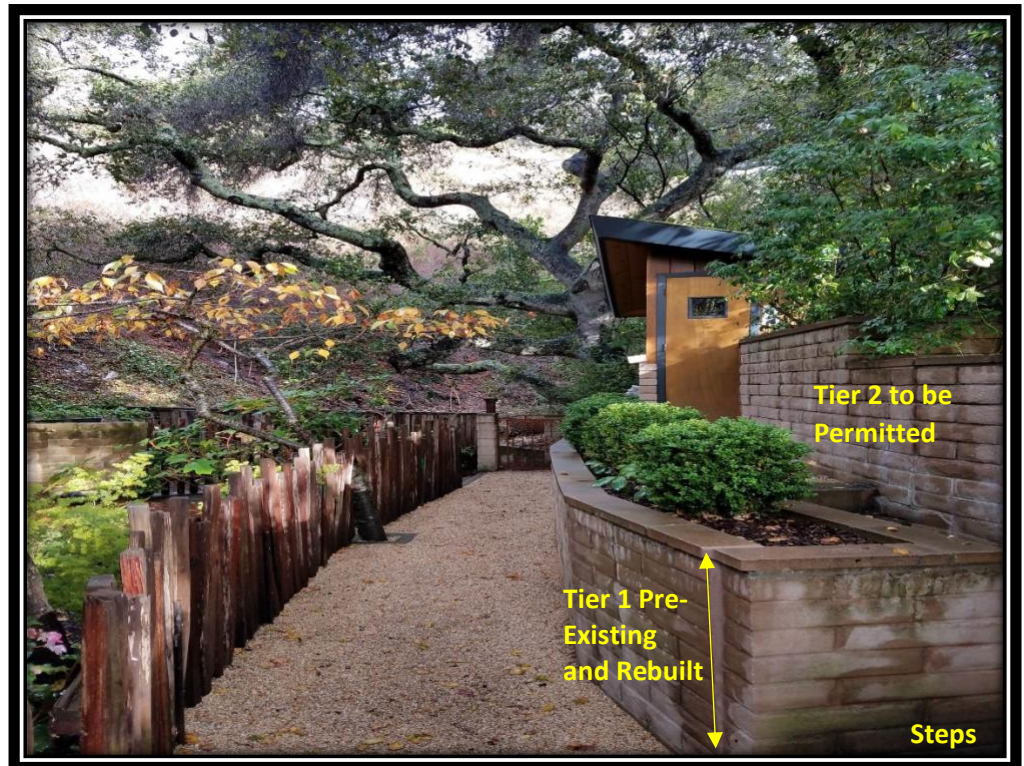
Picture 7

Heights:

Tier 1 Wall = 3.17

Dog run fence along path = variable  
with max of 3.5'

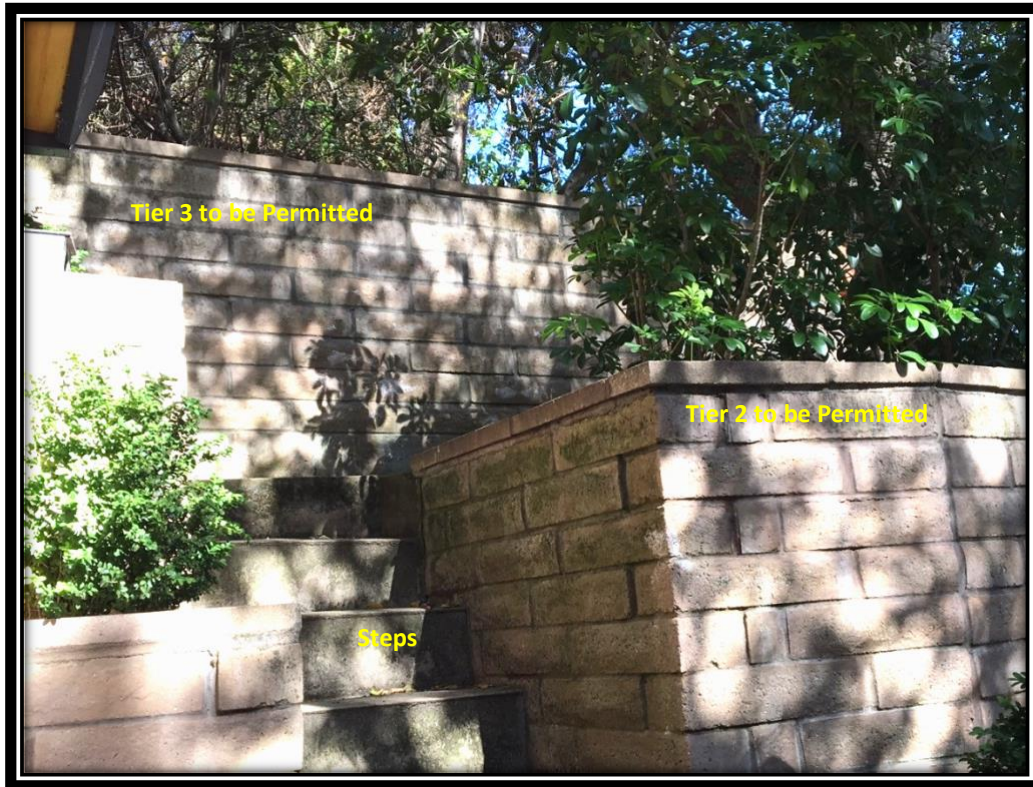
Picture 9

DESCRIPTION: East retaining walls, steps from Tier 1 to Tier 2 and Tiers 2 and 3 walls, front view to right of sauna. (picture 9) Close-up of Tier 3 wall, front view (picture 10). See "Work Area 2" on the Plot Plan.

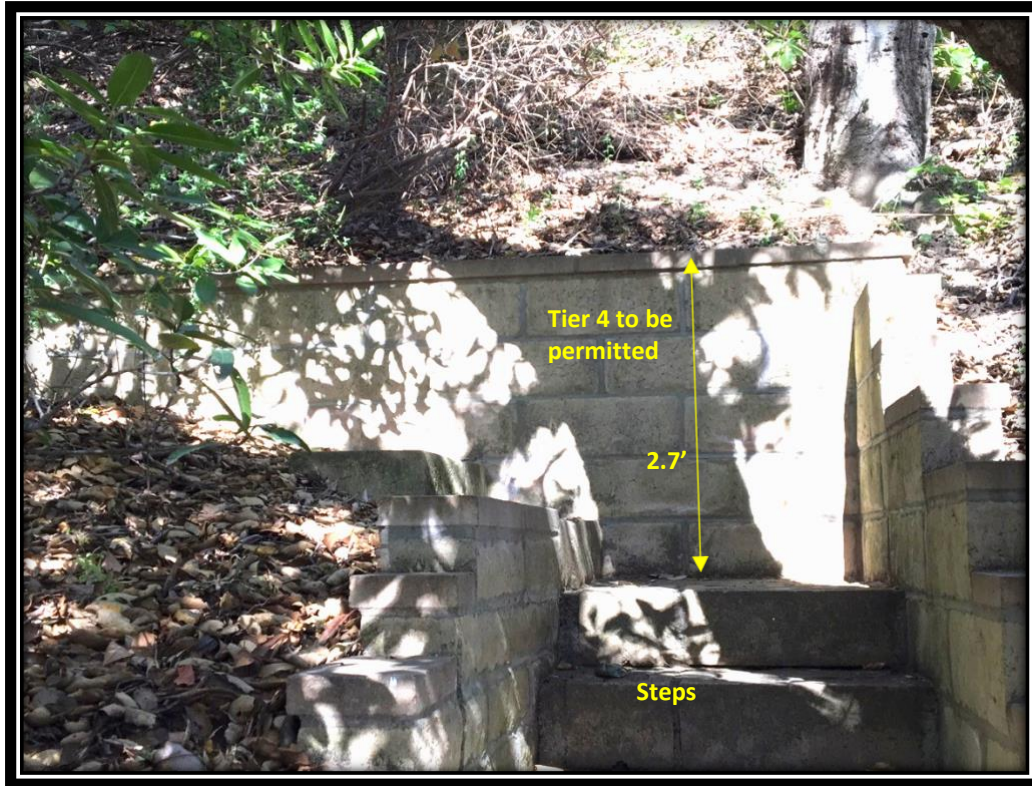
Picture 11

DESCRIPTION: East retaining walls, steps from Tier 3 up to Tier 4, front view (picture 11) View of steps up to Tier 4 from the north looking southeast. (picture 12) See "Work Area 2" on the Plot Plan.

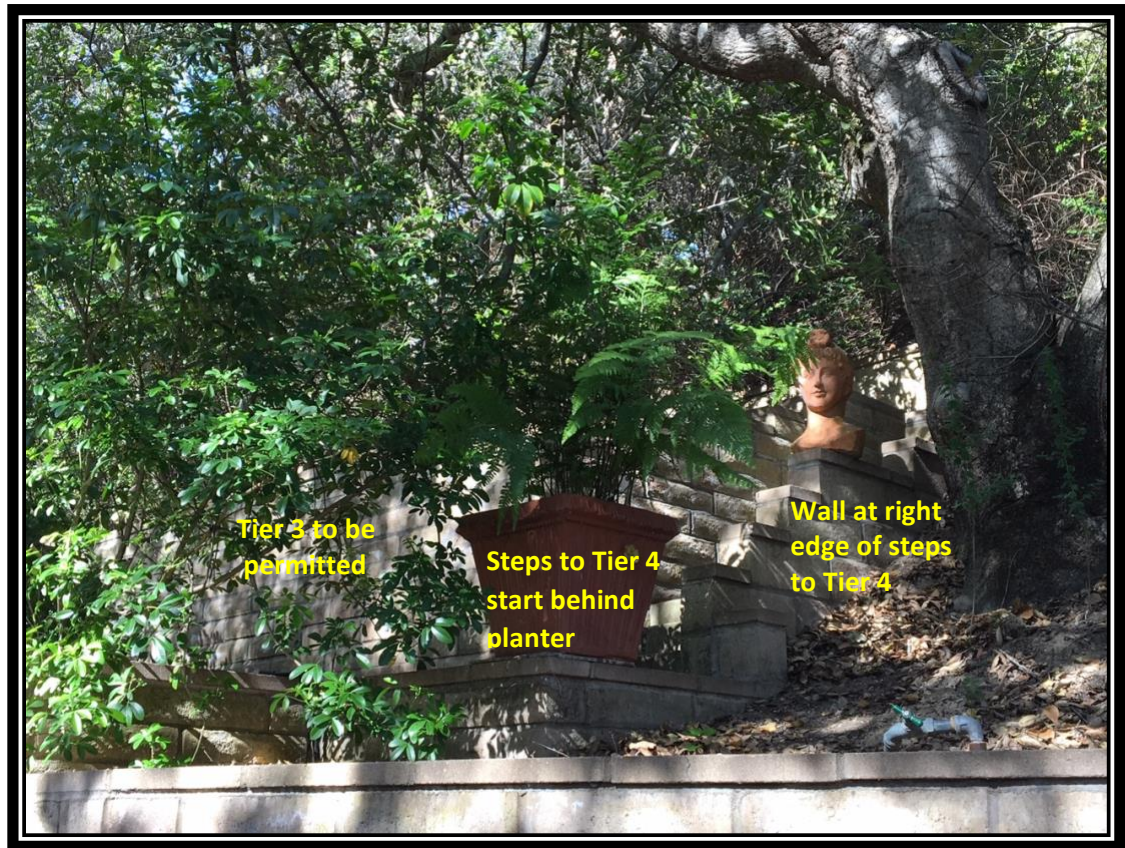
Picture 13

DESCRIPTION: East retaining walls, steps from Tier 3 to Tier 4, viewed from the south looking northeast. (picture 13) Wider view to show length of Tier 4. (picture 14) See "Work Area 2" on the Plot Plan.

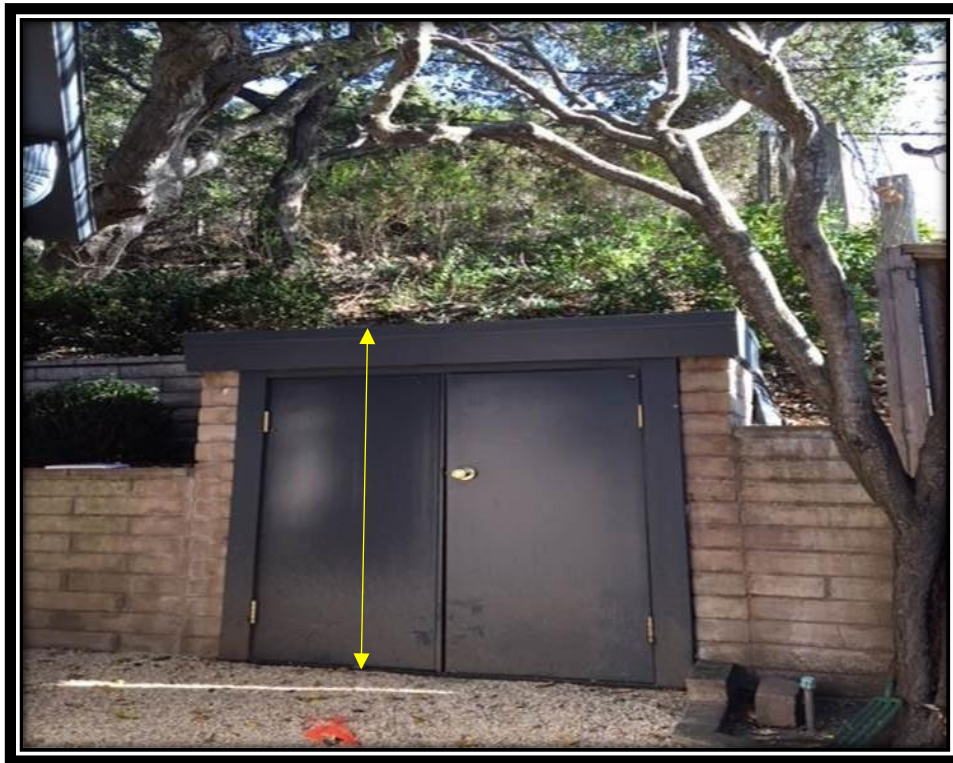
Picture 15

Height of  
toolshed = 5.6'

DESCRIPTION: Tool Shed built into Tier 1 of the East Walls, front view (picture 15) and side view (picture 16)

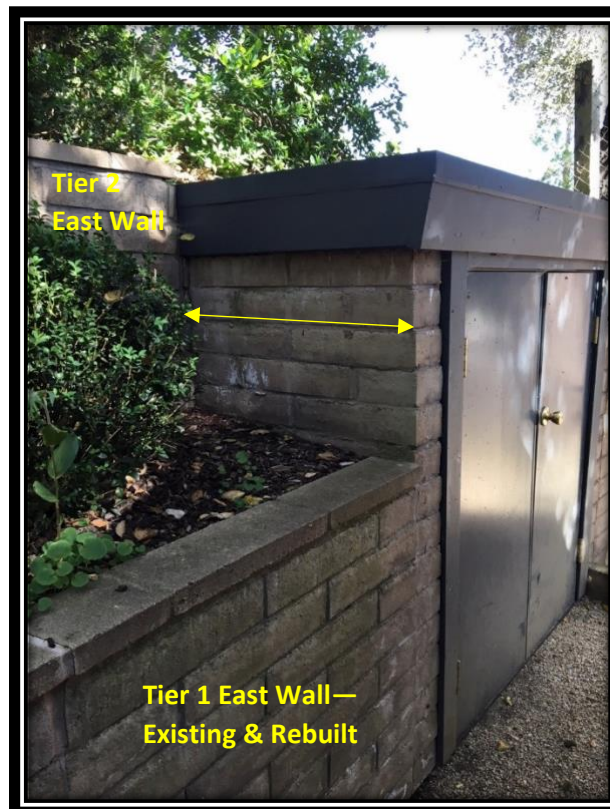
Picture 16

Depth of  
toolshed = 2.6'

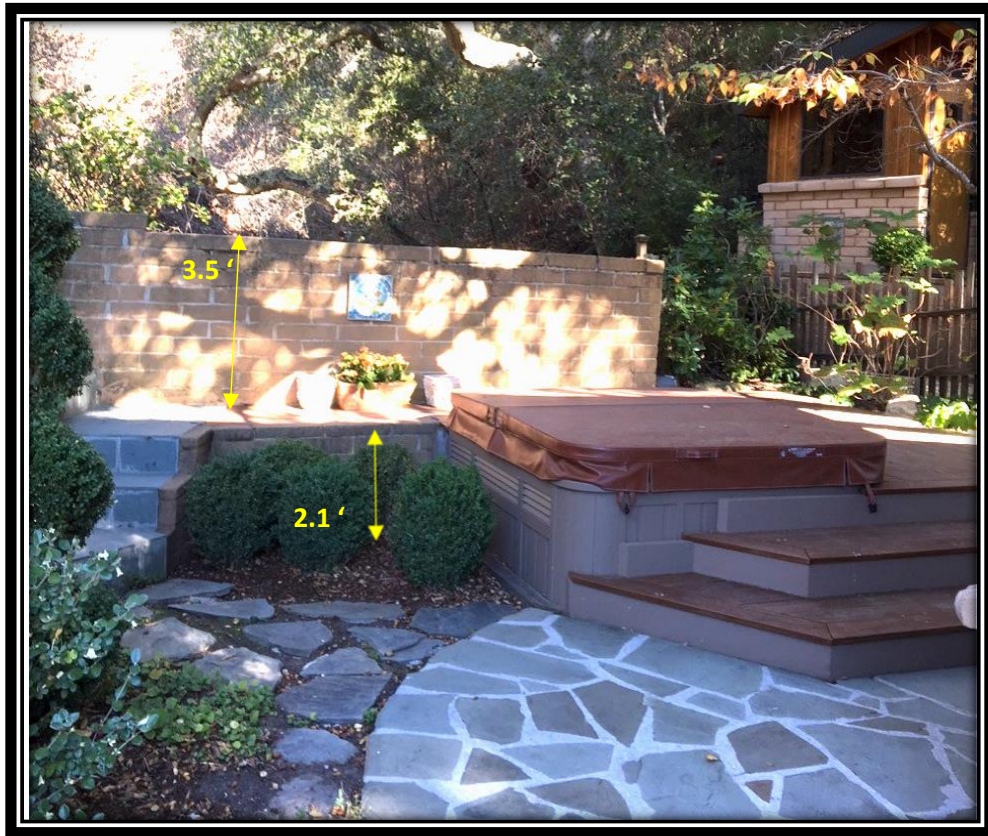
Picture 17

## Heights:

Deck = 2.1' High

Steps to Hot Tub Deck = 6" High

Adobe Wall to left of Hot Tub = 2.1' High

Adobe Wall behind Hot Tub = 3.5' High

## Deck Dimension:

Deck is irregular shape—see Plot Plan;

Inset Hot Tub = 6' x 6'

DESCRIPTION: Hot Tub with deck & steps, adobe wall and steps to left of hot tub, and adobe wall behind hot tub.  
(picture 17) See "Hot Tub, Deck & Steps" on the Plot Plan.

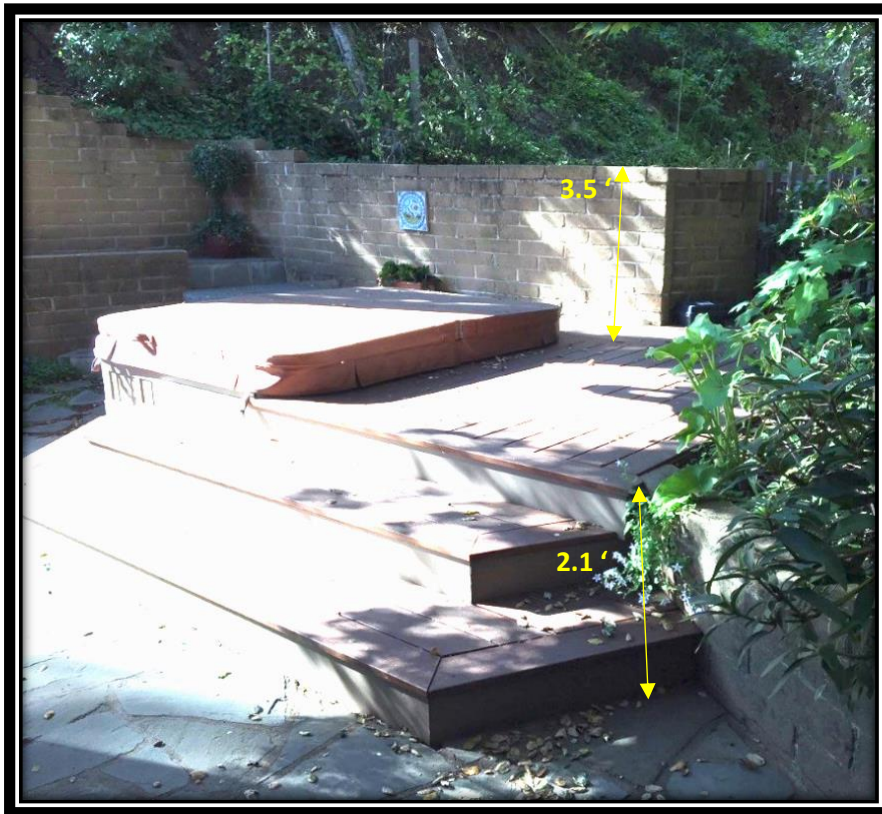
Picture 18

Heights:

Deck = 2.1' High

Steps to Hot Tub Deck  
= 6" HighAdobe Wall behind  
Hot Tub = 3.5' High

Deck Dimension:

Deck is irregular  
shape—see Plot Plan;  
Inset Hot Tub = 6' x 6'

DESCRIPTION: Hot Tub with deck & steps viewed from south looking north. (picture 18) and viewed from north looking south toward house. (picture 19) See "Hot Tub, Deck & Steps" on the Plot Plan.

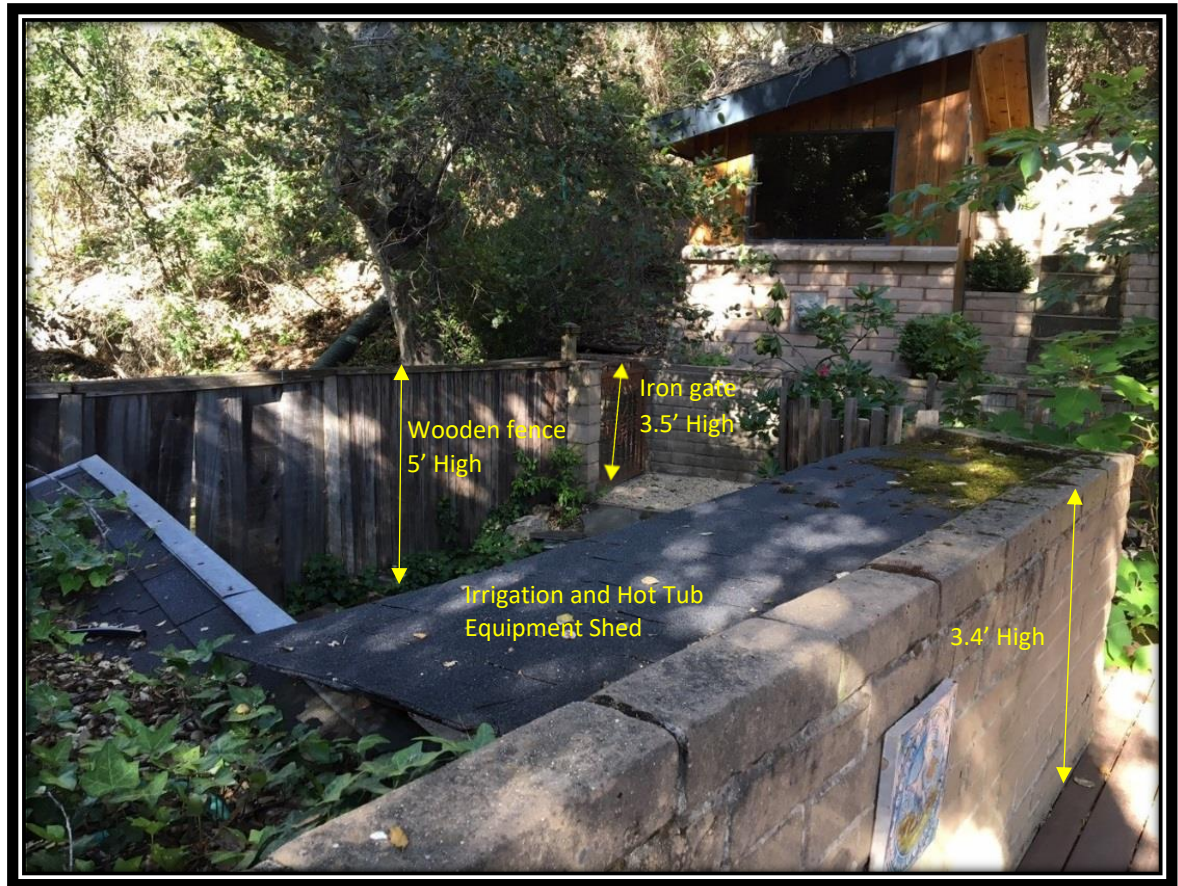
Picture 20

DESCRIPTION: Irrigation Shed at Wall behind Hot Tub viewed from north looking southeast, wooden fence and gate in background. (picture 20) Interior view of Irrigation and Hot Tub equipment in shed, from south looking north. (picture 21) Close-up of irrigation equipment. (picture 22)

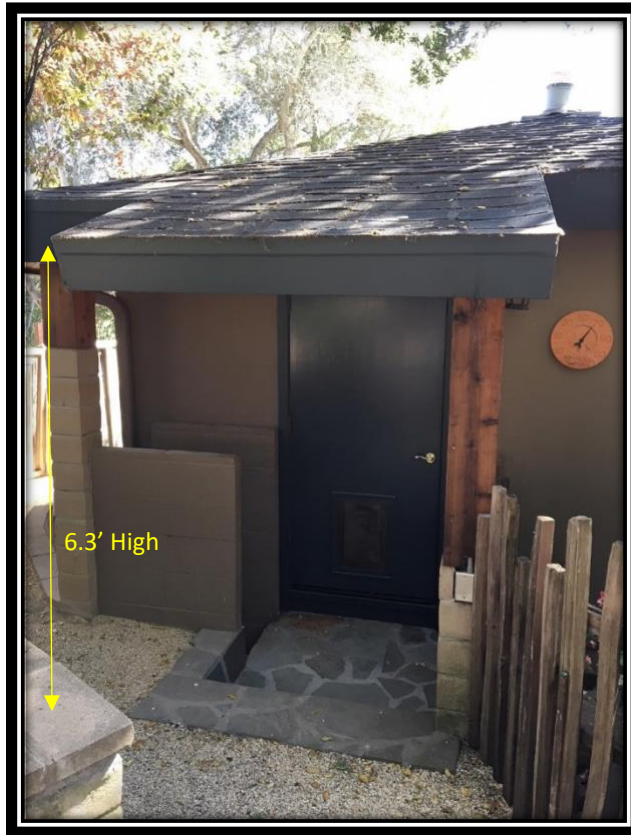
Picture 24

DESCRIPTION: Covered Porch, front view. (picture 24) Covered Porch side view, looking south. (picture 25)

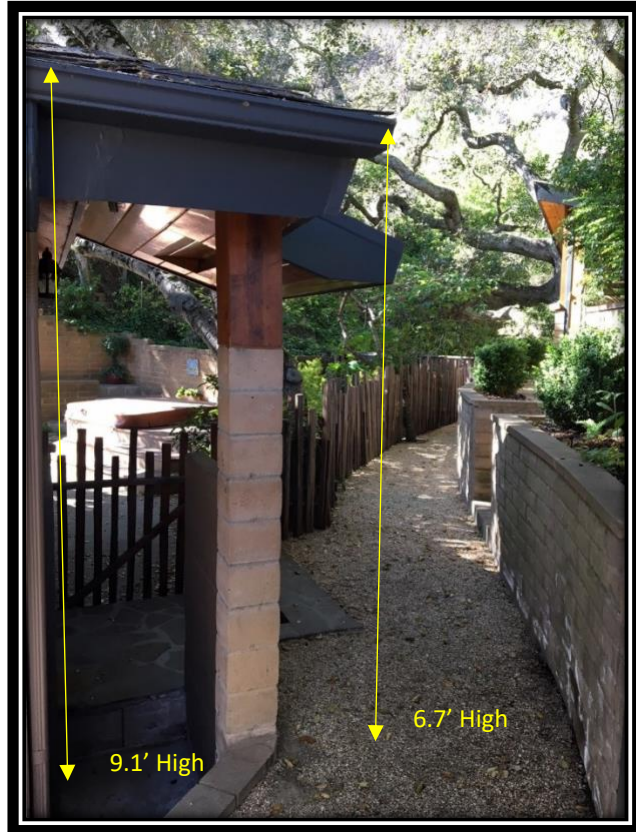
Picture 26

DESCRIPTION: Covered Porch, side view, looking north. (picture 26)
