Shen Properties
9601 Blue Larkspur Lane
Tree Resource Assessment

May 10, 2016

In accordance with your authorization, Landset Engineers, Inc has completed a soil engineering investigation for a proposed commercial/professional office development located at the Laguna Seca Office Park, Monterey County, California. This report presents the results of our field investigation, laboratory testing, along with our preliminary conclusions and recommendations for site development.

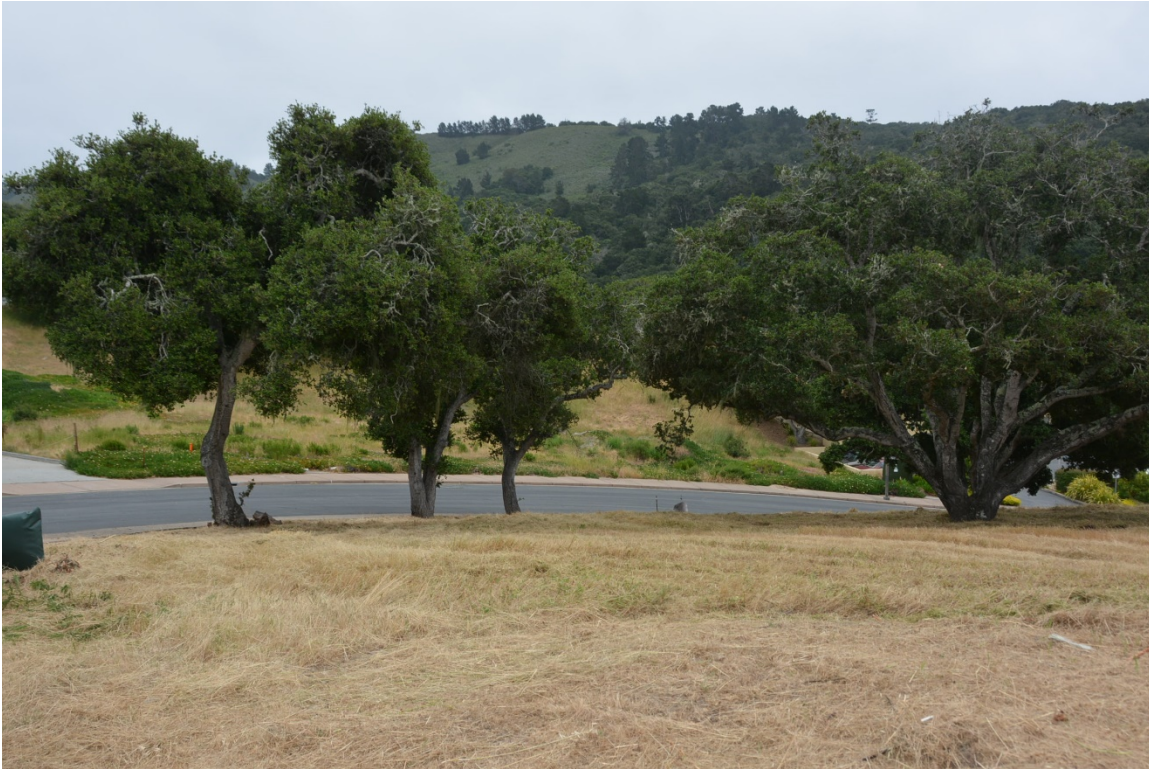
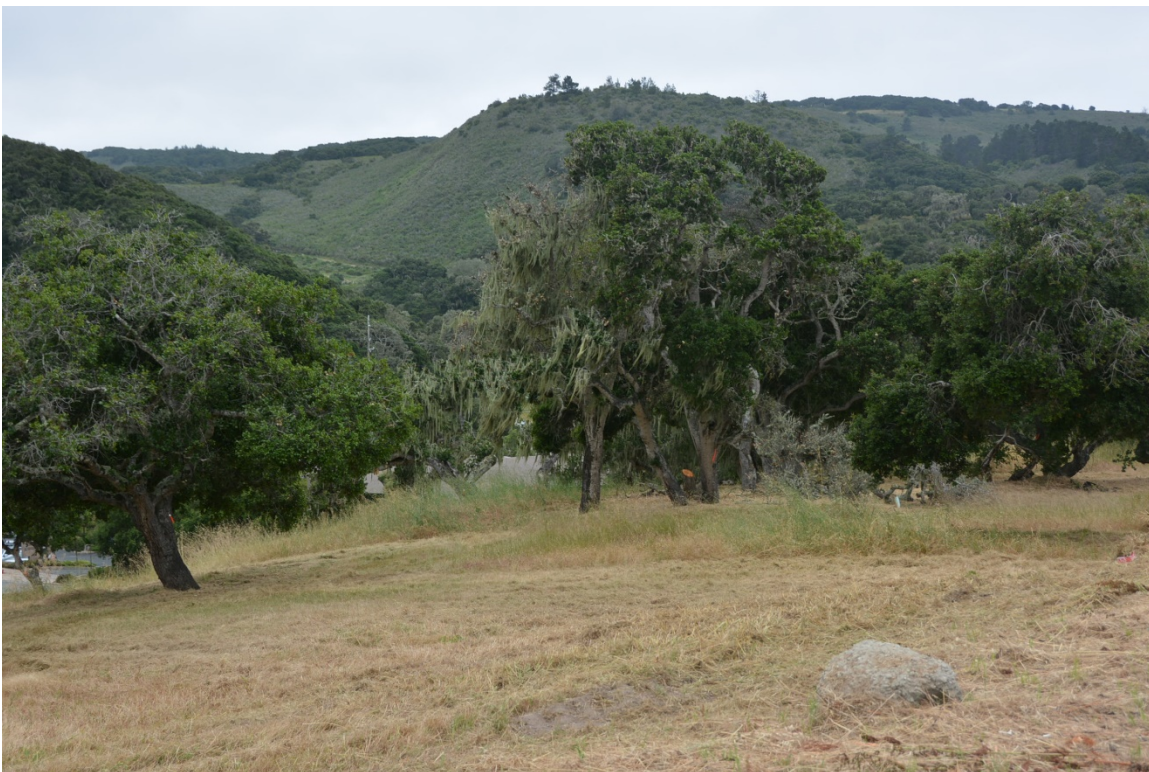
Trees to be retained, these are trees #527-#539

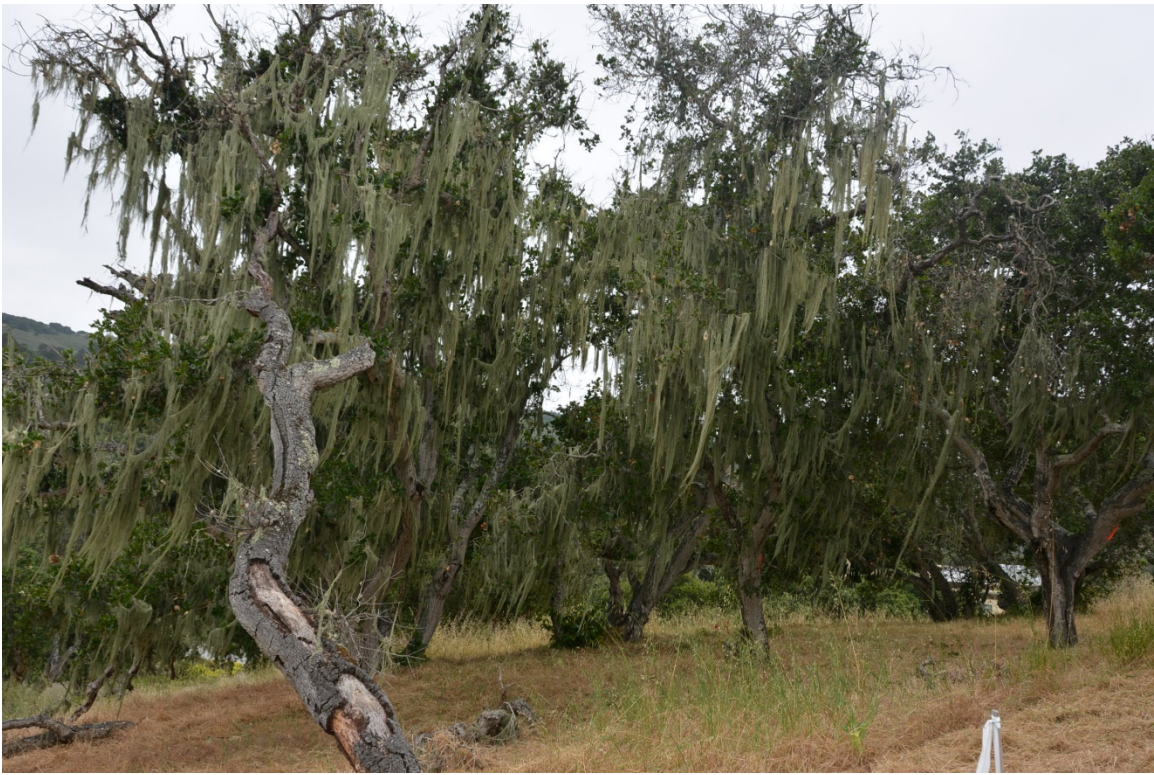
- Oaks are scattered on the property with trees located along the perimeter appearing healthier than the mature trees in the center of the lot. A number of oaks located in the center of the lot are deteriorated or dead with obvious signs of western oak bark beetle frass on stems and trunks.

Declining trees in center of lot, these are trees #524 and #533 to be removed

17 oak trees for removal are proposed for this project. All other trees are to remain and be protected from construction affects when closer than 25 feet from construction. After proper authorization, the trees shall be cut down by a licensed insured professional tree service. No surrounding tree protection is necessary when the tree drop zone is clear of vegetation. Tree removal shall be consistent with safe arboricultural work practices utilizing removal of trees and their parts in smaller manageable pieces and roped down carefully so as not to damage any surrounding trees or plants. The use of specialized equipment may be authorized if it can be shown that no damage to surrounding ecosystem will be sustained. At no time shall the trees be dropped in one piece so as to damage any surrounding trees or property. Tree wood and clippings are to be disposed of consistent with current California Department of Forestry guidelines which would include stockpiling of material on site or disposal at an approved refuse site. When the listed trees are removed, other immediately remaining trees adjacent these should be inspected for potential for pruning (utilizing current arboricultural standards) and deadwood removal.

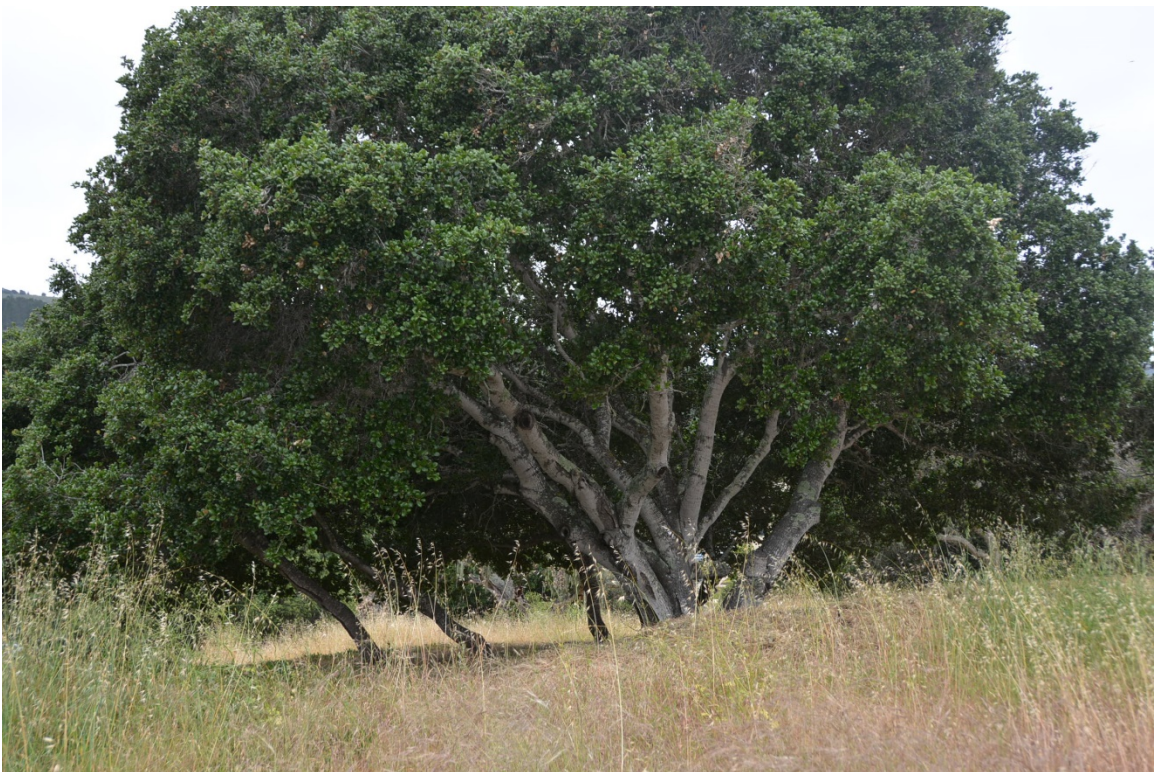
Trees to be removed trees around and near #536

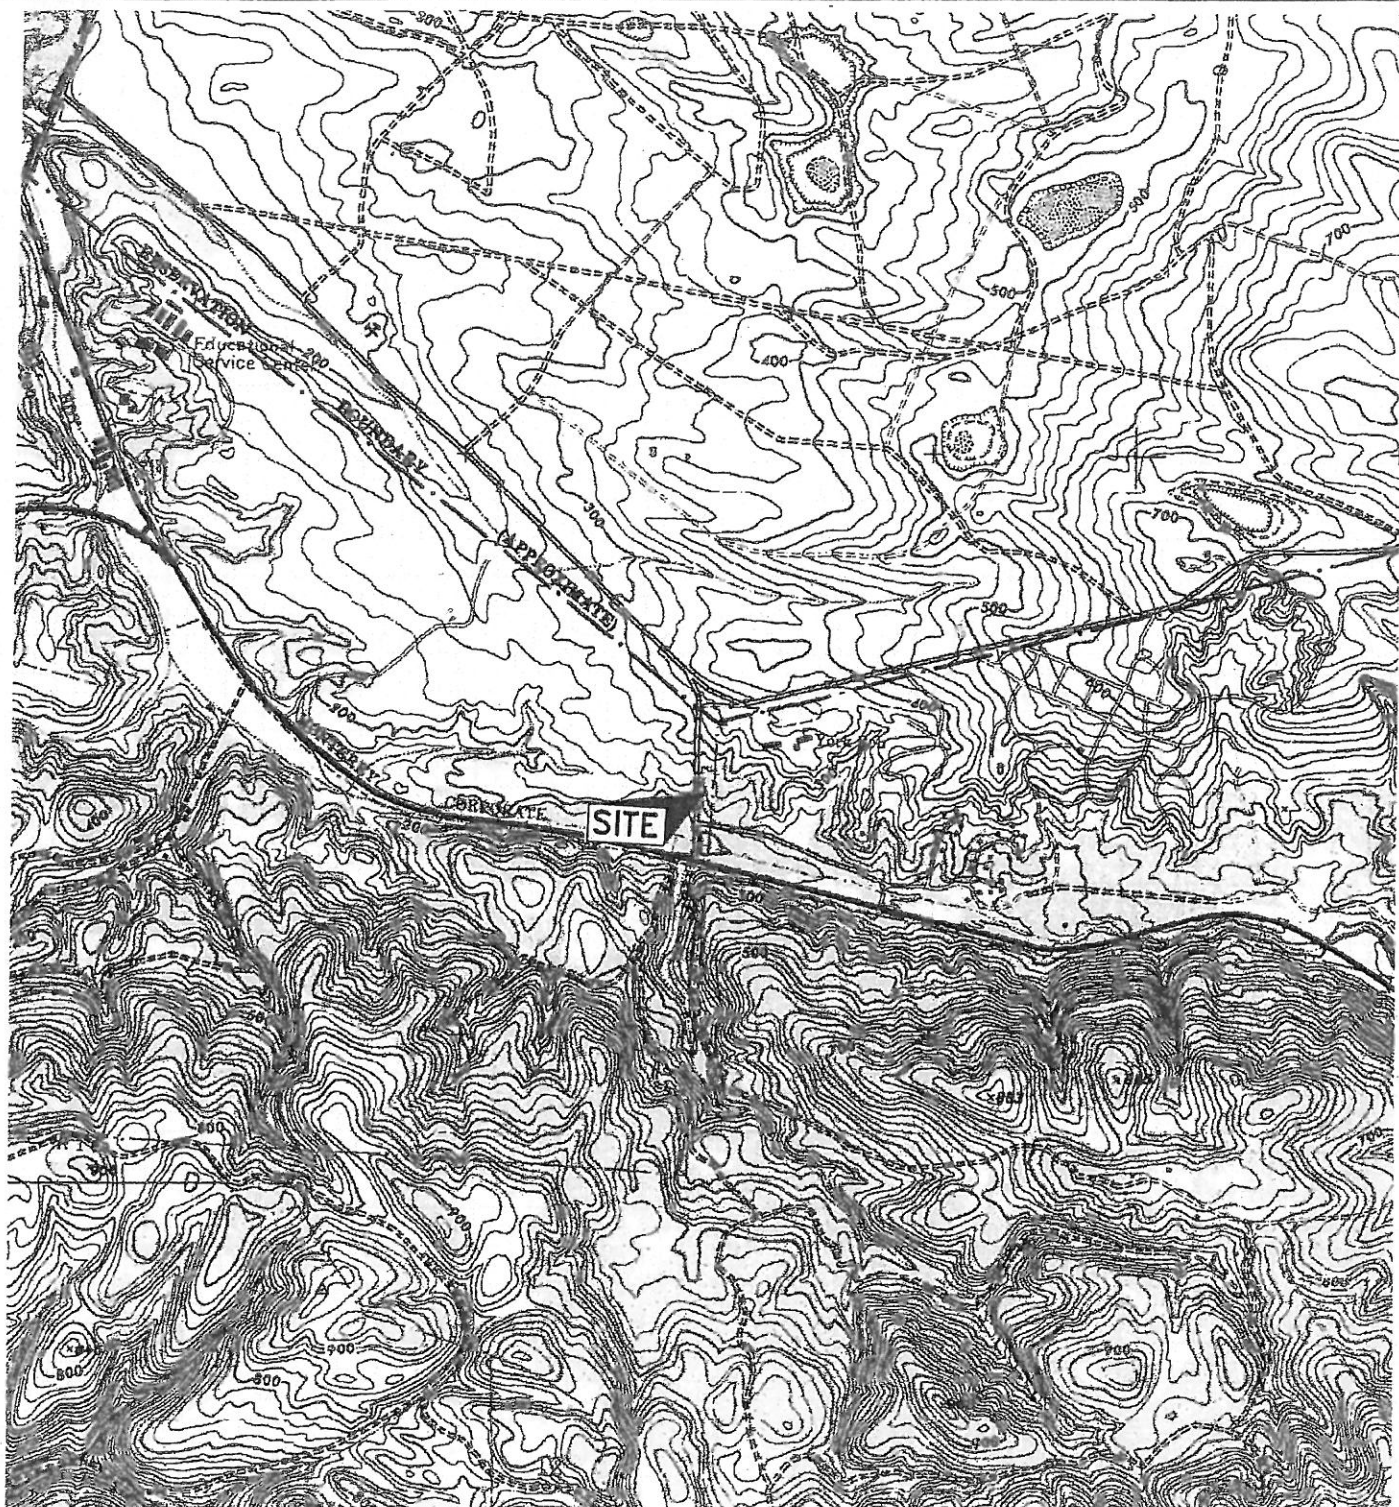
Figure 1, Vicinity Map

BASE MAP: Seaside, California
 U.S.G.S. 7.5' Topographic
 Quadrangle Map
 Scale: 1"=2000'

FIGURE
1
PROJECT
1454-02

This report summarizes the findings, conclusions and recommendations for our soil engineering investigation for a proposed commercial/professional office complex development located off of Citation Court in the Laguna Seca Office Park area of Monterey County, California (see Vicinity Map, Figure 1).

The subject area consists of two commercial parcels (APN's 173-121-002 & 173-121-003). The site is located off of Citation Court in the Laguna Seca Office Park development, adjacent to York Road, Monterey County, California (Figure 1). The overall site (Lots 2 & 3) consists of two irregular shaped parcels totaling approximately 3.4-acres (Figure 2). The site is bounded by undeveloped lands to the north, Blue Larkspur Lane to the south, Citation Court & undeveloped land to the east and York Road to the west. Vegetation consists of scattered oaks and grassland.

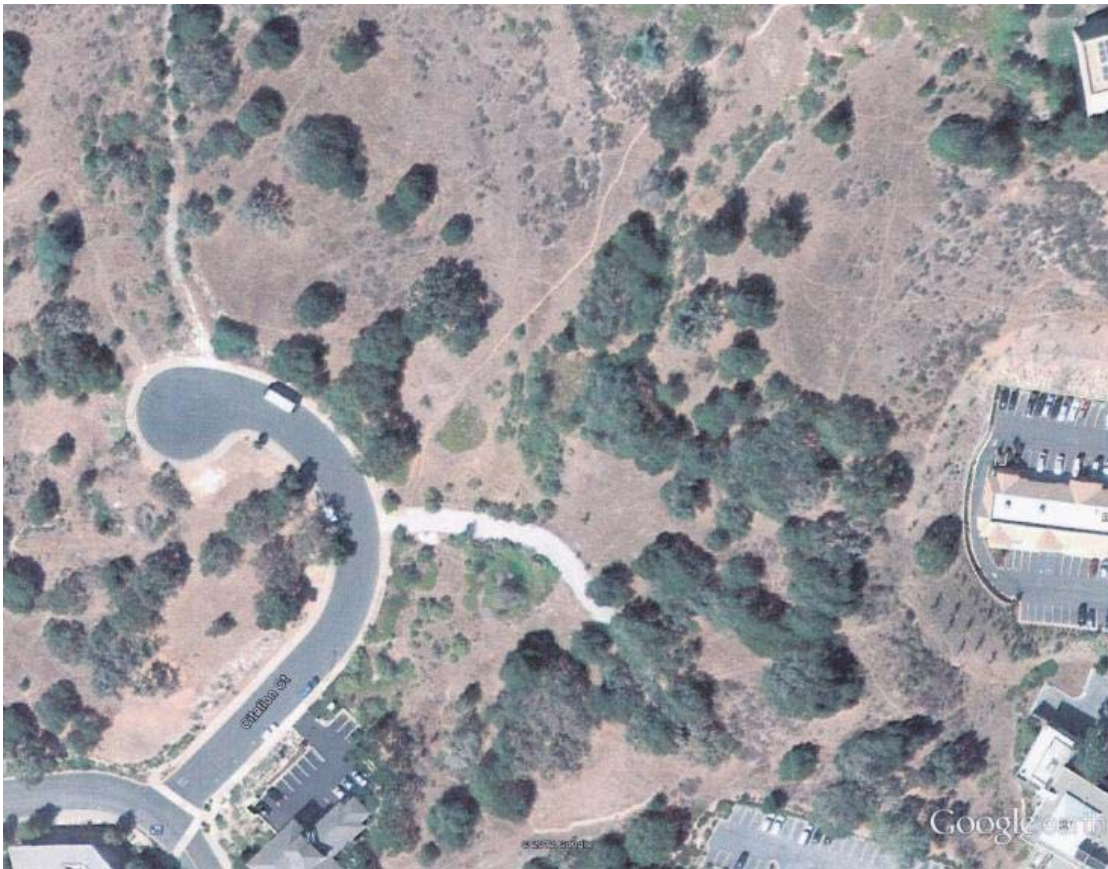
Figure 2: Aerial view of undeveloped lots in Laguna Seca office park. Lot #5 is in center above white roadway and right of curve to cul-de-sac.

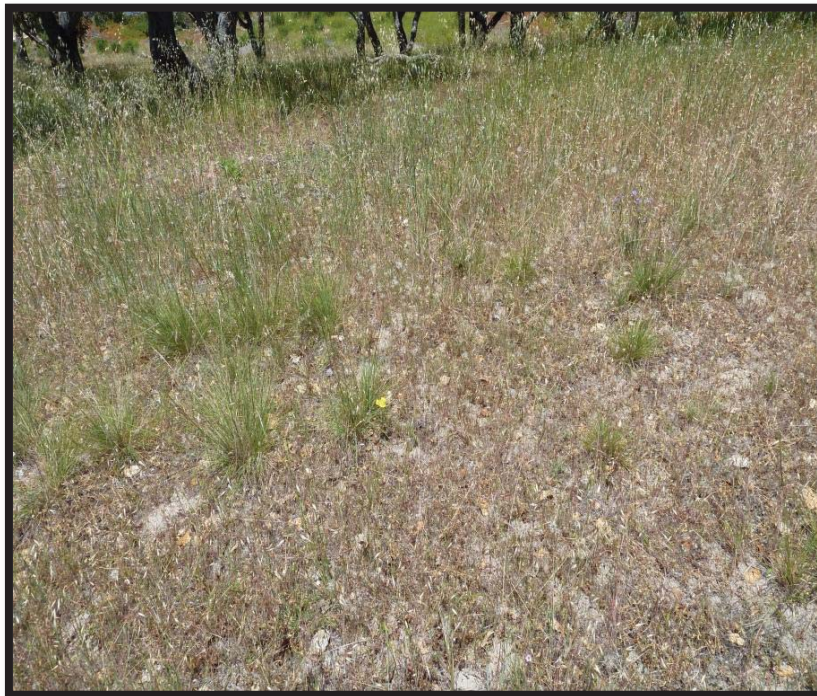
Figure 3: combination of nonnative and native grasses on site.

above, from the east side of the project site, shows a small patch of purple needle grass (*Nassella pulchra*) and a single yellow mariposa lily (*Calochortus luteus*) growing in the midst of a continuous stand of wild oats (*Avena fatua*) and soft chess (*Bromus hordeaceus*). In other areas where the soils are deeper, the annual grasses are more dense and accompanied by weedy, nonnative mustard family species, Thistles and French broom (*Genista monspessulana*)

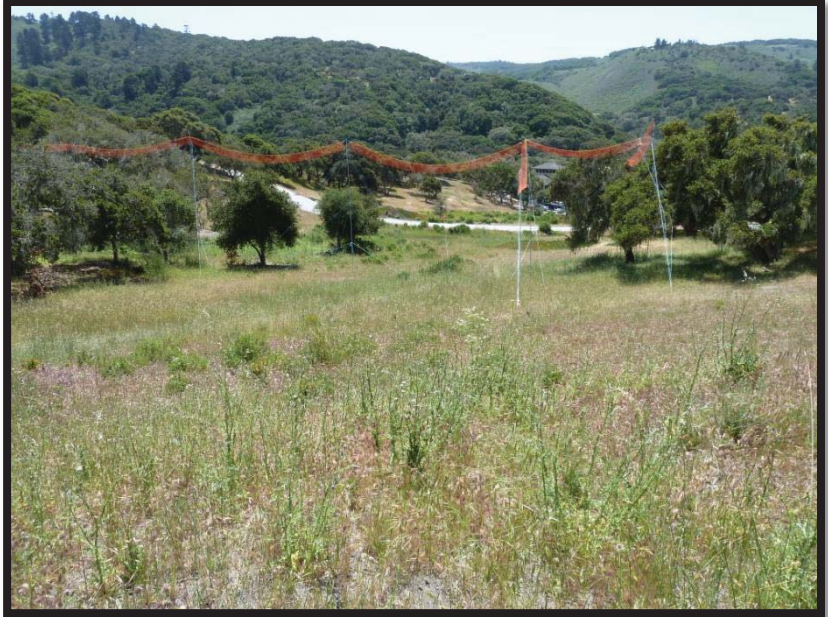
Figure 4: Middle of lot #5 dominated by nonnative grasses and forbs.

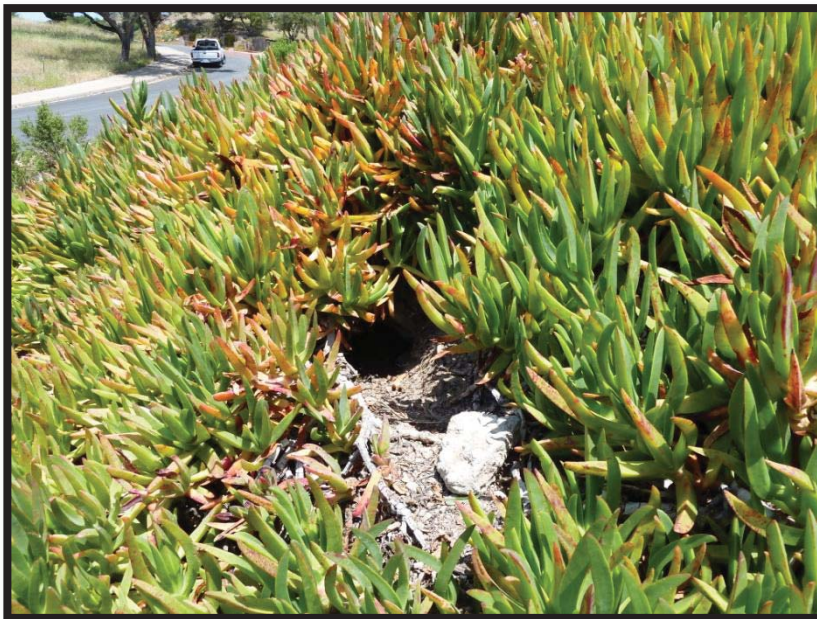
Figure 5 - Ground squirrel burrow in "ice plant"

There was ground squirrel activity and burrowing at the bottom of Lot #7 directly adjacent to utilities boxes and the existing office building at the bottom of Citation court. The photo at the bottom left of the previous page shows the entrance to a ground squirrel burrow on the south side one of the mentioned Hottentot fig patches. Some burrowing tailings and older tunnels were observed in the SW corner of Lot #5 but no squirrels were heard or observed.

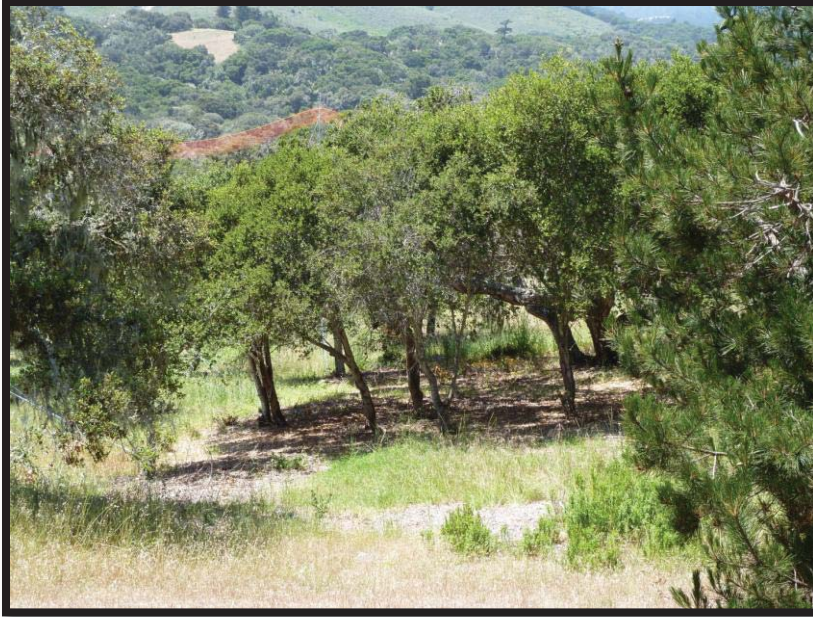
Figure 7: View of live oak woodland looking west through lot #5.

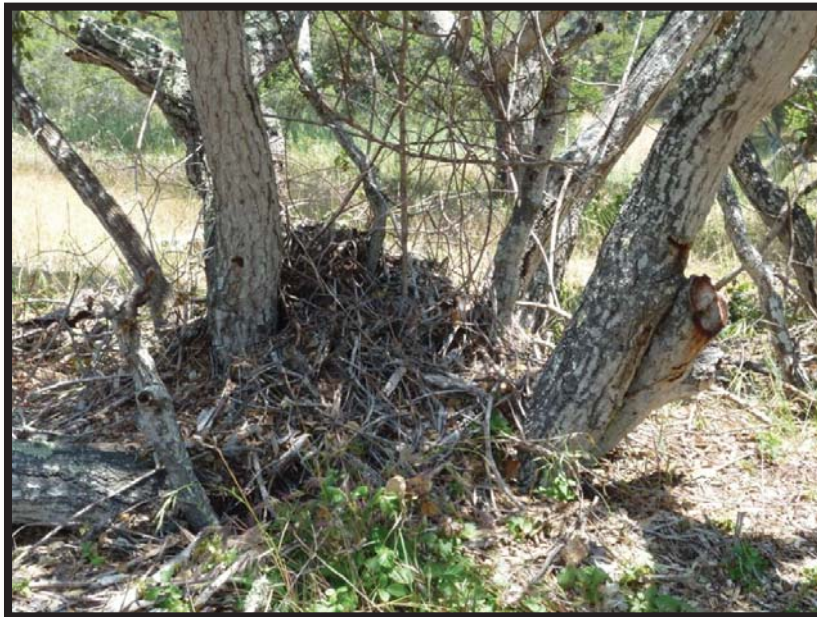
Figure 6 dusky footed wood rat nest.

nest piles could be found in a few locations at the base of Oak trees on lot # 2 and 3 along York road. (see figure 6 at left) There were no dusky footed wood rat nests located on lot #5. The dusky footed wood rat (*Neotoma macrotis*) is a widely distributed species common through much of Central and Southern California south into Baja Mexico. The local subspecies, Monterey dusky-footed wood rat (*Neotoma macrotis luciana*) is a California department of Fish and Game species of special concern and must be considered in CEQA

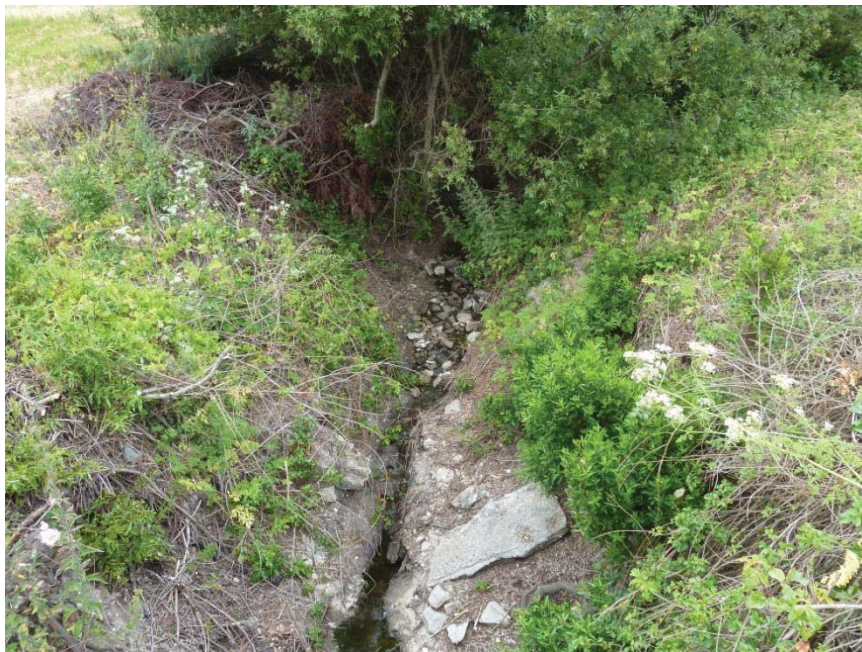
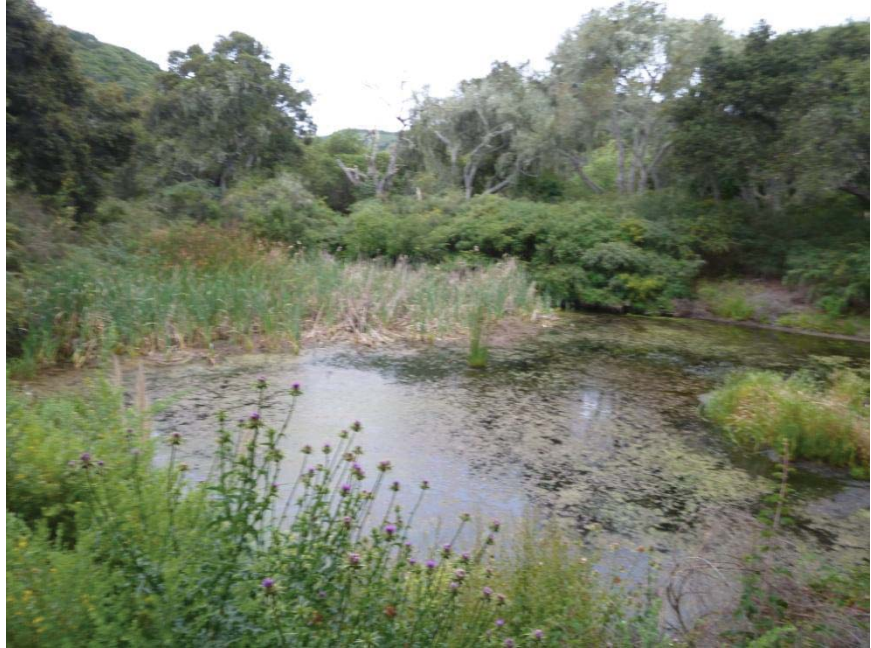
Canyon del Rey creek an intermittent creek paralleling and approximately halfway between highway 68 and Blue Larkspur lane runs in a steep sided channel and pipes east to west. It flows under York road and into a retention pond approximately 1/4 mile west of the Office park next to a parking lot in the neighboring Ryan Ranch Office park. This photo below is of the "channel" from the overpass on York road. It is a steeply incised 10 foot drop from the siding of the overpass to the bottom of the channel.

This is the only location along the channel from York road to the Eastern end of the Laguna Seca Office park where the channel bottom is open to daylight. After the channel passes under York road it continues approximately 200 feet NW through dense cover of Willow, Acacia and Eucalyptus trees to the retention pond on the Ryan Ranch property. The retention pond has dense weed and wetland species growing around it's perimeter and a large population of mosquito

fish (*Gambusia* sp.) occupying the 2-4 foot deep water. I did not hear or see any frog species whether tree frog, bull frog or Redlegged frog while I was there in the morning of June 6. This would be potential habitat best suited for bull frogs that require permanent bodies of water to allow two years of development from larvae into adults. Tree frogs and red-legged frogs could both conceivably occupy this pond as well but their smaller

larvae would be easy prey for the abundant mosquito fish. The pond has steep sloped sides densely vegetated with French broom (*Genista monspessulana*), Poison hemlock (*Conium maculatum*), Milk thistle (*Silybum marianum*), Pampas grass (*Cortaderia jubata*) and California blackberry (*Rubus ursinus*)

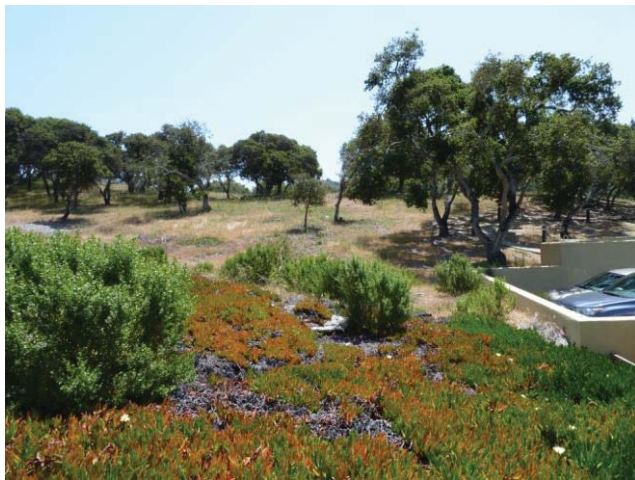
Figure 5: view looking east across lot #7 from Citation court. Active Ground Squirrel burrows are present in the *Carpobrotus* in foreground.

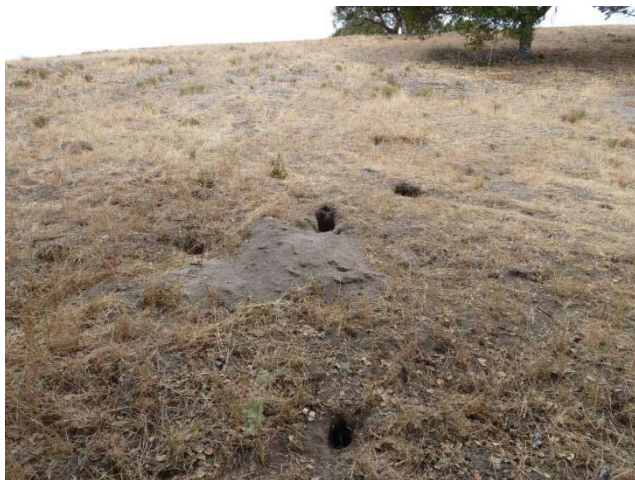
Figure 11: Annual grassland in lower west section of lot #5 with rodent burrows in foreground.

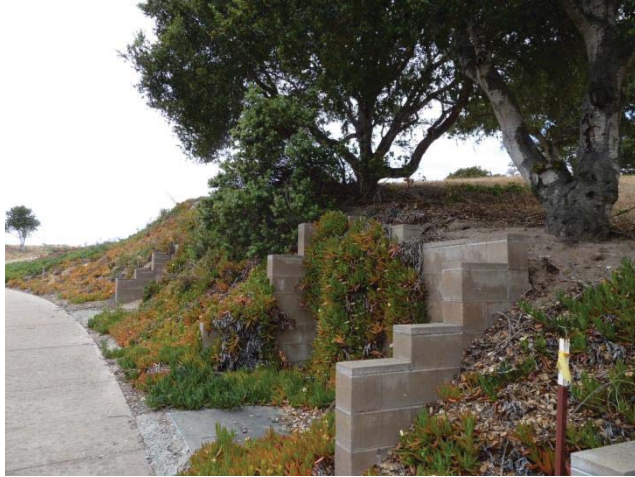
Figure 25: View of two *Arctostaphylos tomentosa* in understory of Coast Live oak, just west of Lot #5 entry.
