# **BIOLOGICAL ASSESSMENT**

Moss Landing-Metcalf 500kV Grading Project

August 2016, Revised October 2018

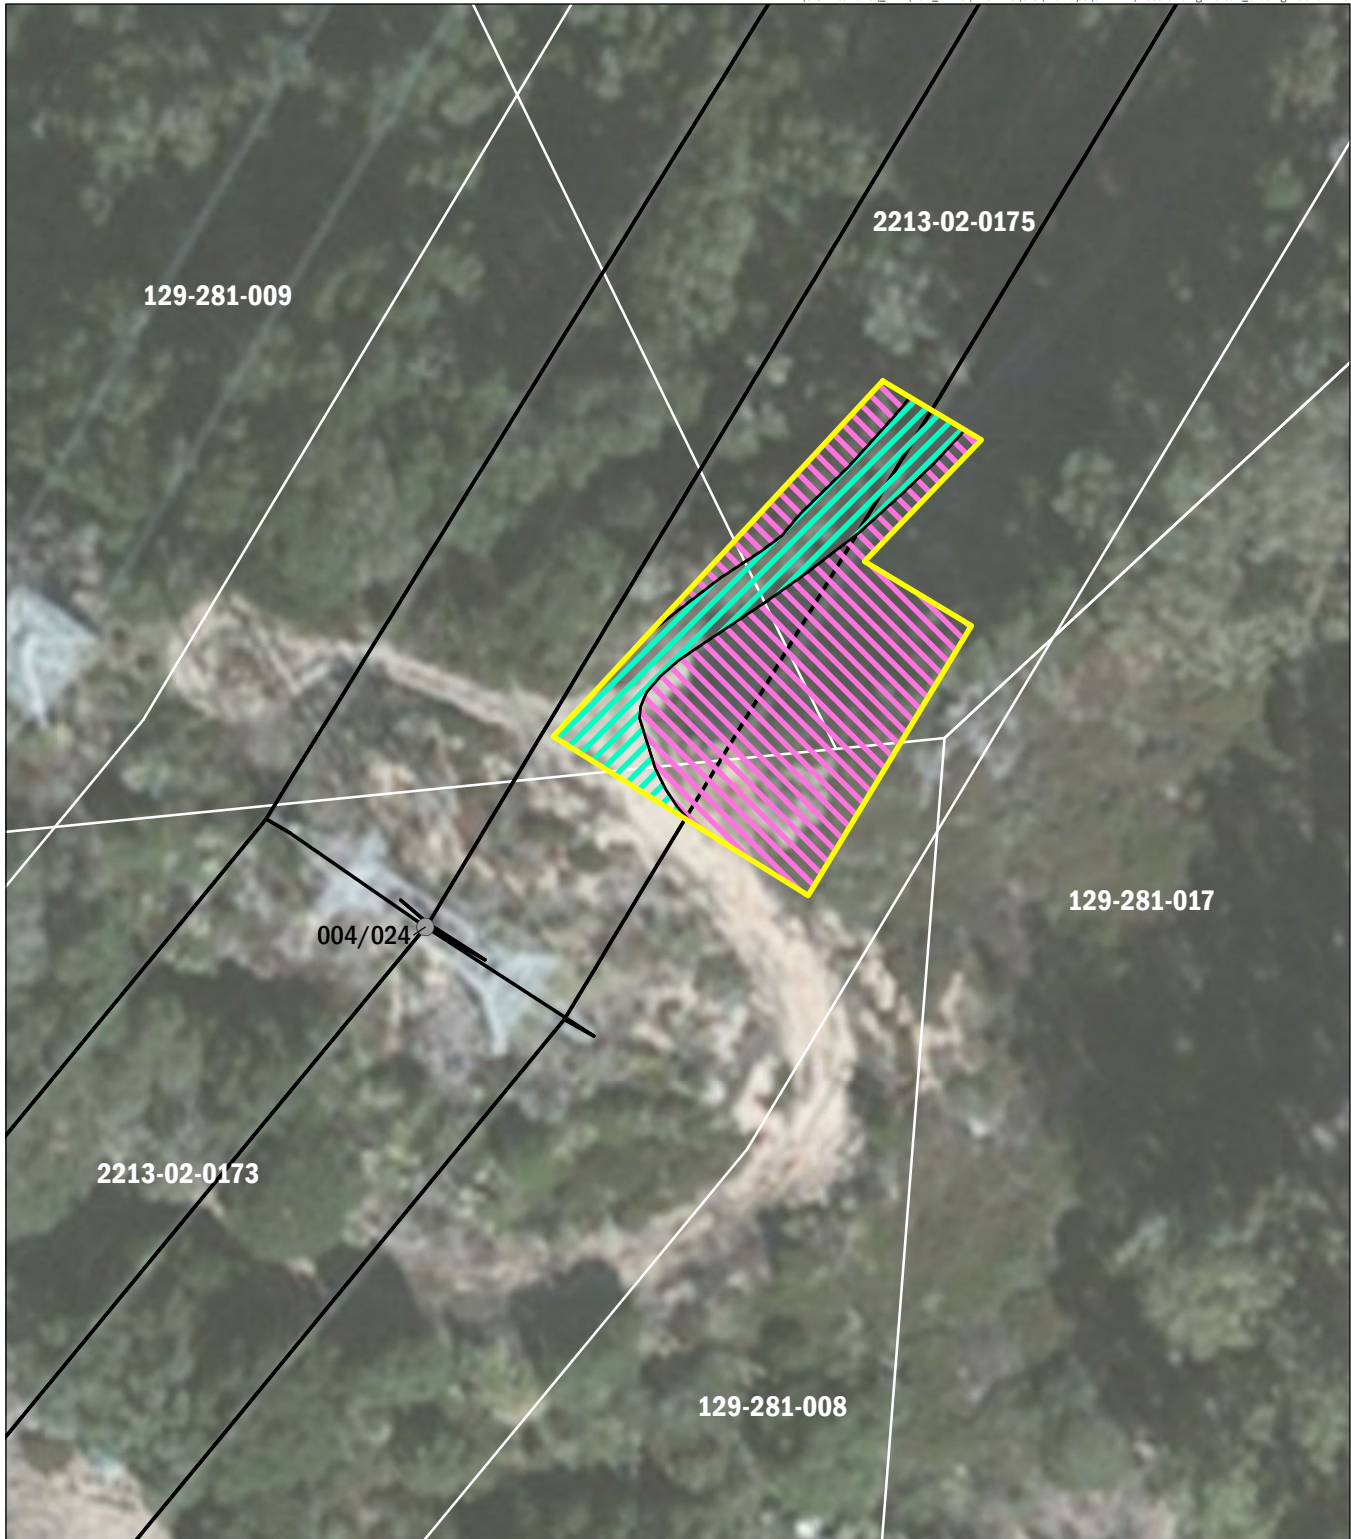
The proposed grading area totals 895 square feet. The entire LOD includes grading and erosion control areas, as well as staging and stockpile areas, and covers 5,164 square feet (Figures 2 and 3); the LOD area is dominated primarily by central maritime chaparral vegetation.

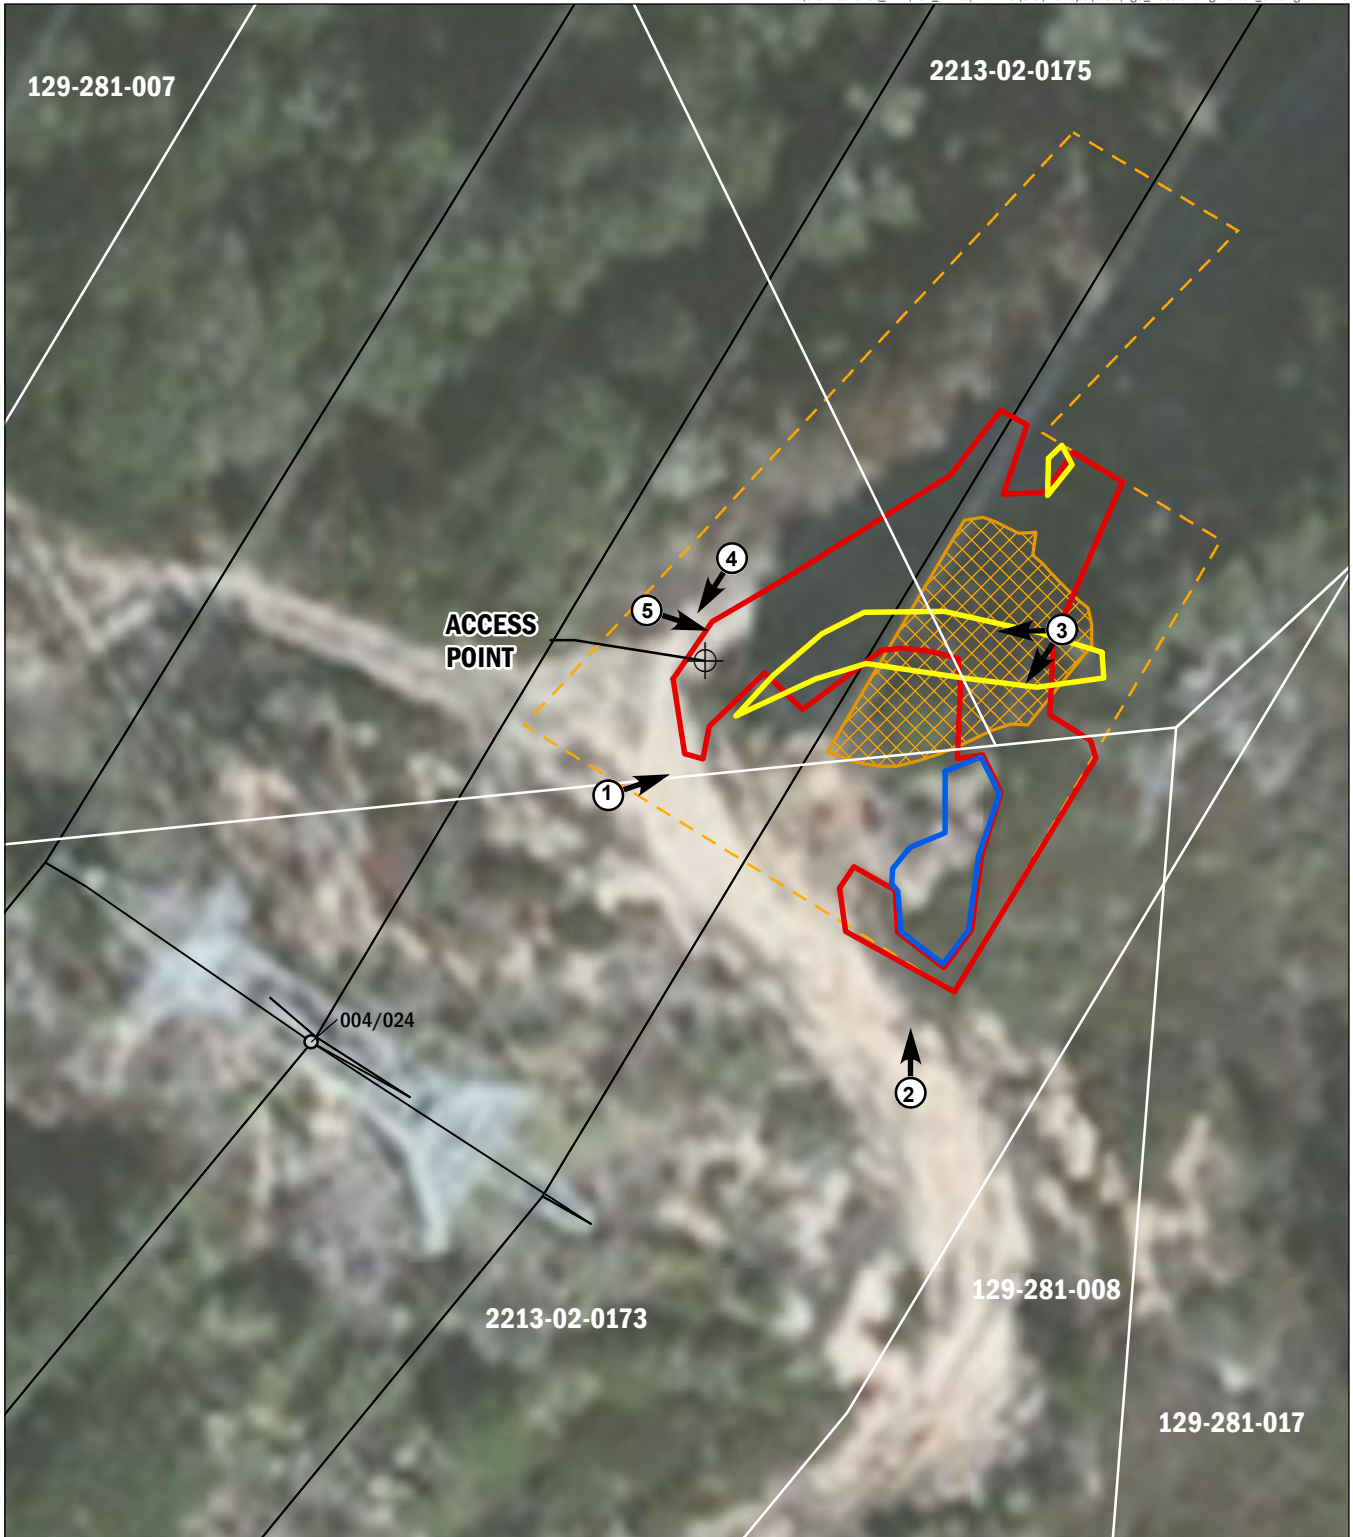
A survey for special-status plant species was conducted on April 18, 2016. Hooker’s manzanita, Pajaro manzanita, and Eastwood’s goldenbush were observed (Figure 3; Table 2). There were other special-status species that were recorded in the CNDDDB search within five miles (Figure 2) of the Site but were not observed at or near the proposed excavation area are. Plants identified in CNDDDB that have suitable habitat within the Site but are not present include Monterey spineflower (*Chorizanthe pungens* var. *pungens*), and Yadon’s rein orchid (*Piperia yadonii*).

Hooker’s Manzanita has a CNPS Rare Plant Threat Rank of 1B.2, a plant of limited distribution that is fairly endangered in California (CNPS 2016). Hooker’s manzanita was observed growing in the south corner of the LOD. No plants were observed in the grading area and six plants were counted in the LOD.

Pajaro Manzanita has a CNPS Rare Plant Threat Rank of 1B.1, a plant of limited distribution that is seriously endangered in California (CNPS 2016). Pajaro manzanita was observed growing throughout the LOD (Figure 3) and surrounding areas. A total of seven plants were counted within the grading area and 45 plants were counted in the LOD.

Eastwood’s goldenbush has a CNPS Rare Plant Threat Rank of 1B.1, a plant of limited distribution that is seriously endangered in California (CNPS 2016). Large, mature individuals of Eastwood’s goldenbush were observed growing in the middle of the LOD. A total of 13 plants were counted within the grading area and 21 plants were counted within the LOD.

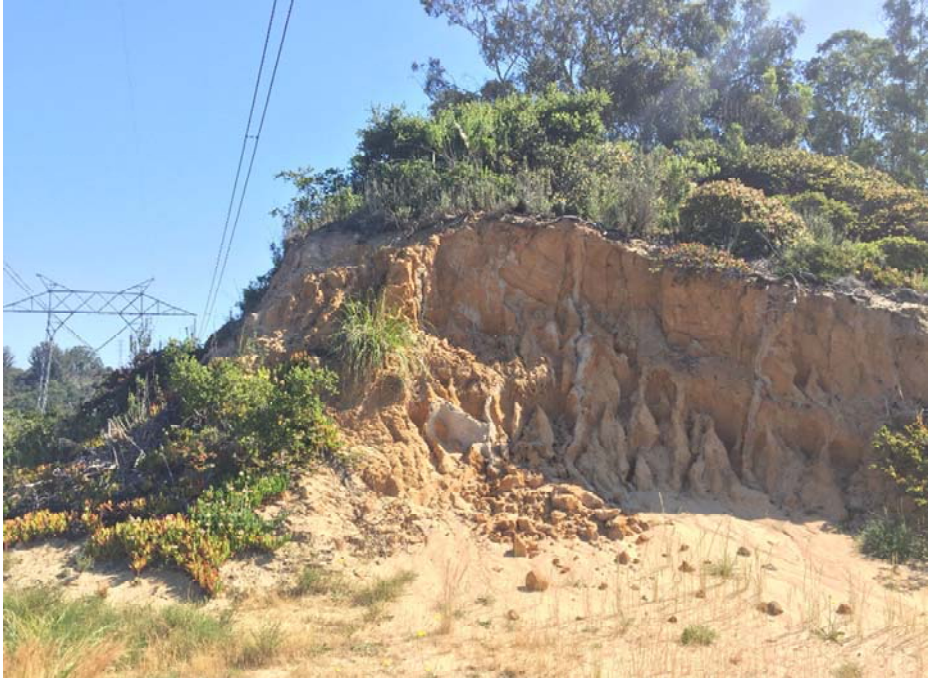
<b>Photo: 1</b>				
<b>Description:</b> Proposed grading area above erosion feature. Tower 004/025 in background.

- After grading, the eroded slope will be stabilized using erosion control best management practices (BMPs) to avoid further slope failure and subsequent impacts to native vegetation surrounding the graded area.

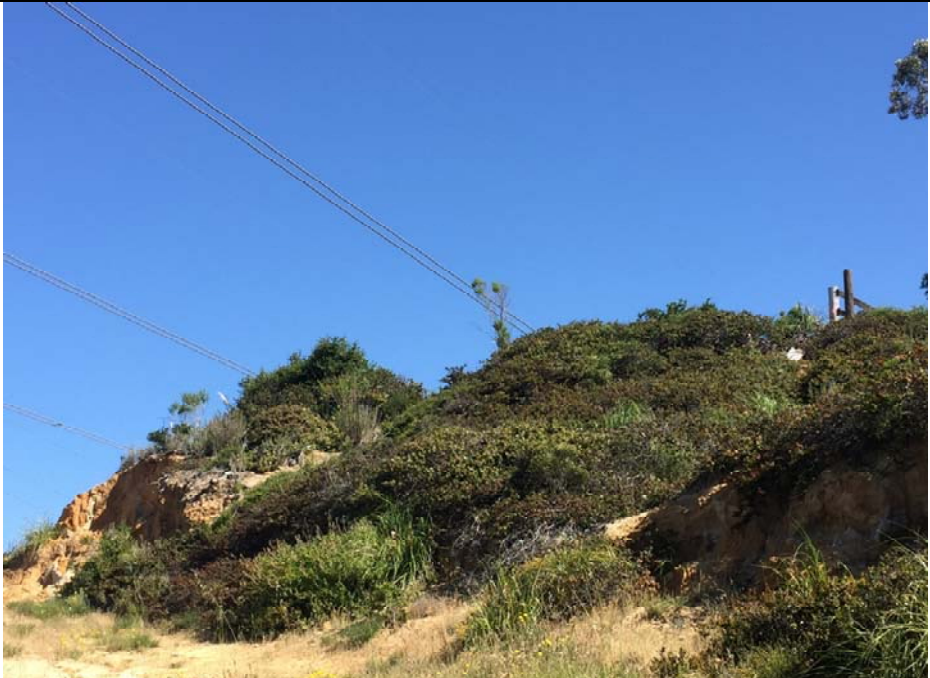
<b>Photo: 2</b>				
<b>Description:</b> Looking north at proposed grading site.

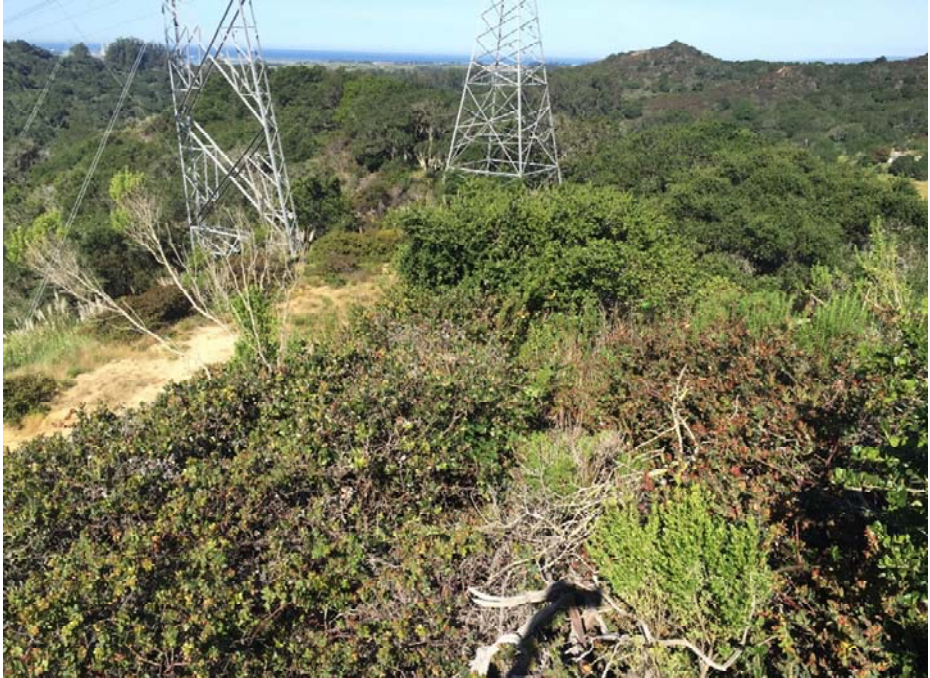
<b>Photo: 3 west</b>				
<b>Description:</b>  Proposed grading area in foreground. Tower 004/024 in background.

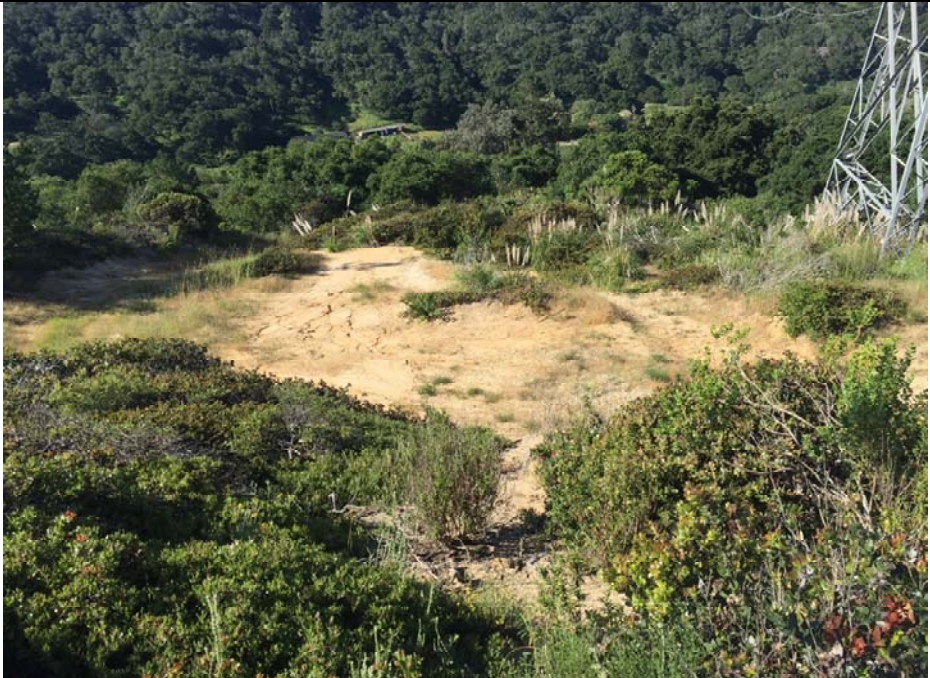
<b>Photo: 3 south</b>				
<b>Description:</b>  Hooker's manzanita in lower left of frame.

- To minimize impacts to special-status plant species, grading will be accessed from the southwest where there is a preexisting eroded slope. All Hooker's manzanita individuals will be avoided this way.

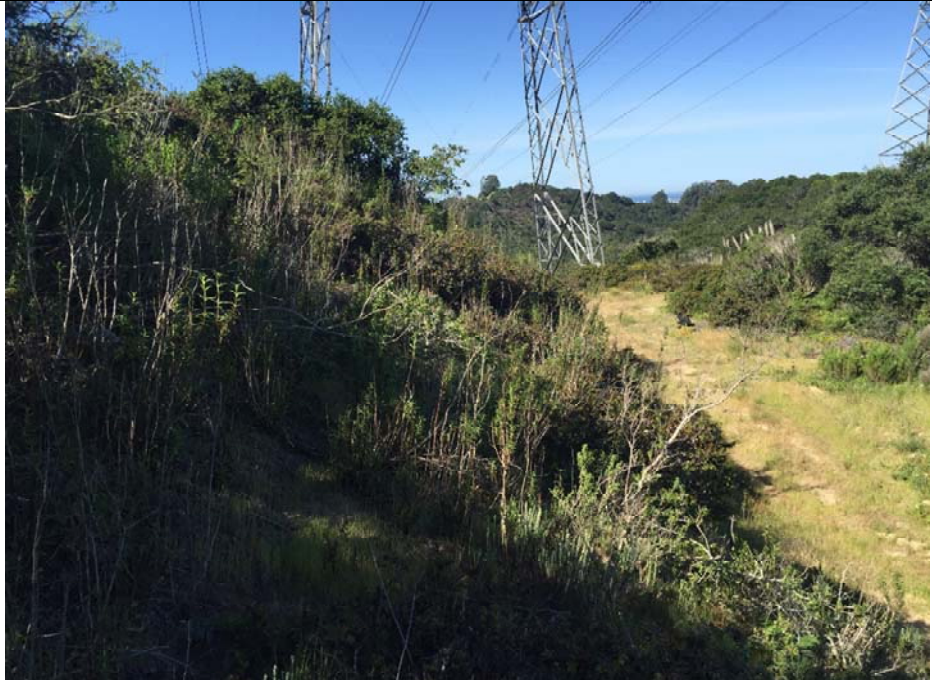
<b>Photo: 4</b>				
<b>Description:</b>  Tower 004/024 in background.

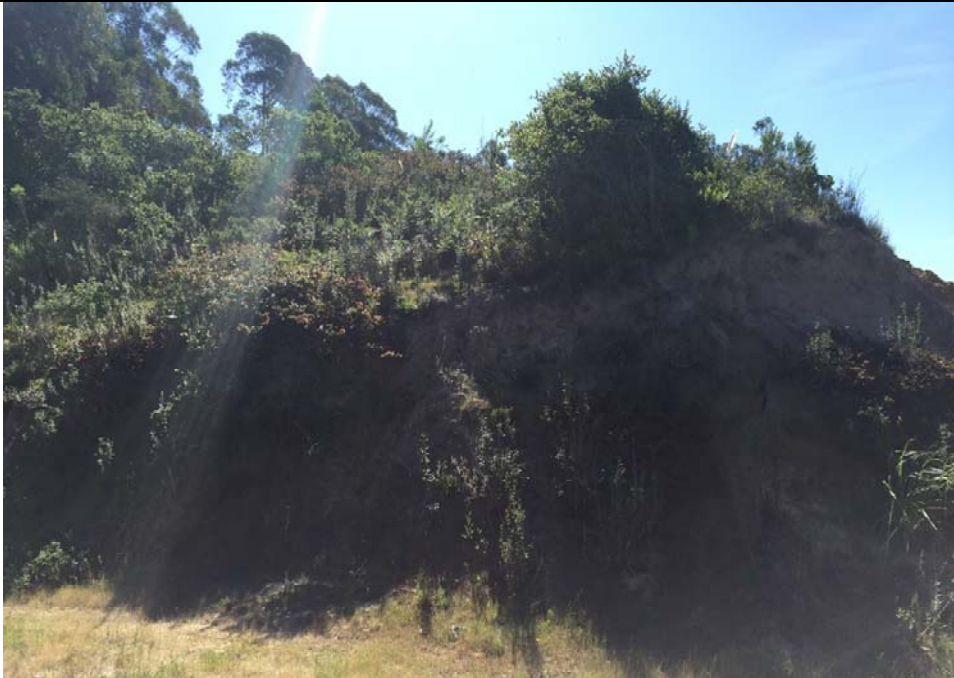
<b>Photo: 5</b>				
<b>Description:</b>  Proposed grading area location on top of small knoll in middle of frame.
