MONTEREY COUNTY

Subject: Post Activity Report - Carmel River Lagoon Sandbar Management: January 4, 2019

Carmel Lagoon Sandbar Mgmt Photos

Subject: Post Activity Report - Carmel River Lagoon Sandbar Management: July 2019 Closure Activities

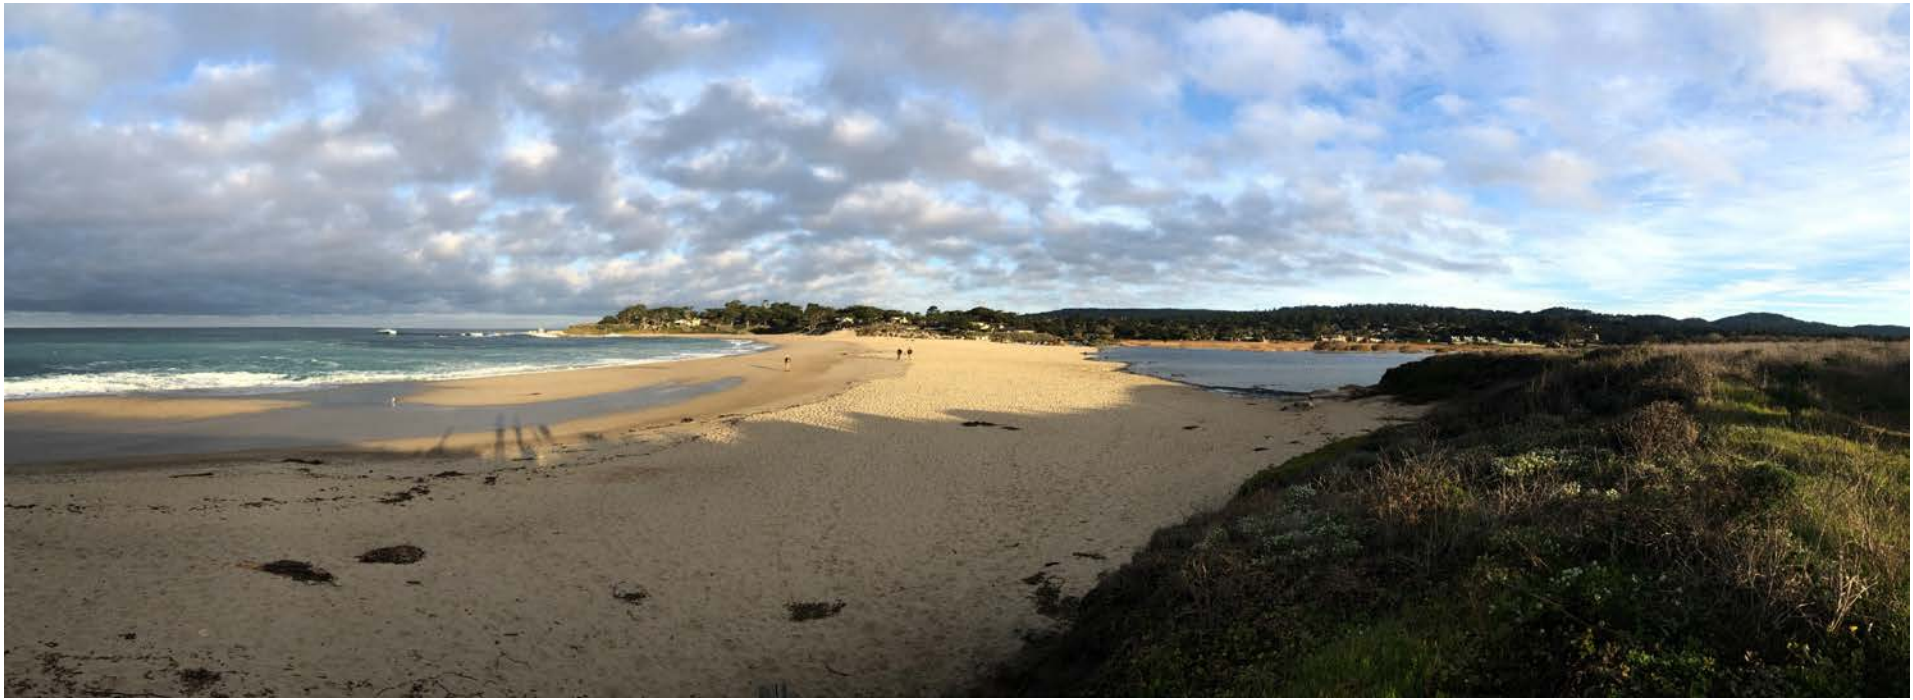
Before
Work –
1/4/19

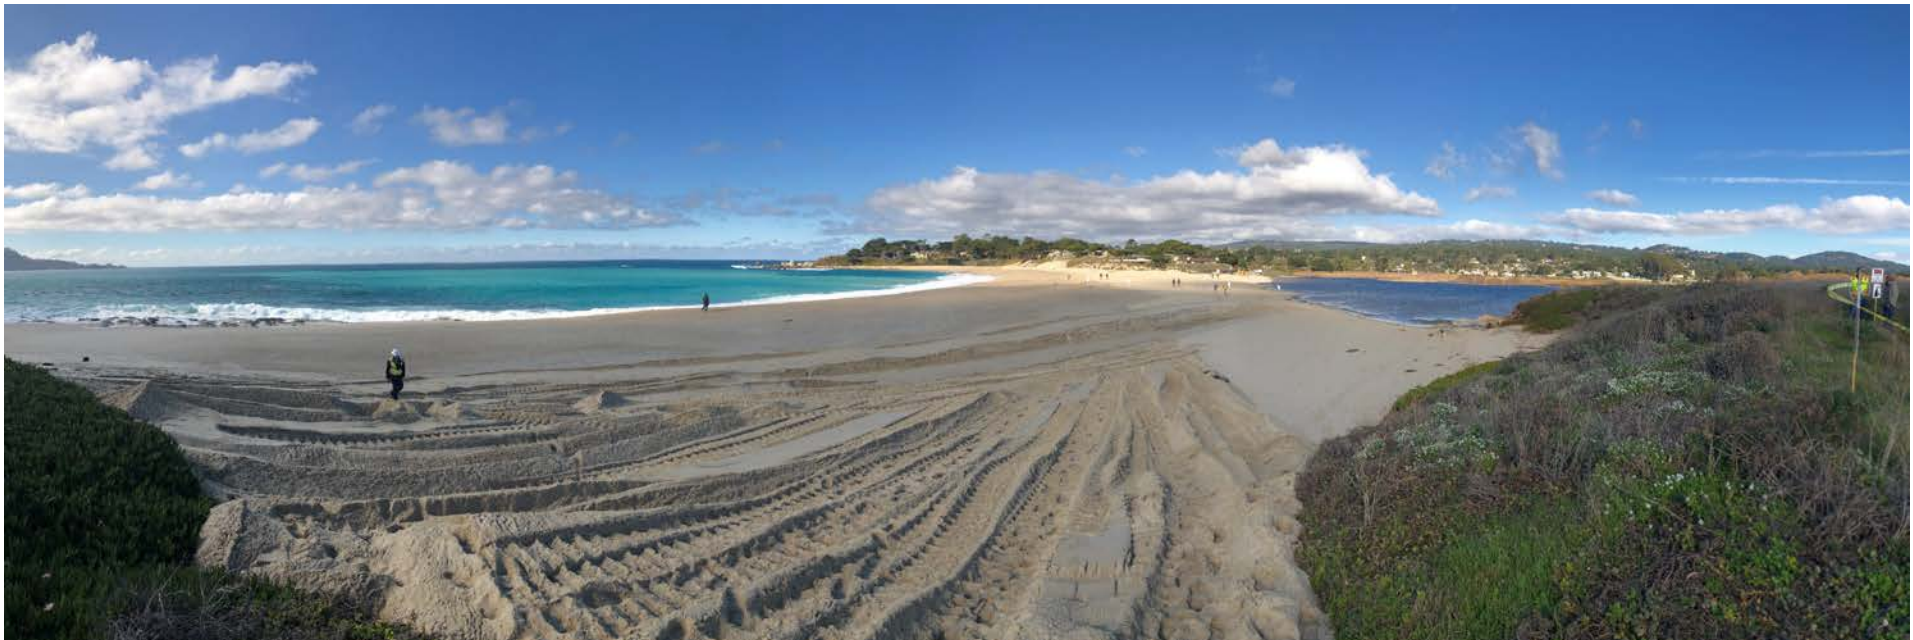
Upon completion of the activity on January 4, the western edge of the Carmel Lagoon was approximately 20 ft east of the beginning of the pilot channel and approximately 0.5 ft below the elevation of the sand plug left in the sandbar (Lagoon elevation: 13.26 ft NAVD 88, plug: 13.7 ft NAVD 88, pilot channel: 12.8 ft NAVD 88).

After
Work –
1/4/19

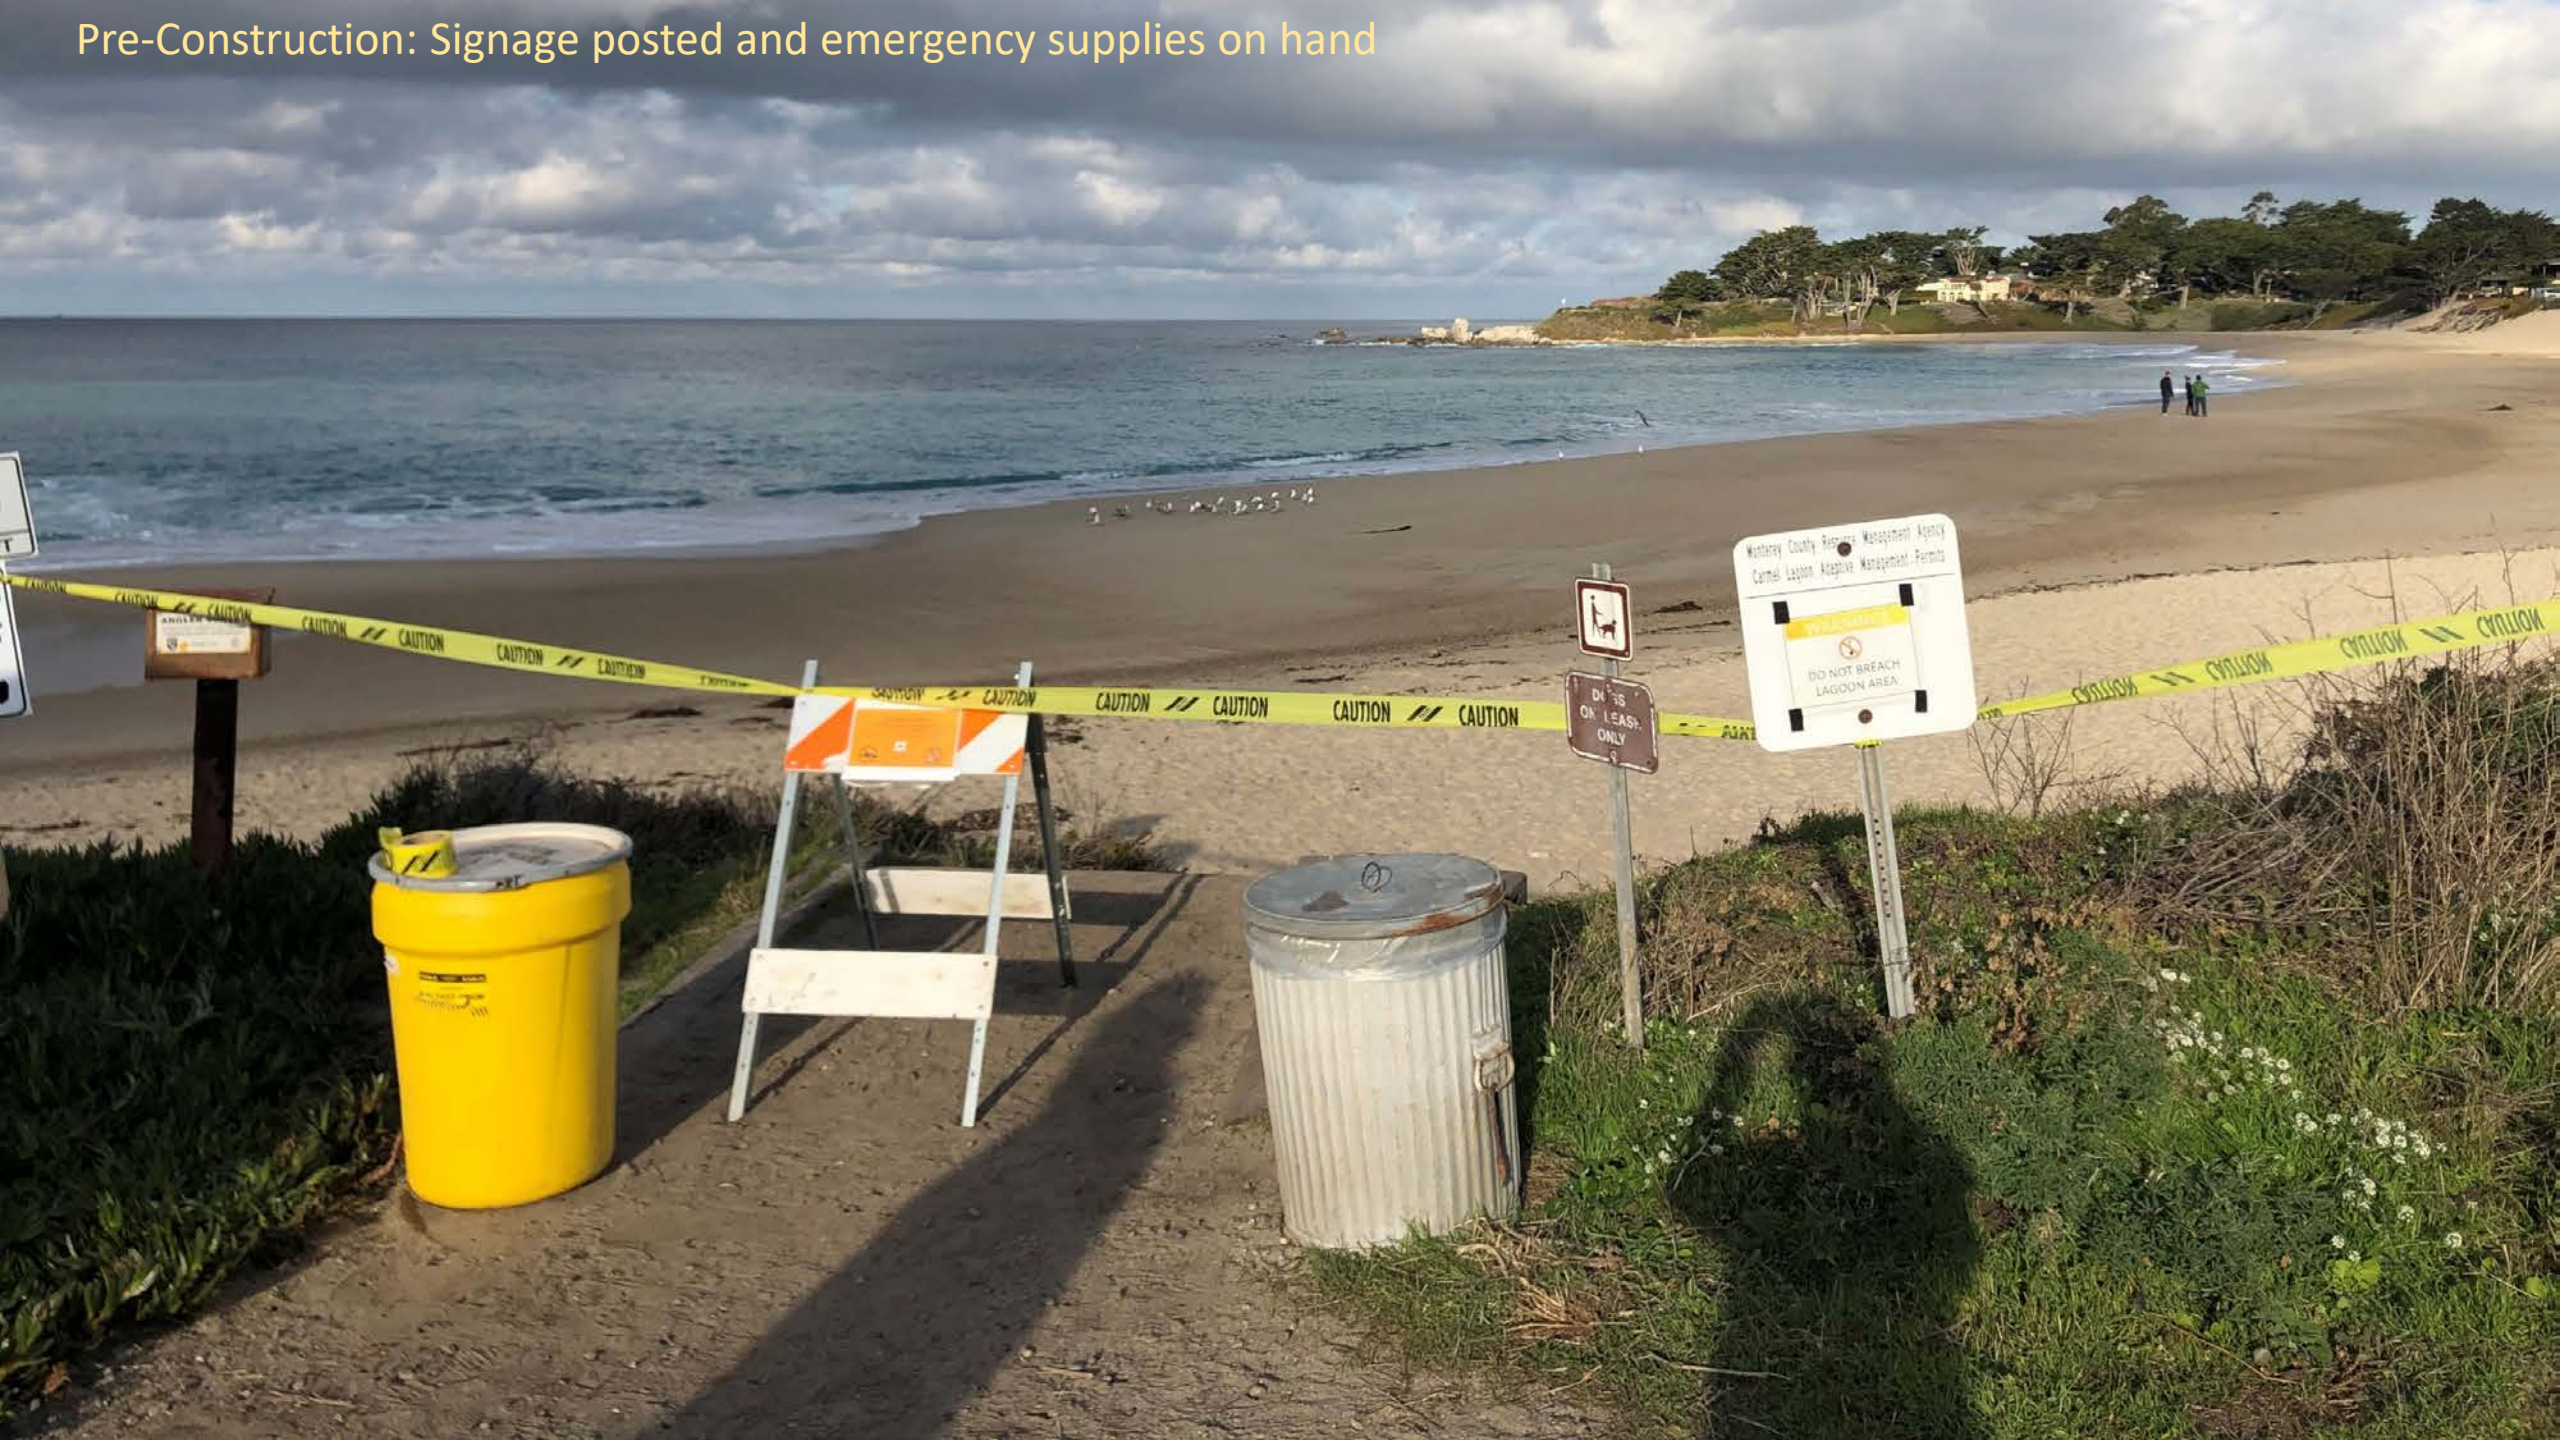
Pre-Construction: Signage posted and emergency supplies on hand

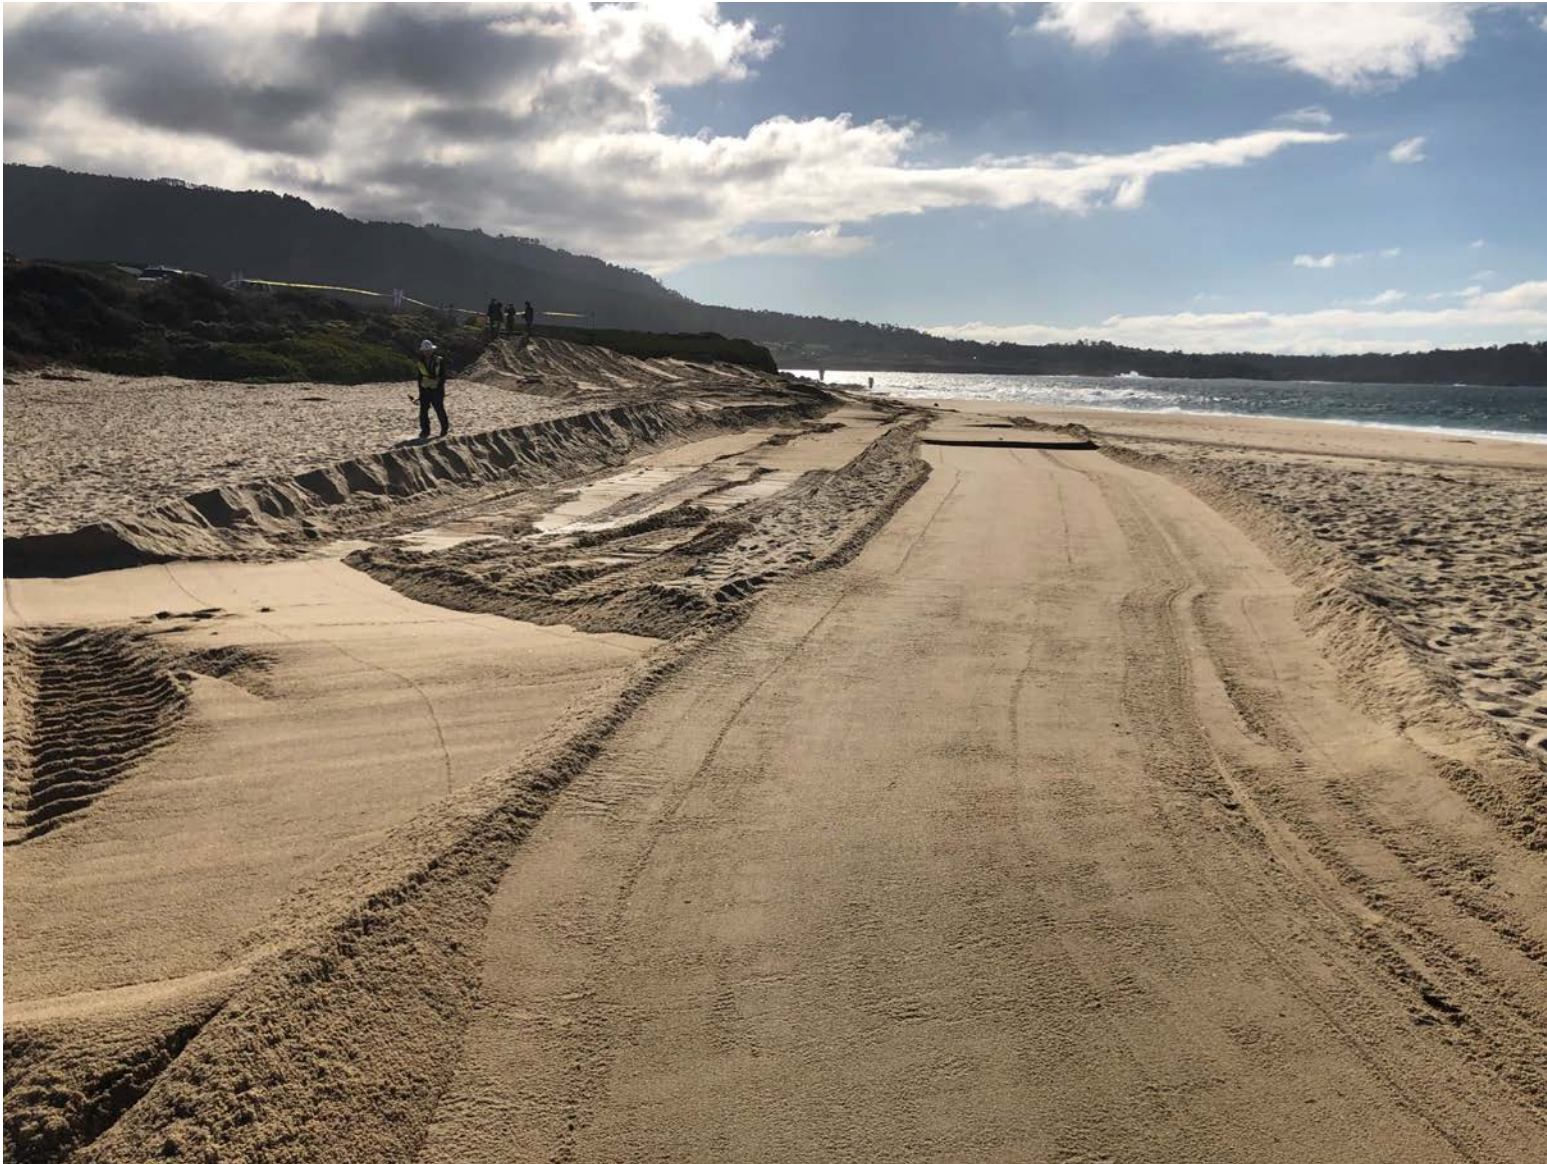
4

During Construction – showing southerly direction of pilot channel

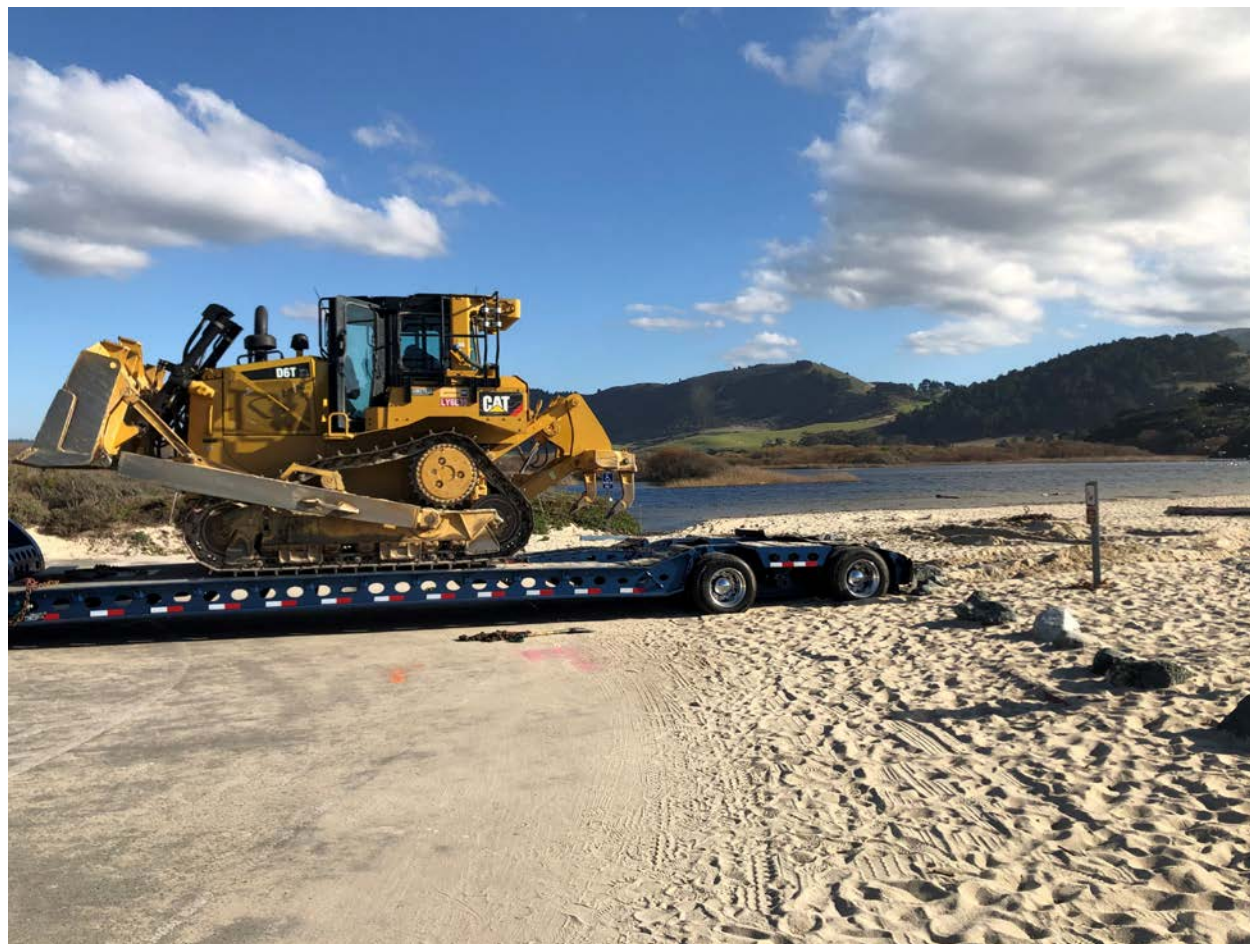
2

After Construction - Removal of equipment

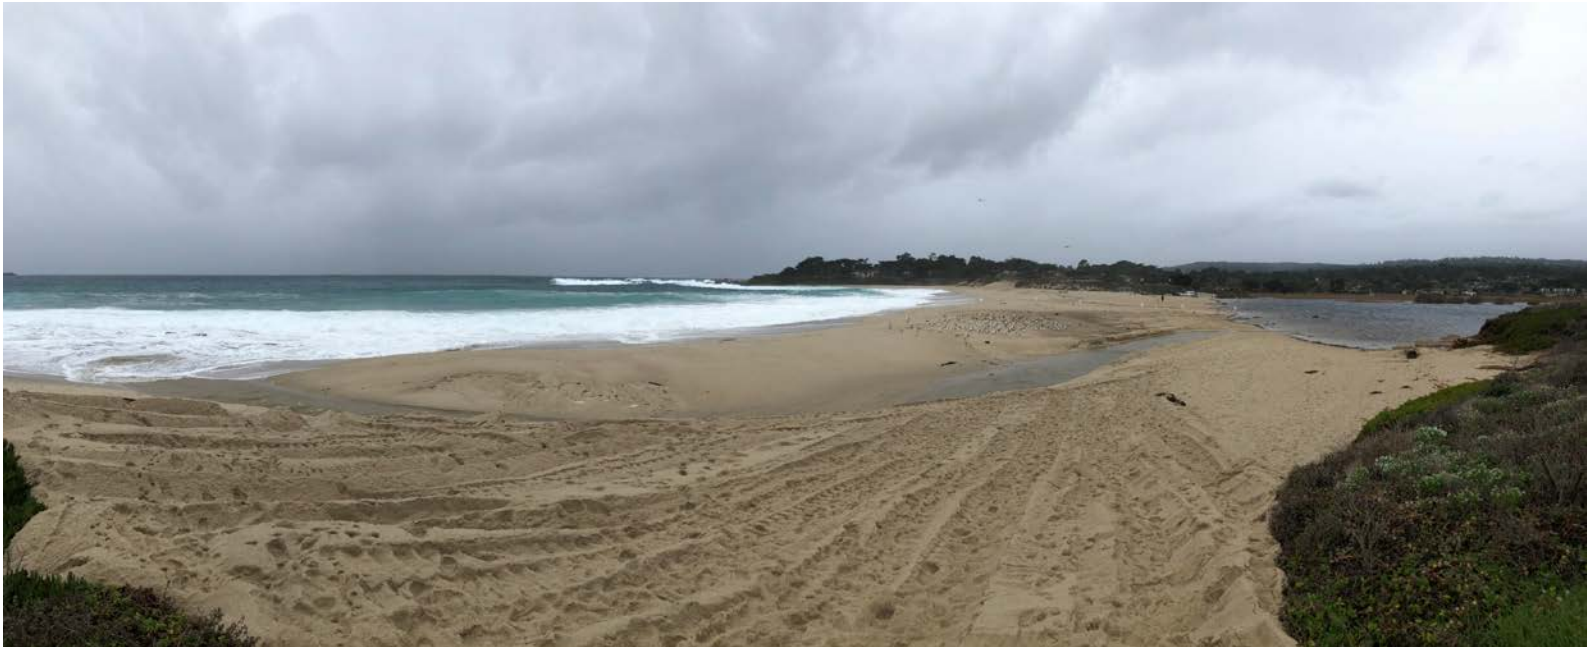
1

During the early morning hours of January 5th, the lagoon naturally opened the sandbar creating a channel approximately 10 ft wide with a flow rate of approximately 2 cubic feet per second (cfs). On January 6th, river inflows from heavy rain reached 300 cfs and allowed the channel to fully develop. After starting out in a southwesterly direction, given the limited sand and relatively narrow sandbar, the Lagoon evacuated at a straight out (westerly) alignment. Consistent with prior discussions with NOAA Fisheries, due to the lack of sand to form a closure plug, the County did not attempt to close the Lagoon opening after this management event. The County will continue to monitor through the winter into the spring to determine possible need and feasibility to close the sandbar heading into the dry summer months.

After natural breach - January 6, 2019.

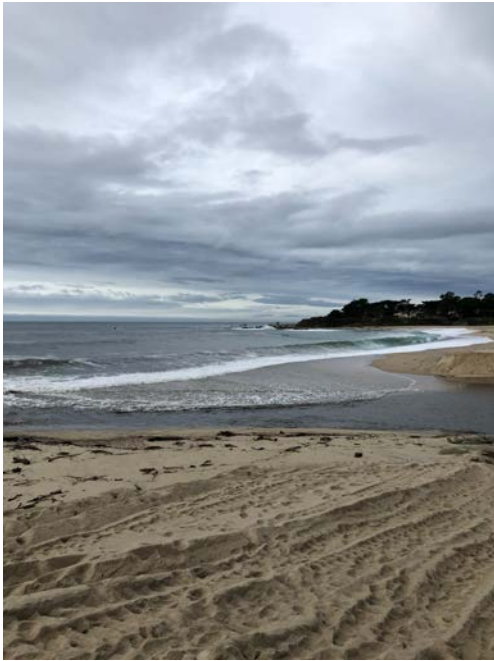
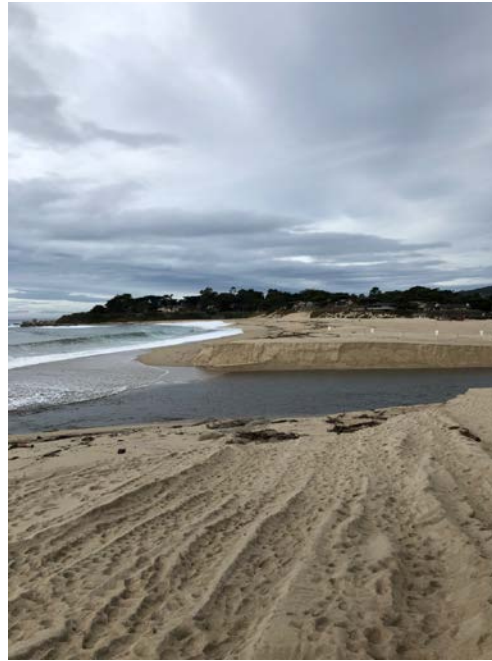
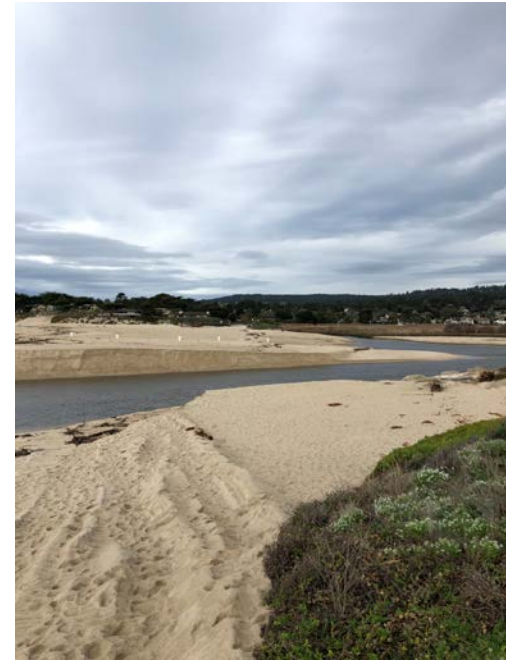
3

After natural breach - January 8, 2019.
