# Attachment E

Based on the application for an after-the-fact Demolition permit for the McDonald Residence at 30560 Aurora del Mar in Otter Cove and review of the site plan for the project, I visited the site on December 12, 2019. I have completed biological assessments for this project on two previous occasions in the past 7 years. Beyond the demolition of the house and removal of landscape screen plantings in the upper most portion of the property I find no changes on site that would affect my original assessment.

The current site plan shows 3 areas that Monterey County has requested clarification and explanation for with an updated biological report to include the discussion and support for the retention of these improvements in those areas They are:

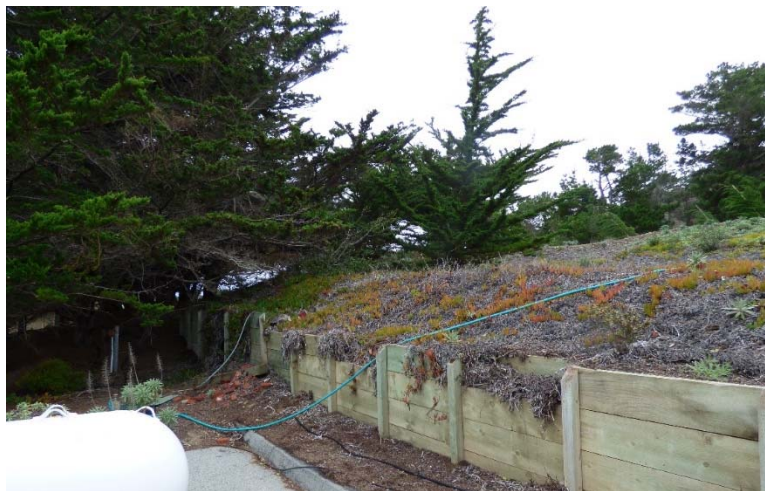
1. The wood retaining wall between the asphalt parking area and the uppermost (eastern) portion of the

*Figure 1: View looking N NE at upper retaining wall between parking area and conservation easement area.*

property provides stabilization of the slope above the parking area right at the entry from the driveway all the way to the northern property line above a stand of planted Monterey Cypress trees. This parking area has been in place since at least the mid-eighties. A large percentage of this parking area is not within the conservation easement and is being legally utilized as a parking area. Removal of the retaining wall would serve no biological benefit as it would destabilize the slope and require further grading and sloping of the

upper conservation easement area to reach equilibrium without burying the trunks of the mature Monterey Cypress. Since I first visited the site in 2012, a large quantity of nonnative landscape planting has been removed from this area, leaving the exposed retaining wall, and the LP tank has been installed in the northern portion of the asphalt pad. As a transition between the parking space and the conservation easement the wall provides a structural benefit and boundary and allows for future restoration on the upper slope with no detriment to the soil structure or potential establishment of native plant community. I do not see a net biological gain to be made by removing all or even part of this wall structure.

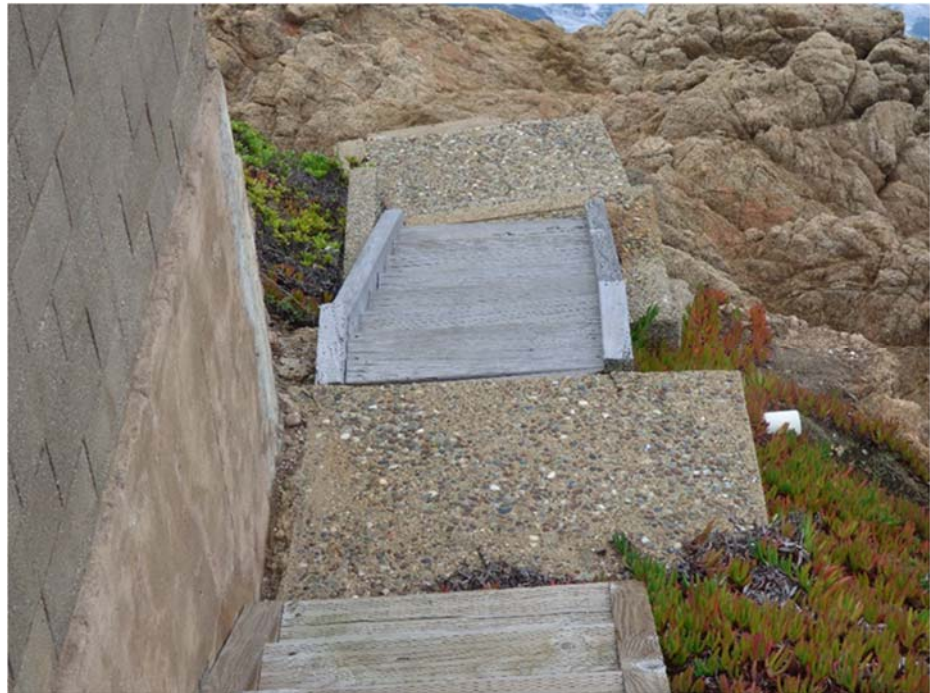
2. The two flights of wooden stairs and three concrete landing pads, extending from the westerly most section of the patio, are shown to be within the Conservation easement drawn for the project in 2012. The concrete pads are mortared to bedrock granite. They are within storm splash zone but outside of normal high tide line. The only vegetation growing near them is *Carpobrotus* or what is commonly called ice plant, an introduced species

from South Africa that has been used to stabilize dunes and rights-of-way up and down the Coast of California. It has proven to be too successful and has literally buried native species on bluffs and dunes throughout the Central Coast. The *Carpobrotus* is now and has been for at least 40 years, the dominant plant in this ocean bluff setting. It is unfortunate that it has proven to be detrimental to the native species while being the only remaining plant to have a foothold on the rock face here.

Figure 2: View looking w SW at flights of stairs and concrete landing pads at edge of proposed conservation easement area.

It appears that this stairway, significantly predates the development of conservation easement boundaries. Removal of the concrete pads would likely require a jackhammer and like the retaining wall in the upper part of the property, would offer no biological benefit. Forceful breaking out of the concrete would possibly degrade the rock below it and destabilize it hastening weathering and erosion. There is nothing biologically sensitive that these stairs and landing pads are impacting by remaining in place and there is no meaningful restoration of native ocean bluff scrub habitat that could be implemented that would be likely to survive on the exposed granite were the stairs to be removed.

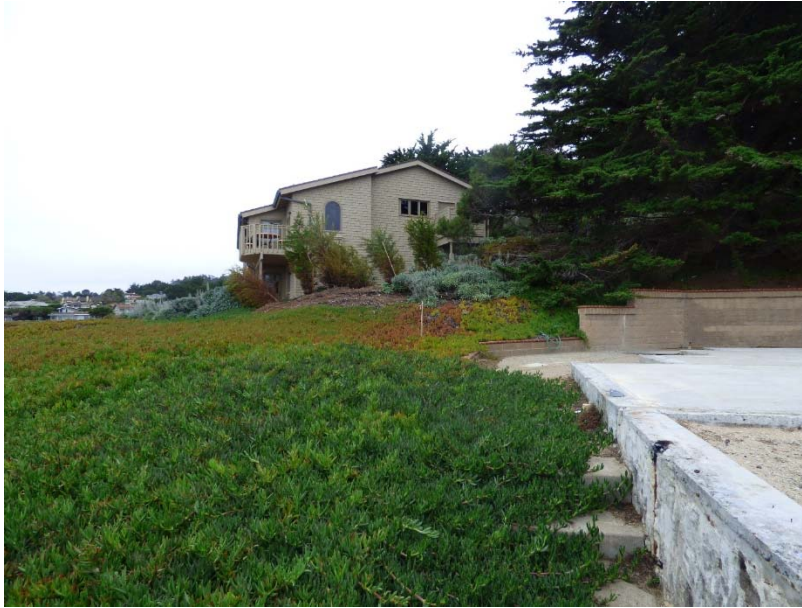
3. In the most northerly part of the property, it appears that the original development of a retaining wall and concrete slab for the house encroached upon HOA property beyond the property line of APN 243-

*Figure 3: View looking east at stake indicating property line which cuts diagonally across image from lower left to upper right and runs through the far left of the retaining wall*

retaining wall currently supports the root systems of several Monterey Cypress that provide some screening between the neighboring house and the Mr. McDonald's former and future house. The HOA open space between the two home sites is, like most of the surrounding area, completely dominated by the nonnative vegetation. Removal of the north end of the retaining wall would (again) destabilize the slope and the Monterey Cypress tree roots unnecessarily and only create more opportunity for invasion of the nonnative species which could not be controlled with any amount of restoration in this small area if the nonnatives were left unchecked on the neighboring HOA property. Given the age of the wall and the trees above it and the obvious benefit of the screening for both homesite, perhaps a compromise could be reached between Mr. McDonald and the HOA to keep the retaining wall in its entirety. Beyond the Civil implications, I do not see a biological benefit to removing the wall as it currently exists.

331-003. To remedy this oversight Mr. McDonald may need to find a creative option other than simply dismantling part of the wall and slab.

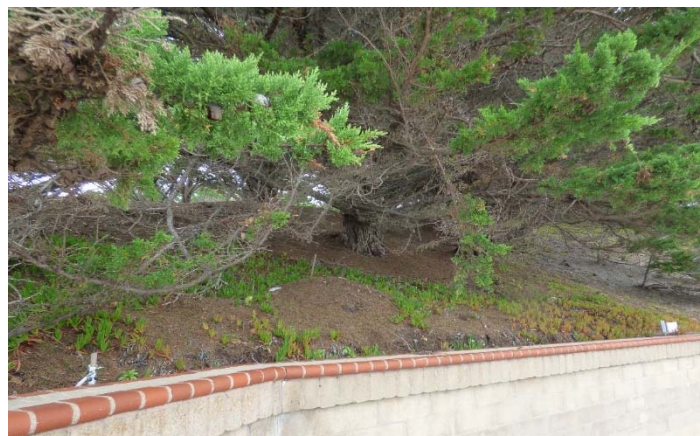
*Figure 4: Close up of retaining wall running past property line. white marker lower left*

As with the remainder of this property the "improvements" consisting of the retaining wall and house slab are at least 34 years old, and time has allowed for the significant growth of the Monterey Cypress on the uphill side of the retaining wall and the invasion of ice plant (*Carpobrotus* sp.) and Pride of Madeira (*Echium* sp.) on the HOA property (APN 243-331-006) north of the property line. The far northern end of the
