September 19, 2023

W&Smith CA, Inc Residence  
3180 Cortez Road  
Pebble Beach, CA. 93953  
APN: 008-233-010-000

Subject: 3180 Cortez Road Pre-Construction Tree Impact Assessment

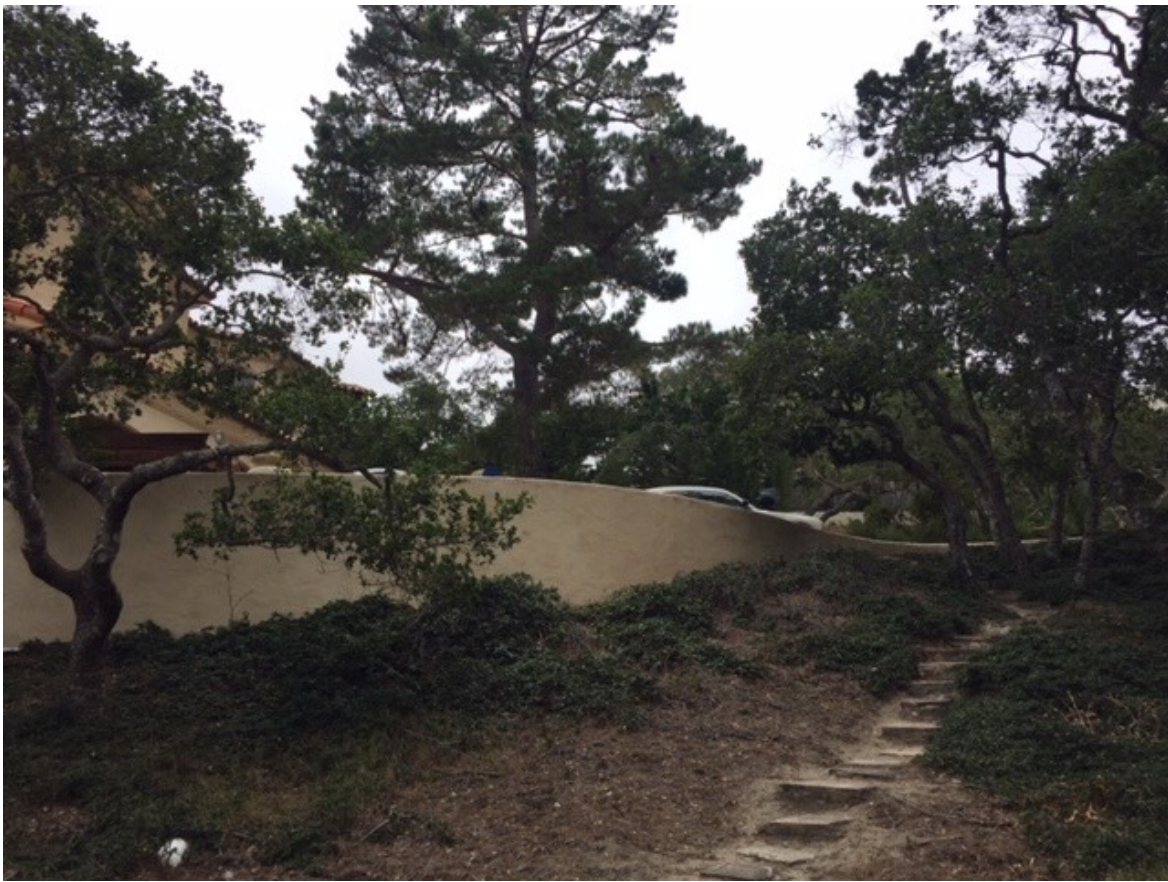
Figure 1. Proposed new driveway will pass between oaks to the left and right side of photo through previously disturbed landscaped area to connect with existing driveway. Retaining wall will be removed and nearby oaks will receive tree protection measures.

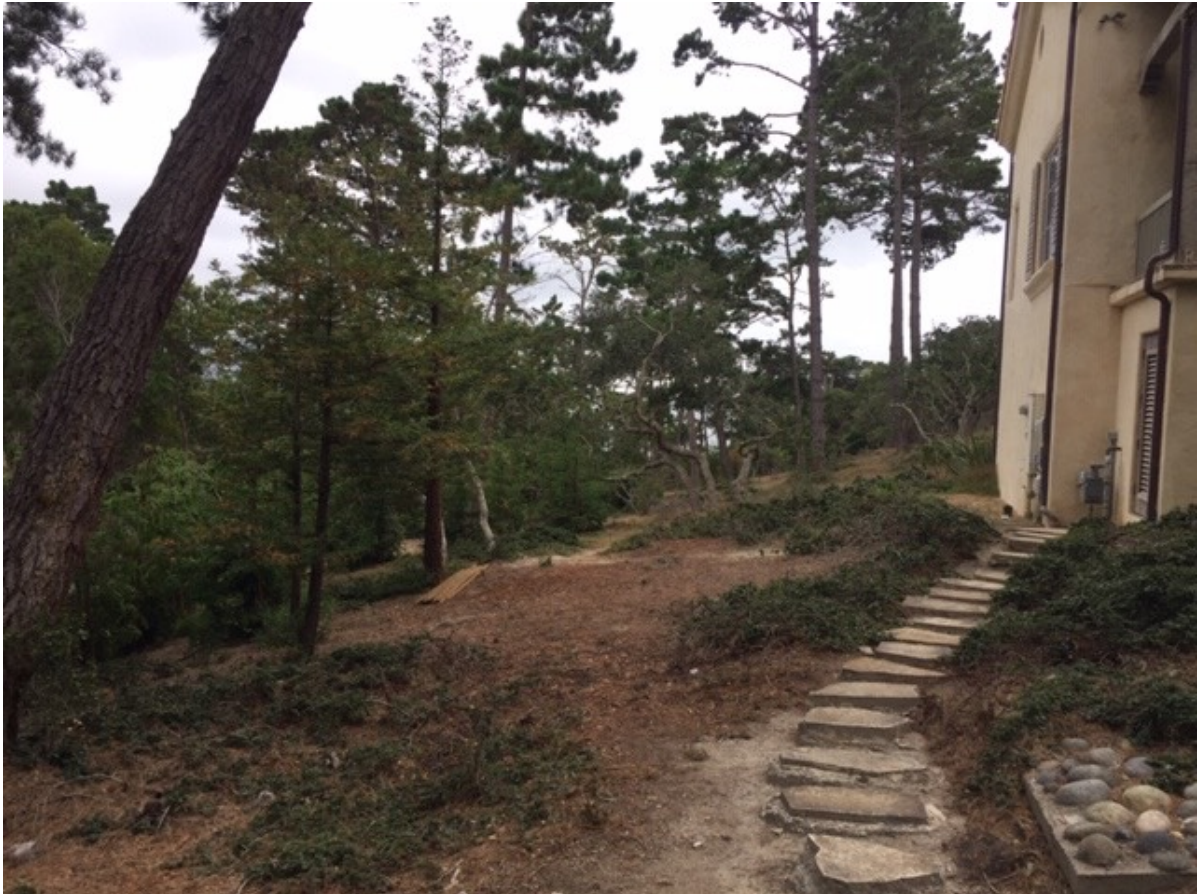
Figure 2. New driveway will continue along existing home through previously disturbed landscaped area. Trees will receive tree protection measures.

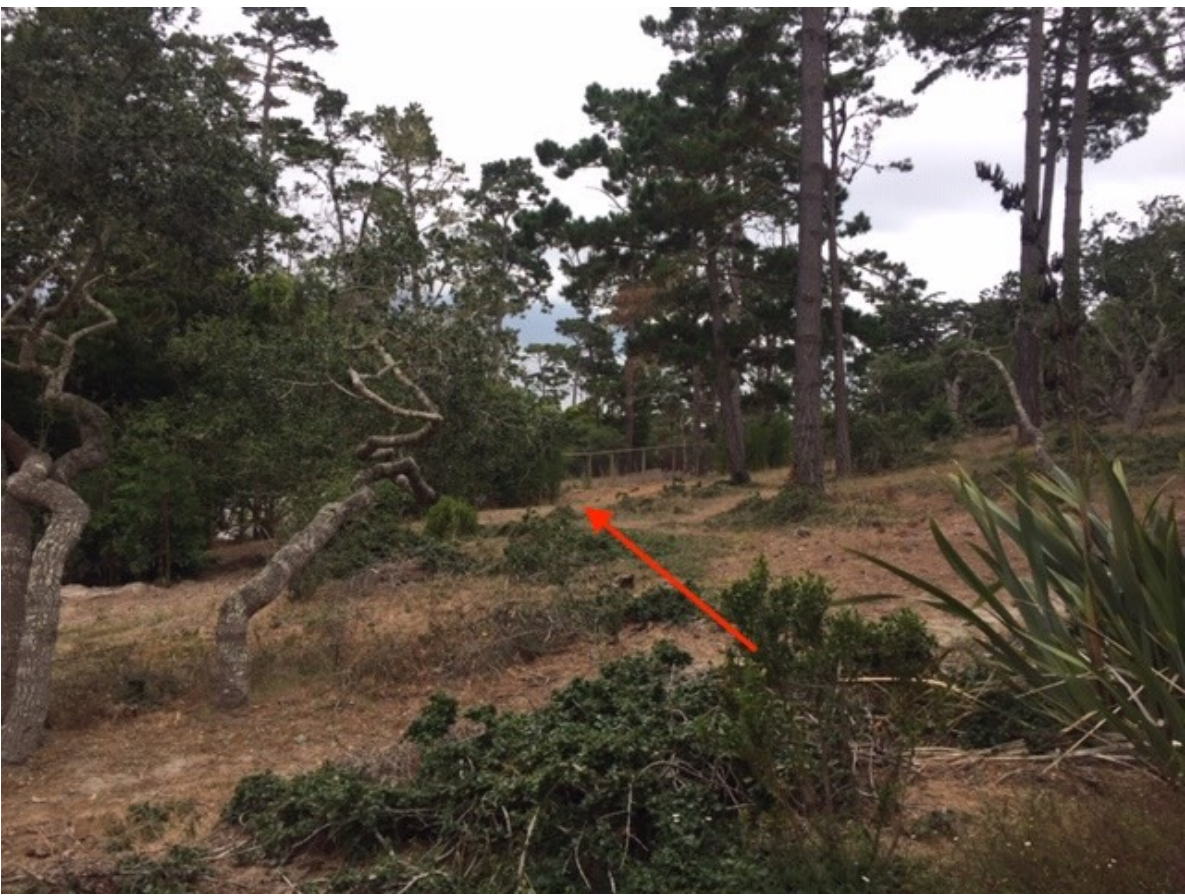
Figure 3. Proposed new driveway will continue into wooded area of lot going around mature pine and oak trees in the direction of the red arrow. Trees protection fencing will be installed and properly maintained and no trees are proposed for removal.

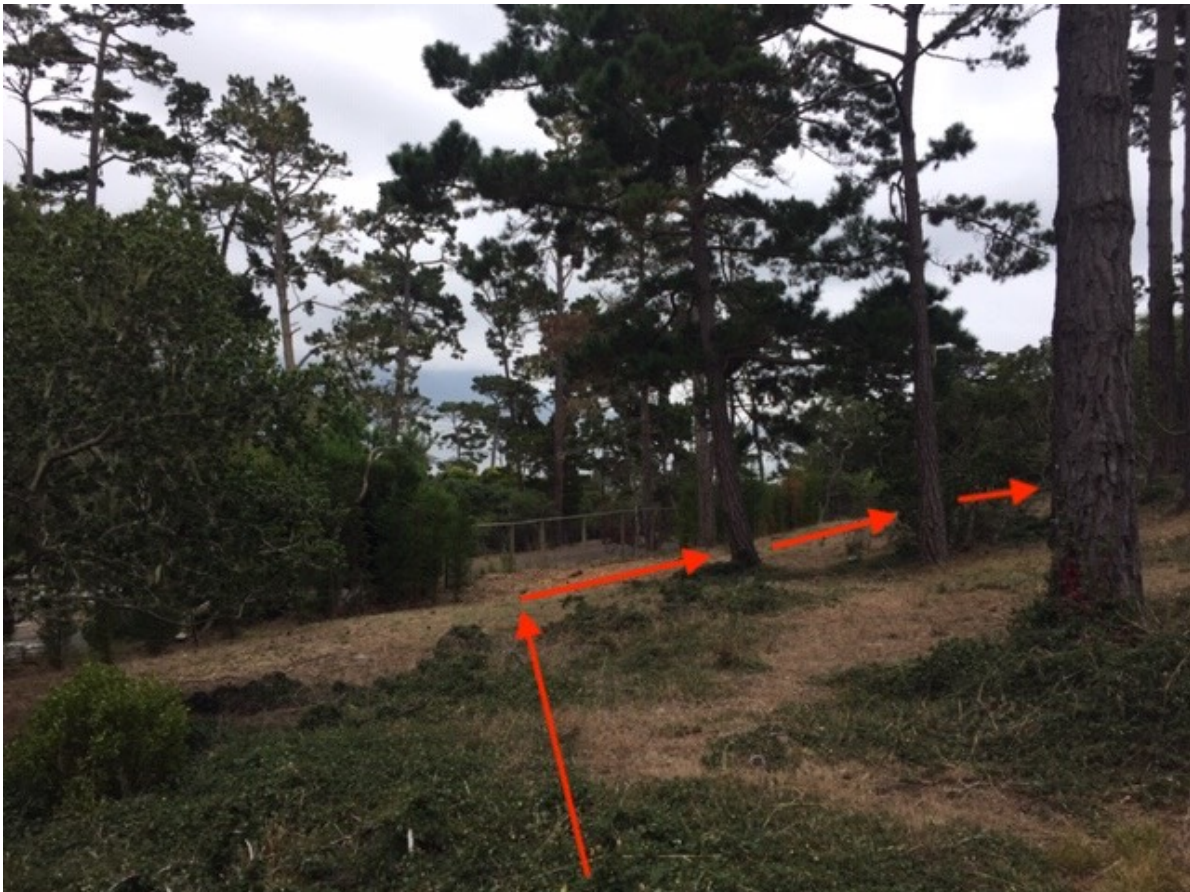
Figure 4. Proposed permeable surfaced driveway (i.e., pavers) will pass around pine trees located right of center in the direction of red arrows.

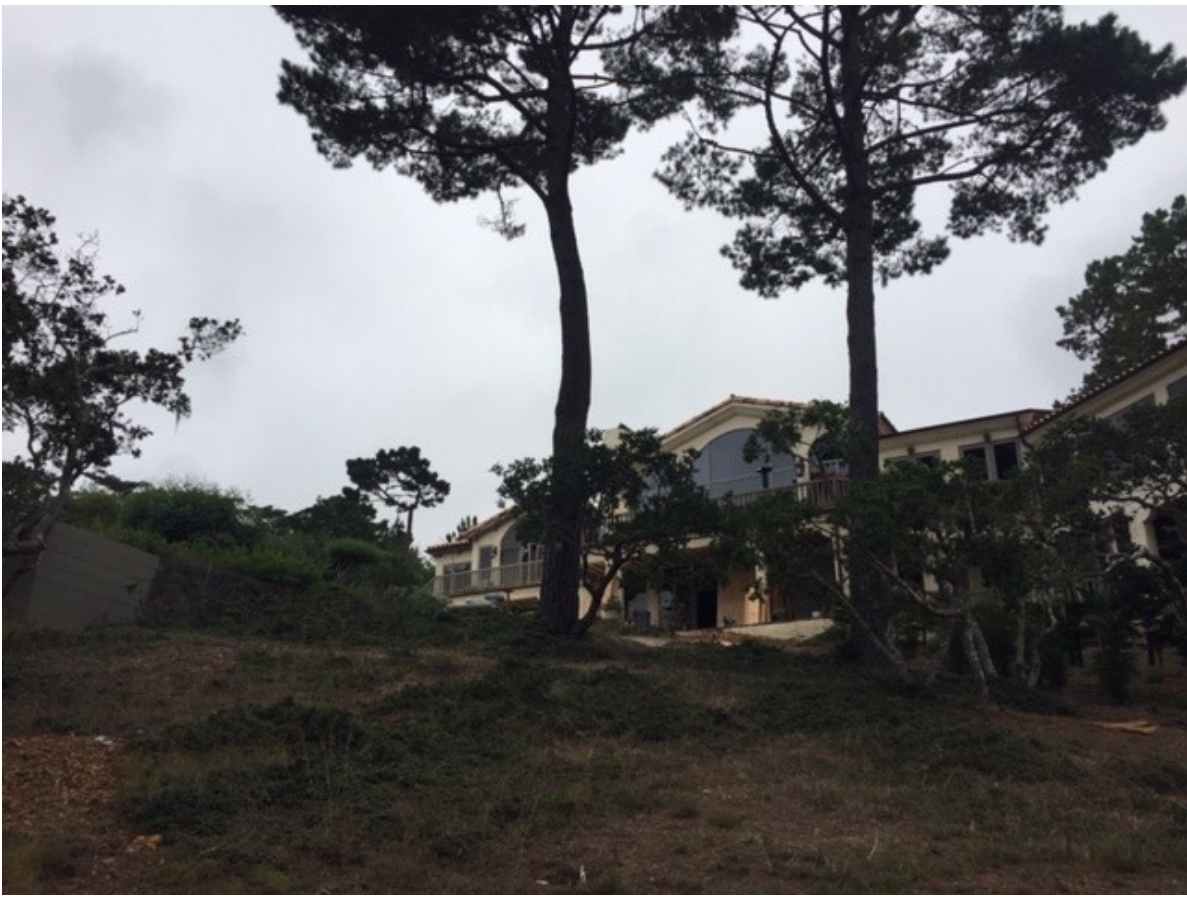
Figure 5. Existing home and mature pine and oak trees are located a safe distance from proposed driveway construction activities and will be retained and protected.

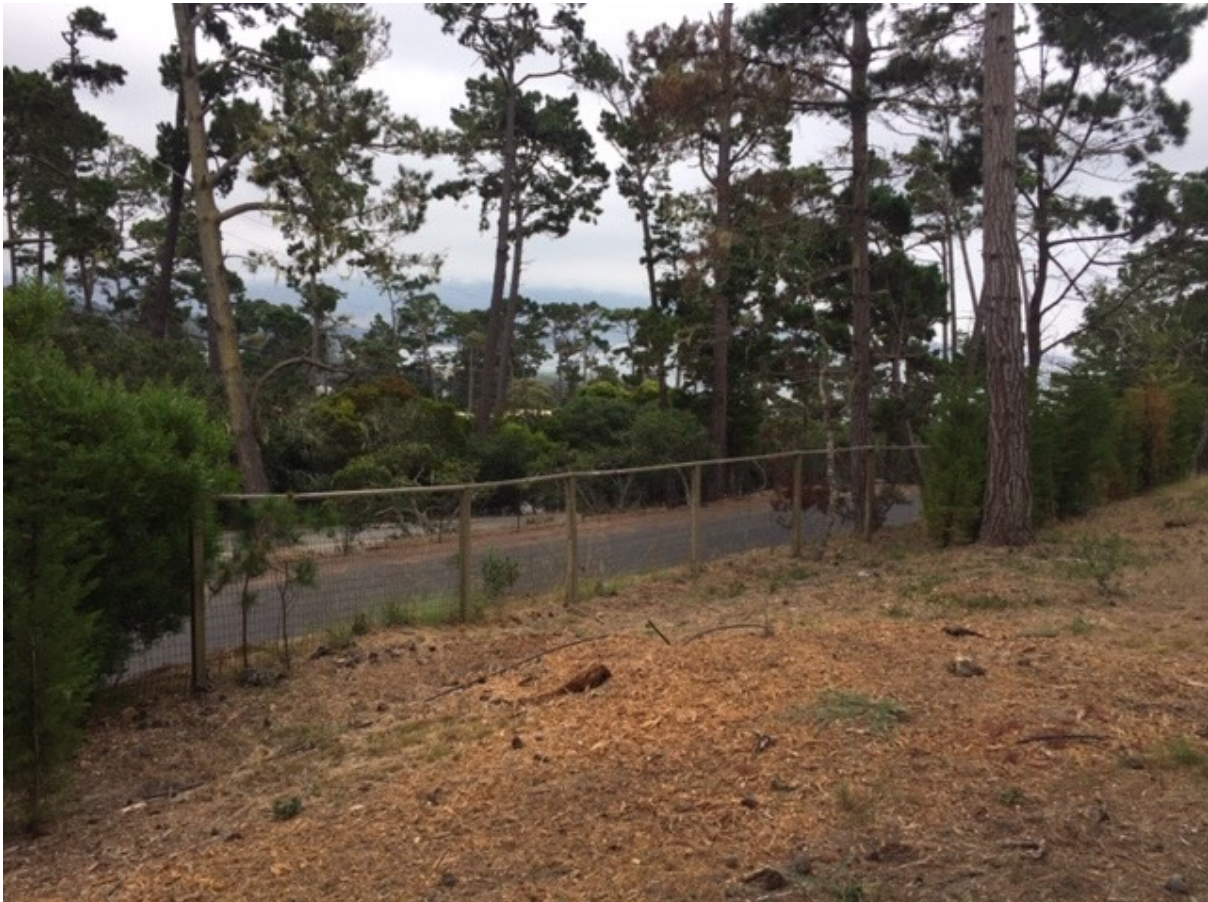
Figure 6. Proposed new driveway will enter property at this location off of Oleada Road.

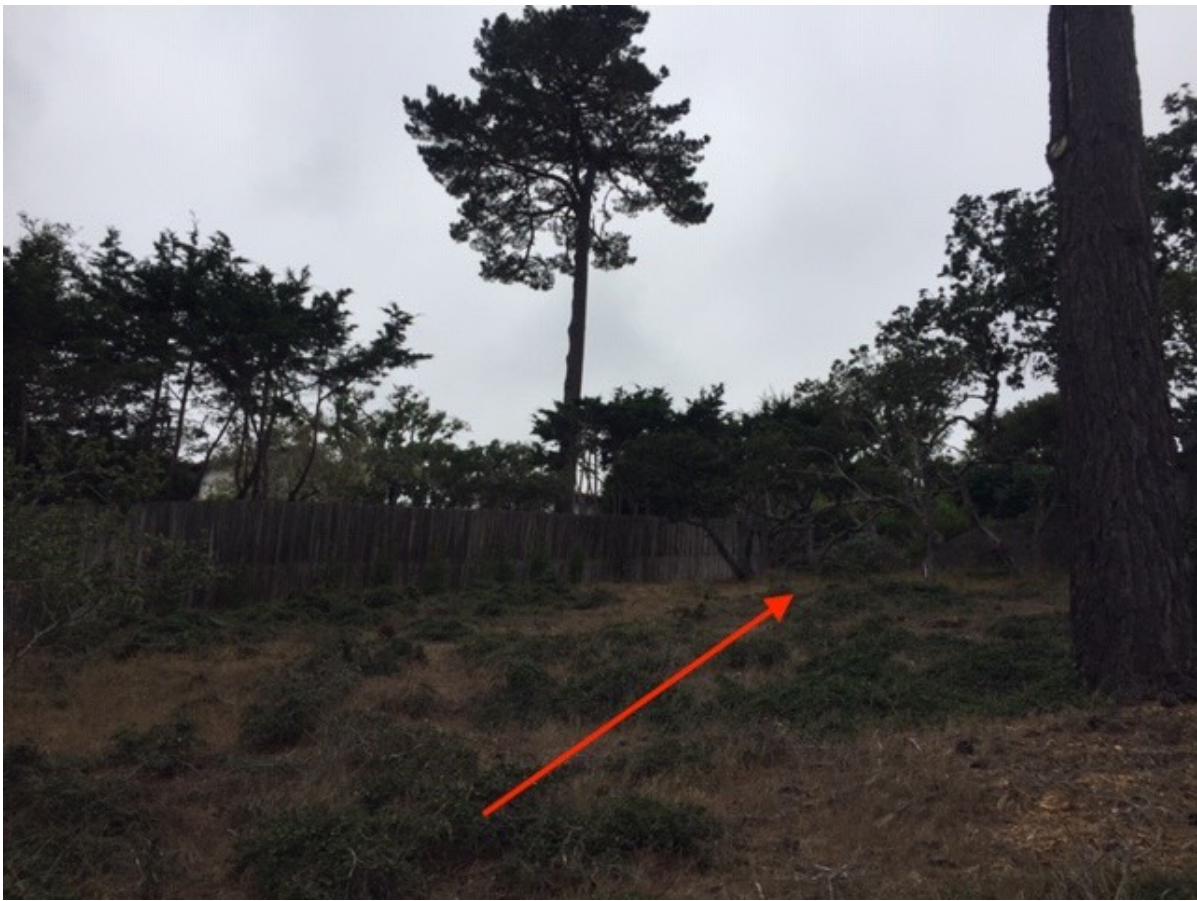
Figure 7. Proposed driveway continues up gradual slope to area where the new motor court and guest parking area will be located. Oaks and pines will be protected and retained.

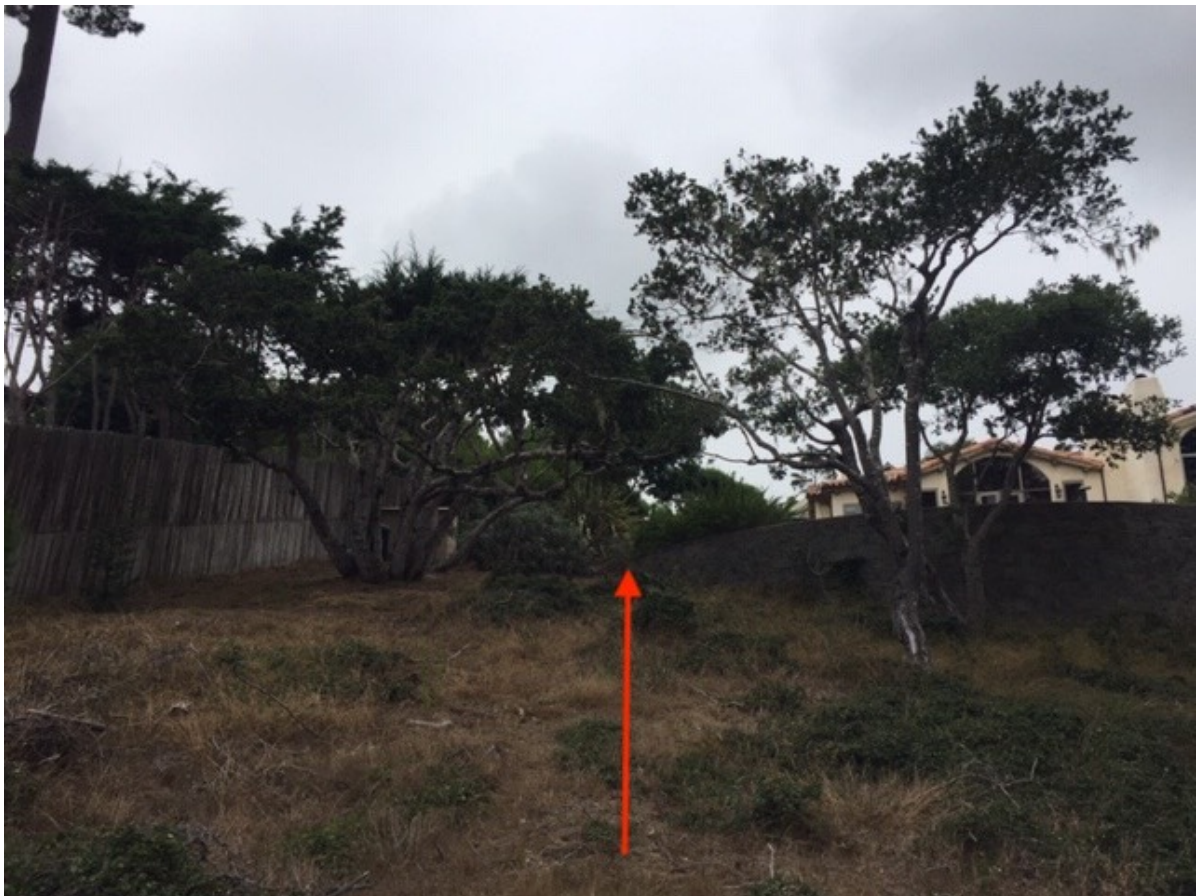
Figure 8. Proposed driveway continues up towards backyard area where new motor court and guest parking area is located.

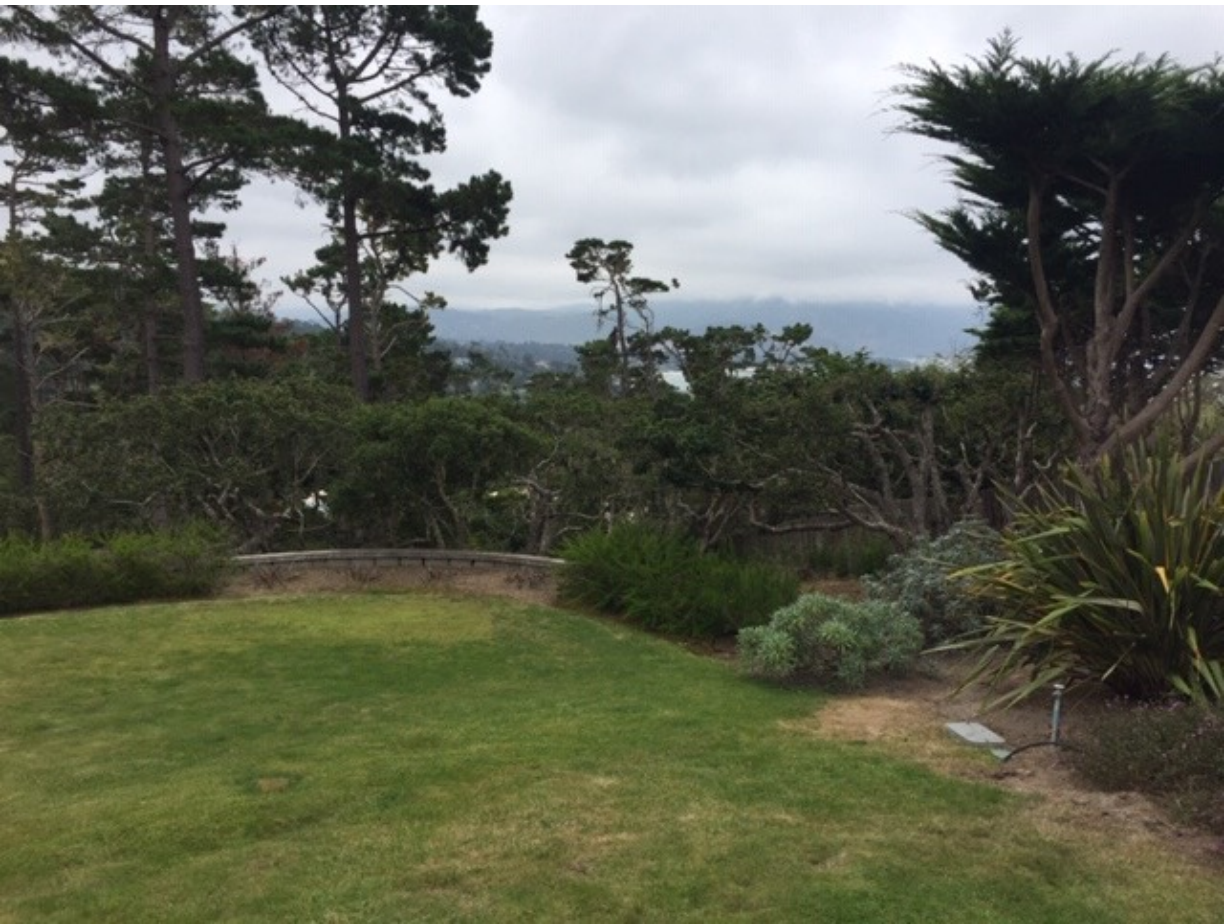
Figure 9. Existing lawn and landscaped area will be the new motor court and guest parking area.

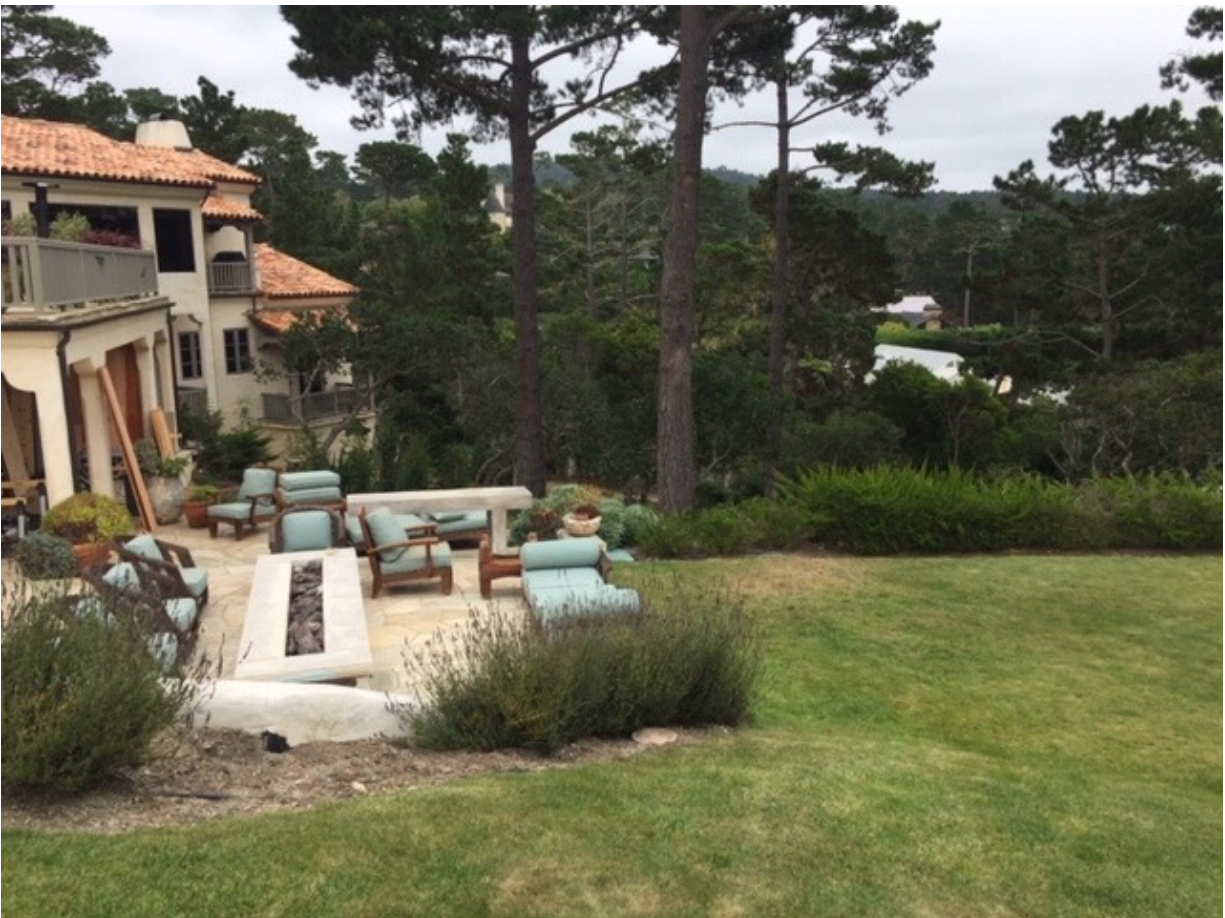
Figure 10. More of the existing lawn and landscaped area that will be the new guest parking and motor court area.

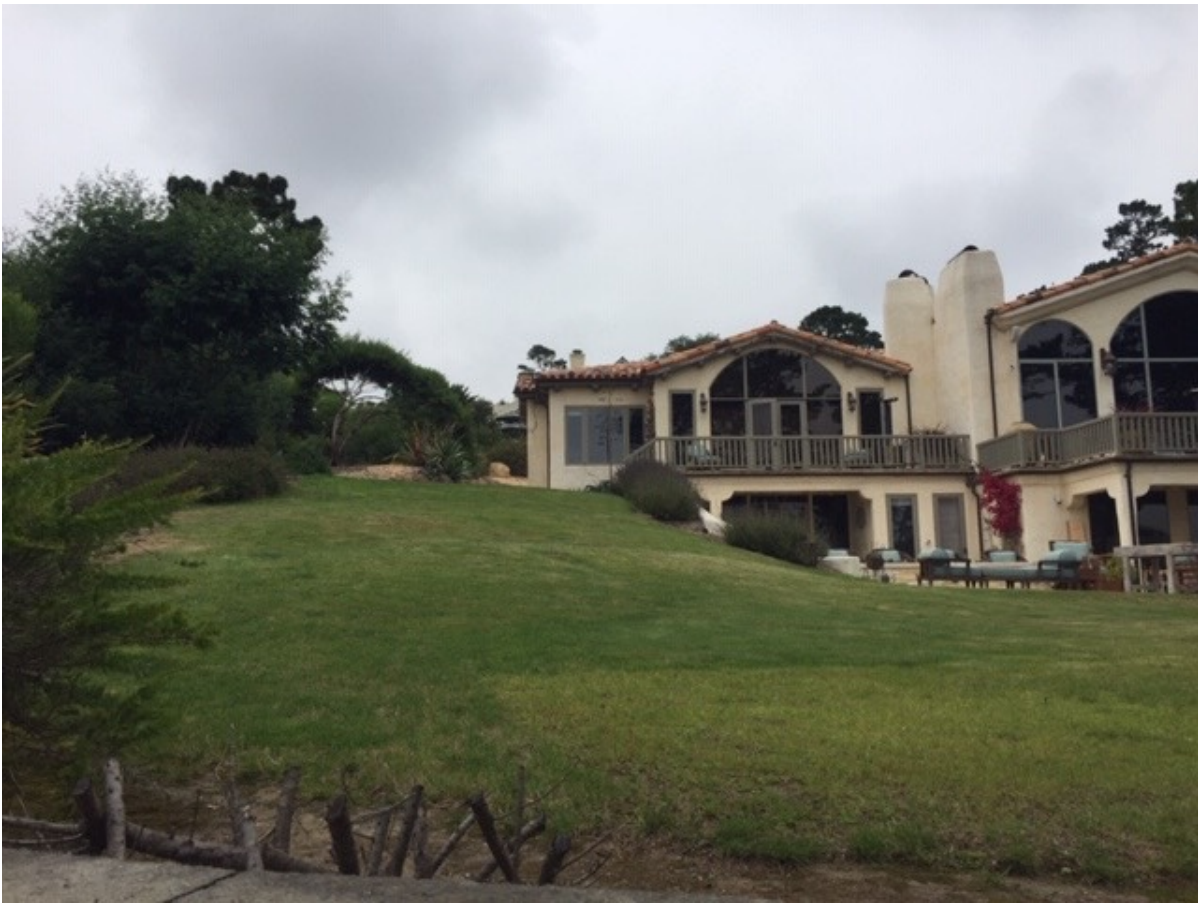
Figure 11. Another view of previously impacted lawn area where motor court and guest parking area will be located. No tree impacts will occur in this area.

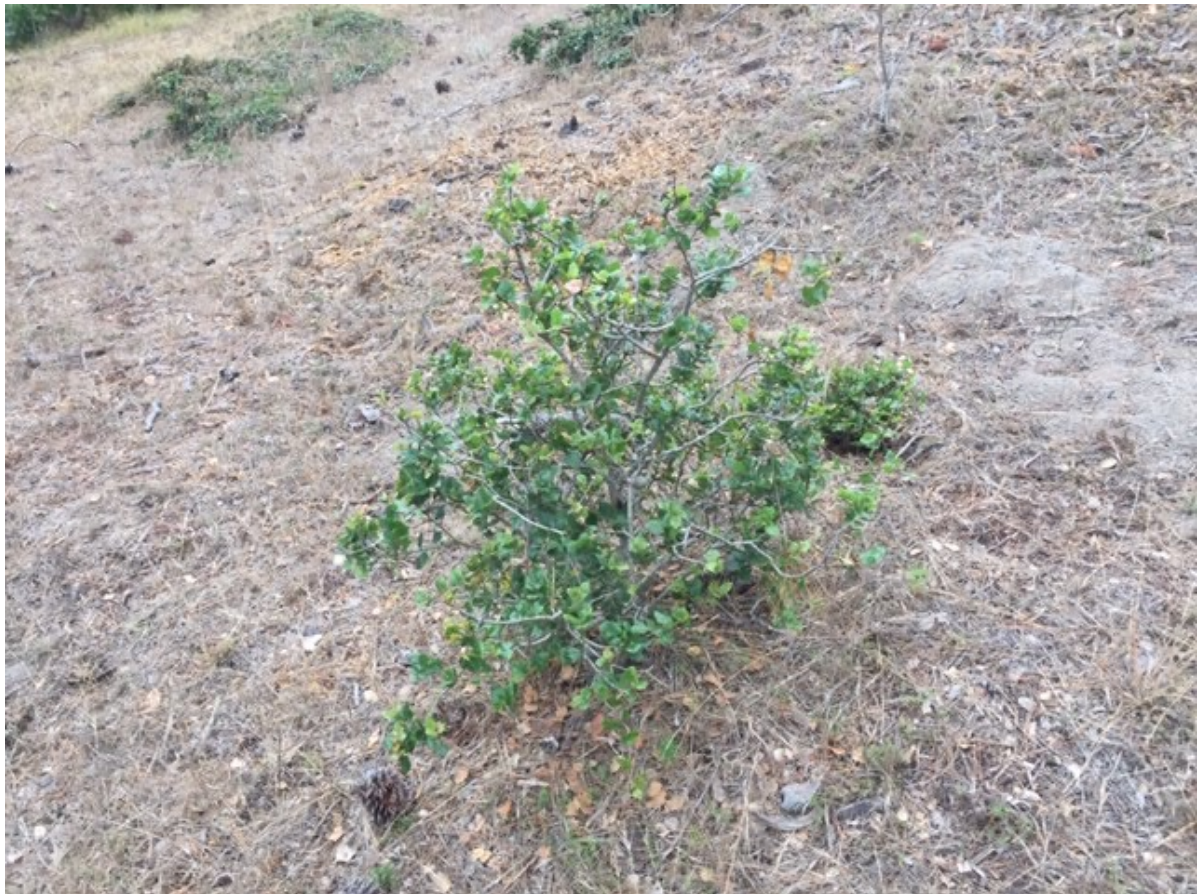
Figure 12. Natural oak and pine regeneration and recruitment is sufficient for sustaining woodland health and character.
