**Salinas River
Stream Maintenance Program
2020 Work Season**

Annual Report

United States Army Corps of Engineers

Regional General Permit 20, Corps File # 1996-22309S, Effective September 28, 2016

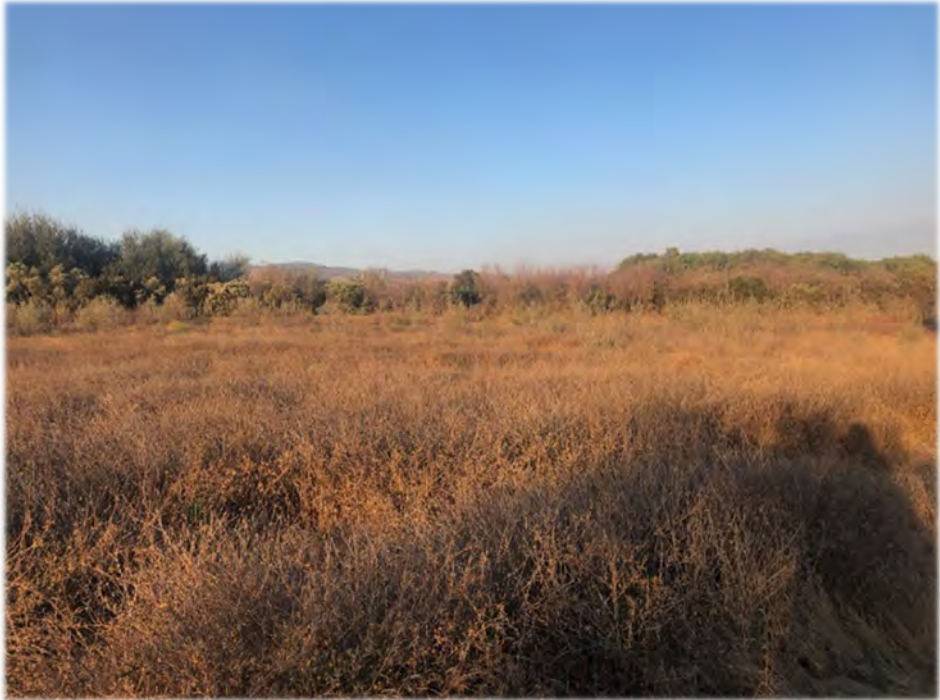
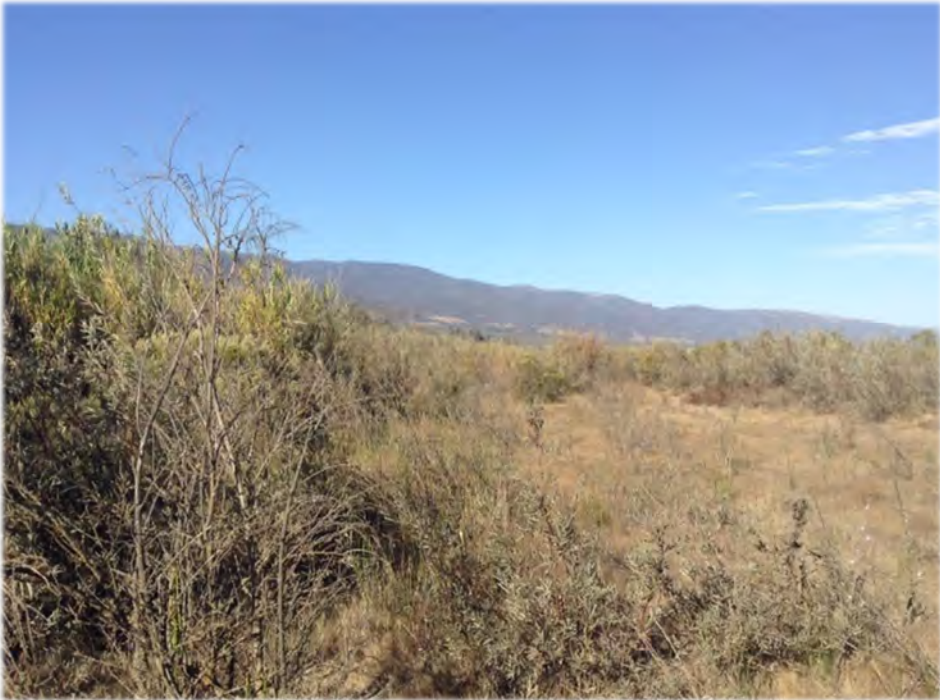
Pre-maintenance Areas

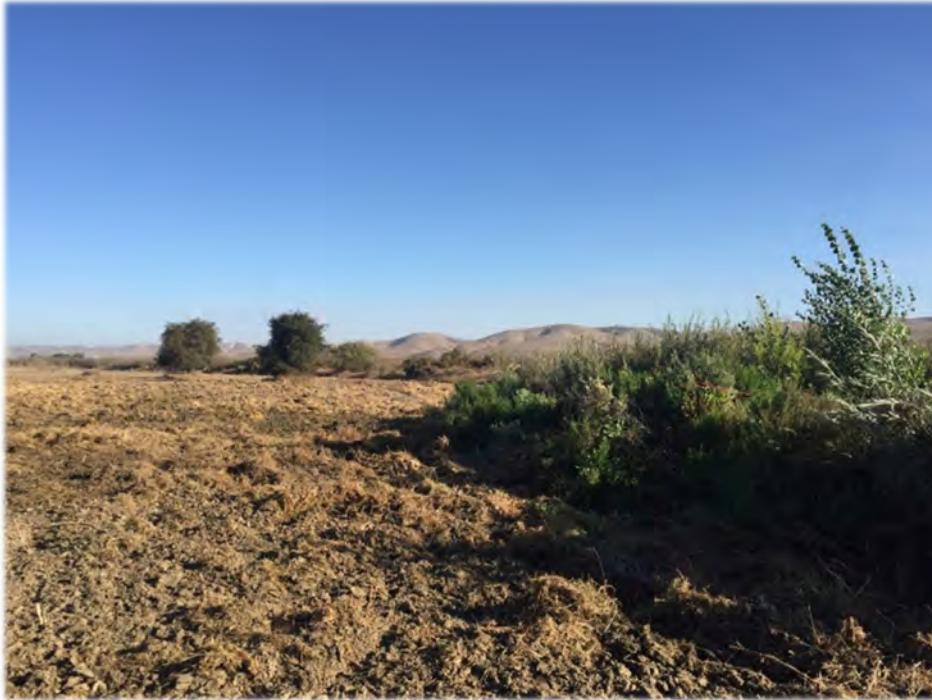
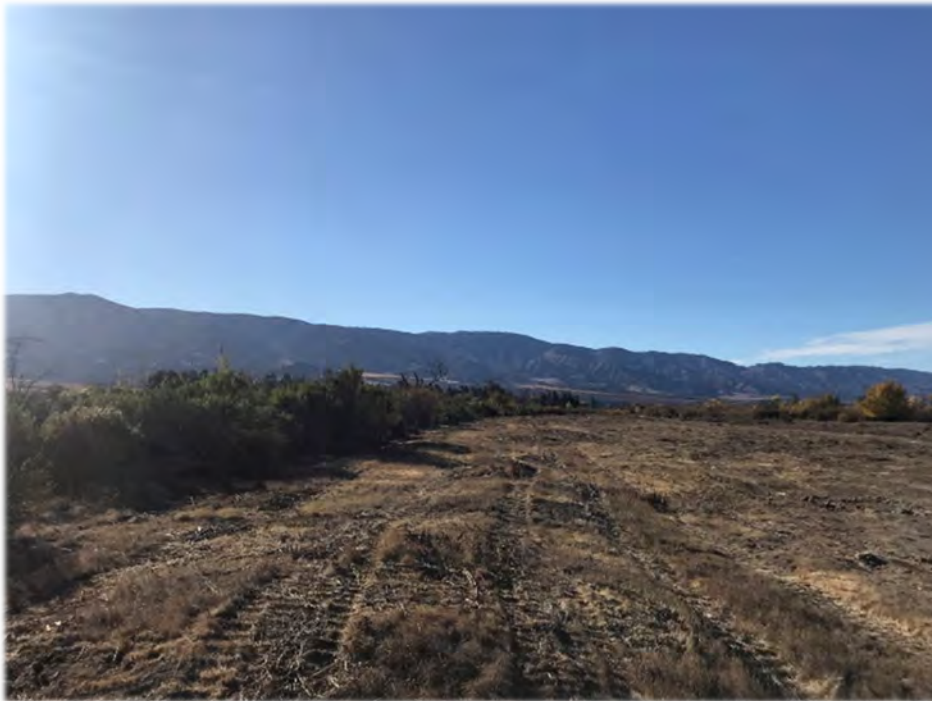
Vegetation Removal

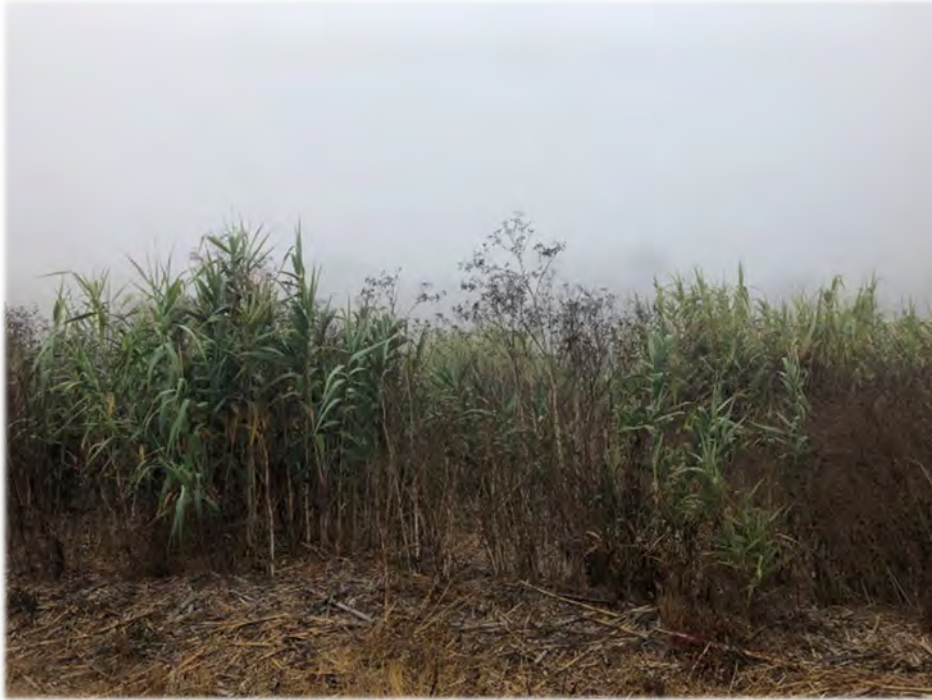
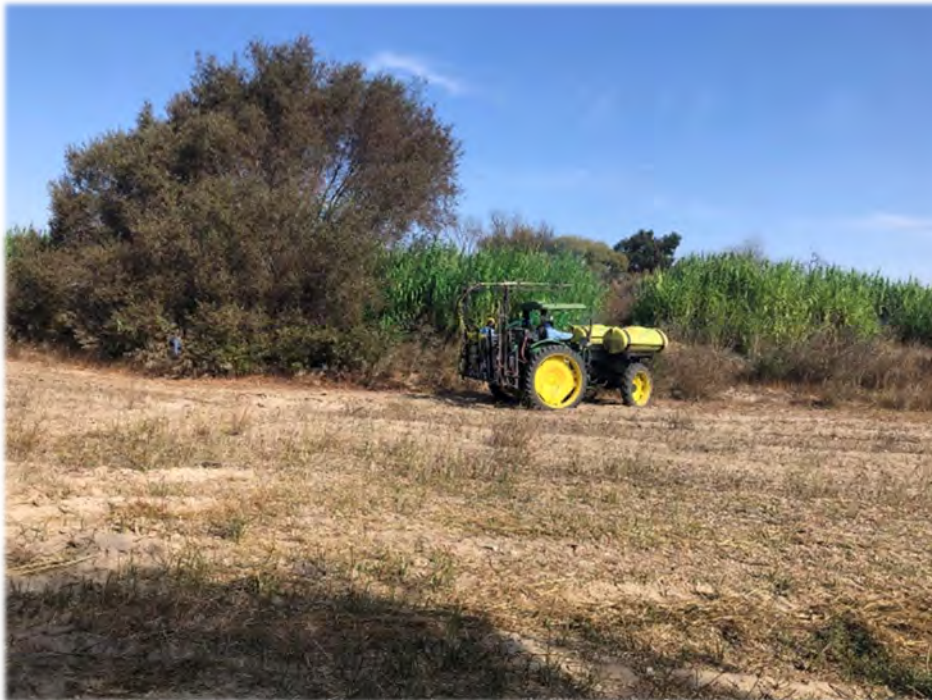
Arundo Treatment

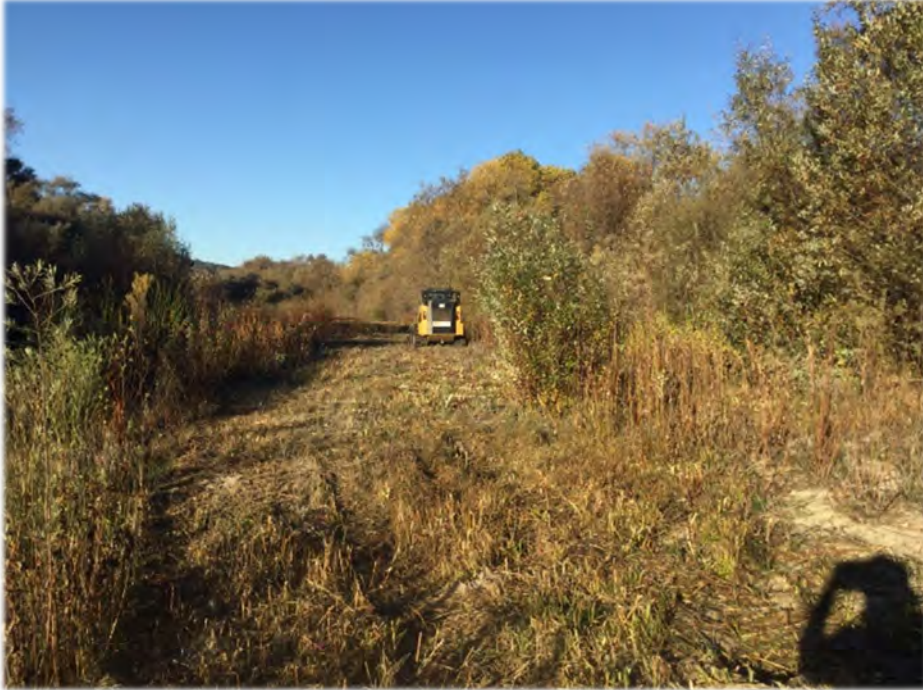
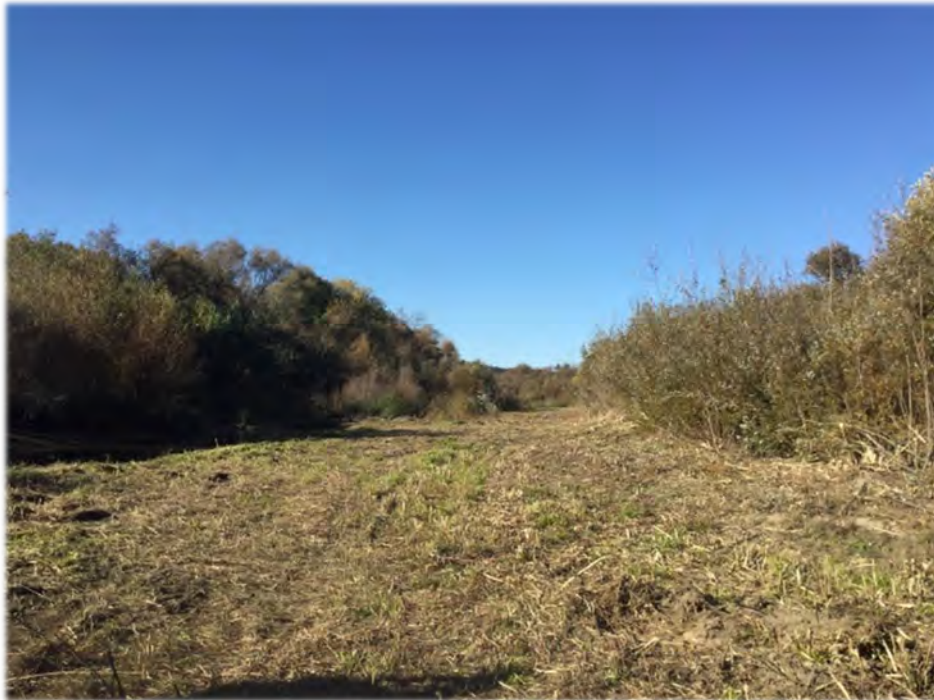
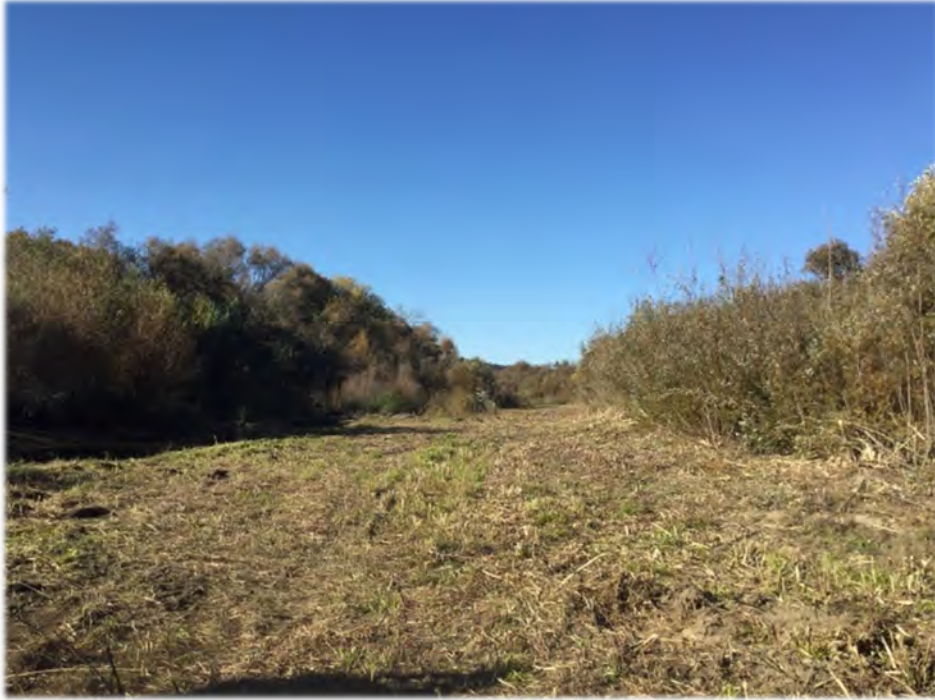
Selective Treatment Area Pre- and Post-work

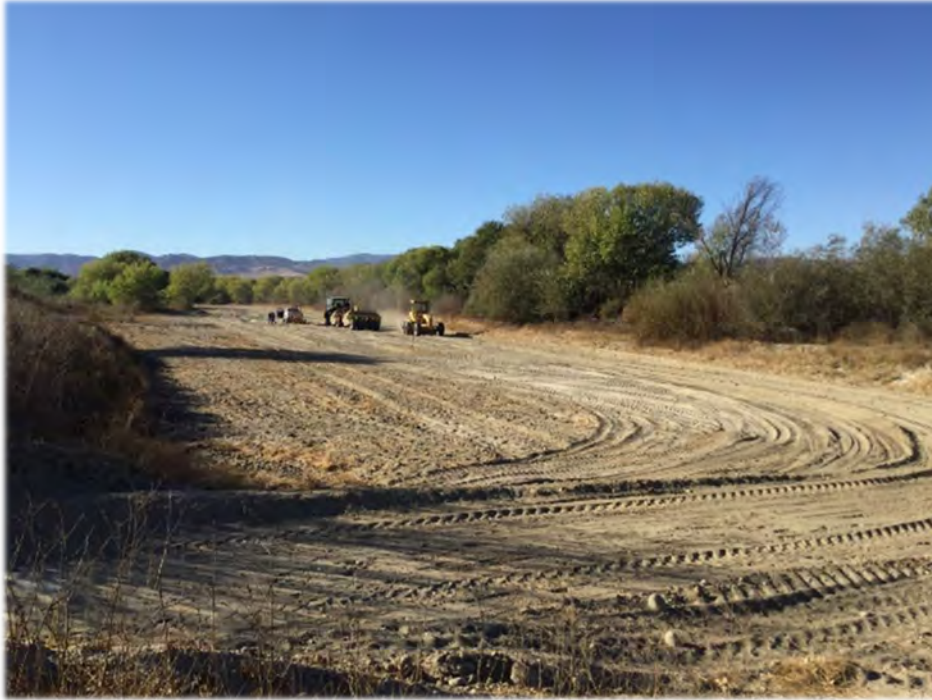
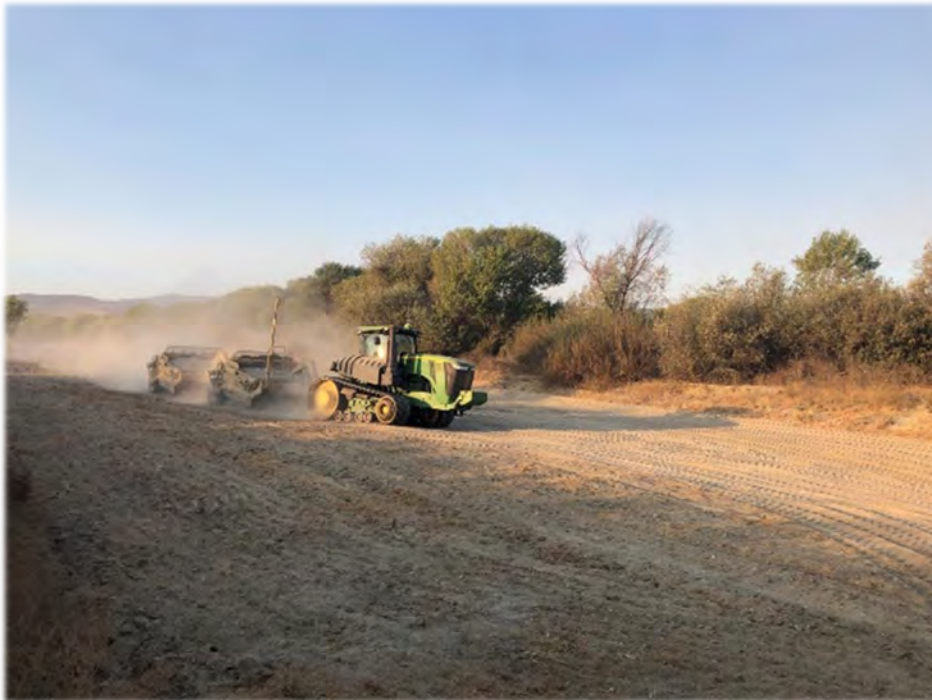
Grading & Sediment Removal
