CONSULTING GEOTECHNICAL & COASTAL ENGINEERS

Subject: Geologic and Coastal Bluff Recession Assessment Report

Reference: 35700 Highway 1, Big Sur, CA 93920
Monterey County APN 418-111-012

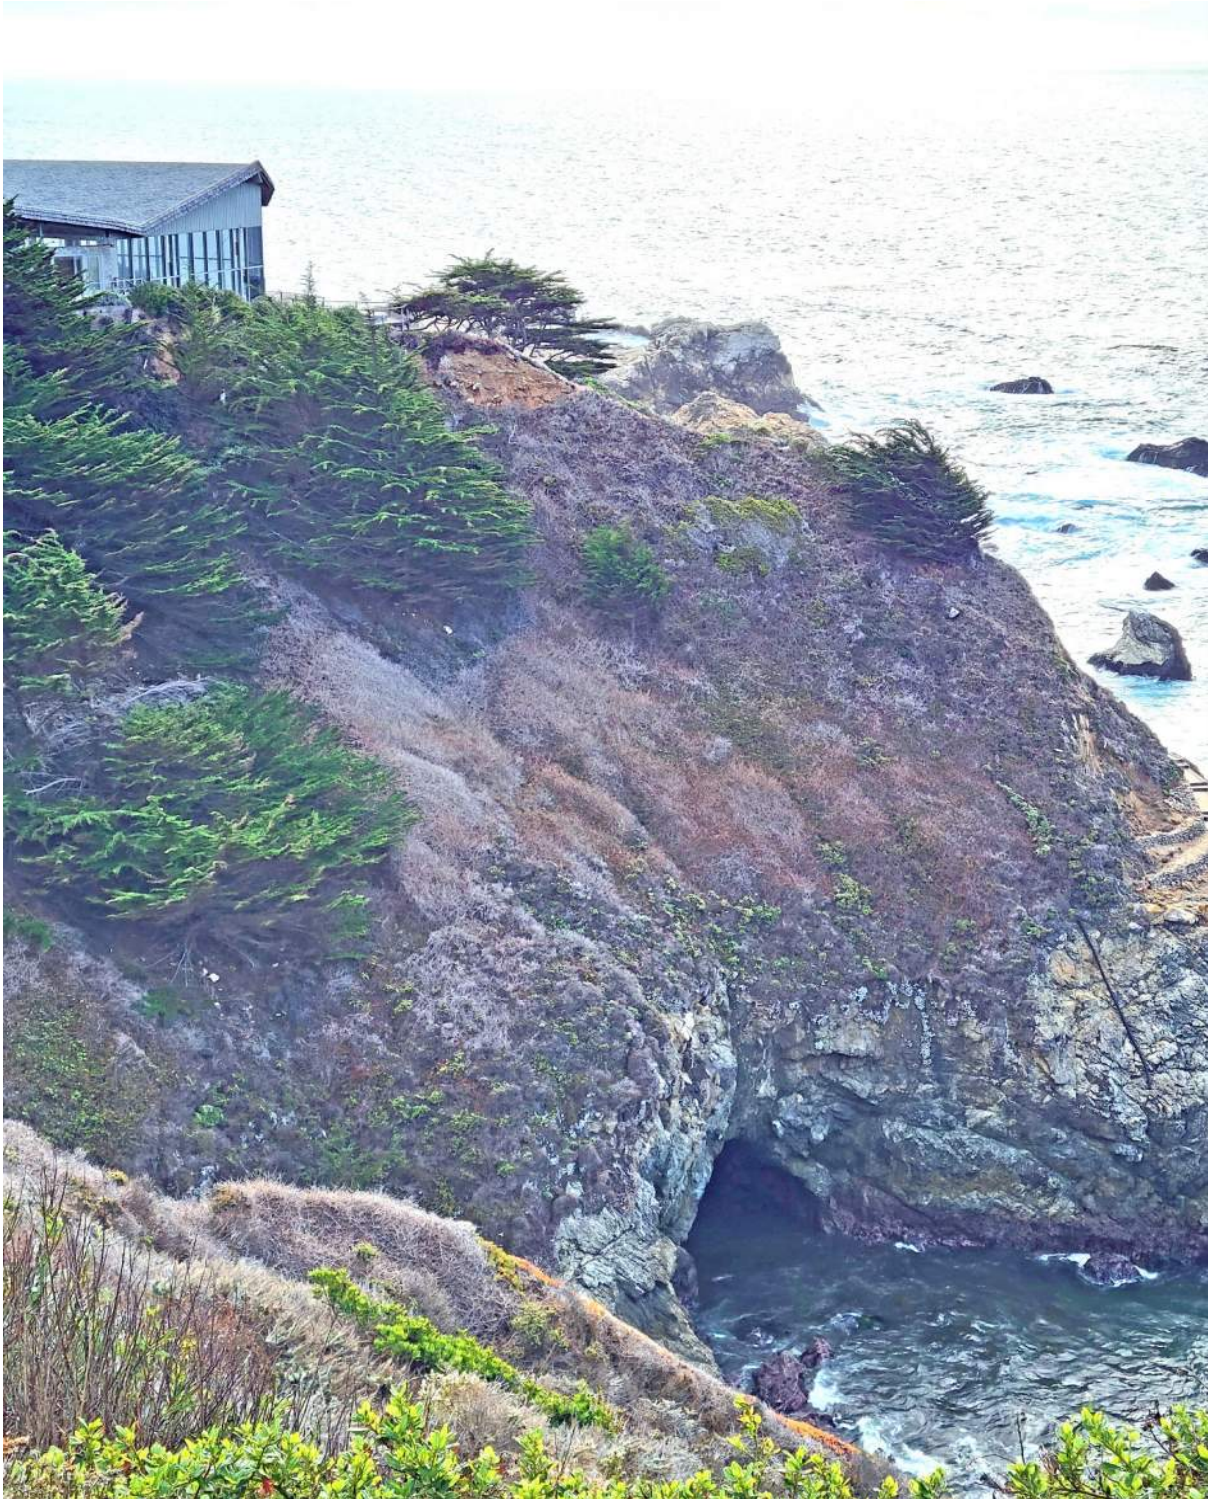
Photograph 3: November 2021 Photograph Looking Downcoast

The geologic conditions at the site are relatively simple, and as seen in the coastal bluff face; with erosion resistant granodiorite bedrock exposed in the bluff up to about an elevation of 50 feet NAVD88 or higher along the bluff. A large seacave exists in the granodiorite in the lowermost portion of the bluff facing the cove to the north. Photograph 3 below shows the bluff in that area and the mouth of the seacave.

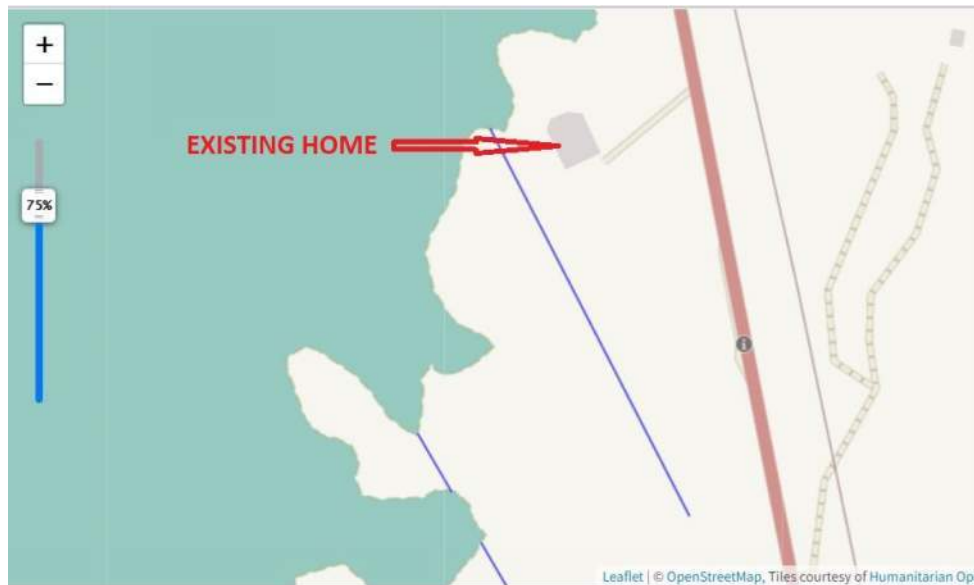
Figure 8: Monterey County GIS Map Showing Site with Local Inactive Fault In Relation to Existing Home at 37600 Highway 1

The published online Monterey County GIS Map (Figure 8) which shows a short discontinuous fault in the immediate vicinity of the property notes that fault as an inferred queried pre-Quaternary age fault mapped by Gary Greene in 1972. This fault does not pose a significant hazard to the existing home or a proposed new home, because based upon it's age it is classified as Inactive. Figure 8 shows this fault:

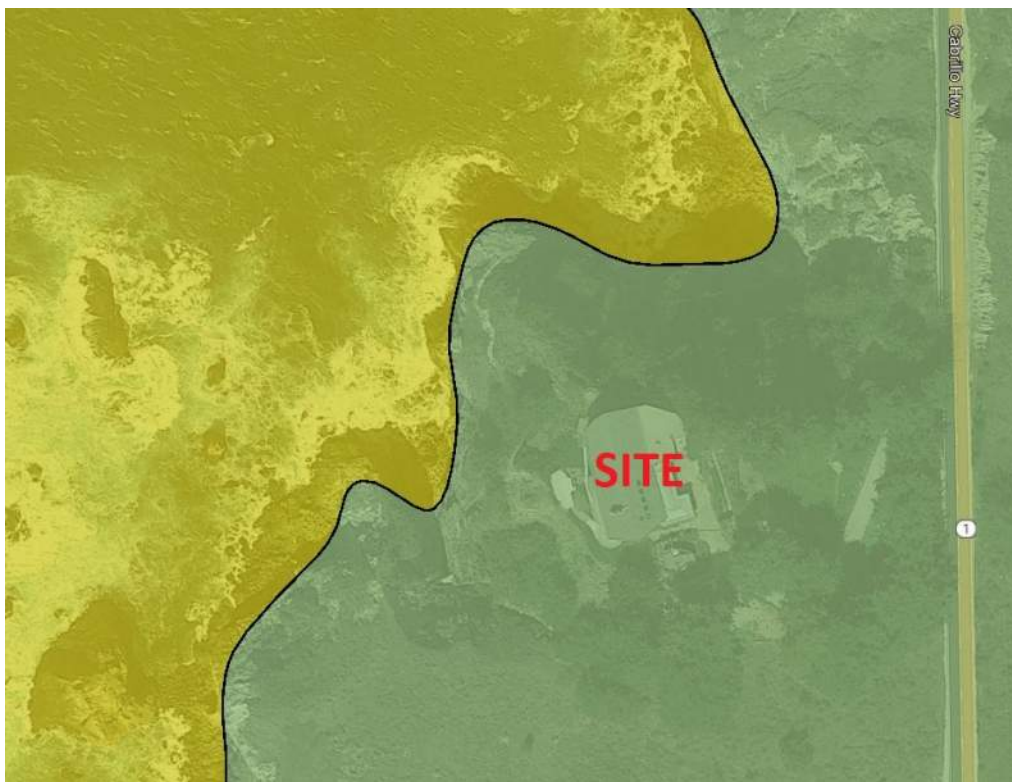
Figure 9: County of Monterey Tsunami Hazard Area Map

We have reviewed the 2021 Monterey County Tsunami Inundation Map for Emergency Planning for the Soberanes Point Quadrangle. This map shows that the line designating the limit of tsunami inundation is near the bluff edge based on comparison with the USGS Topographic Map and the Topographic Survey for the project. A partial copy of that map is shown in Figure 9 below, and shows that the existing home and the area where improvements are proposed is more than 100 feet inland of the hazard (potential inundation) zone. The limit of the mapped tsunami inundation appears to be 50 feet or more in elevation below the existing home.

5. Tsunami hazards at the property are low, based on the Monterey County Tsunami inundation Map dated March 2021 prepared by the California Geological Survey.

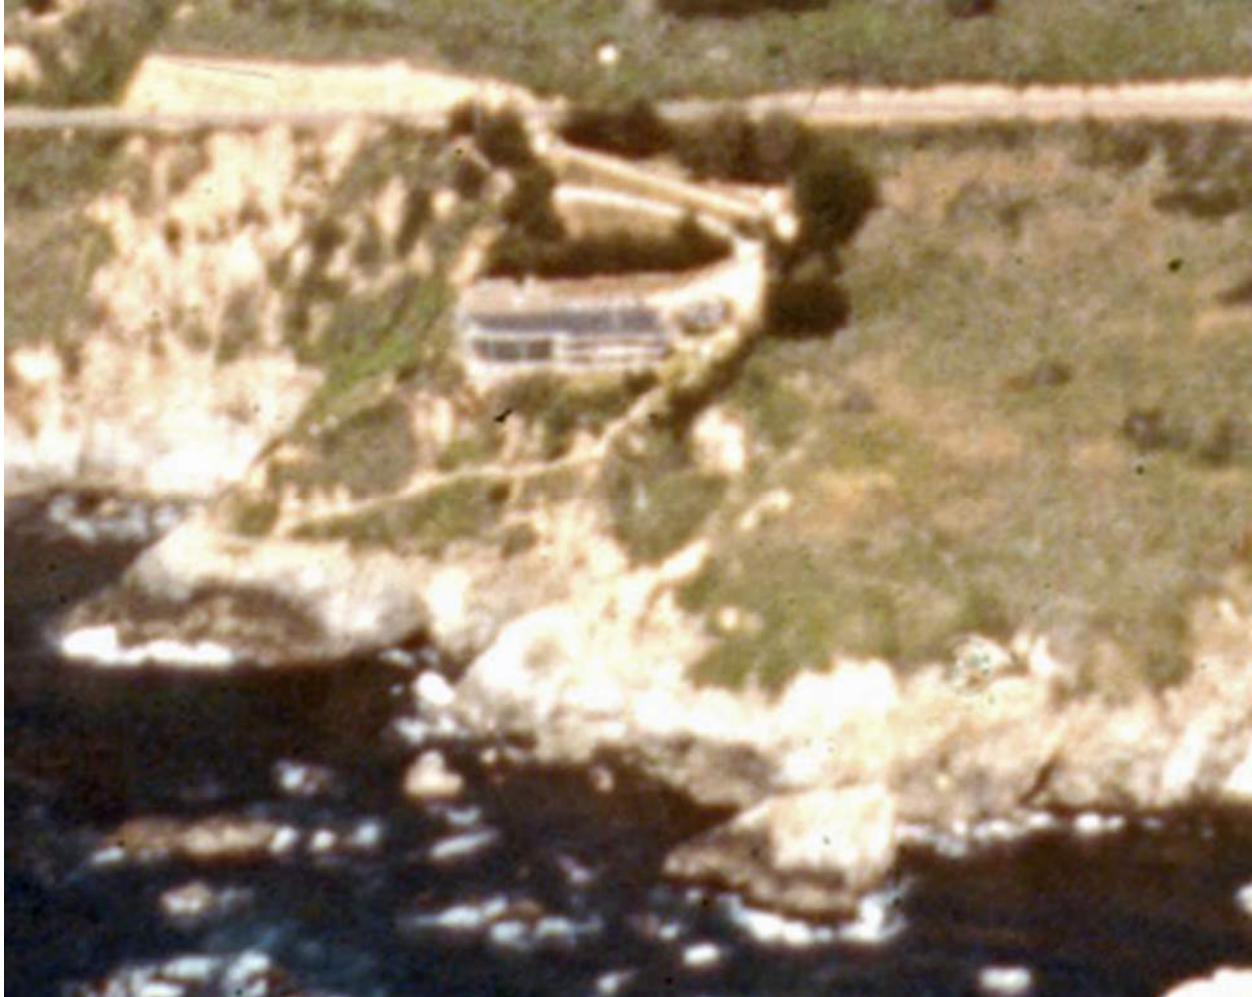
Photograph 15: Aerial Photograph from 1972
(courtesy of www.californiacoastline.org)

The 1972 photograph below shows the homesite in its pre-development condition.

Using the high end of the average annual terrace deposit erosion rates that appear to have historically occurred on the property since 1972 (50 years) would suggest that about 4 feet of debris fan deposit erosion could cause 4 feet of recession of the bluff edge from surficial erosion could occur at the subject property in the next 50 years.

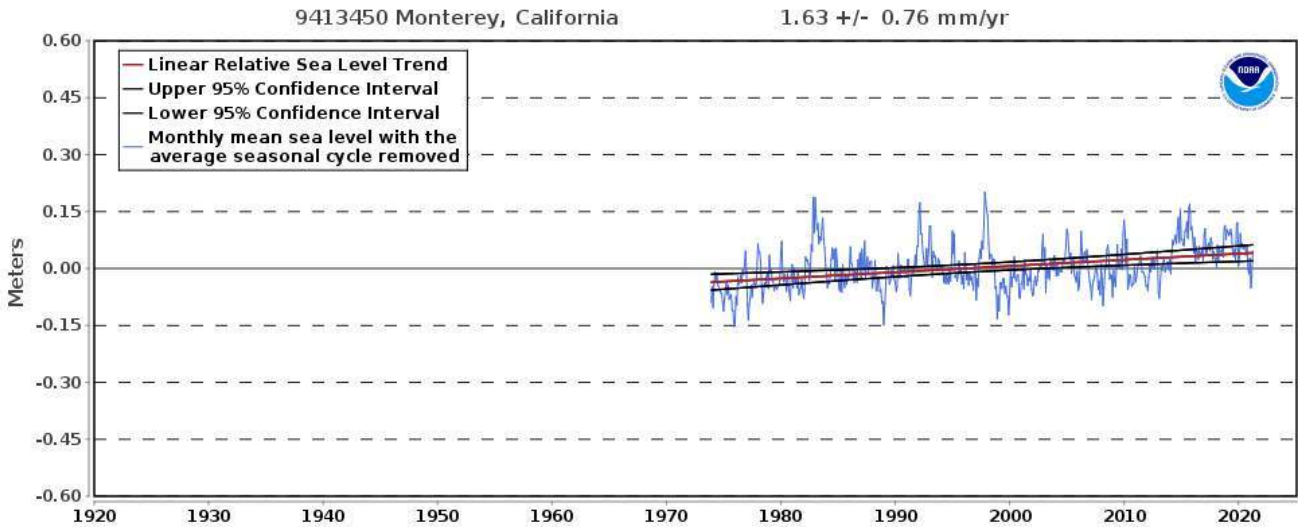
Figure 6: Sea Level Rise at Monterey Tide Gauge 1973-2021

This indicates that the coastline at Monterey is undergoing uplift, which significantly lessens the overall impact of sea-level rise in this area. We note that the actual measured sea level rise at Monterey in the 21 years since 2000 is only about 0.12 feet. This suggests it is highly unlikely that 0.3 to 0.5 feet of sea level rise will occur between 2000 and 2030 as indicated in the Low Risk Aversion scenario presented in Table 2 suggesting that the probabilistic projections of future sea level rise Table 2 are very conservative for the Pebble Beach area, including this site.
