LOT-SPECIFIC FUEL MANAGEMENT PLAN

DECEMBER 5, 2022

LOT 119 FUEL MANAGEMENT PLAN

21 EAST PRONGHORN RUN; APN 239-091-044

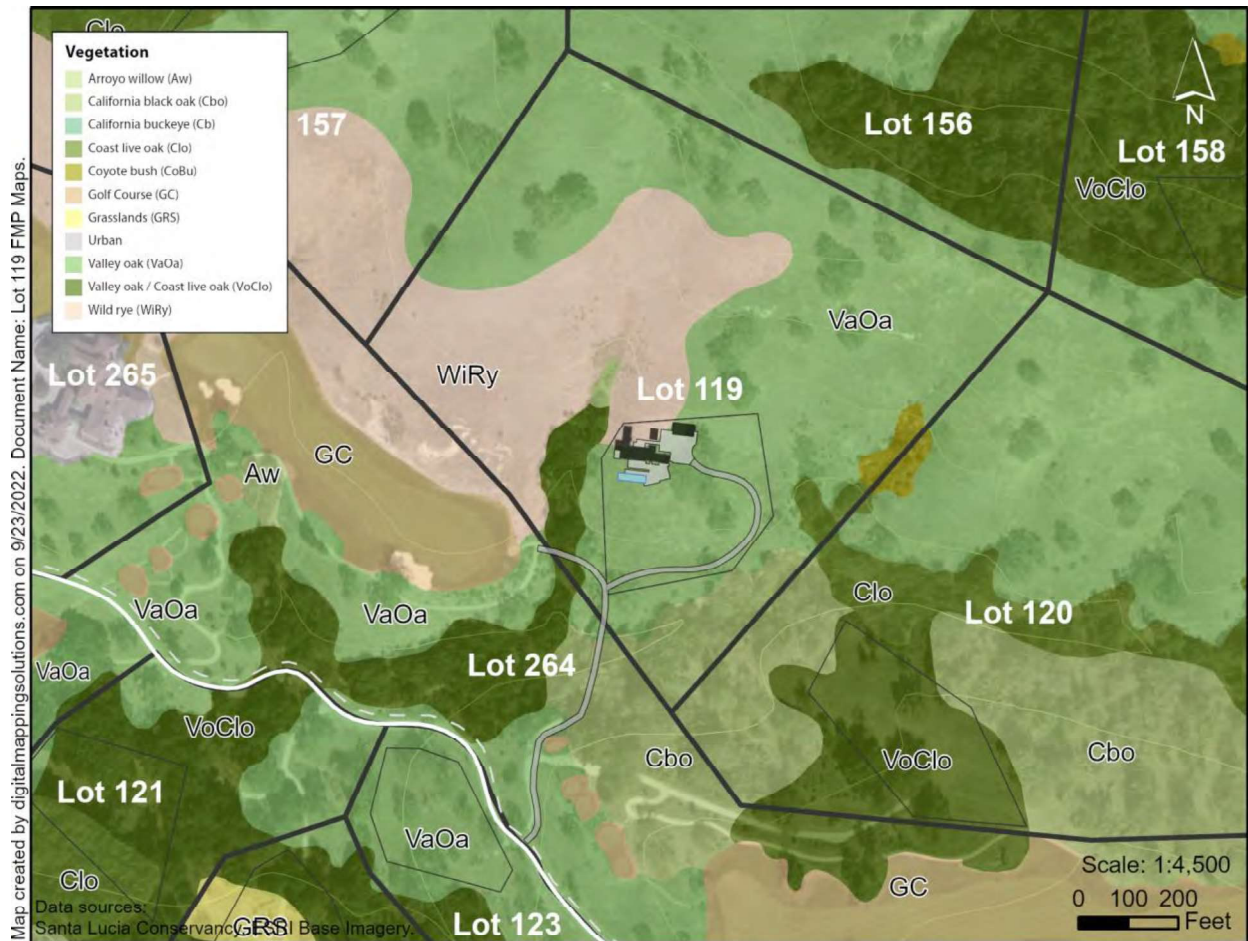
FIGURE 5. VEGETATION MAP OF LOT 119.

During the site visit, the grasses appeared to have been mowed recently in the Valley oak (VaOa) savannah zones within the Homeland perimeter. Low hanging oak branches appear to have been pruned in the past but will need to be pruned again, and the understory mowed seasonally, according to prescriptions below.

General observations of the vegetation on Lot 119 include the following: (1) there is an overabundance of vegetation (and dense ladder fuels) in the understory of the Valley oak/ Coast live oak (VoClo) woodland area between the planned structures and the Golf Course (GC); (2) There is an overabundance of ladder fuels and tall grasses along the shared driveway. Coordination with the owner of the adjacent Lot 264 (the Golf Course), which share the majority of the driveway, will be necessary in order to appropriately treat the fuels and provide for safe ingress and egress for civilian and emergency vehicles; (3) Densely growing ladder fuels are growing in direct contact with the wooden bridge within the area designated as containing Sensitive Resources - Riparian (See Figure 6 for details); (4) Invasion of Coyote Bush (CoBu) is more extensive than indicated in the maps above, particularly in the Valley oak (VaOa) and Wild rye (WiRy) areas. Consult the Santa Lucia Conservancy and coordinate with the owner(s) of the Golf Course in order to have an Openlands Management Plan (a free service) created in order to address these issues.

Further guidance on managing excess fuel loads and recommended measures to be taken to protect the planned structures are outlined below.

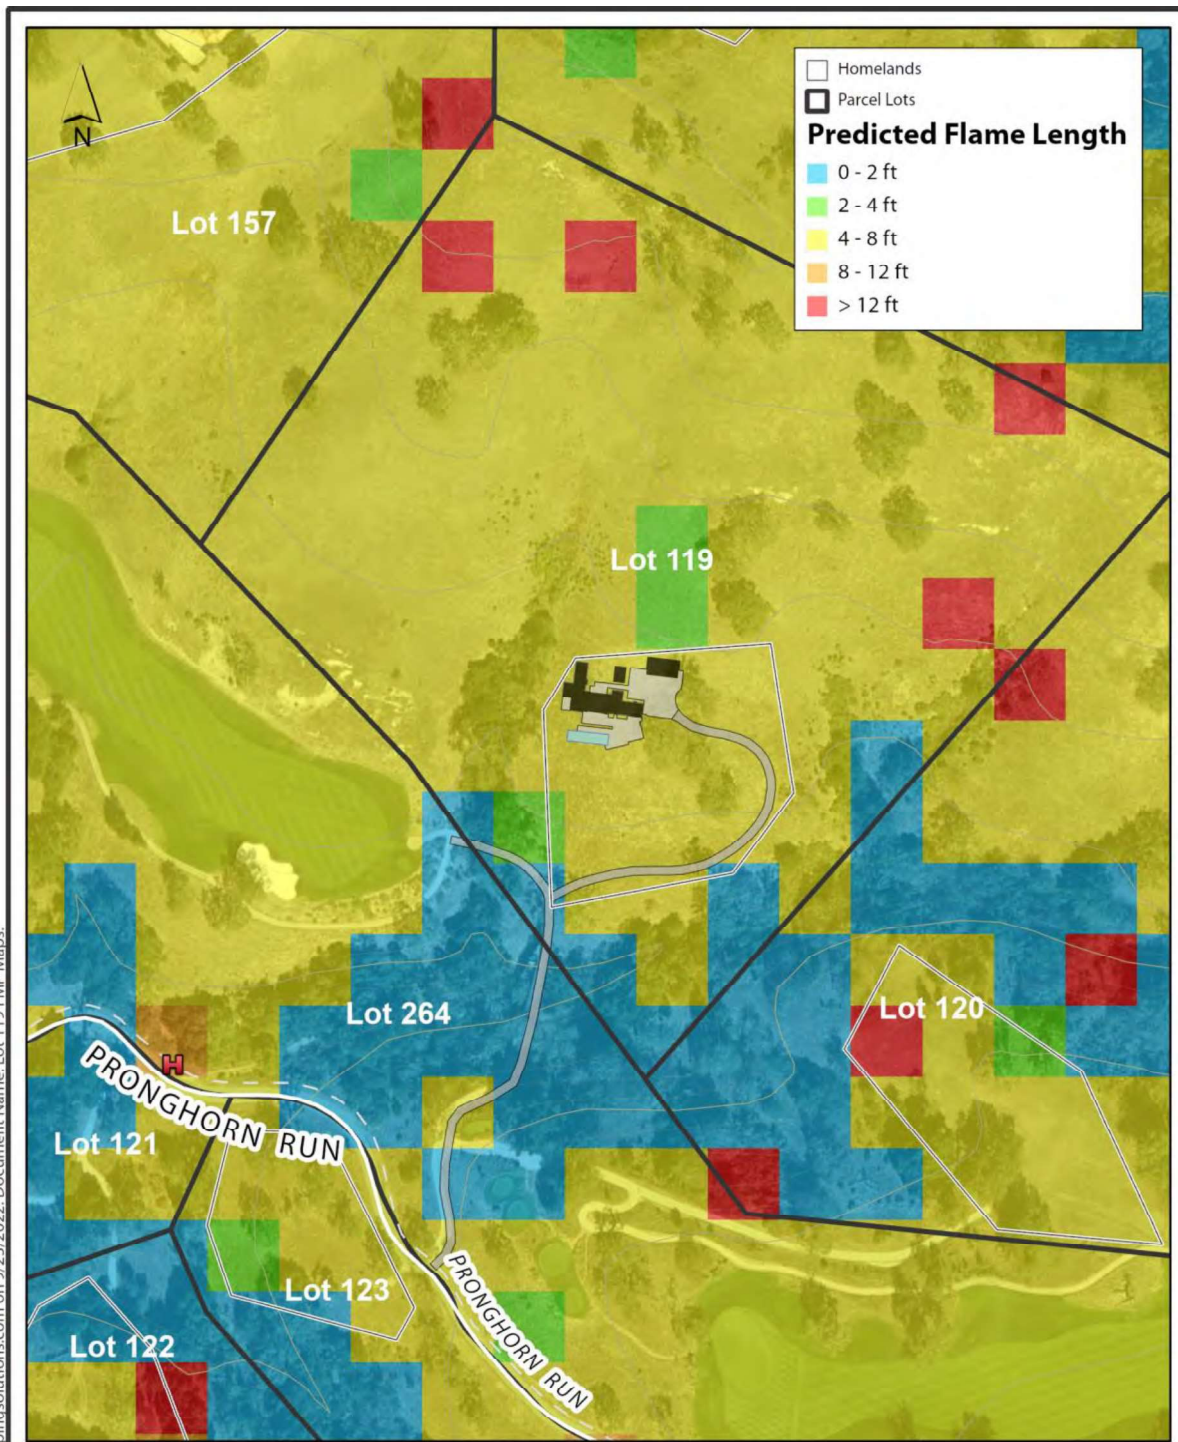
Predicted Flame Lengths

Fire behavior modeling indicates under current conditions, a wildfire on the property would burn fairly low with pockets of greater fire intensity. Flame lengths are generally under 8 feet throughout the oak savannah and grassland portions of the lot. Flame lengths at the entrance of the lot are expected to be under 2 feet, however taller flame lengths (4-8 feet) are mapped along the driveway and around the planned structures.

A worst-case fire scenario would be a fast-moving wildfire moving uphill through the property from the south (i.e. originating along the shared access road), aided by strong winds, which normally occur in the afternoon. The structures could be threatened as fire moves up slope especially quickly when aided by wind and receptive fuels such as dry grasses and shrubby ladder fuels. Another worst-case scenario would involve the narrow driveway, particularly the bridge, becoming compromised by a fast-moving wildfire, impeding emergency ingress by fire-fighting personnel or emergency egress for the residents. Proper fuel maintenance in these areas and as described below will reduce these scenarios.
