Natividad Medical Center Facility Assessment Report

*Prepared by Kitchell
For*

County of Monterey, California

December 9, 2015
Job No. 4983A3

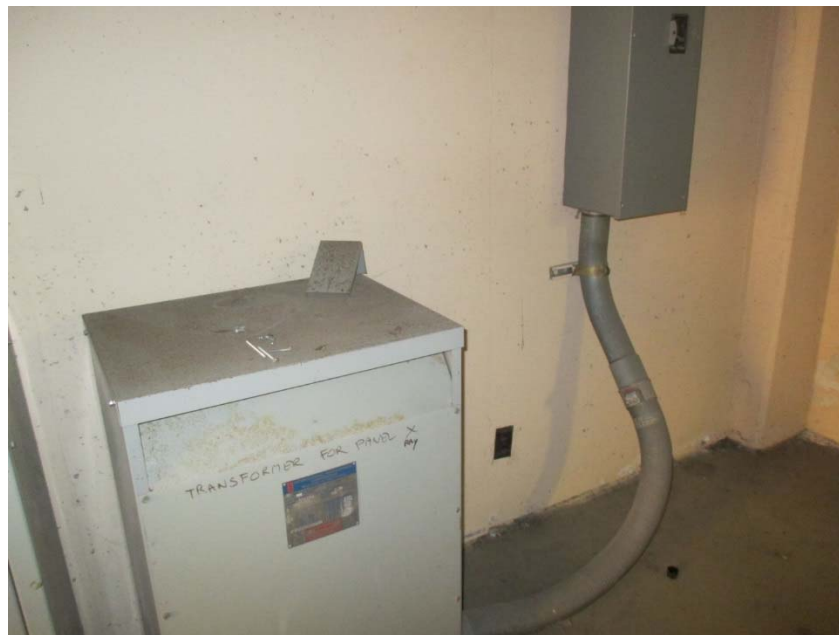
All transformers are past their expected useful lives.

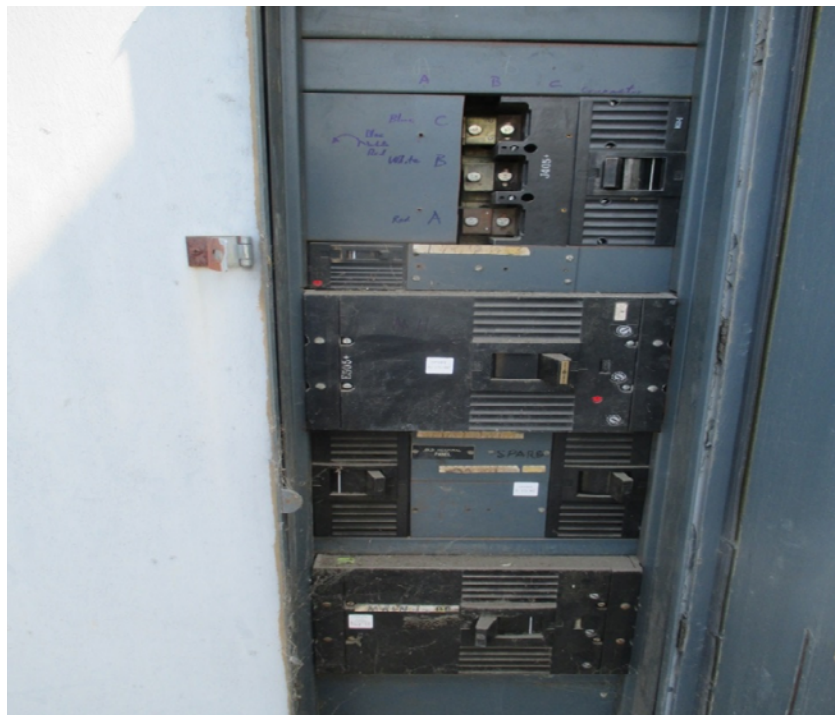
All wall recessed panels are approaching the end of their expected useful lives.

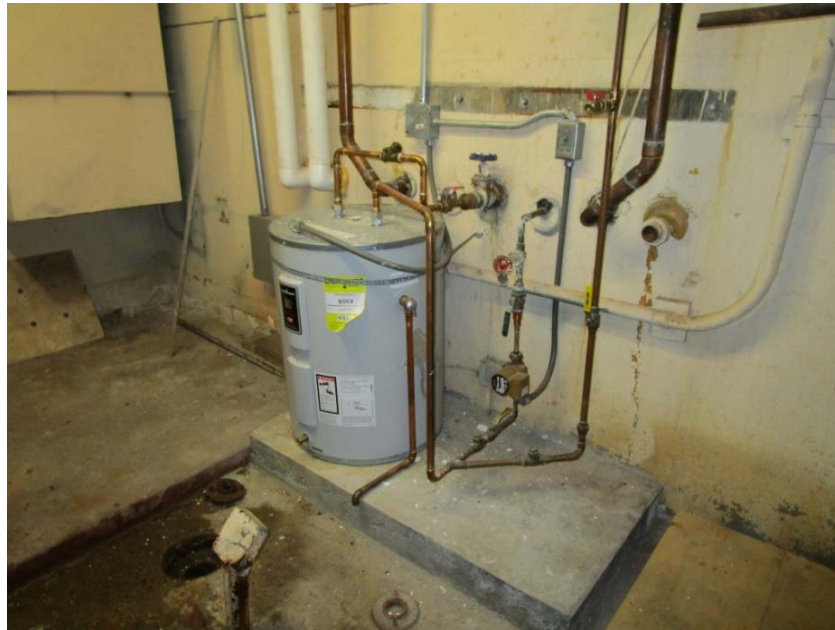
Plumbing system and plumbing fixtures are at the end of their expected useful lives.

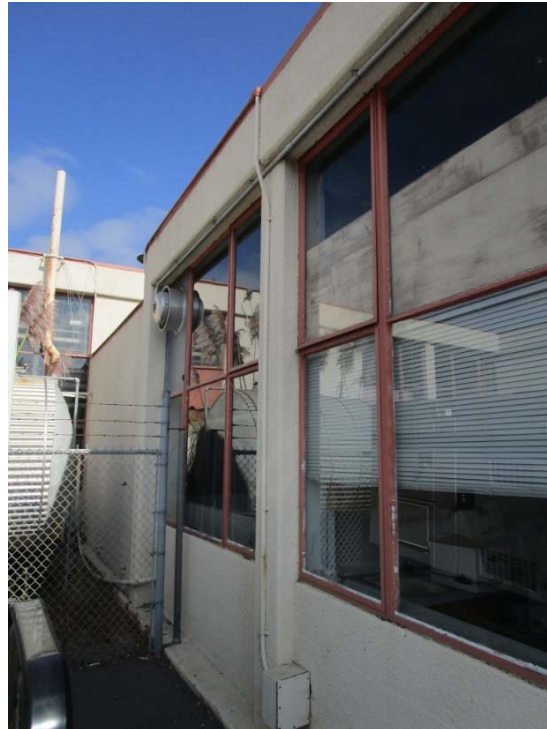
Ceiling exhaust fan is at the end of its expected useful life.

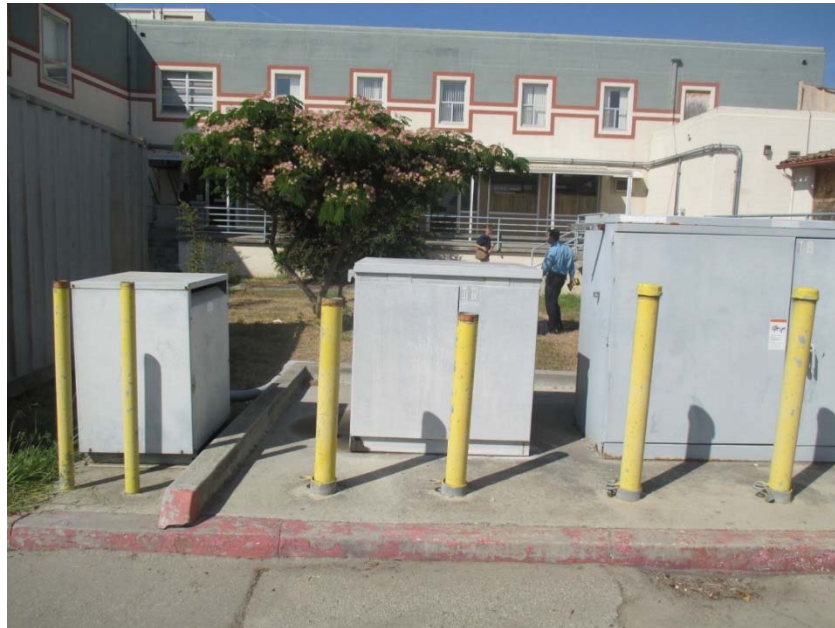
All panels are past their expected useful lives.

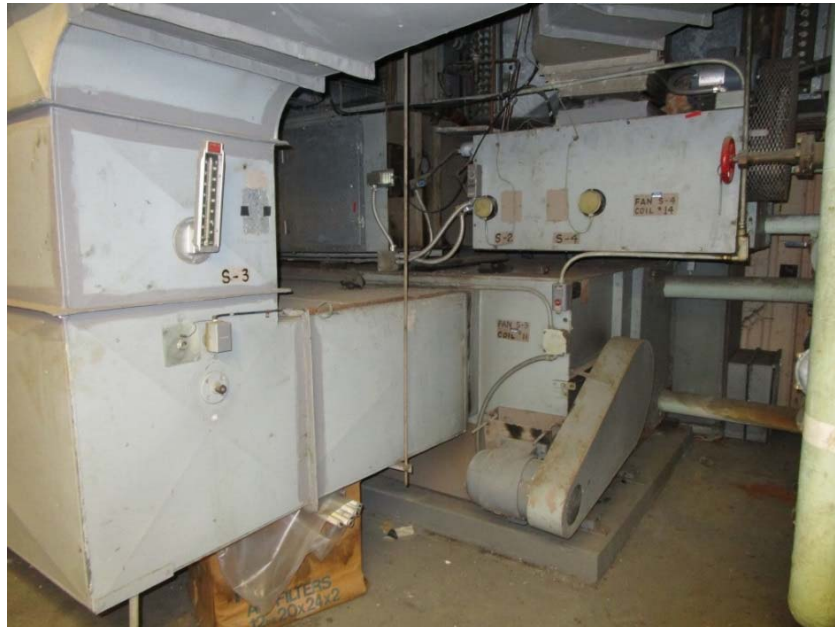
Heating hot water fan coil unit is at the end of its expected useful life.

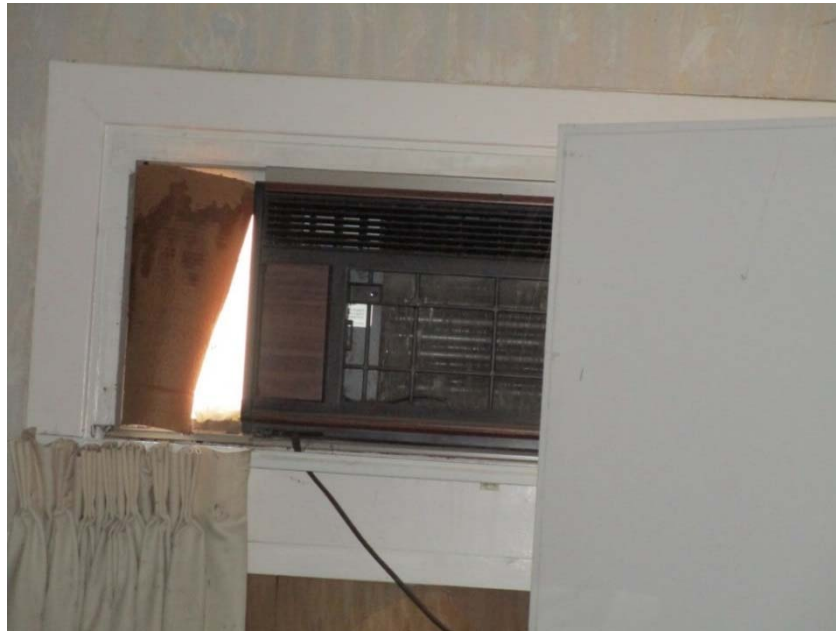
Window mounted AC unit is at the end of its expected useful life.

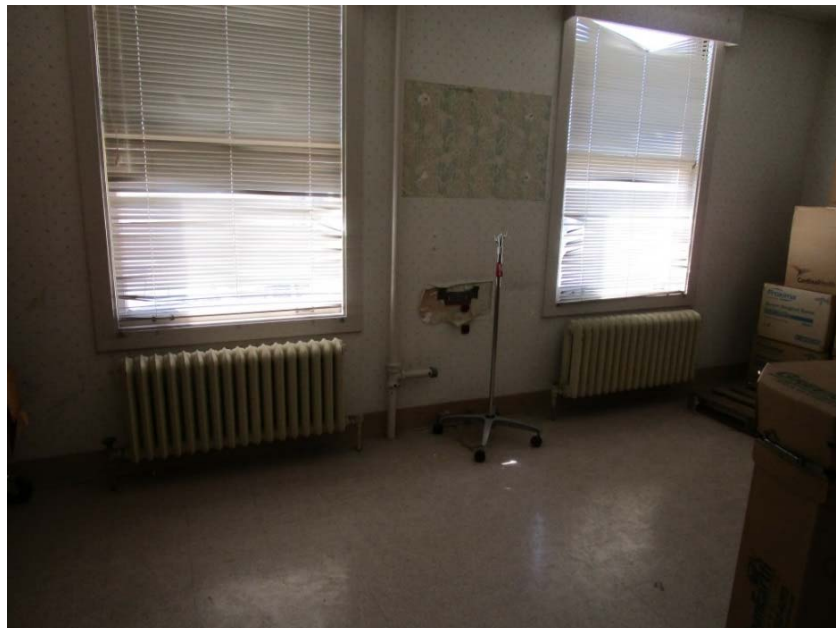
Radiant wall heaters are at the end of their expected useful lives.

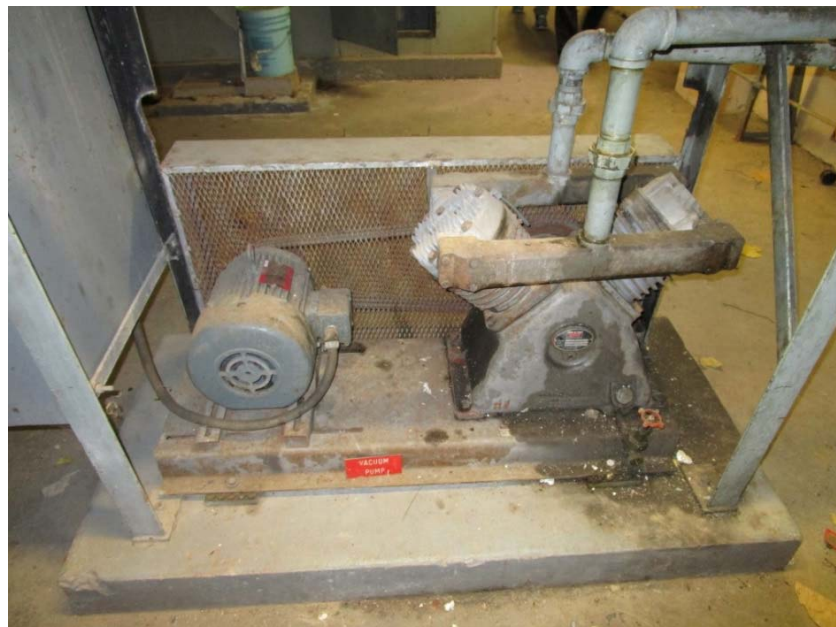
Vacuum pump system is at the end of its expected useful life.

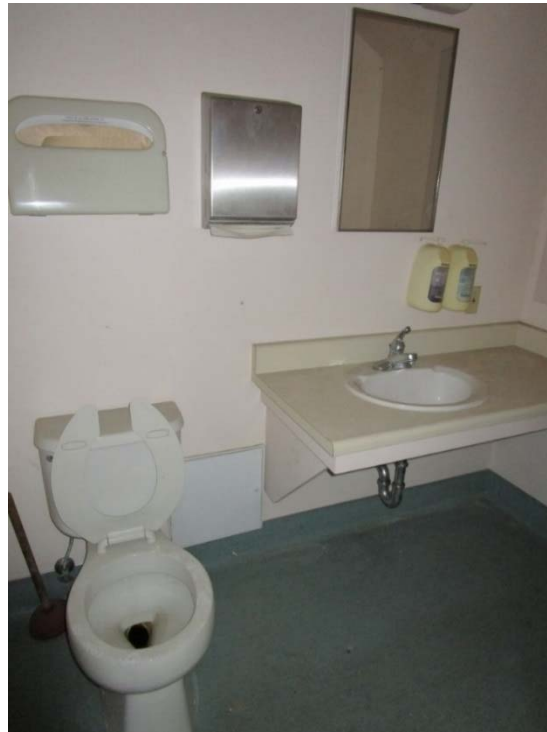
Plumbing system and plumbing fixtures are at the end of their expected useful lives.

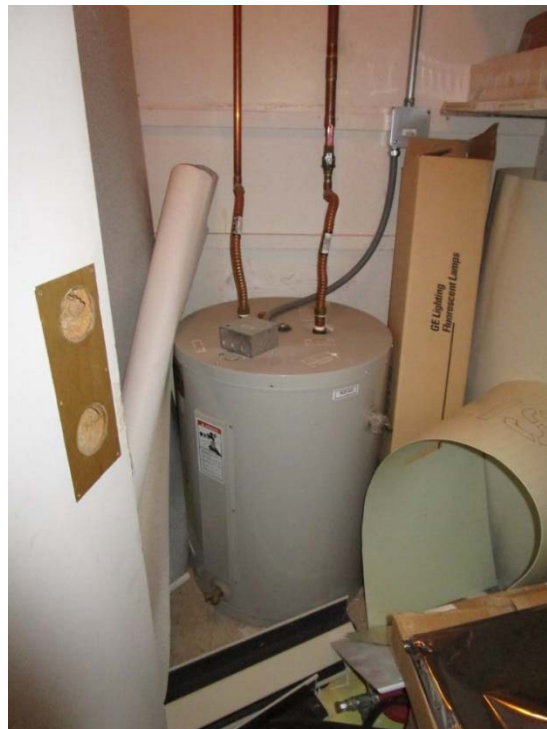
Electric water heater is at the end of its expected useful life.

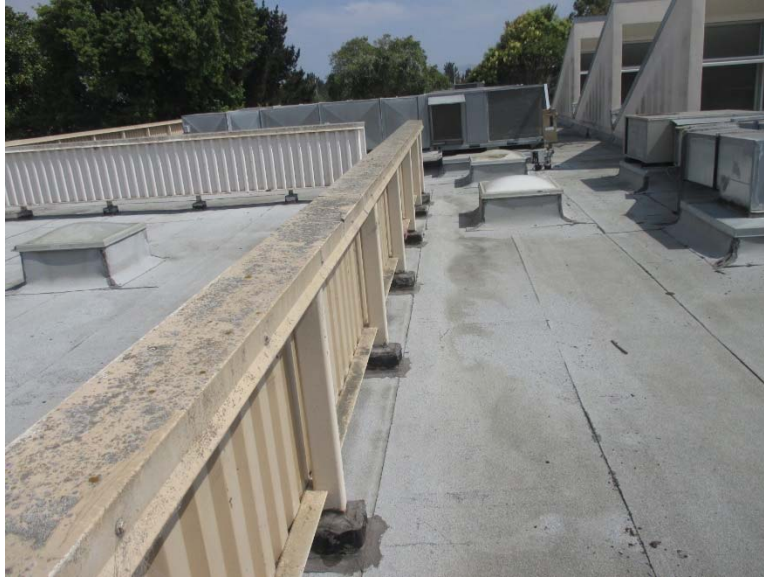
The existing landscaping surrounding the structure has been maintained and is in fair condition. The existing concrete and asphalt surrounding the building appear to be in fair condition. There is a metal screen wall surrounding a portion of the building which is worn and requires some maintenance and paint.

Rooftop mechanical screen is worn

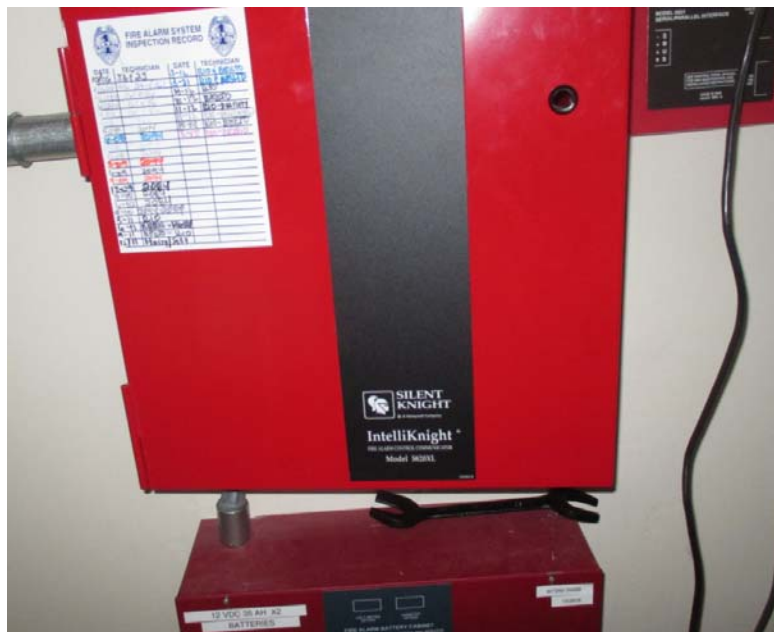
The fire alarm is past its expected useful life.

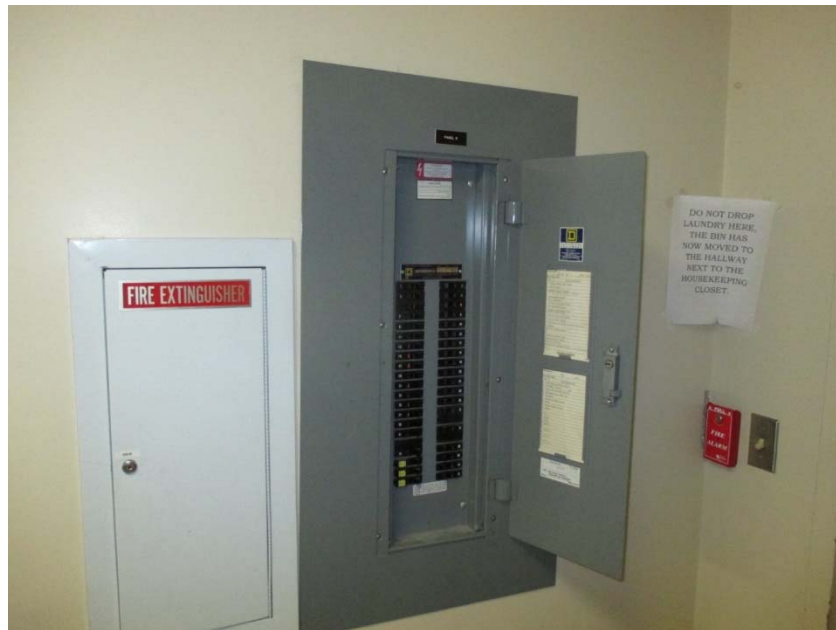
All panels are past their expected useful life.

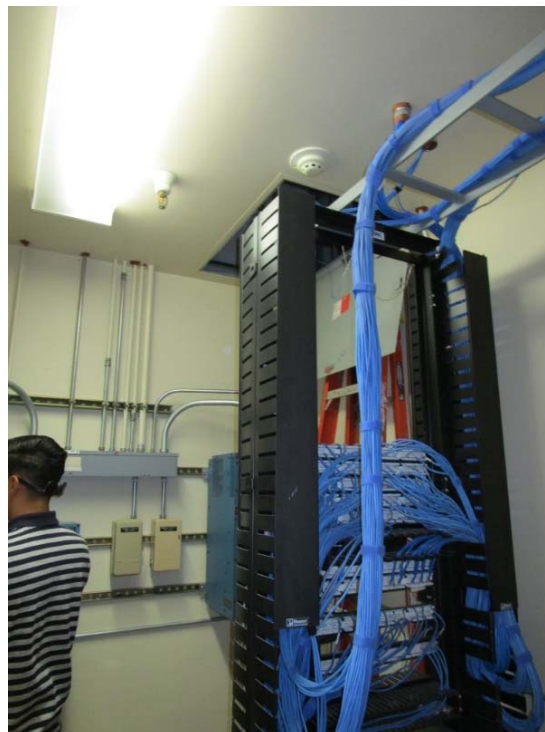
The Data Room contains data equipment and gets very warm. Recommend installing a new split ductless HVAC system in this room to maintain proper room temperature.

The Data Room contains data equipment and gets very warm. Recommend installing a new split ductless HVAC system in this room to maintain proper room temperature.

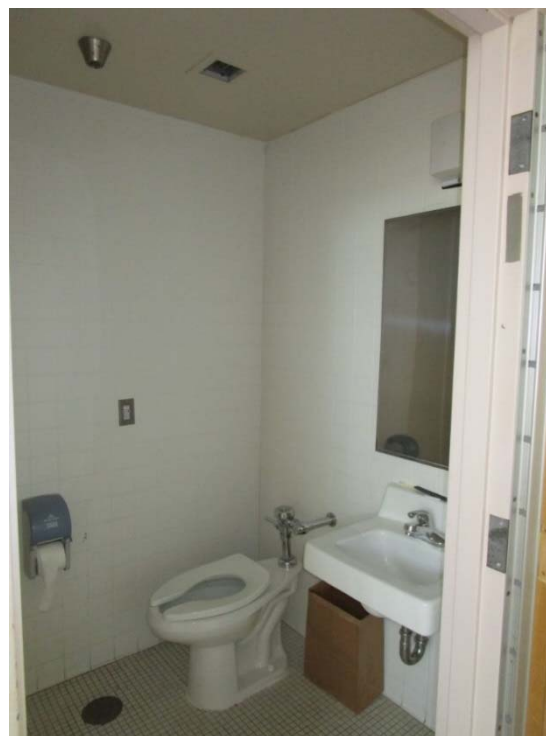
and no issue was noted nor reported by the maintenance personnel. However, the plumbing system and plumbing fixtures are at the end of their expected useful lives and will need to be replaced.

The plumbing system and plumbing fixtures are at the end of their expected useful lives.

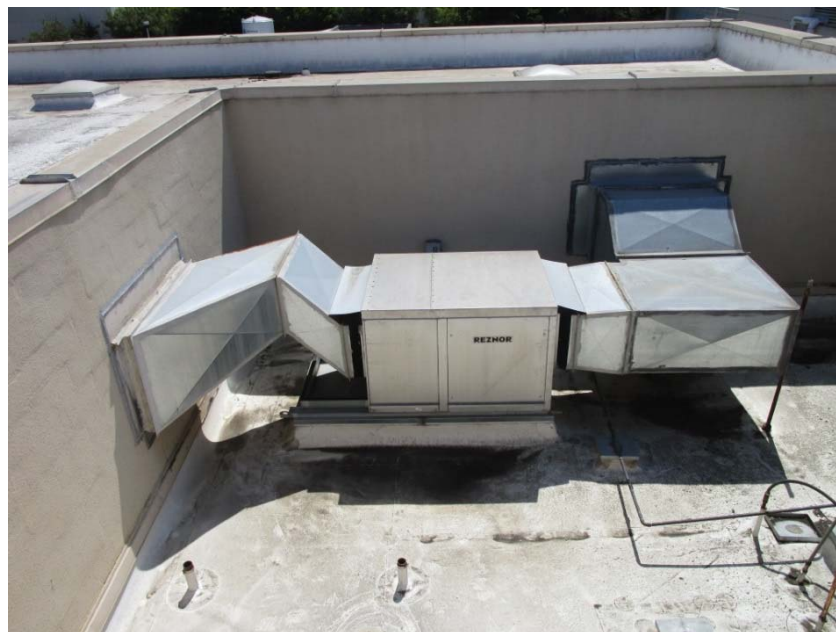
Rooftop heating and ventilation unit is at the end of its expected useful life.

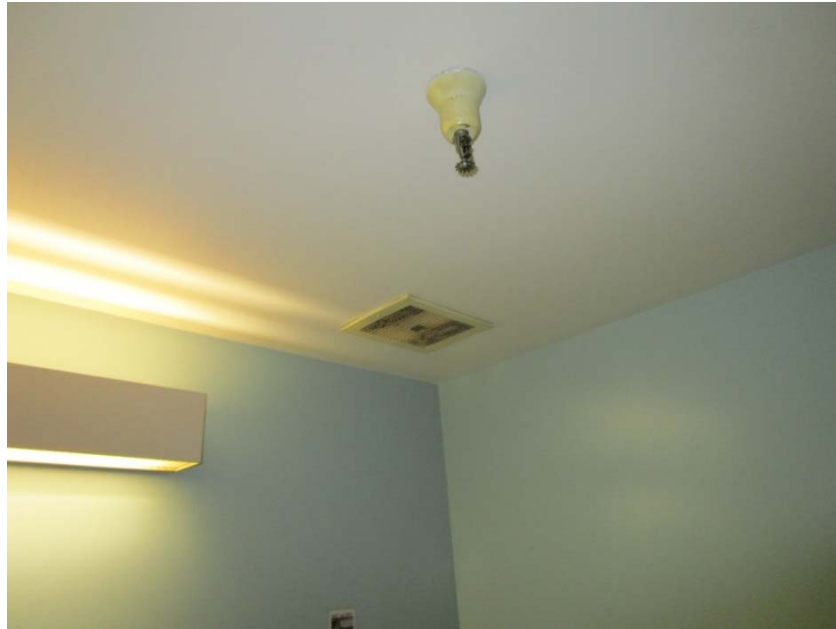
Ceiling exhaust fan is at the end of its expected useful life.

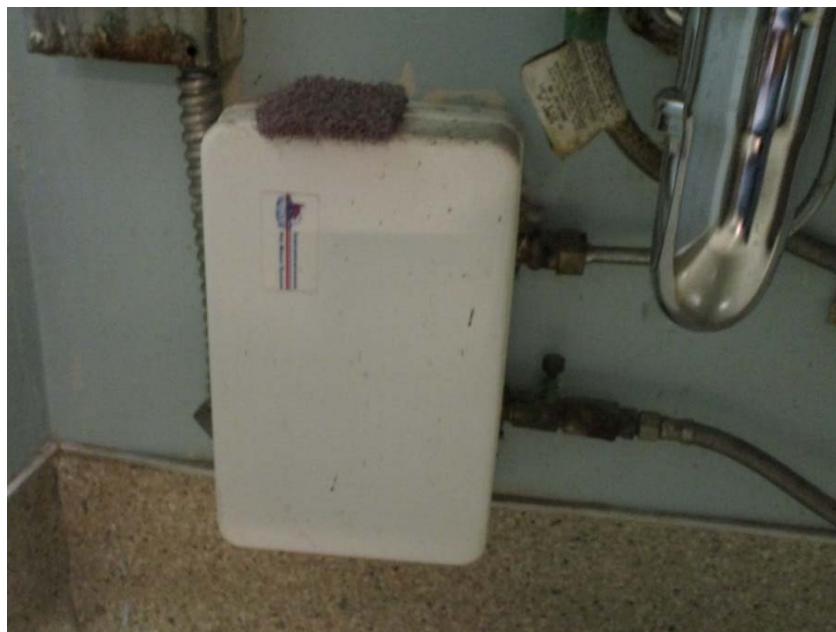
Electric instantaneous water heater is at the end of its expected useful life.

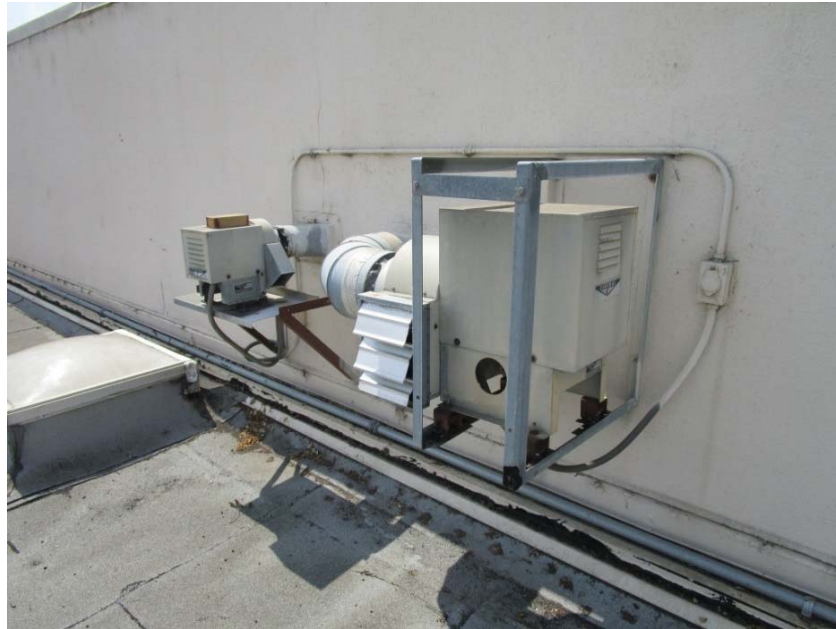
Utility exhaust fan is at the end of its expected useful life.

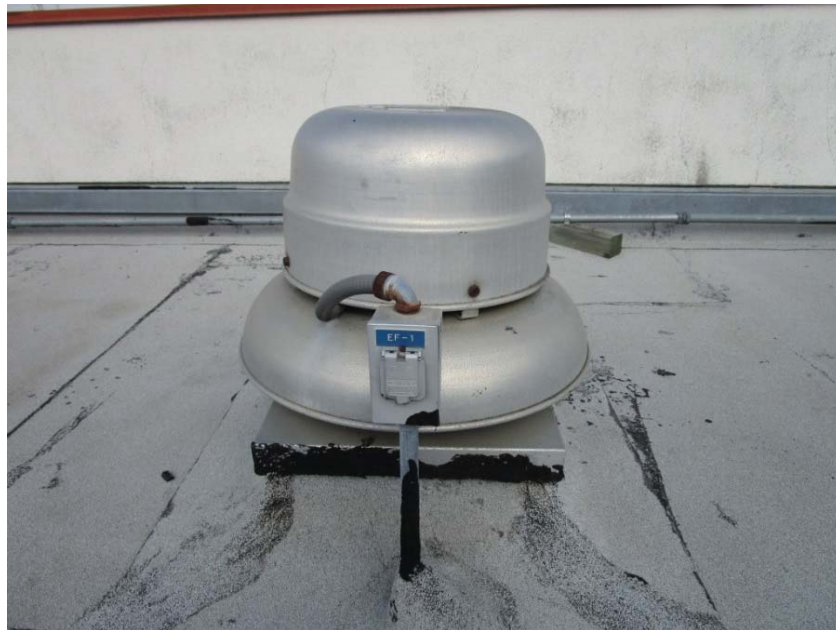
Rooftop exhaust fan is at the end of its expected useful life.

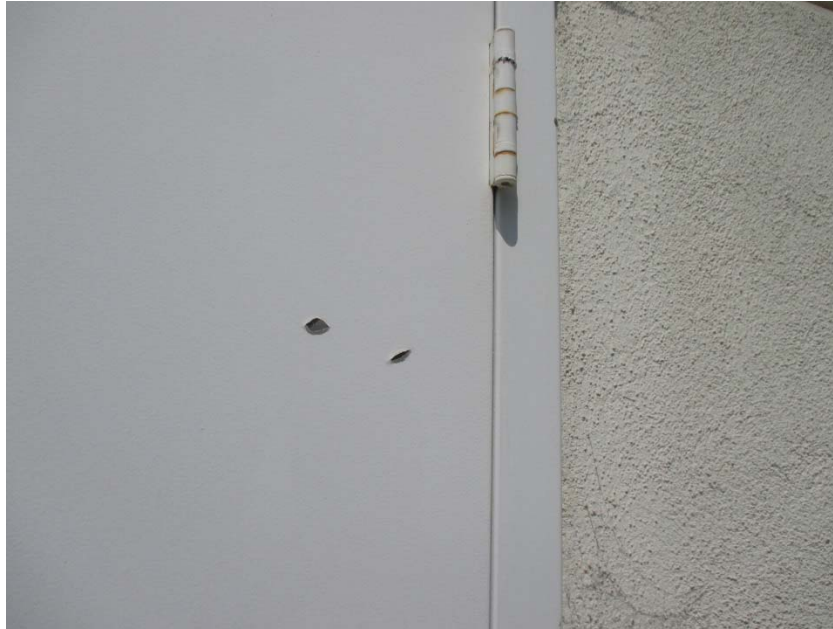
Exterior door needs paint

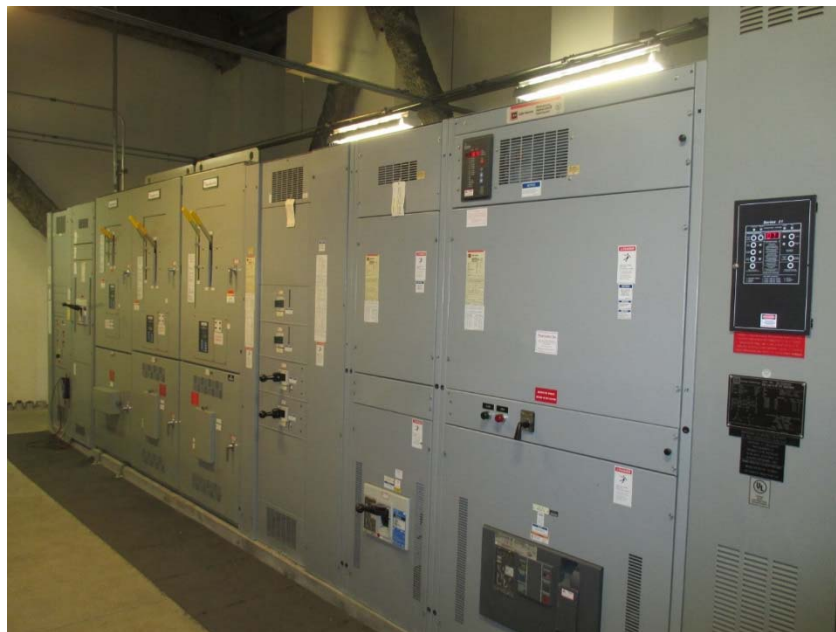
The main switchboards have reached the end of their expected useful lives.

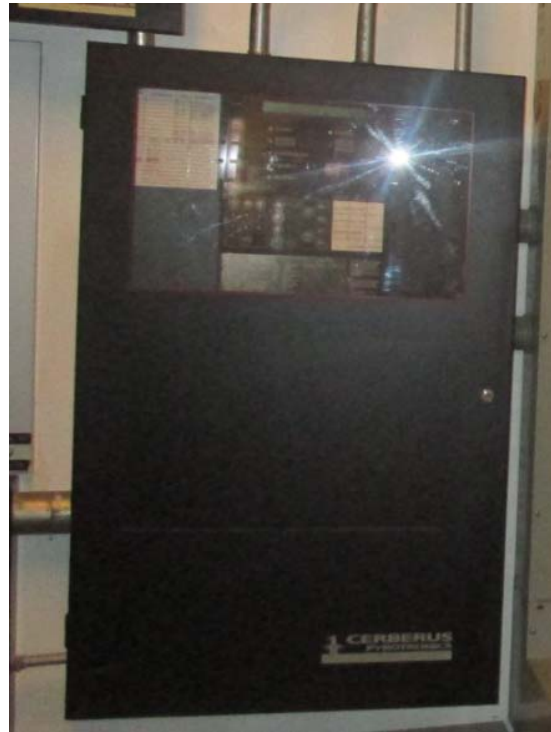
The fire alarm has reached the end of their expected useful lives.

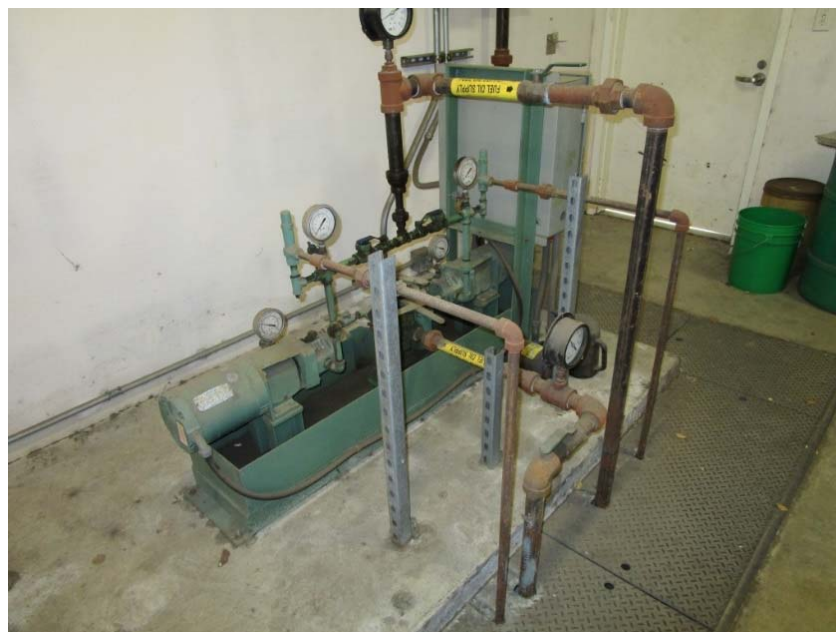
Booster pump controller system for the diesel fuel daytank is at the end of its expected useful life.

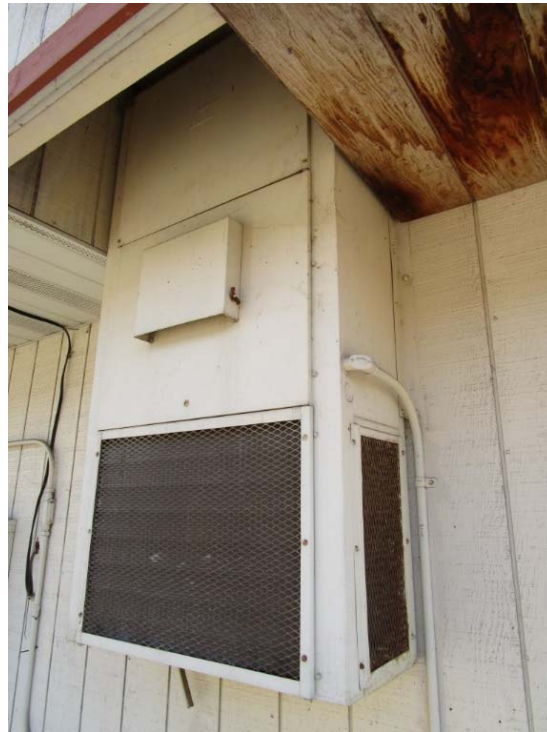
Buildings 820 and 870 Bard wall mounted AC units are at the end of their expected useful lives.

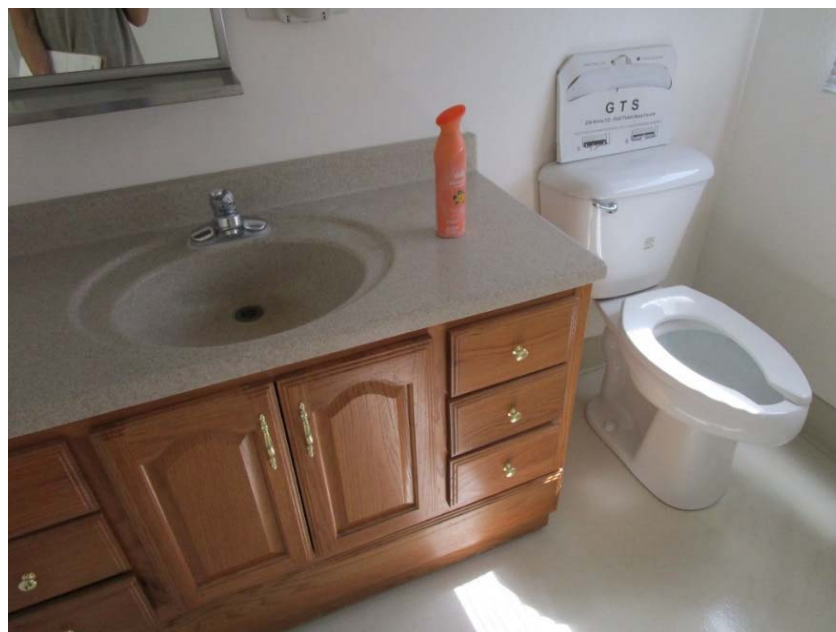
Building 820 currently no means of ventilation in the restroom. A ceiling exhaust fan will need to be installed to maintain proper ventilation.

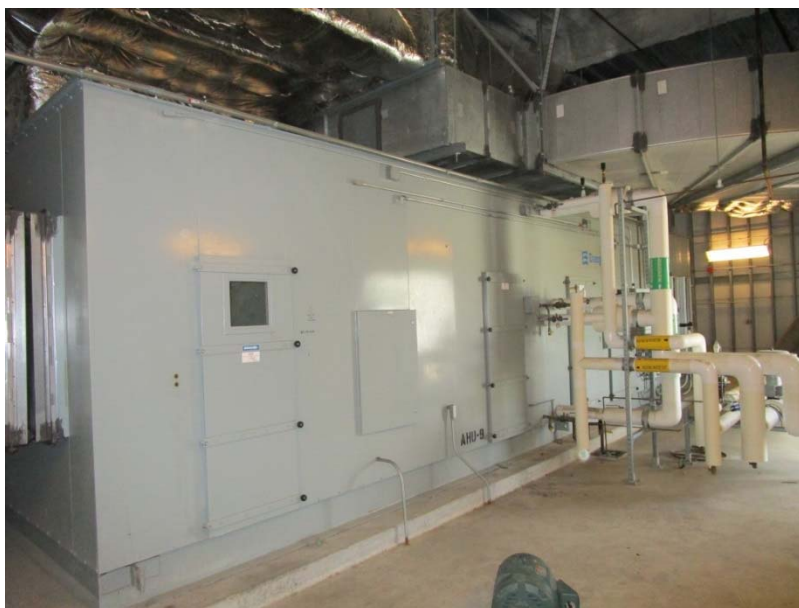
Buildings 100, 200, 300, 500 and 580 built-up AHUs are at the end of their expected useful lives.

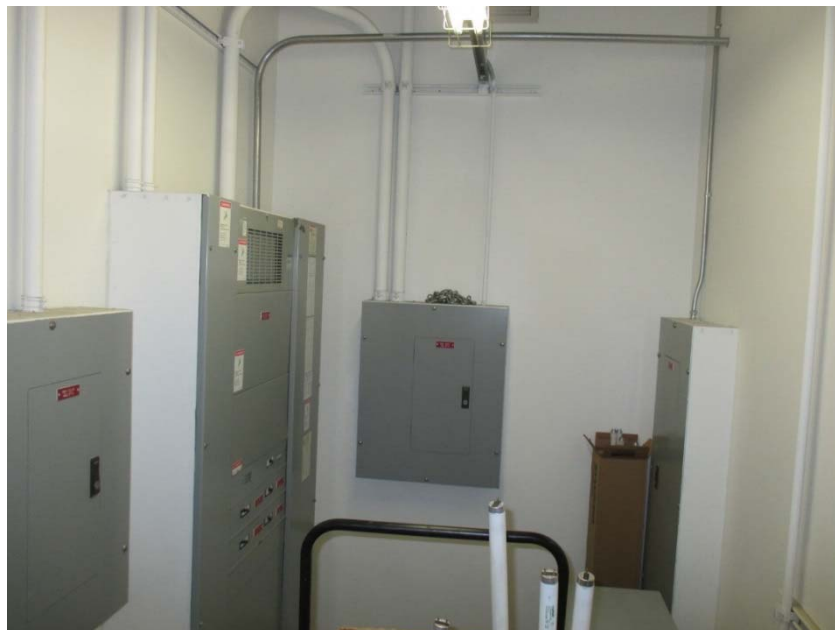
The main switchboard is approaching its expected useful life.

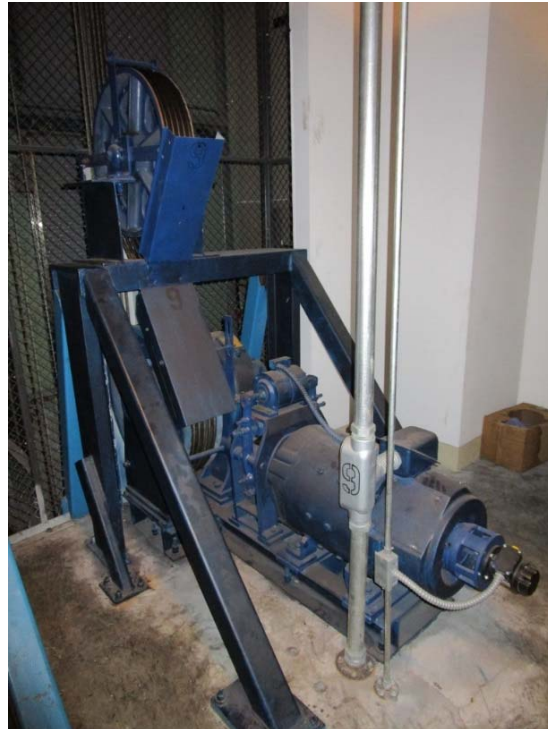
Elevator motors frequently go down and will eventually need to be replaced.

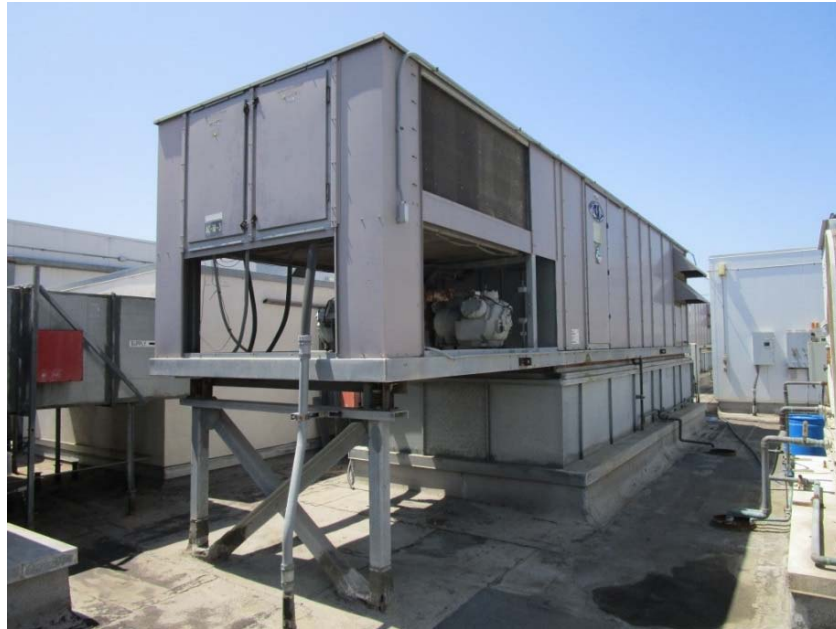
Rooftop AHUs are at the end of their expected useful lives.

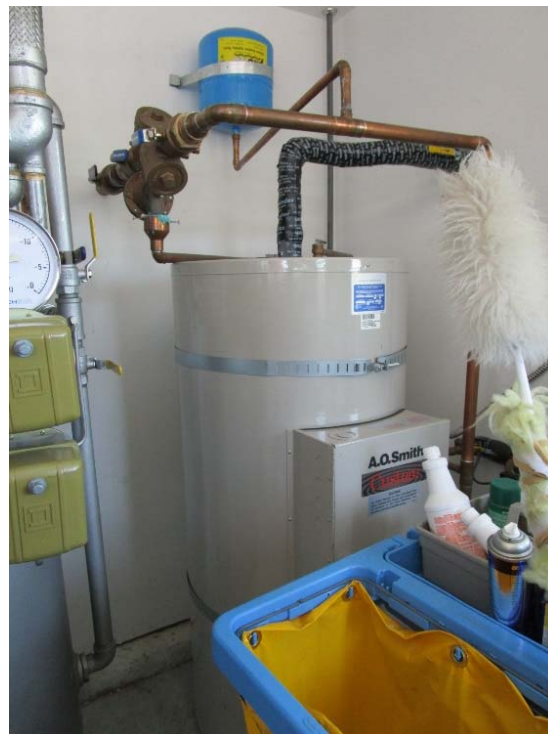
Electric water heater is at the end of its expected useful life.

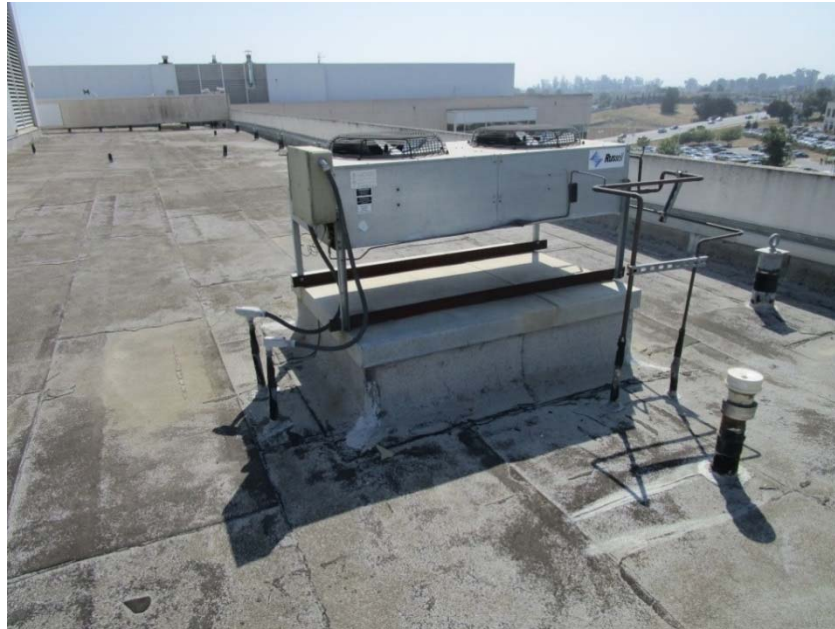
Rooftop refrigeration condensing unit and indoor evaporator for the walk-in refrigeration system is at the end of its expected useful life.

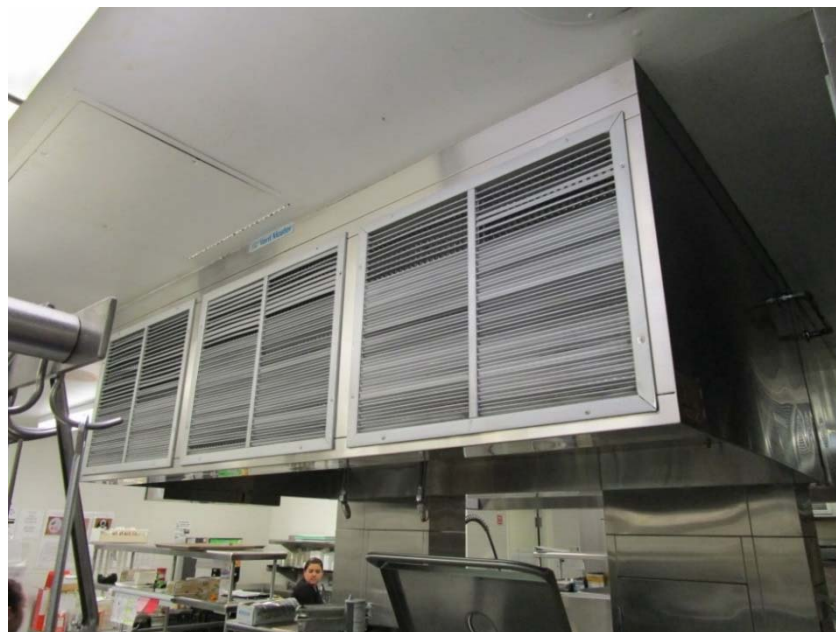
Kitchen exhaust hood with fire suppression systems are at the end of their expected useful lives.

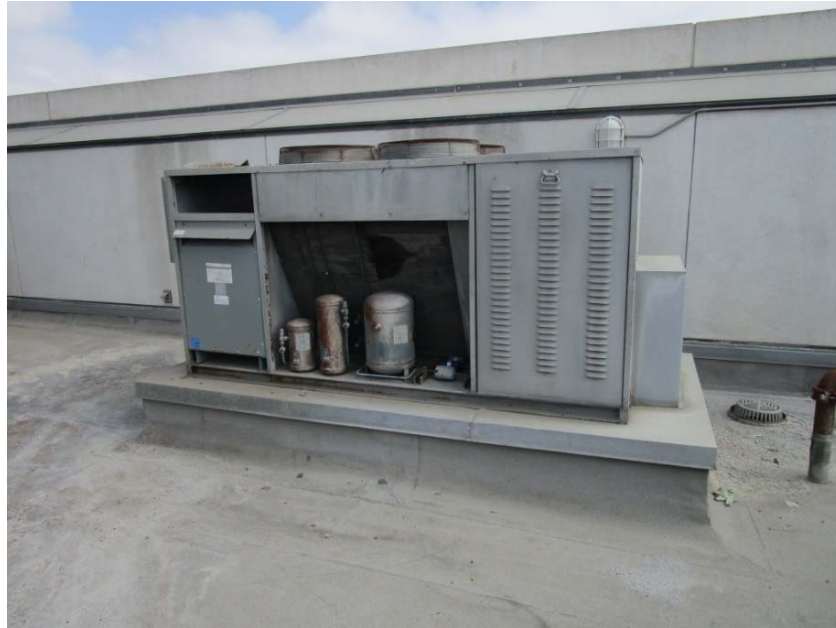
Rooftop refrigeration condensing unit and indoor evaporators for the walk-in refrigeration system are at the end of their expected useful lives.

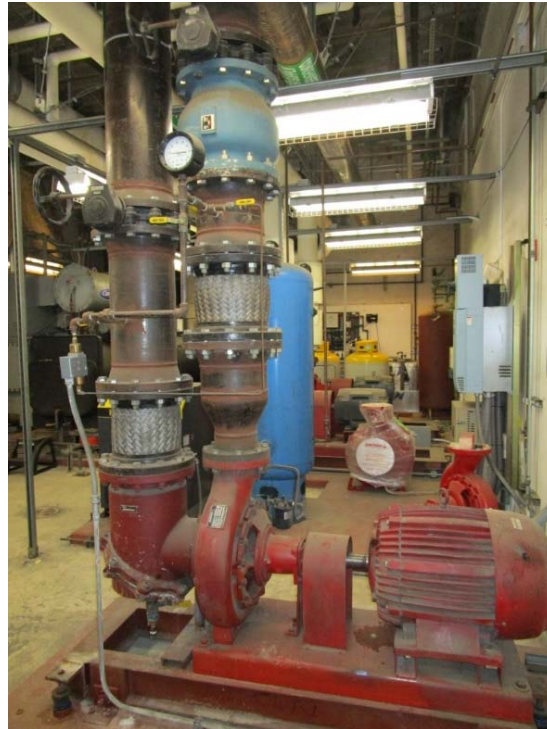
Condenser water pumps are at the end of their expected useful lives.

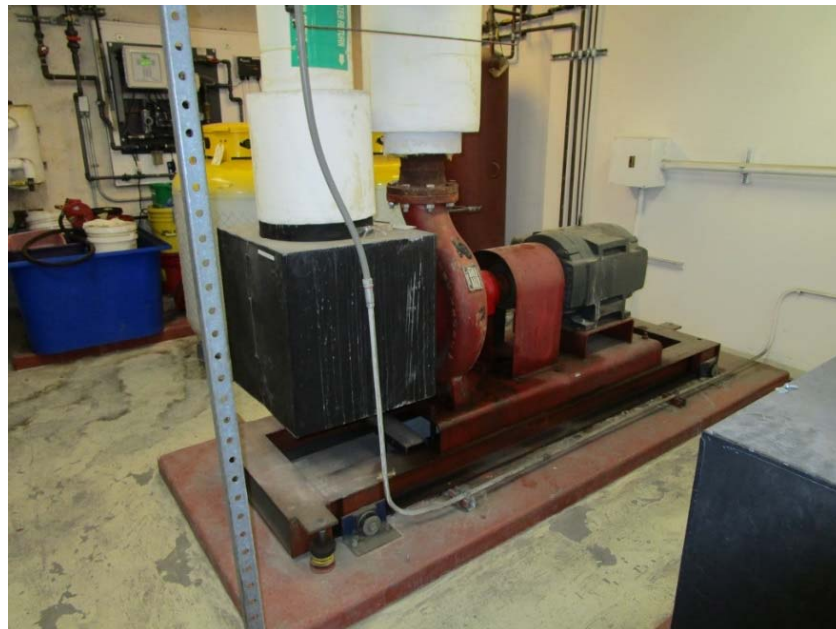
Chilled water pumps are at the end of their expected useful lives.

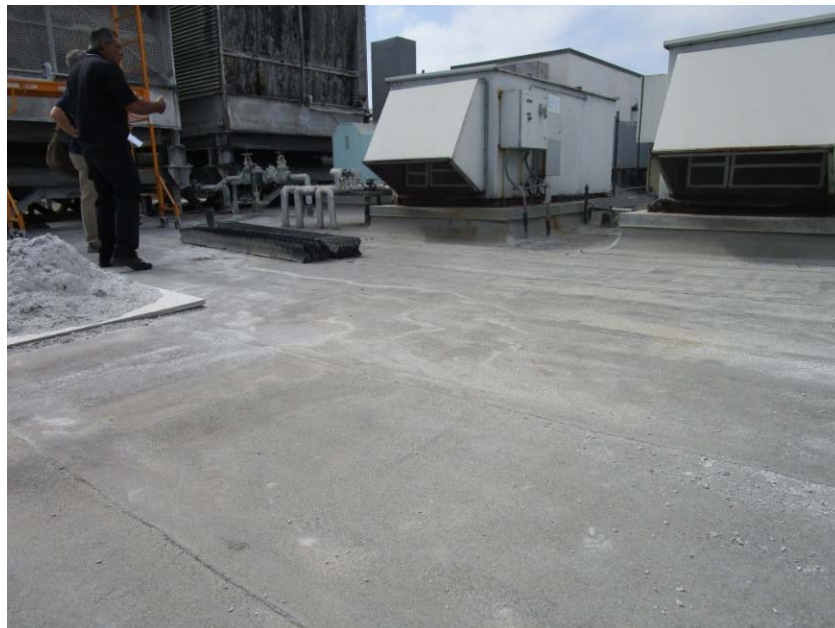
Make-up air handling units pulls in calcium deposits from the cooling towers and contaminates the air and food in the kitchen.

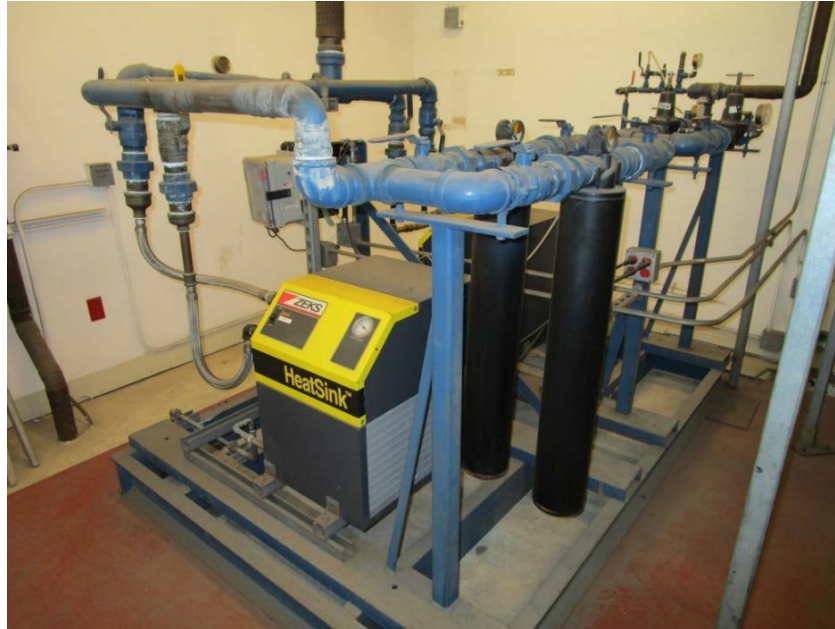
Refrigerated air dryer systems are at the end of their expected useful lives.

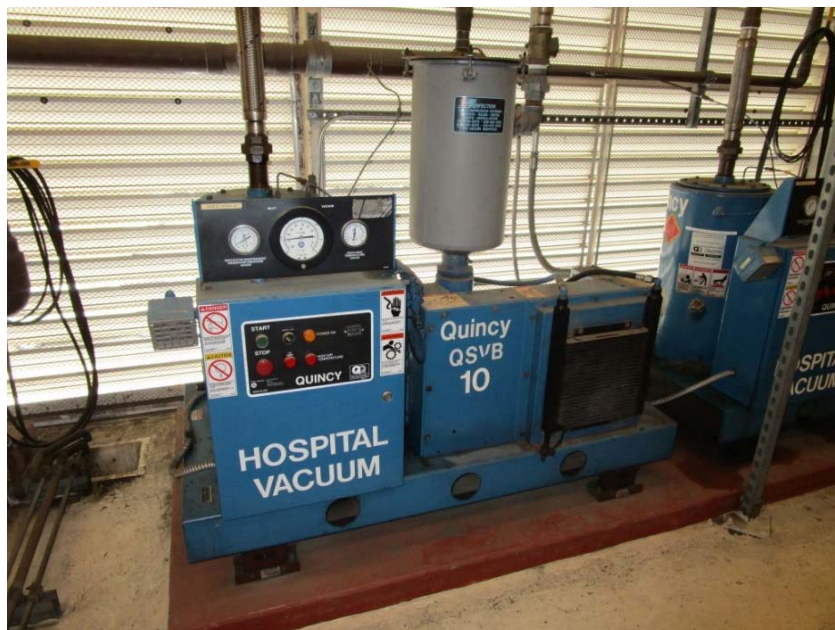
Medical vacuum systems are at the end of their expected useful lives.

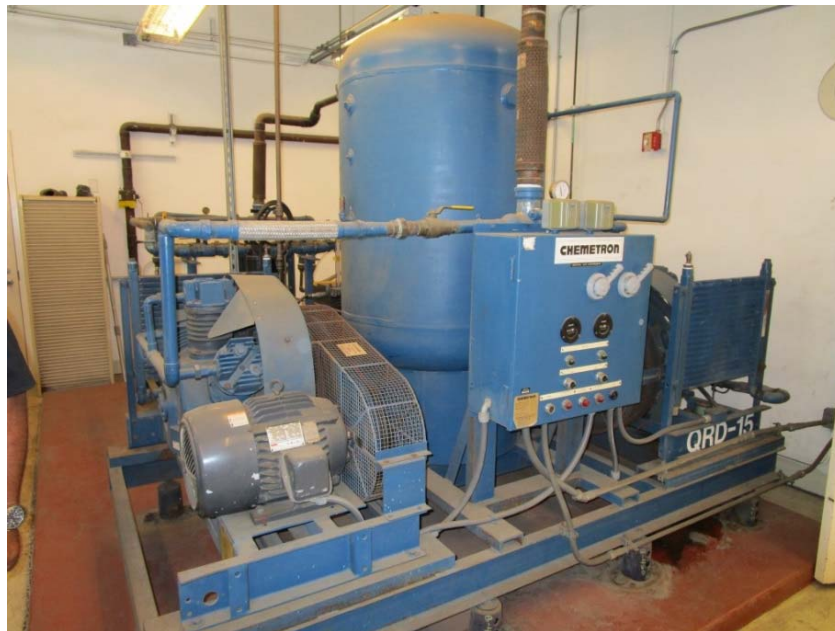
Medical air compressor system is at the end of its expected useful life.

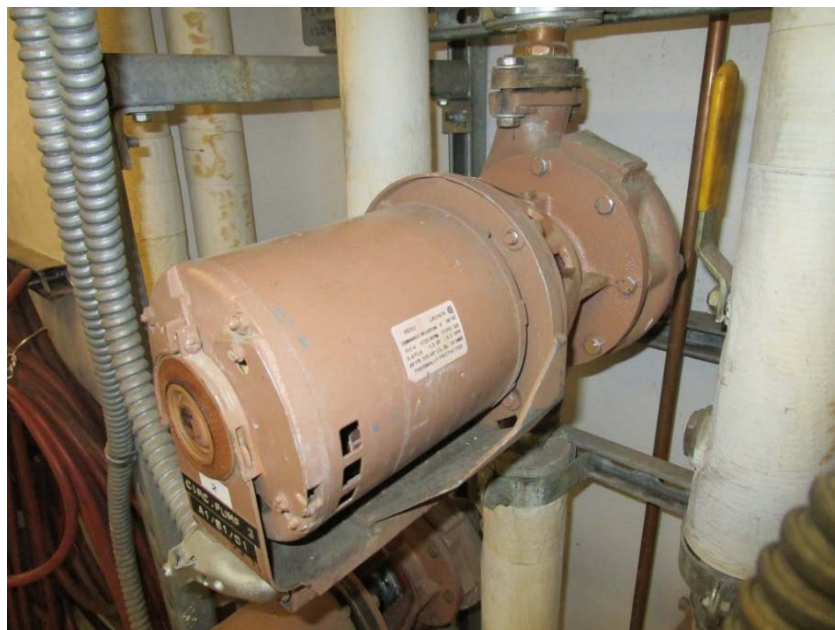
Circulating pumps are at the end of their expected useful lives.

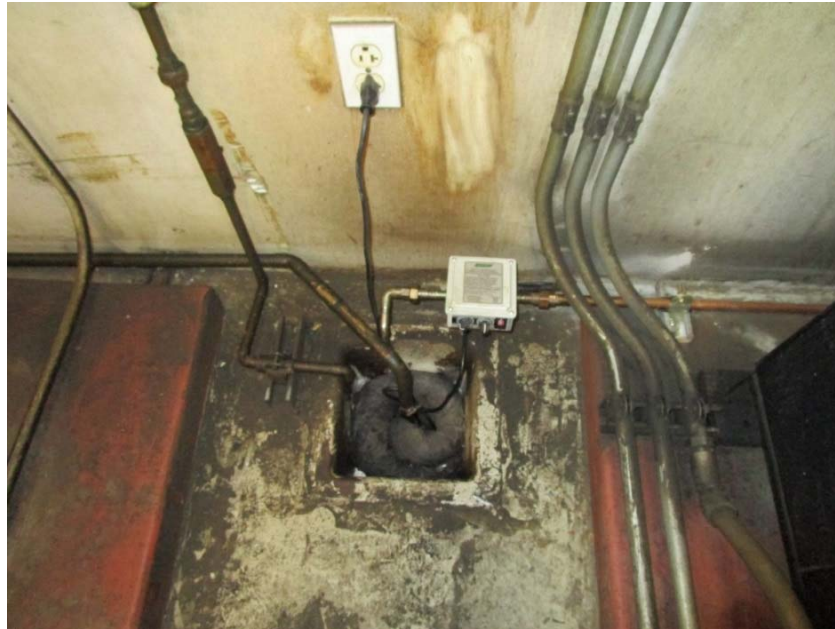
Condensate pump is at the end of its expected useful life.

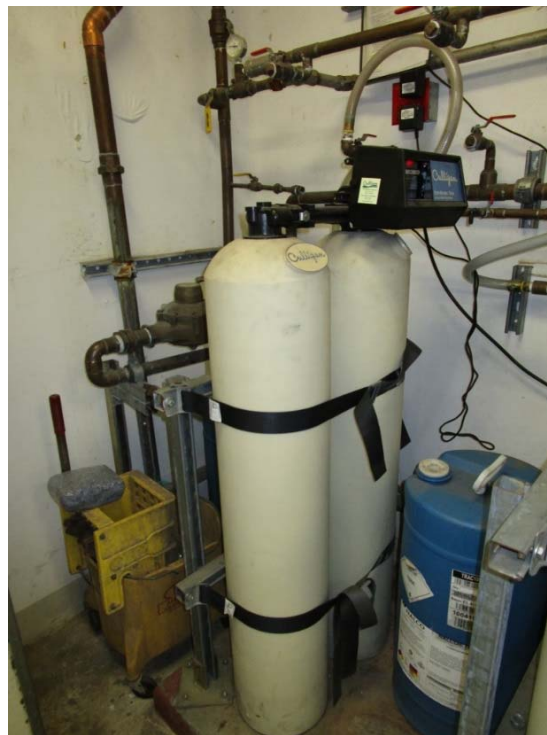
Water softener system is at the end of its expected useful life.
