Natividad Medical Center Facility Assessment Report

*Prepared by Kitchell
For*

County of Monterey, California

December 9, 2015
Job No. 4983A3

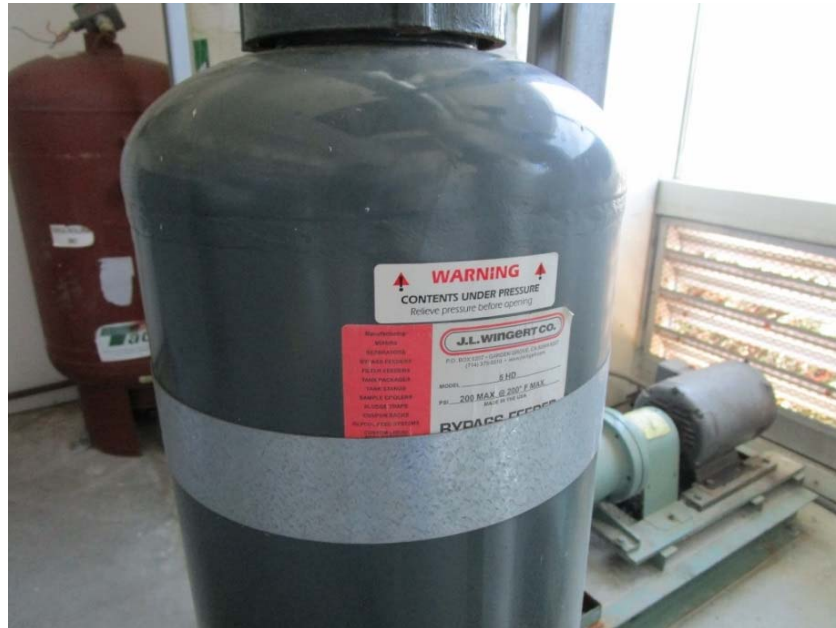
Chemical feeder is at the end of its expected useful life.

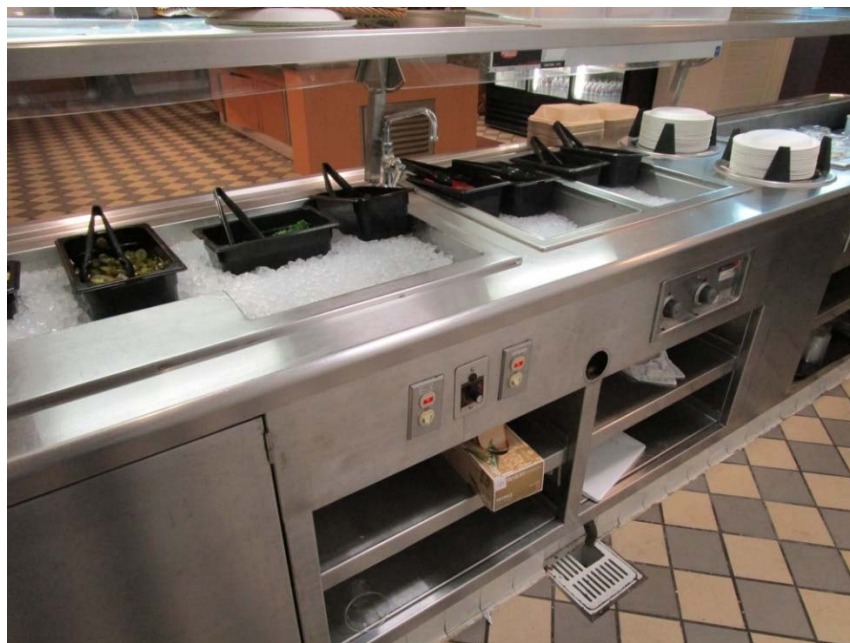
The food service equipment located in the kitchen are at the end of their expected useful lives.

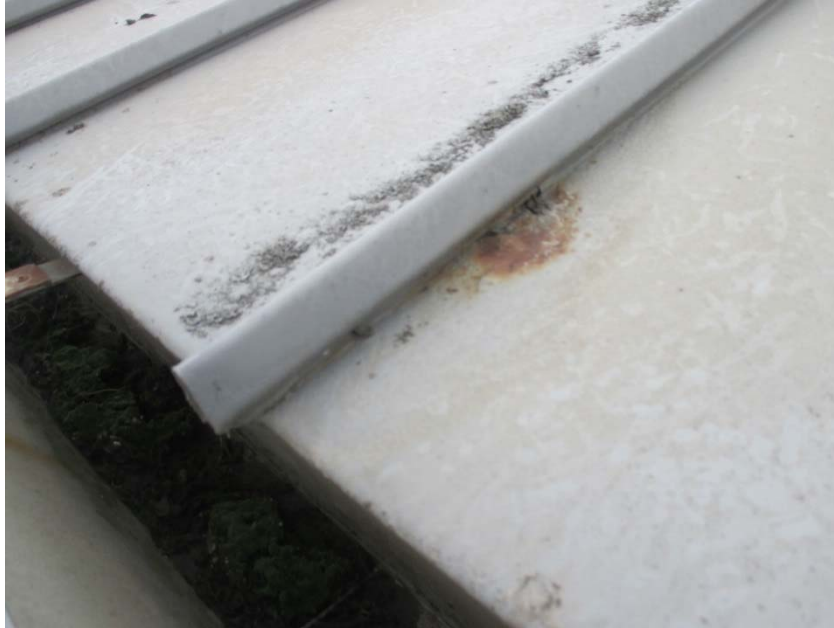
The existing built-up roof is in fair condition. It lacks walk pads for foot traffic. The roof hatch needs fall protection to be installed. The areas of metal roofing are starting to rust and will require replacement before the built-up areas. Several areas with caulking and sealant are failing and should be replaced to prevent water intrusion.

Metal roofing is rusting and starting to fail

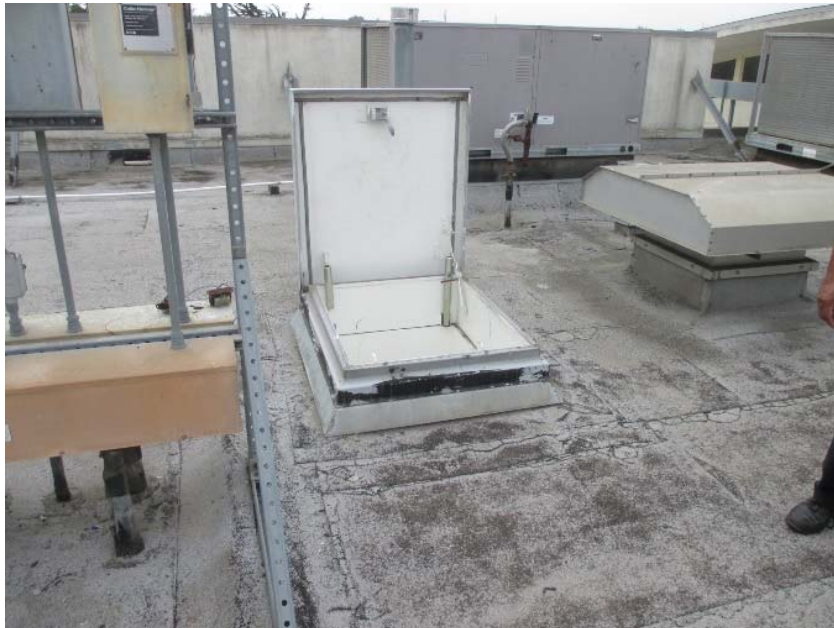
Roof hatch with no fall protection

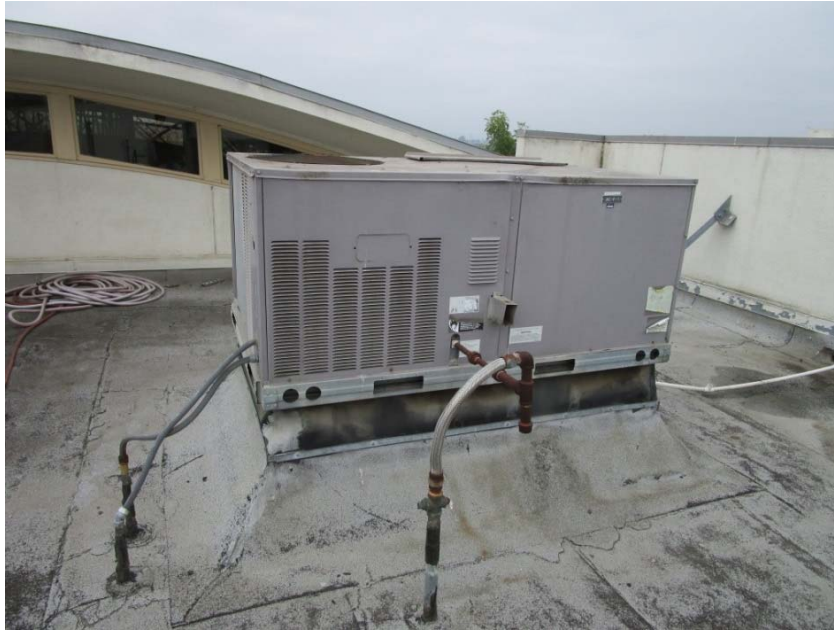
The HVAC systems at the building consist of seven Carrier packaged rooftop DX cooling and gas heating air conditioning units. These units are original to the building (1999) and appear to be in fair operational condition. One of the units has a nonfunctional economizer and will need to be replaced. These units are at the end of their expected useful lives and will need to be replaced. No major damage around the casing, air leakage, or unbalanced motor noise was noted at these units.

Packaged rooftop AC unit is at the end of its expected useful life.

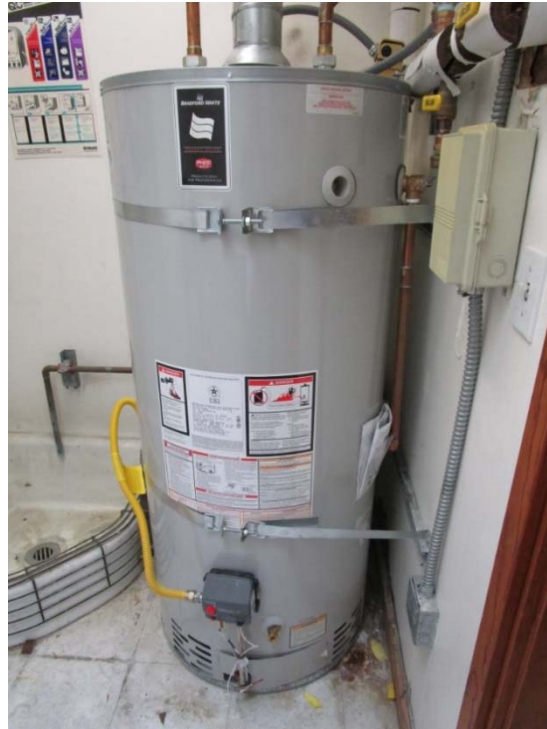
The domestic hot water is provided by a gas water heater located in the Janitor Closet. The water heater is original to the building (1999) and appears to be in fair operational condition. However, it is at the end of its expected useful life and will need to be replaced.

Gas water heater is at the end of its expected useful life.

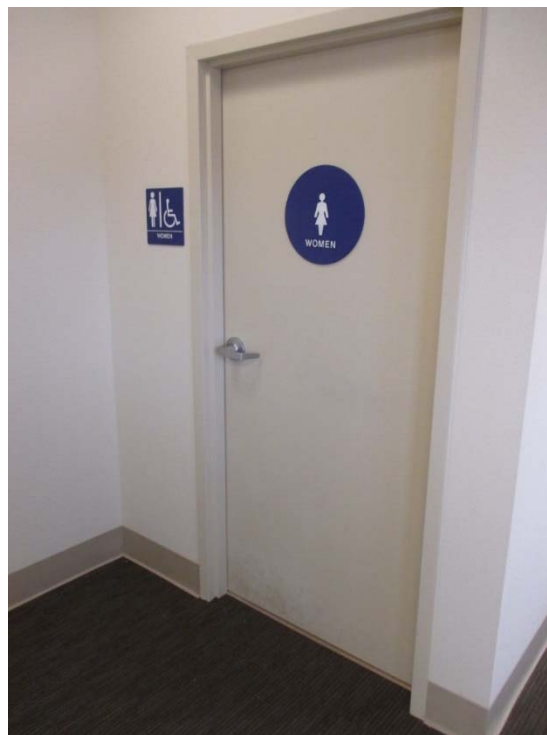
Restroom doors need paint

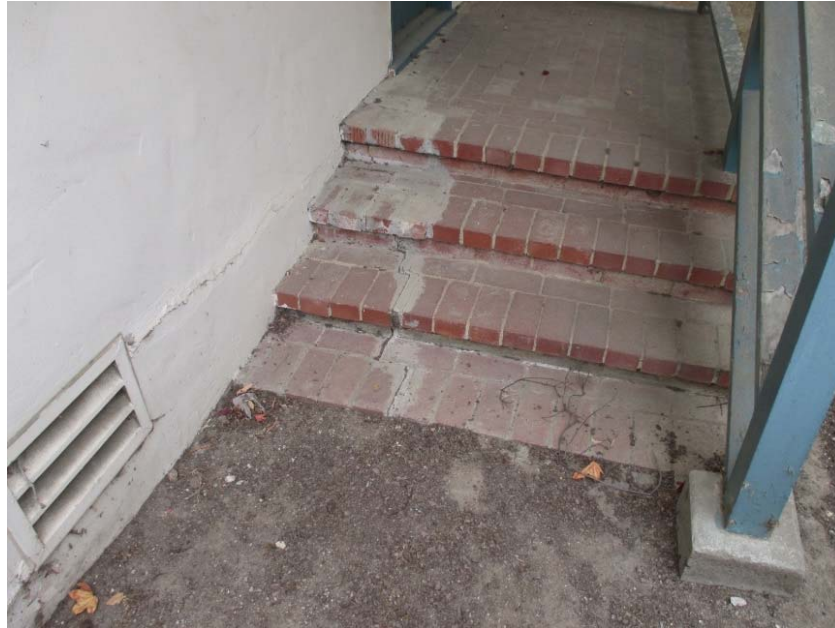
Exterior steps require correction

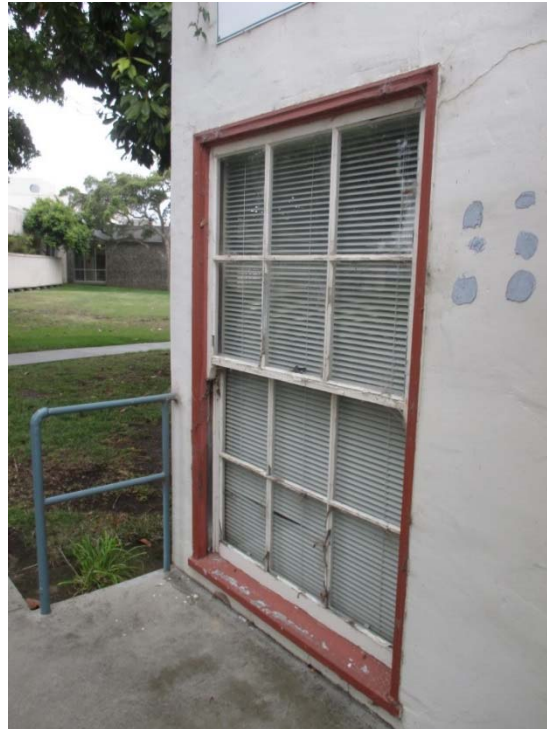
Exterior windows are ready for replacement

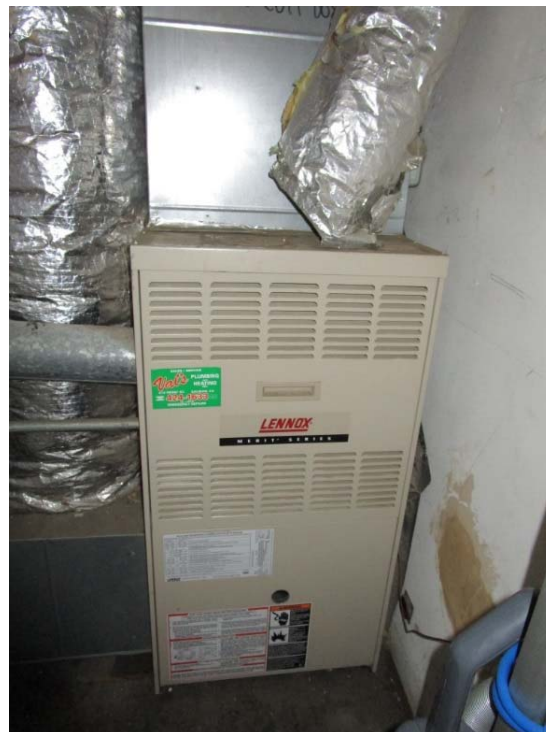
Indoor gas furnace unit is at the end of its expected useful life.

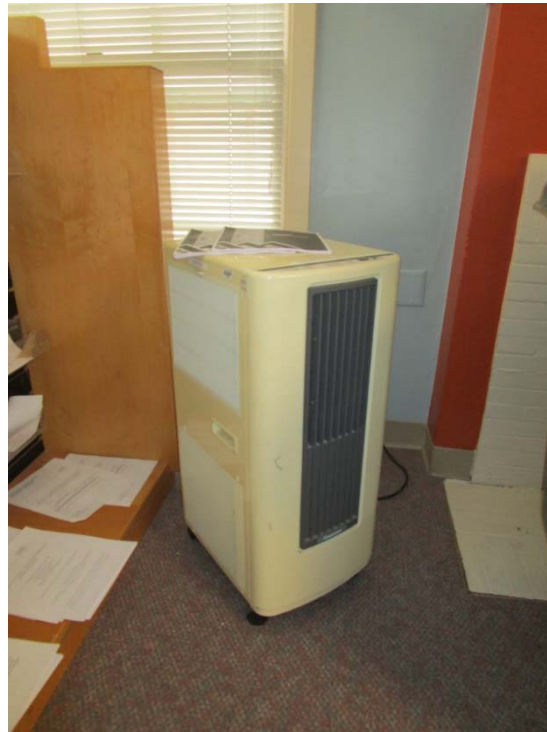
Portable air conditioning unit is at the end of its expected useful life.
