**Frank Ono**  
**International Society of Arboriculture**  
**Certified Arborist # 536**  
**Society of American Foresters Professional Member 48004**  
**1213 Miles Avenue**  
**Pacific Grove CA, 93950**  
Telephone (831) 373-7086  
Cellular (831) 594-2291

RE: 25475 Hatton Proposed ADU and Redwoods

The purpose of this report is to address concerns expressed by the neighboring property owner regarding construction related impacts to the 4 redwood trees. In response to these concerns and, per the project design plans, it is my professional opinion that construction related impacts to these 4 redwoods will be insignificant and not harmful to tree health due to the fact these redwoods are a safe distance away from the proposed ADU and, more importantly, the foundation of the ADU will be elevated (i.e., floated) resulting in minimal and inconsequential impacts to the critical root zones of the subject trees.

Ms. Nagafuji requested my services to assess the condition of twenty-two trees within or near the project limits, and the construction impacts that may affect them. Further, to provide a report with my findings and recommendations to meet MCMRA planning requirements.

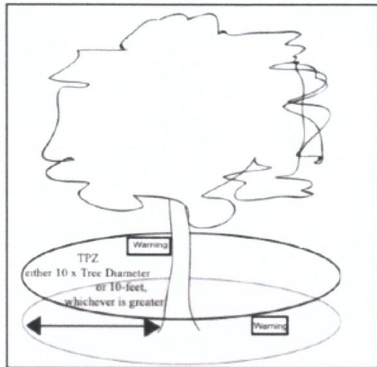
### Tree Protection Zone (TPZ) shown in grey

*(radius of TPZ equals 10-times the diameter of the tree or 10-feet, whichever is greater.  
(Or as space allows under the guidance of the project arborist).*

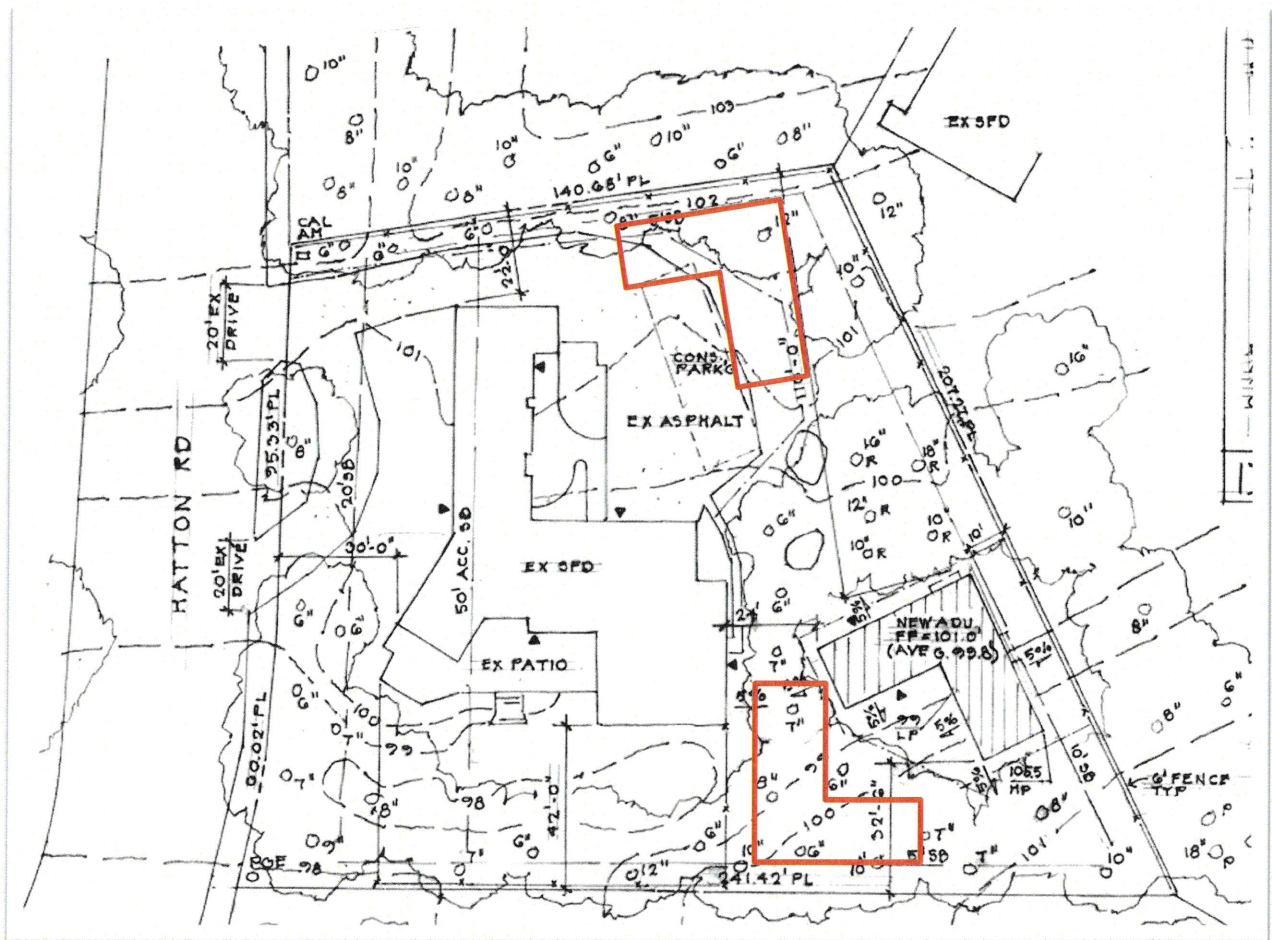
"Relocation of the ADU footprint further way from the critical root zone of the trees would help secure vertical stability of the trees as they grow in height. In this case, the overall distance should be at least 30 feet from the base of the trees."

The following shows two clearly feasible alternative locations for the Project:

Because the Project's material health and safety risks can be mitigated or eliminated by relocating the ADU to another area of the Kitayama Property, the Application cannot be approved as presented. Rather, relocation of the ADU to the northern or southern portions of the Kitayama Property is required.
