Tree Resource Assessment
Management Plan
24726 Dolores Street

Hastings Construction

Ono Consulting
Members Society of American Foresters
ISA Certified Arborist #WE-0536A
ISA Board Certified Master Arborist WE-9388B
1213 Miles Avenue
Pacific Grove, CA 93950

September 1, 2021

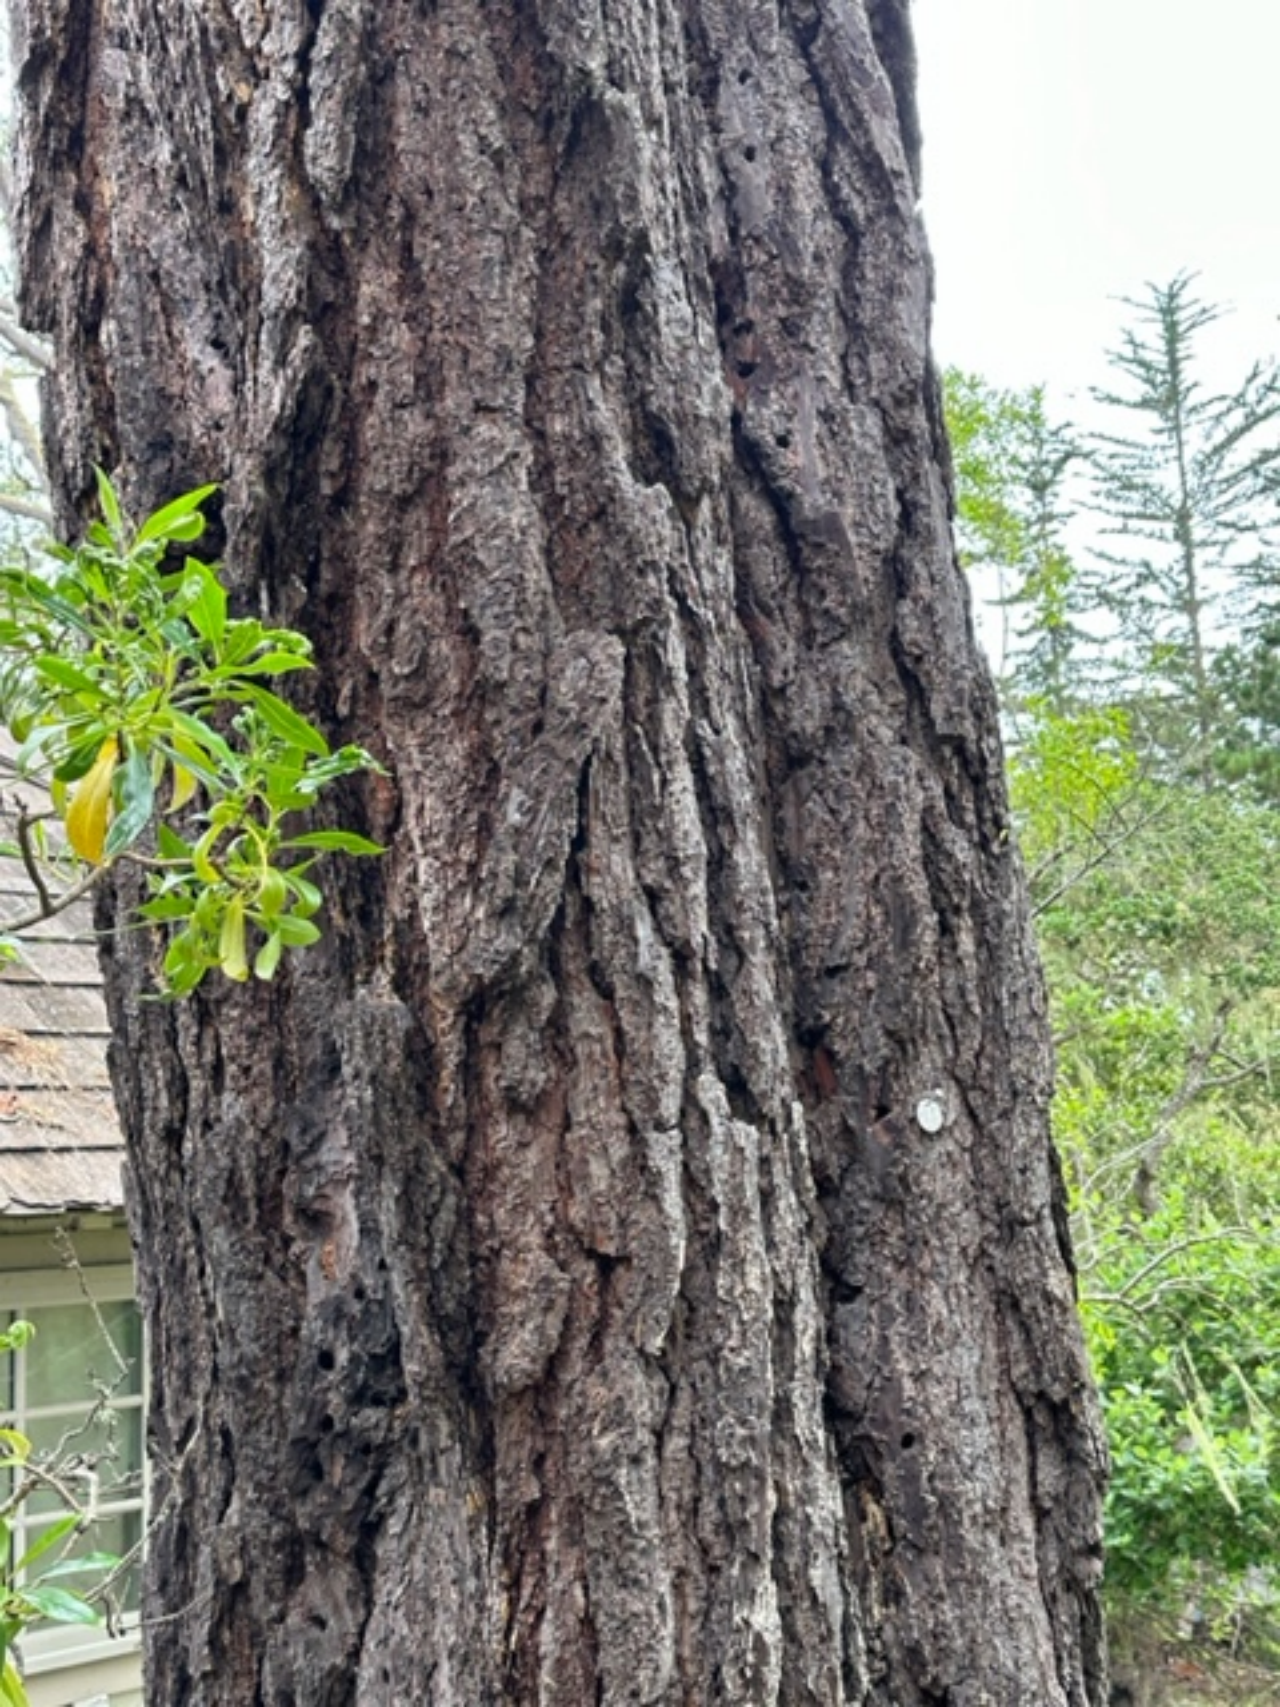
1st Comment: "Forest Resources: Please consider preserving tree number #114, or provide appropriate information from the consulting forester that would address the Monterey County Coastal Implementation Plan for the Carmel Area Land Use Plan findings for landmark trees."

- In the report it is listed as poor and has a thinning crown, but is looking for a more detailed explanation. I would prefer the tree be removed because my biggest concern is it seems like it would be a danger if it fails and since it's
