**PRELIMINARY
GEOTECHNICAL ENGINEERING AND
GEOLOGIC INVESTIGATION
PROPOSED RANCHO EL POTRERO
TEN (10) LOT RESIDENTIAL SUBDIVISION, PLN060603
APN 157-181-006, 007, AND 008
CARMEL, MONTEREY COUNTY, CALIFORNIA**

Project Number: D69201.01-01

January 16, 2008

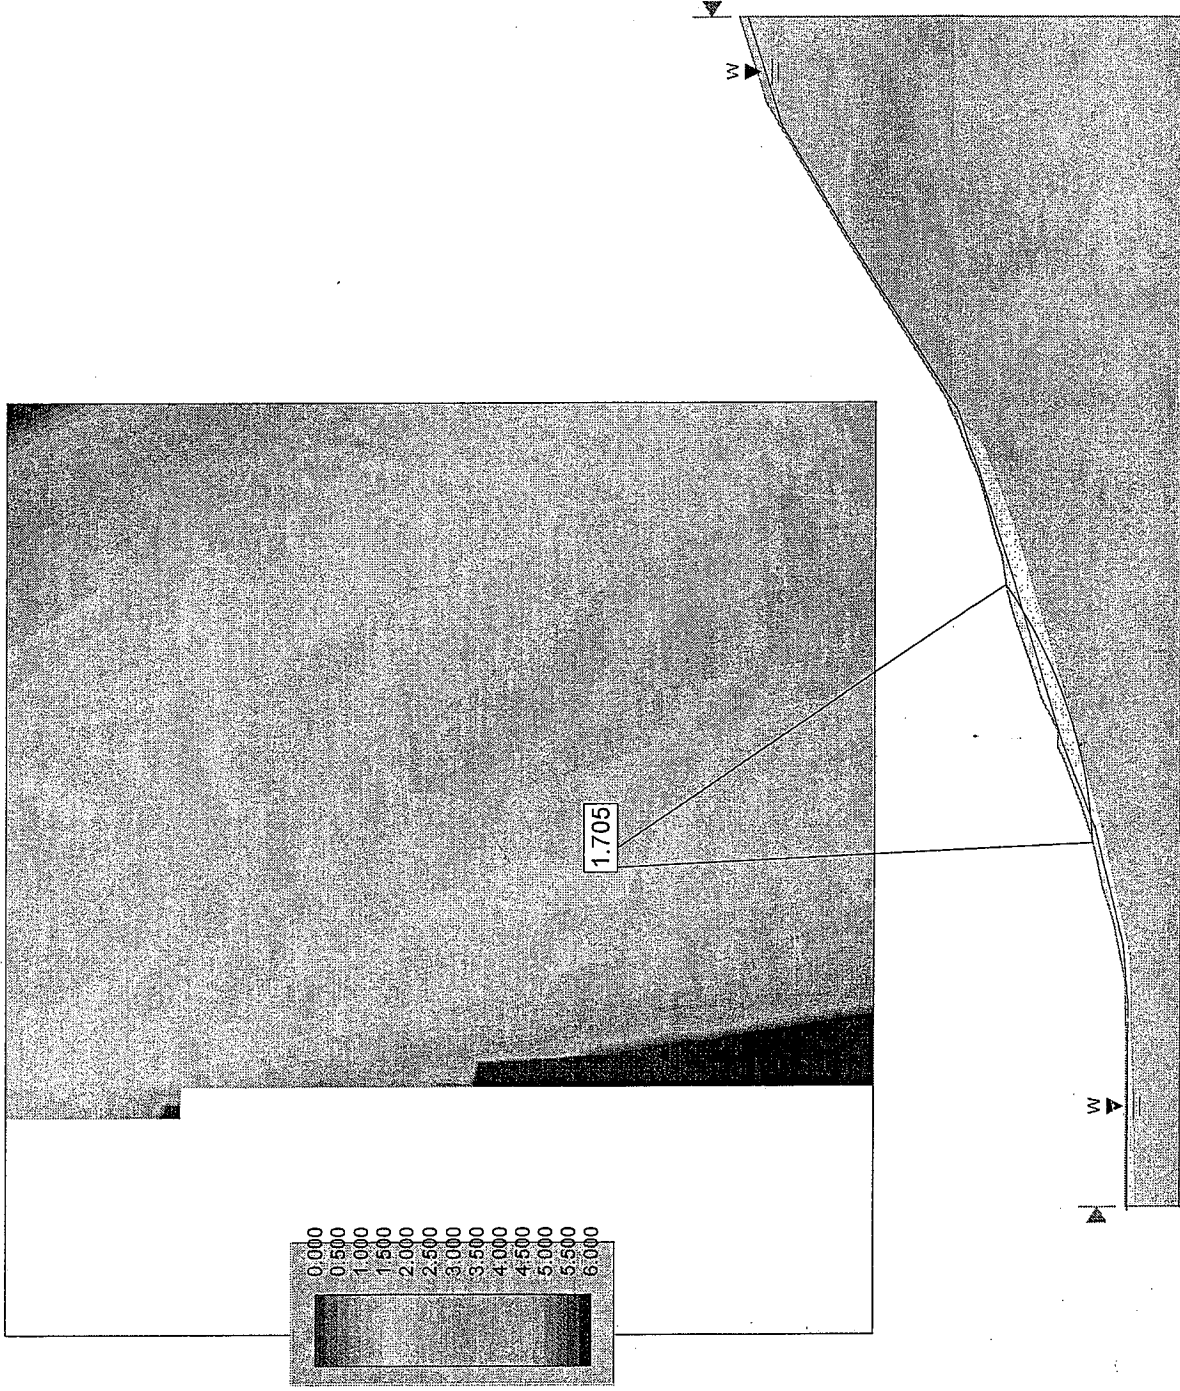
FILE NO. 69201-01-X	DATE DRAWN: 01/24/08
DRAWN BY: RM	APPROVED BY: <i>KC</i>
PROJECT NO. D69201.01	DRAWING NO. 5A

FAILURE SURFACE WITH LOWEST
FACTOR OF SAFETY SHOWN

RESULTS OF SLOPE STABILITY ANALYSES - NATIVE SITE SLOPES -
CIRCULAR SLIP FAILURE SURFACES - STATIC CONDITION

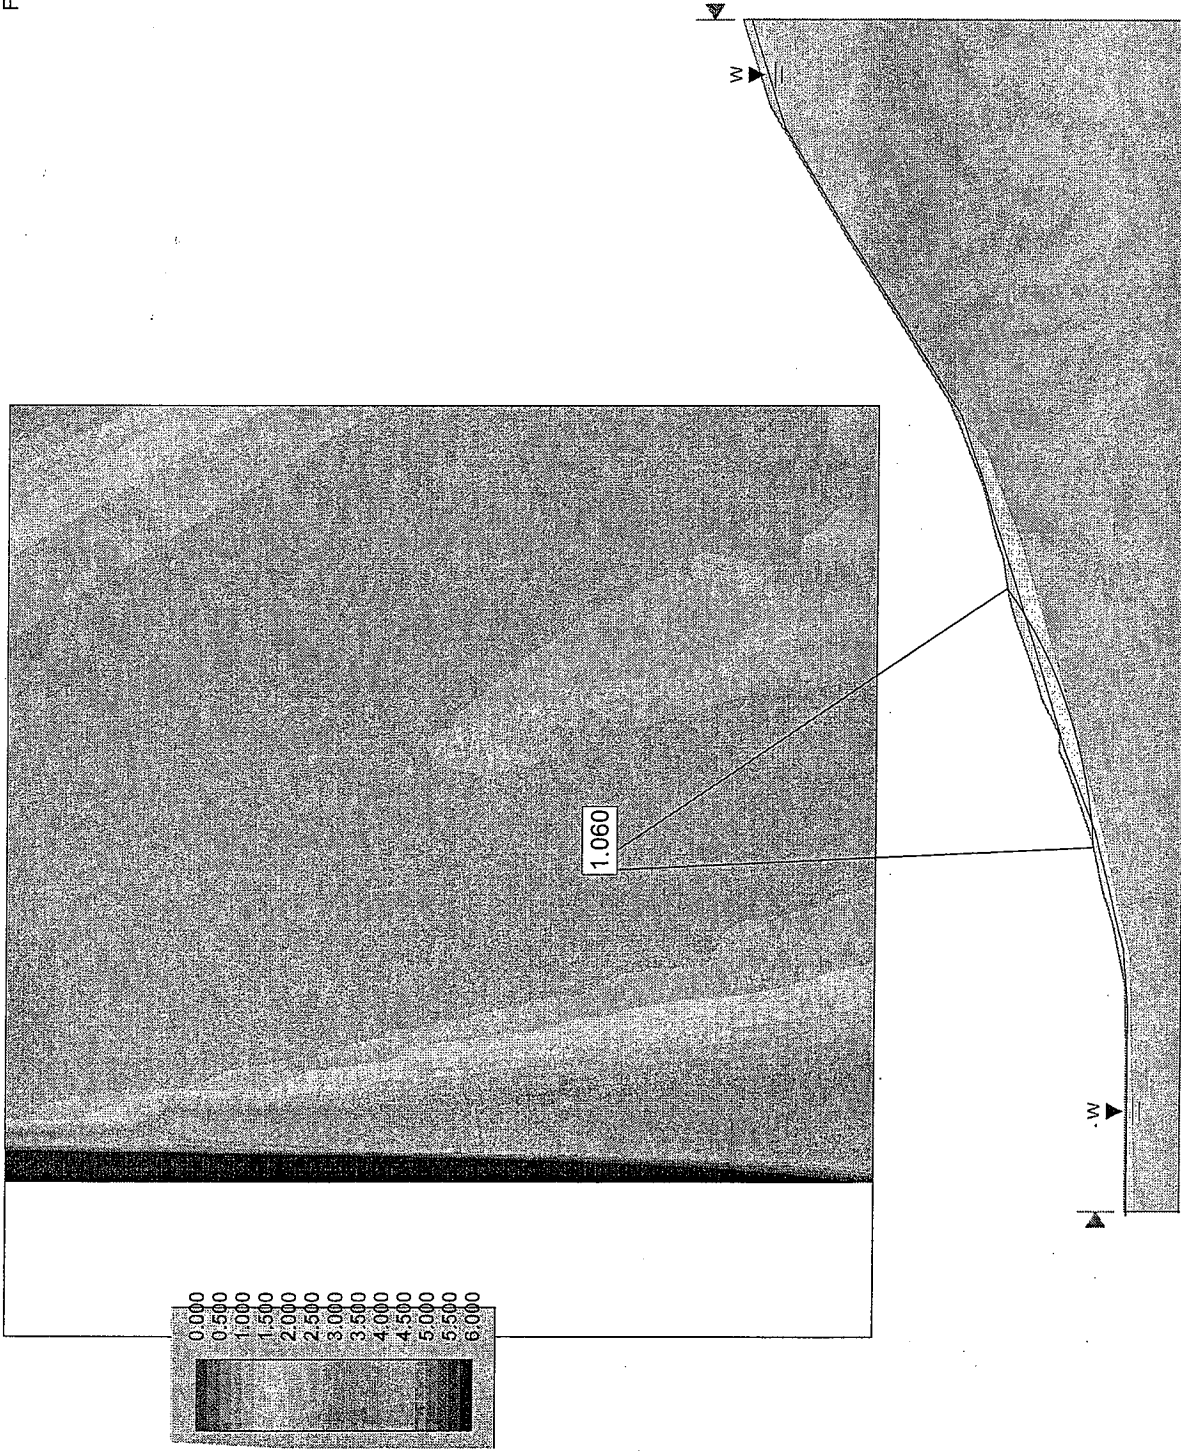
FILE NO. 69201-01-X	DATE DRAWN: 01/24/08
DRAWN BY: RM	APPROVED BY: <i>RC</i>
PROJECT NO. D69201.01	DRAWING NO. 5B

FAILURE SURFACE WITH LOWEST
FACTOR OF SAFETY SHOWN

RESULTS OF SLOPE STABILITY ANALYSES - NATIVE SITE SLOPES -
CIRCULAR SLIP FAILURE SURFACES - SEISMIC CONDITION

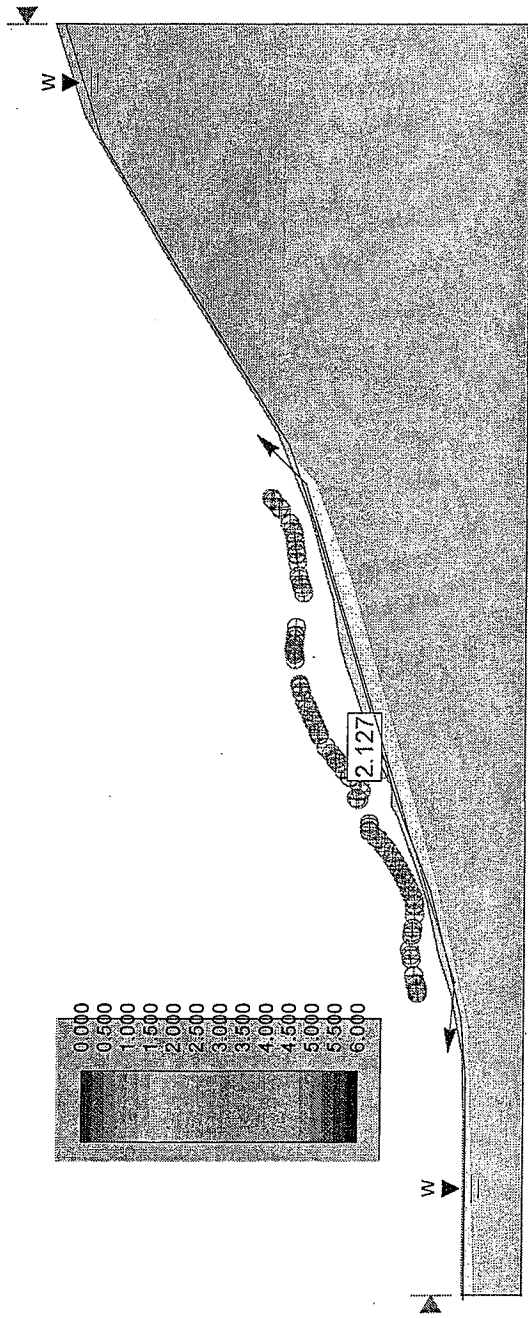
FILE NO. 69201-01-X	DATE DRAWN: 01/24/08
DRAWN BY: RM	APPROVED BY: <i>[Signature]</i>
PROJECT NO. D69201.01	DRAWING NO. 6A

FAILURE SURFACE WITH LOWEST
FACTOR OF SAFETY SHOWN

RESULTS OF SLOPE STABILITY ANALYSES - NATIVE SITE SLOPES -
SHALLOW TRANSLATIONAL SLIP FAILURE SURFACES - STATIC CONDITION

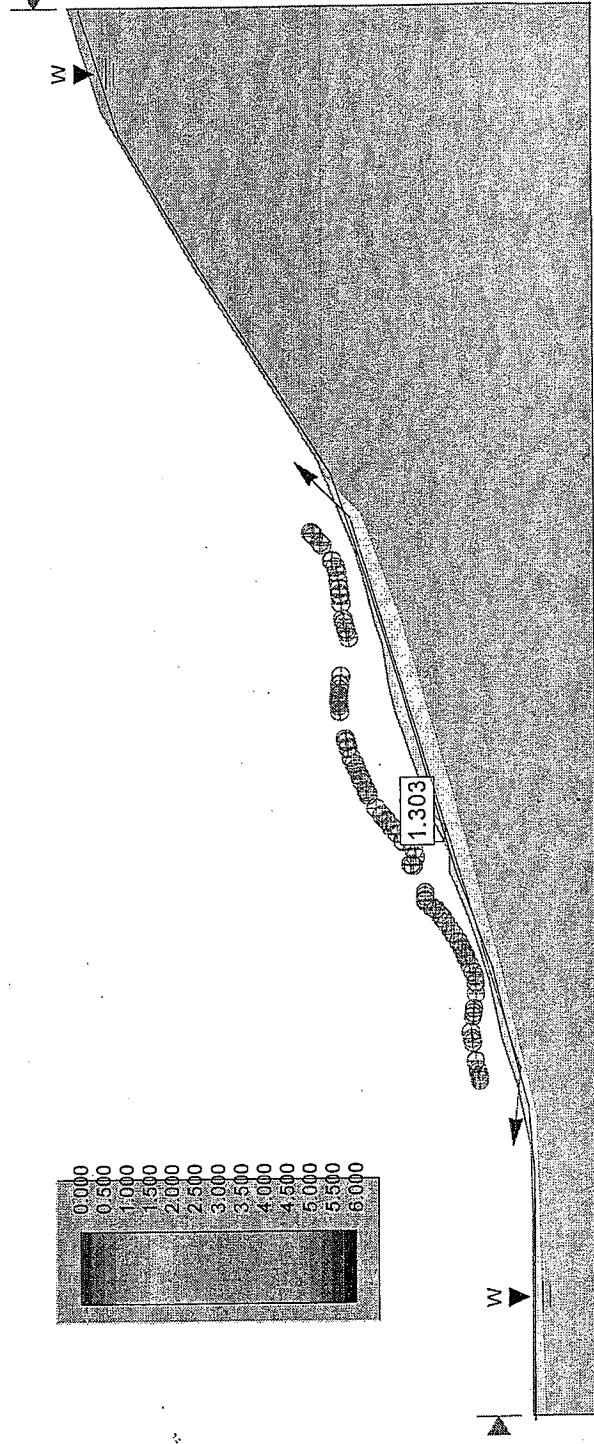
FILE NO. 69201-01-X	DATE DRAWN: 01/24/08
DRAWN BY: RM	APPROVED BY: <i>RM</i>
PROJECT NO. D69201.01	DRAWING NO. 6B

FAILURE SURFACE WITH LOWEST
FACTOR OF SAFETY SHOWN

RESULTS OF SLOPE STABILITY ANALYSES - NATIVE SITE SLOPES -
SHALLOW TRANSLATIONAL SLIP FAILURE SURFACES - SEISMIC
CONDITION

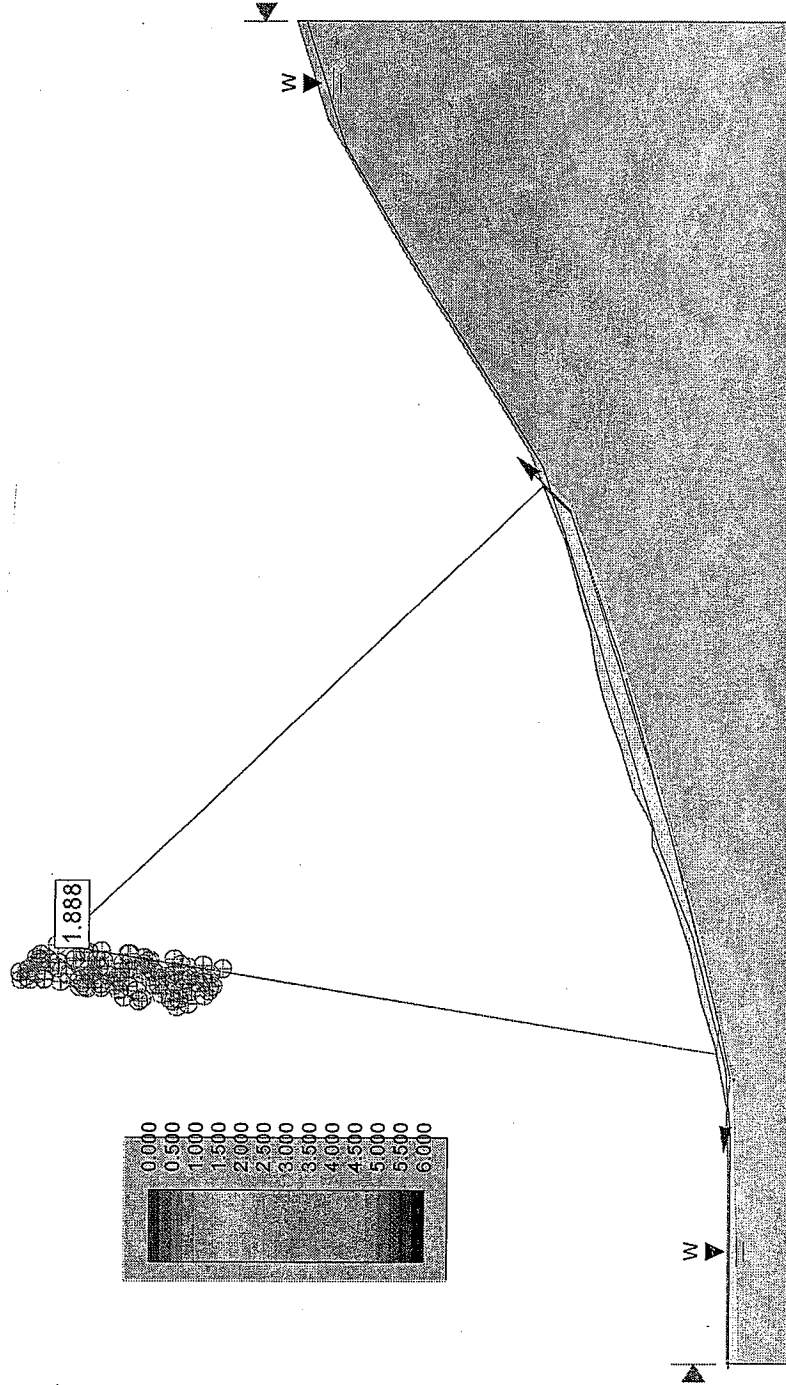
FAILURE SURFACE WITH LOWEST
FACTOR OF SAFETY SHOWN

RESULTS OF SLOPE STABILITY ANALYSES - NATIVE SITE SLOPES - DEEP
TRANSLATIONAL SLIP FAILURE SURFACES - STATIC CONDITION

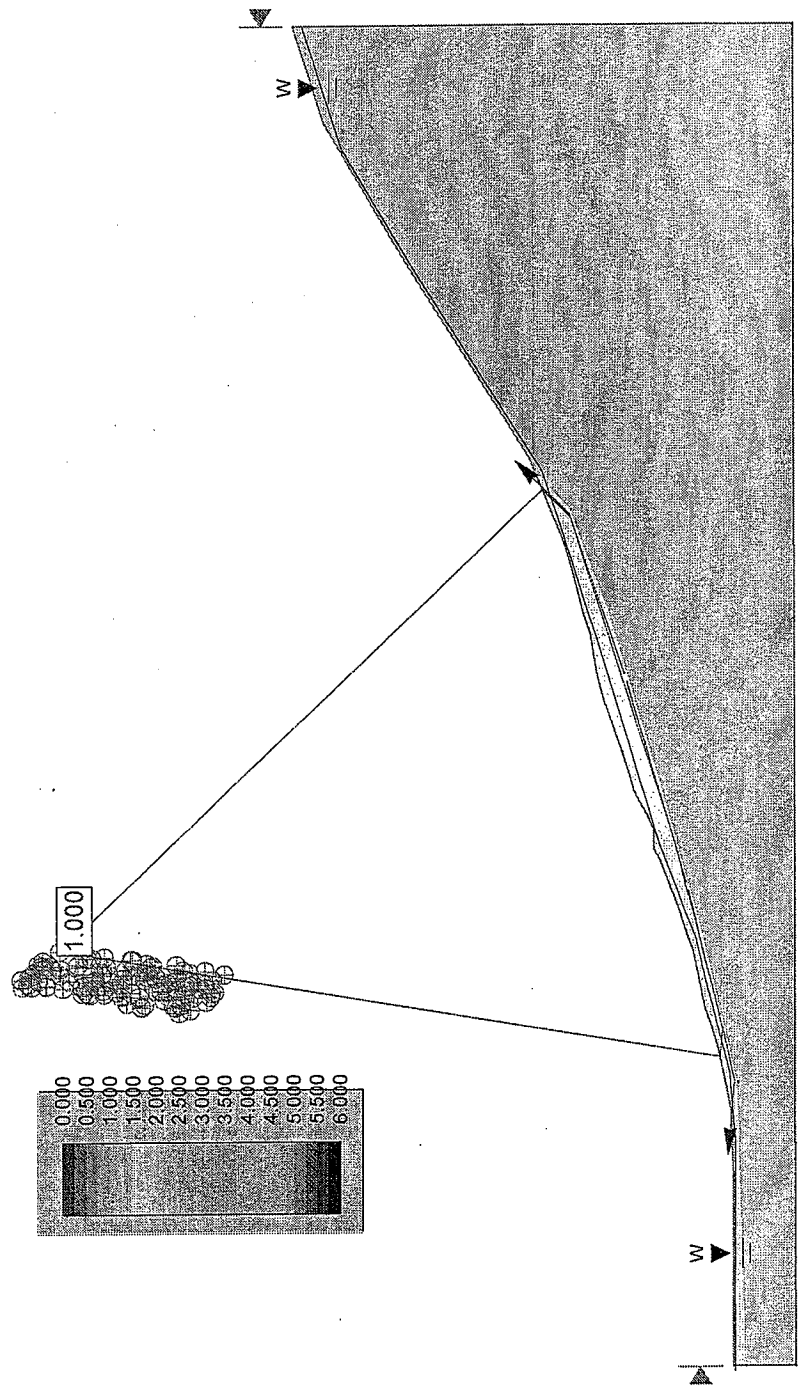
FILE NO. 69201-01-X	DATE DRAWN: 01/24/08
DRAWN BY: RM	APPROVED BY: <i>[Signature]</i>
PROJECT NO. D69201.01	DRAWING NO. 7B

FAILURE SURFACE WITH LOWEST
FACTOR OF SAFETY SHOWN

RESULTS OF SLOPE STABILITY ANALYSES - NATIVE SITE SLOPES - DEEP
TRANSLATIONAL SLIP FAILURE SURFACES - SEISMIC CONDITION

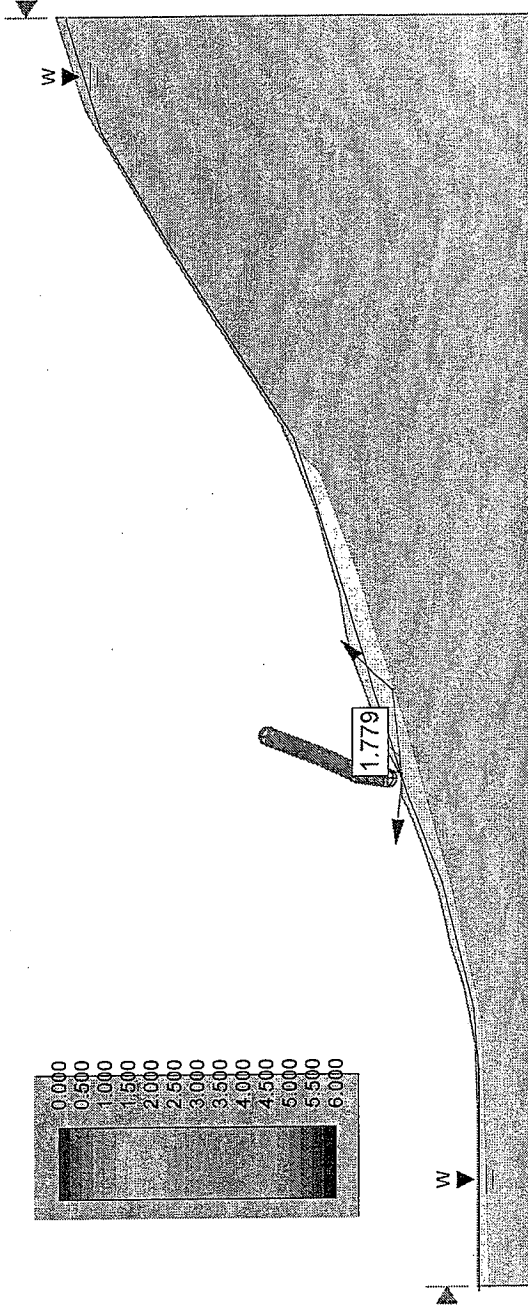
FILE NO. 69201-01-X	DATE DRAWN: 01/24/08
DRAWN BY: RM	APPROVED BY: <i>RM</i>
PROJECT NO. D69201.01	DRAWING NO. 8A

FAILURE SURFACE WITH LOWEST
FACTOR OF SAFETY SHOWN

RESULTS OF SLOPE STABILITY ANALYSES - NATIVE SITE SLOPES -
ADVERSE SLIP PLAN ORIENTATION 1 - STATIC CONDITION

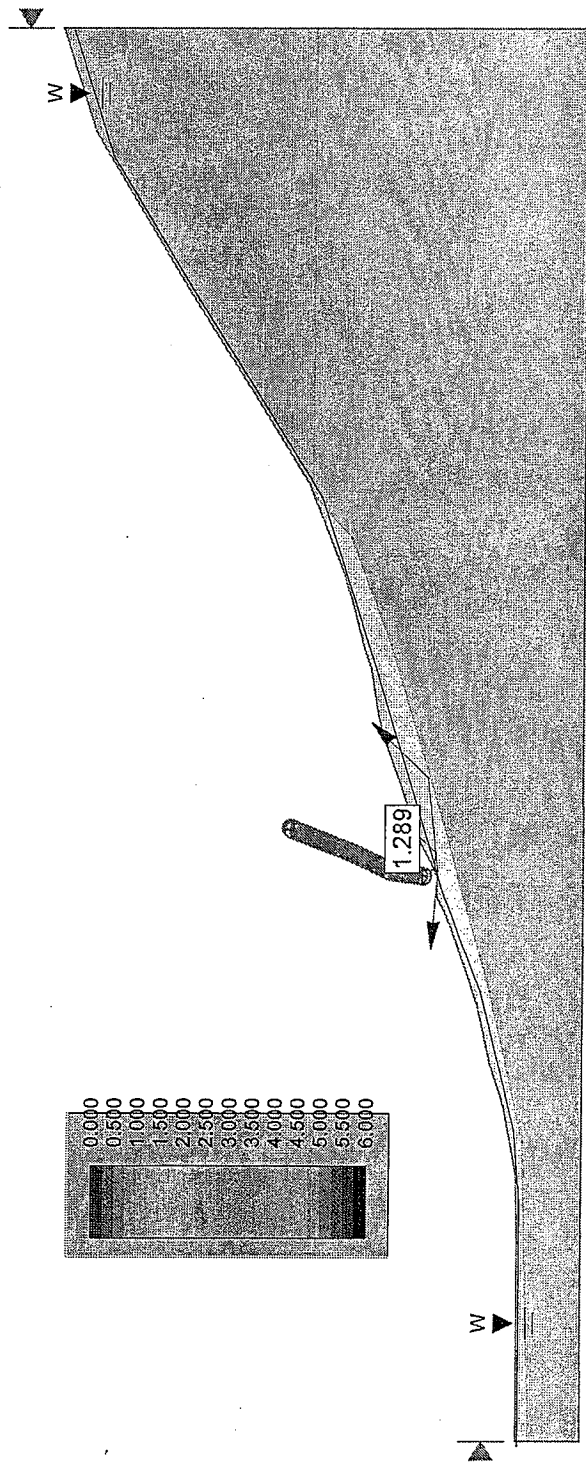
FAILURE SURFACE WITH LOWEST
FACTOR OF SAFETY SHOWN

RESULTS OF SLOPE STABILITY ANALYSES - NATIVE SITE SLOPES -
ADVERSE SLIP PLANE ORIENTATION 1 - SEISMIC CONDITION

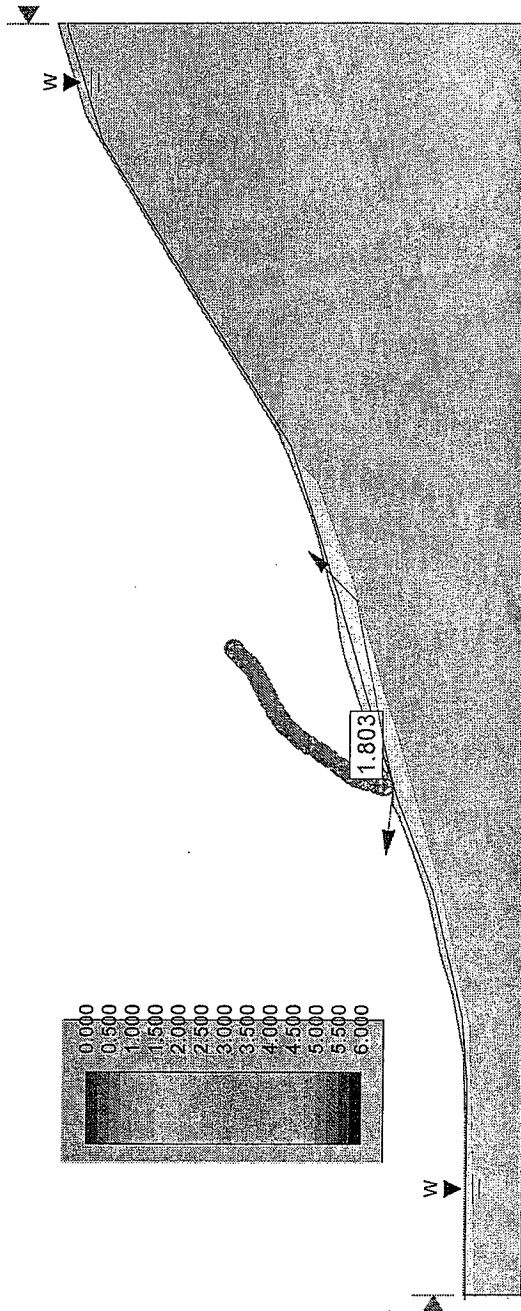
FILE NO.	69201-01-X	DATE DRAWN:	01/24/08
DRAWN BY:	RM	APPROVED BY:	<i>HC</i>
PROJECT NO.	D69201.01	DRAWING NO.	9A

FAILURE SURFACE WITH LOWEST
FACTOR OF SAFETY SHOWN

RESULTS OF SLOPE STABILITY ANALYSES - NATIVE SITE SLOPES -
ADVERSE SLIP PLANE ORIENTATION 2 - STATIC CONDITION

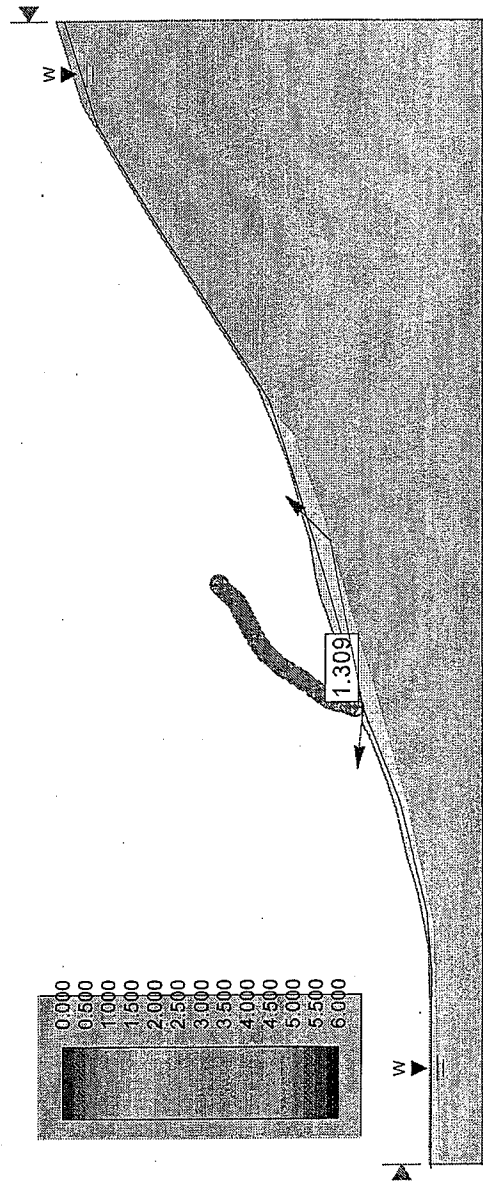
FILE NO. 69201-01-X	DATE DRAWN: 01/24/08
DRAWN BY: RM	APPROVED BY: <i>JC</i>
PROJECT NO. D69201.01	DRAWING NO. 9B

FAILURE SURFACE WITH LOWEST
FACTOR OF SAFETY SHOWN

RESULTS OF SLOPE STABILITY ANALYSES - NATIVE SITE SLOPES -
ADVERSE SLIP PLANE ORIENTATION 2 - SEISMIC CONDITION

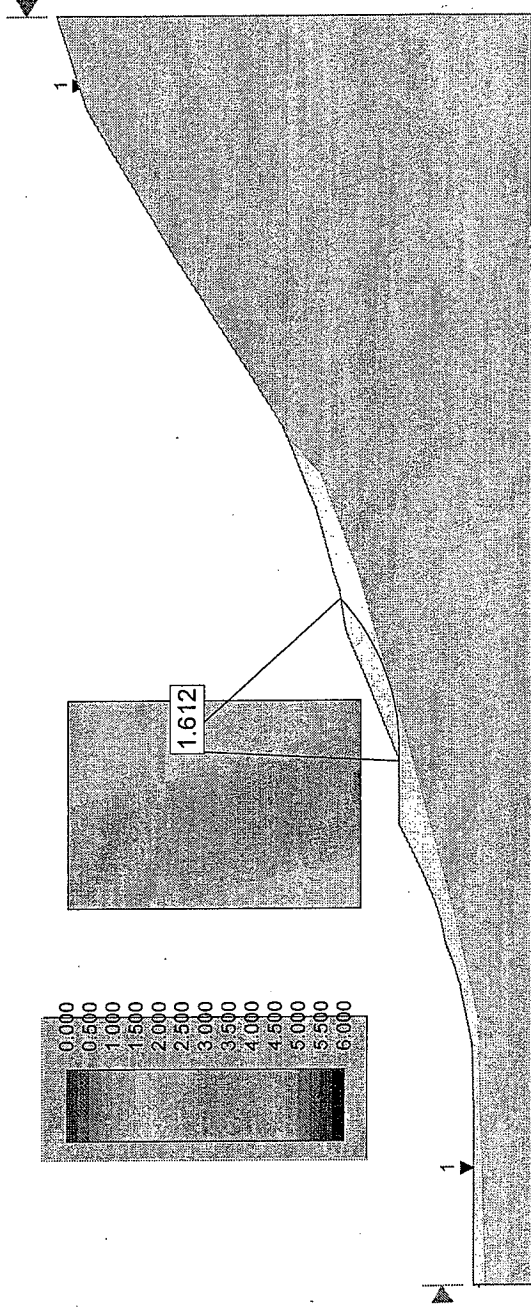
FILE NO. 69201-01-X	DATE DRAWN: 01/24/08
DRAWN BY: RM	APPROVED BY: KE
PROJECT NO. D69201.01	DRAWING NO. 10A

FAILURE SURFACE WITH LOWEST
FACTOR OF SAFETY SHOWN

RESULTS OF SLOPE STABILITY ANALYSES FOR PROPOSED 2½H TO 1V
CUT SLOPES - STATIC CONDITION

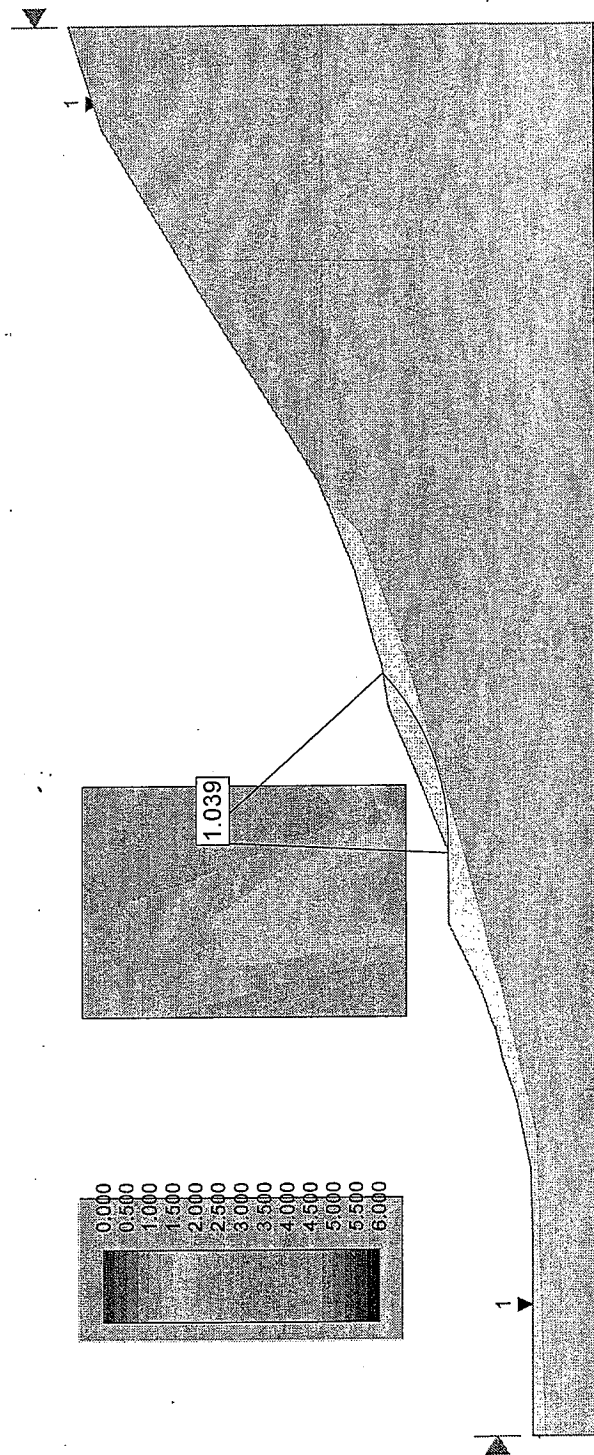
FILE NO. 69201-01-X	DATE DRAWN: 01/24/08
DRAWN BY: RM	APPROVED BY: <i>[Signature]</i>
PROJECT NO. D69201.01	DRAWING NO. 10B

FAILURE SURFACE WITH LOWEST
FACTOR OF SAFETY SHOWN

RESULTS OF SLOPE STABILITY ANALYSES FOR PROPOSED 2 1/2 H TO 1 V
CUT SLOPES - SEISMIC CONDITION

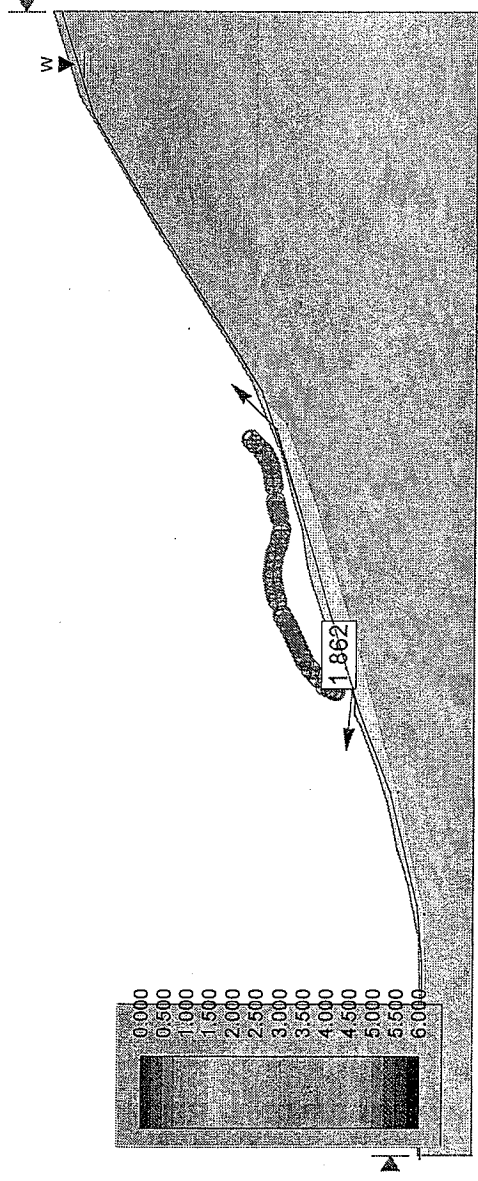
FILE NO. 69201-01-X	DATE DRAWN: 01/24/08
DRAWN BY: RM	APPROVED BY: <i>RM</i>
PROJECT NO. D69201.01	DRAWING NO. 10C

FAILURE SURFACE WITH LOWEST
FACTOR OF SAFETY SHOWN

RESULTS OF SLOPE STABILITY ANALYSES FOR PROPOSED 2 1/2 H TO 1 V
CUT SLOPES - TRANSLATIONAL SLIP FAILURE SURFACES - STATIC
CONDITION

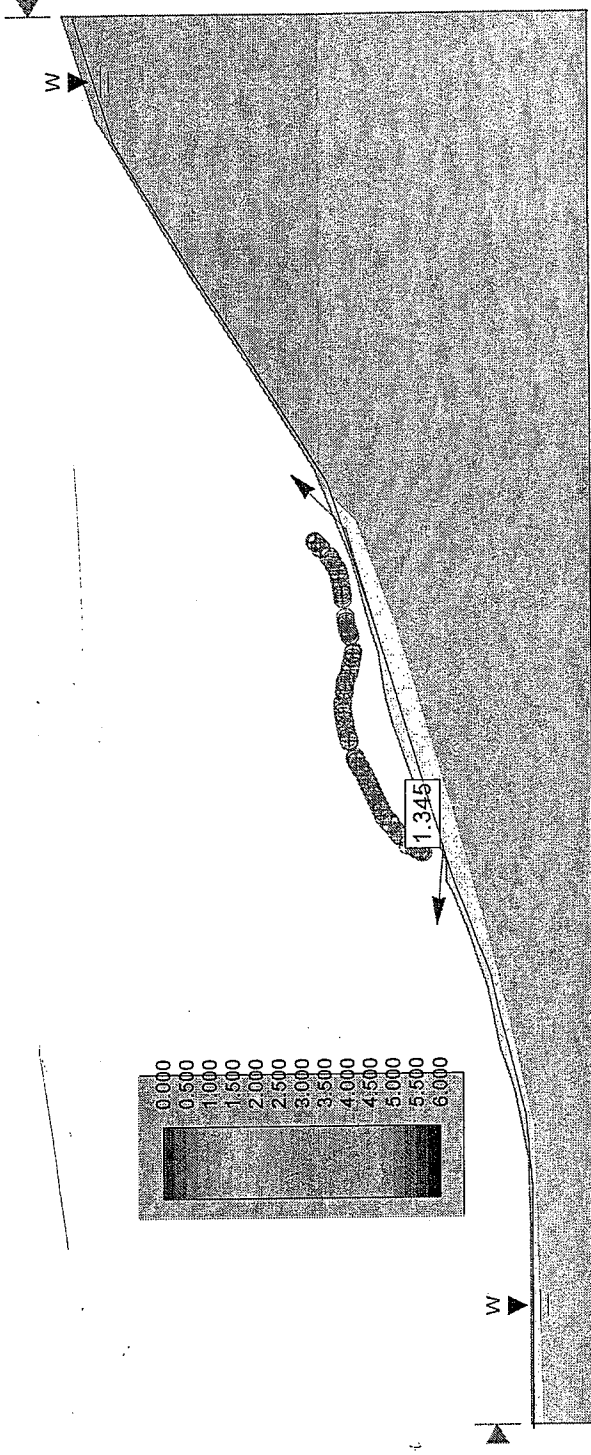
FILE NO. 69201-01-X	DATE DRAWN: 01/24/08
DRAWN BY: RM	APPROVED BY: <i>XC</i>
PROJECT NO. D69201.01	DRAWING NO. 10D

FAILURE SURFACE WITH LOWEST
FACTOR OF SAFETY SHOWN

RESULTS OF SLOPE STABILITY ANALYSES FOR PROPOSED 2 1/2 H TO 1 V
CUT SLOPES - TRANSLATIONAL SLIP FAILURE SURFACES - SEISMIC
CONDITIONS

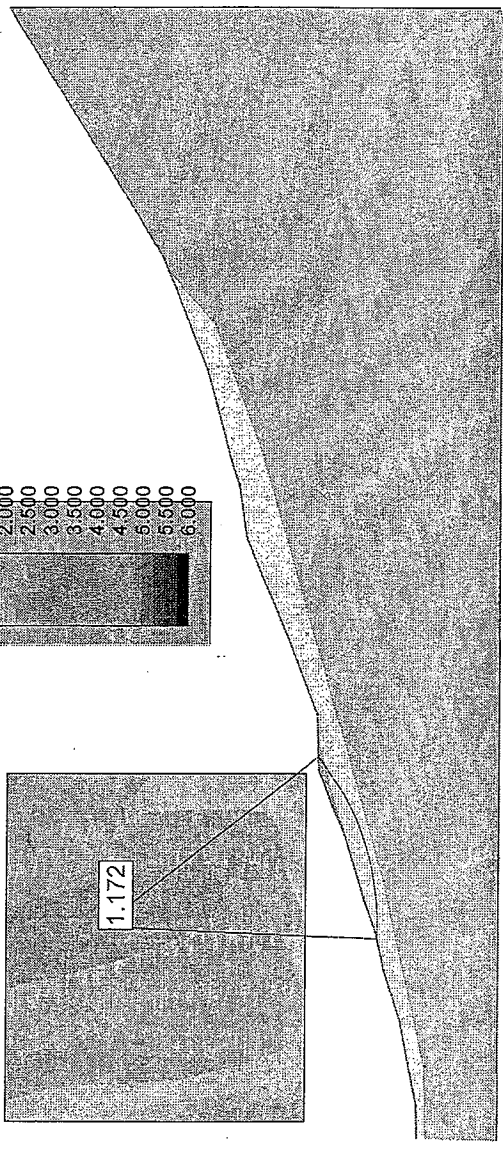
FAILURE SURFACE WITH LOWEST
FACTOR OF SAFETY SHOWN

RESULTS OF SLOPE STABILITY ANALYSES FOR PROPOSED 2 1/4H TO 1V
FILL SLOPES - SEISMIC CONDITION

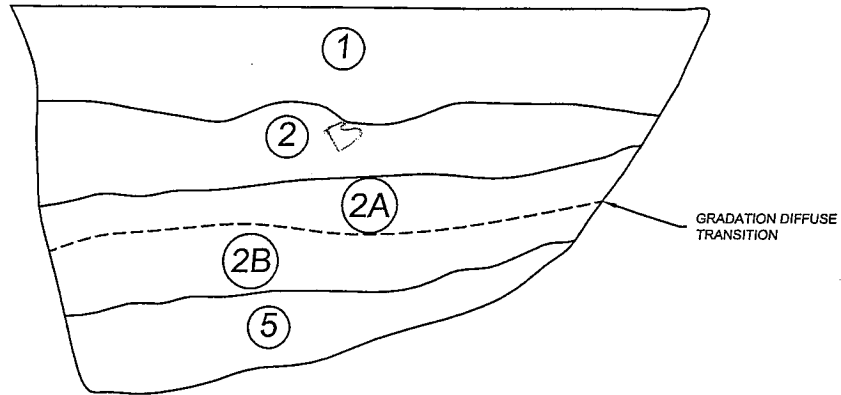
Unit 1: Organic rich top soil: Sandy silt, brown to dark brown, with abundant fine grass rootlets and abundant roots about $\frac{1}{4}$ inch diameter to about $1\frac{1}{2}$ feet below site grade.

Unit 2: Silt: tan to yellowish brown, abundant siltstone, claystone, and porcelanite fragments $\frac{1}{8}$ to 1 inch in diameter. Increase in clay content below about 5 feet below site grade. Granitic boulder note, rounded granitic and fine sandstone cobbles.

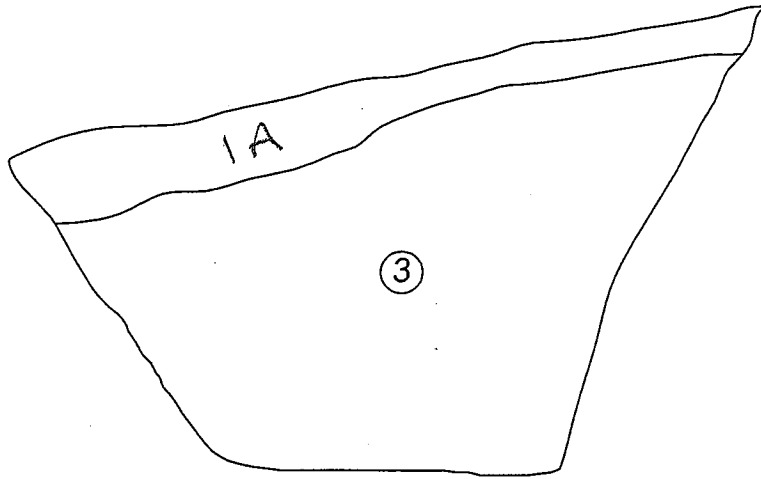
Unit 1A: Silt: greyish tan, some rootlets, abundant siltstone and porcelanite fragments, porous, appears loose.

Unit 3: Lean Clay: Grey, abundant siltstone and porcelanite fragments generally less than 1 inch in diameter.

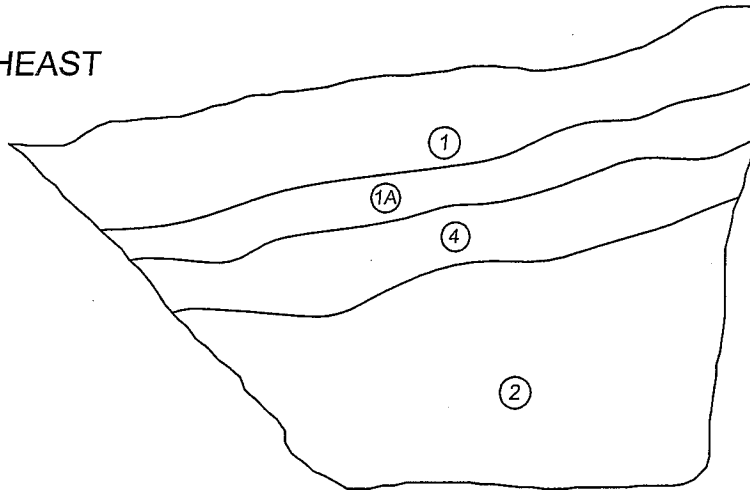
TP-5

Unit 1: Organic rich top soil: Sandy silt, dark brown to black, organic rich with scattered fine grass rootlets to about 18 inches below site grade. Scattered rounded granitic cobbles and pebbles up to 1 foot in diameter. Undulatory bottom surface grading to light grey silt (Unit 1A).

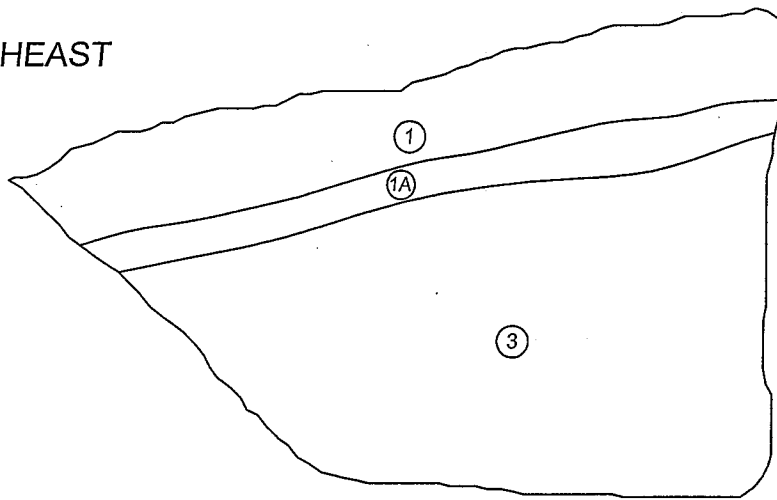
TP-4

Unit 1: Organic rich top soil: Sandy silt, dark grey, organic rich with scattered fine grass rootlets to about 18 inches below site grade. Scattered rounded granitic boulders, cobbles and pebbles. Undulatory bottom surface grading to light grey silt (Unit 1A).

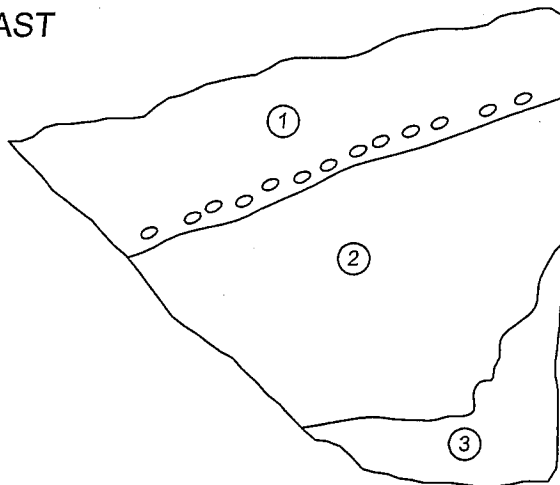
TP-2

Unit 1: Organic rich top soil: Sandy Silt, dark brown to black, organic rich with abundant fine grass rootlets and occasional roots about 1/4 inch diameter. Undulatory bottom surface grading to greyish tan silt (Unit 2).

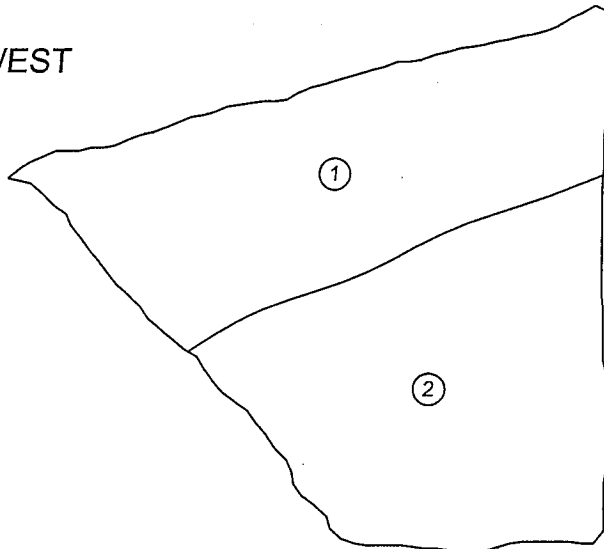
TP-6

Unit 1: Organic rich top soil: Sandy silt, brown to dark brown, organic rich with scattered fine grass rootlets to about 36 inches below site grade and occasional roots to 1/4 inch diameter.

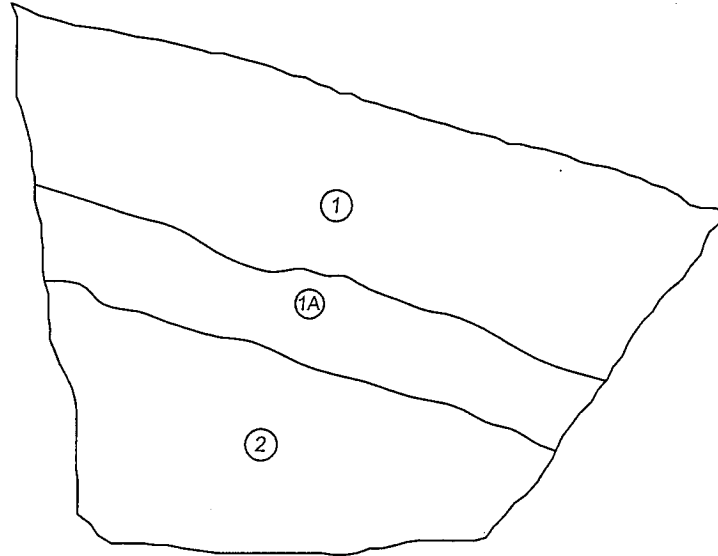
TP-8

Unit 1: Organic rich top soil: Sandy silt, dark brown, organic rich with abundant fine grass rootlets and occasional roots about 1/4 inch diameter to depths of 3 to 3½ feet below site grade. Undulatory bottom surface grading to greyish tan silt (Unit 1A).

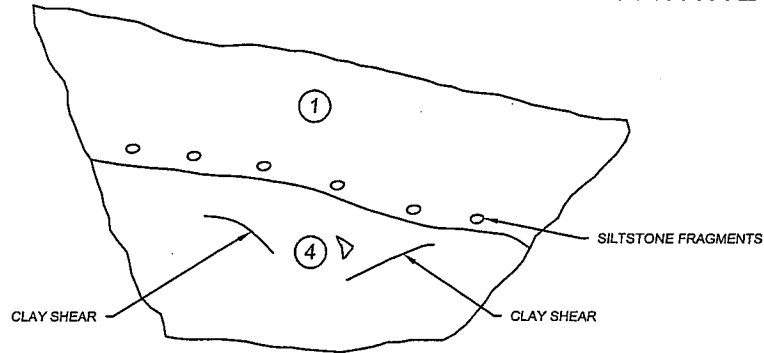
Unit 1: Organic rich top soil: Sandy silt, dark brown, organic rich with abundant fine grass rootlets and occasional roots about 1/4 inch diameter to depth of 2½ feet below site grade. Undulatory bottom surface with angular siltstone fragments notable near bottom of unit.

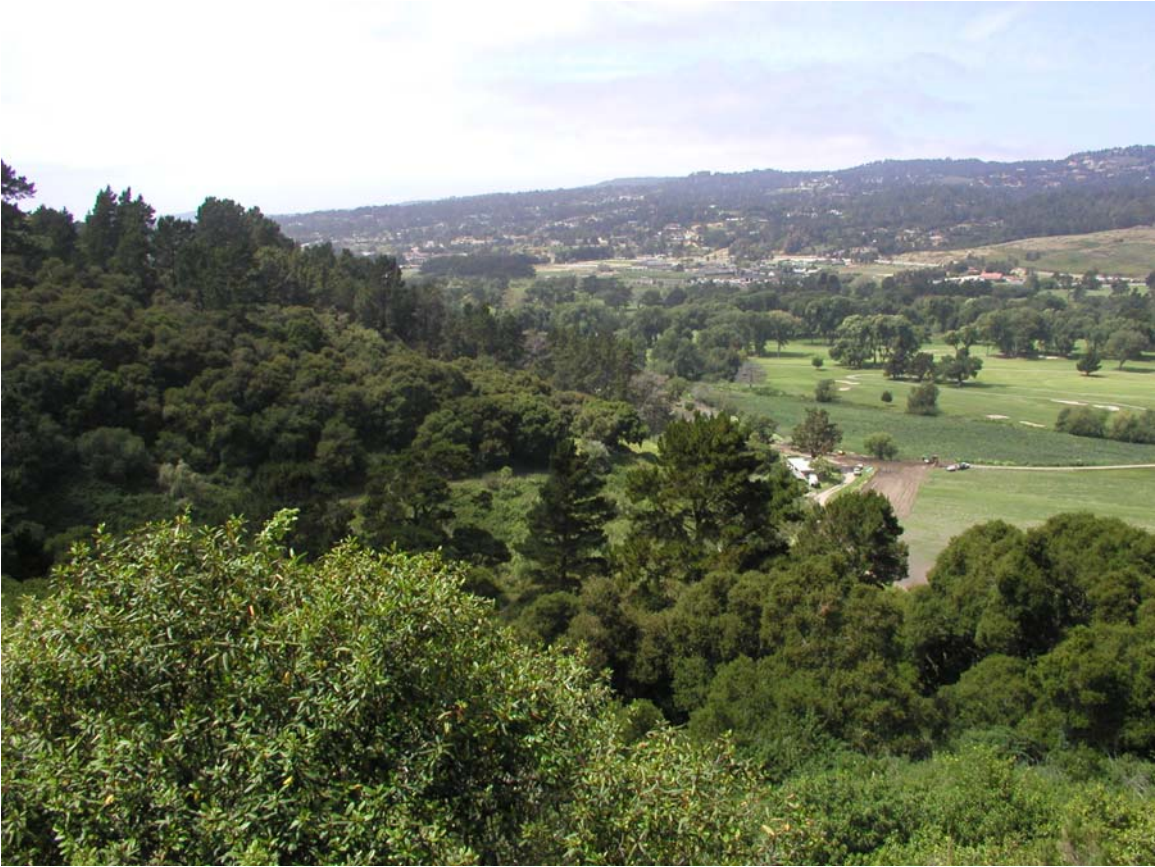
At the time of the field investigation, an existing residence was noted in the north central portion of the site, downslope (north) of the Lot 10 home site (see Photograph No. 1, Appendix D). Existing out buildings were also noted in the central portion of Lot 10. It is our understanding that the existing residence and buildings will remain after development of the site. Other existing improvements noted on the site included a total of three (3) water wells located just east of Lot 8, just north of Lot 5, and in the north-central portion of Lot 10, respectively (see Drawing No. 2 for approximate well locations).

Photograph No. 1: View to northwest toward site. Wooded hillside with lots 8 and 10 (Lot 10 includes existing residence) in mid-ground with Quail Lodge Resort golf course beyond.

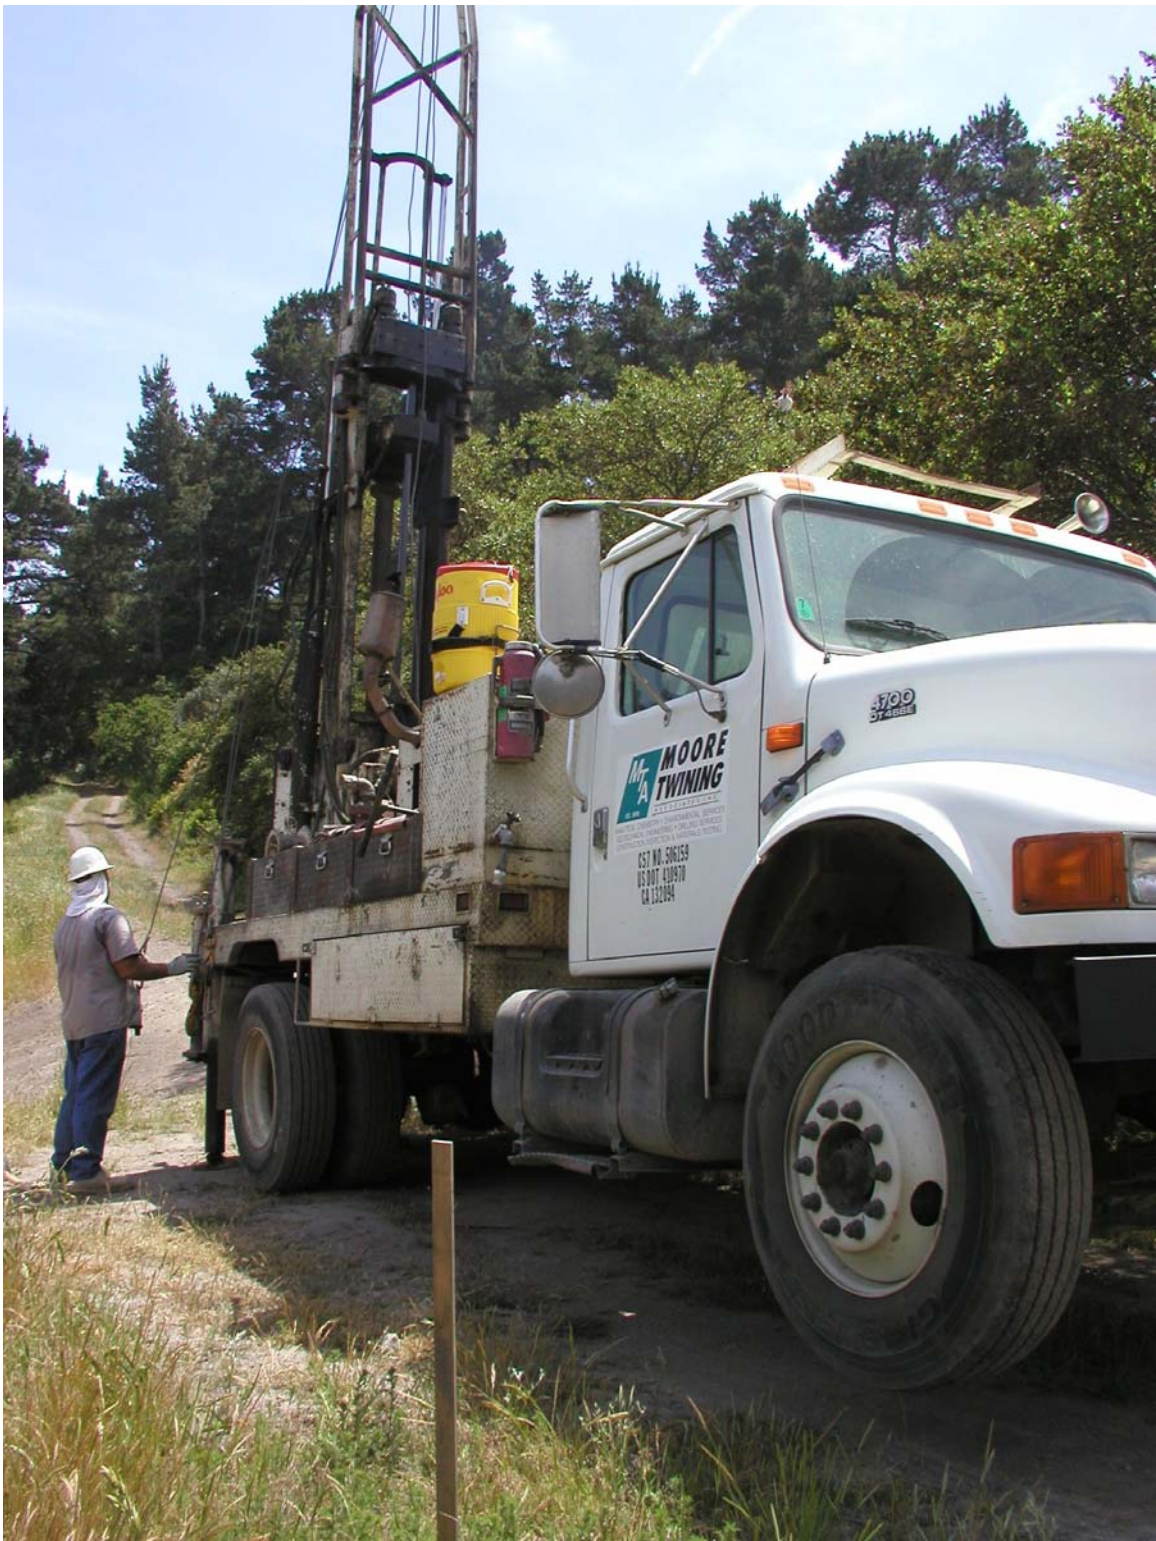
Photograph No. 2: Drilling at test boring B-2.

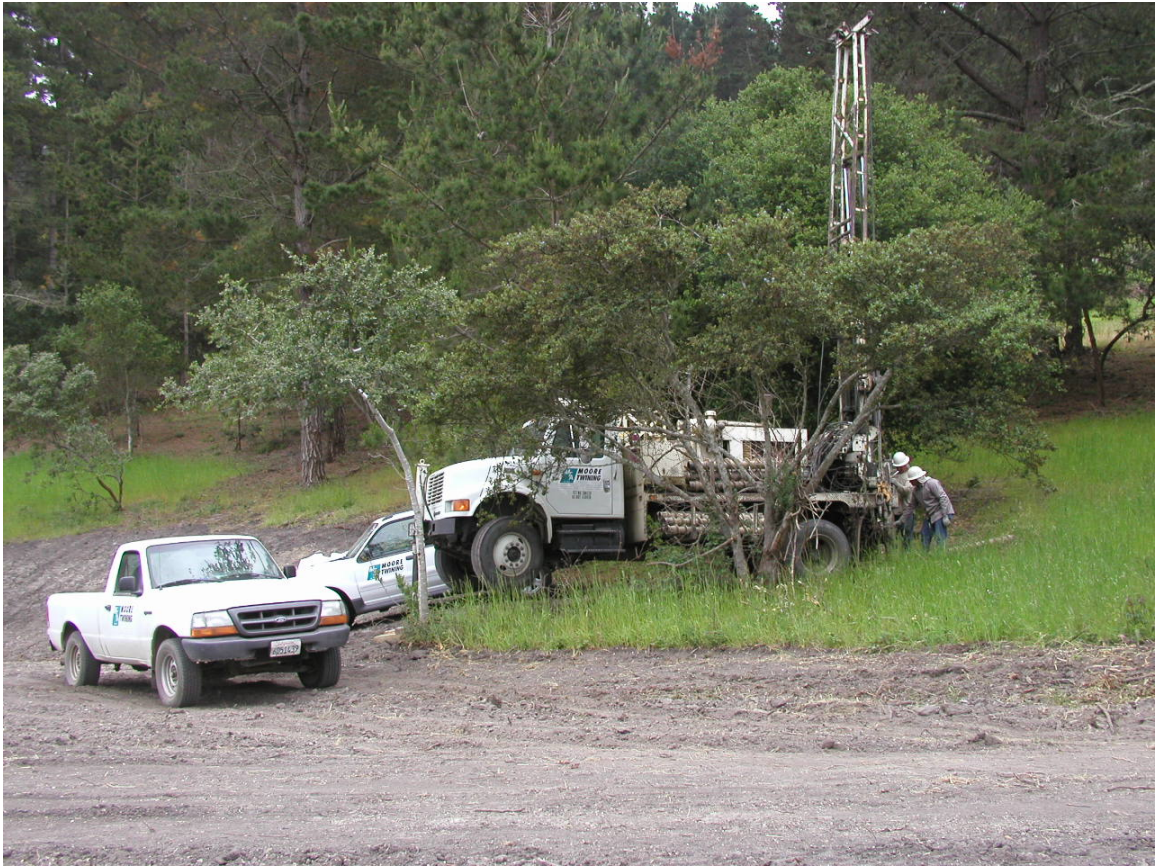
Photograph No. 3: Drilling at test boring B-5, Lot 1.
