**PRELIMINARY
GEOTECHNICAL ENGINEERING AND
GEOLOGIC INVESTIGATION
PROPOSED RANCHO EL POTRERO
TEN (10) LOT RESIDENTIAL SUBDIVISION, PLN060603
APN 157-181-006, 007, AND 008
CARMEL, MONTEREY COUNTY, CALIFORNIA**

Project Number: D69201.01-01

January 16, 2008

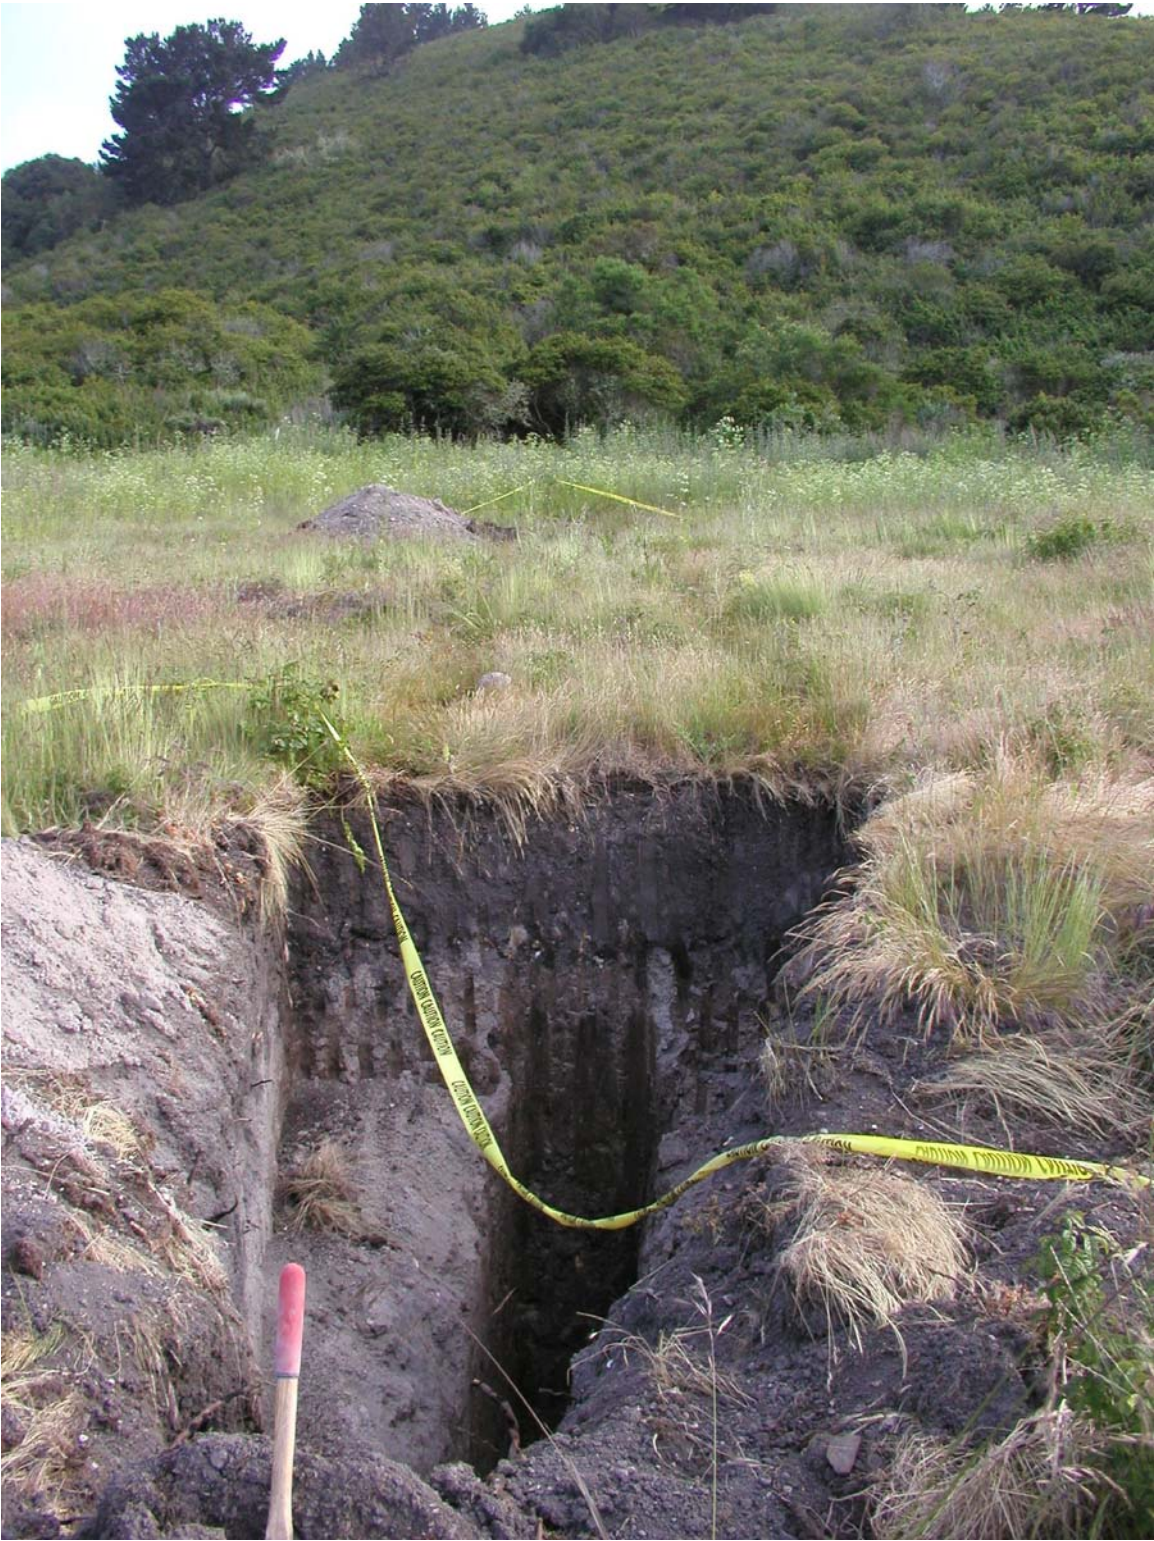
Photograph No. 16: View toward the south across Lot 5 home site area and test pit TP-2.

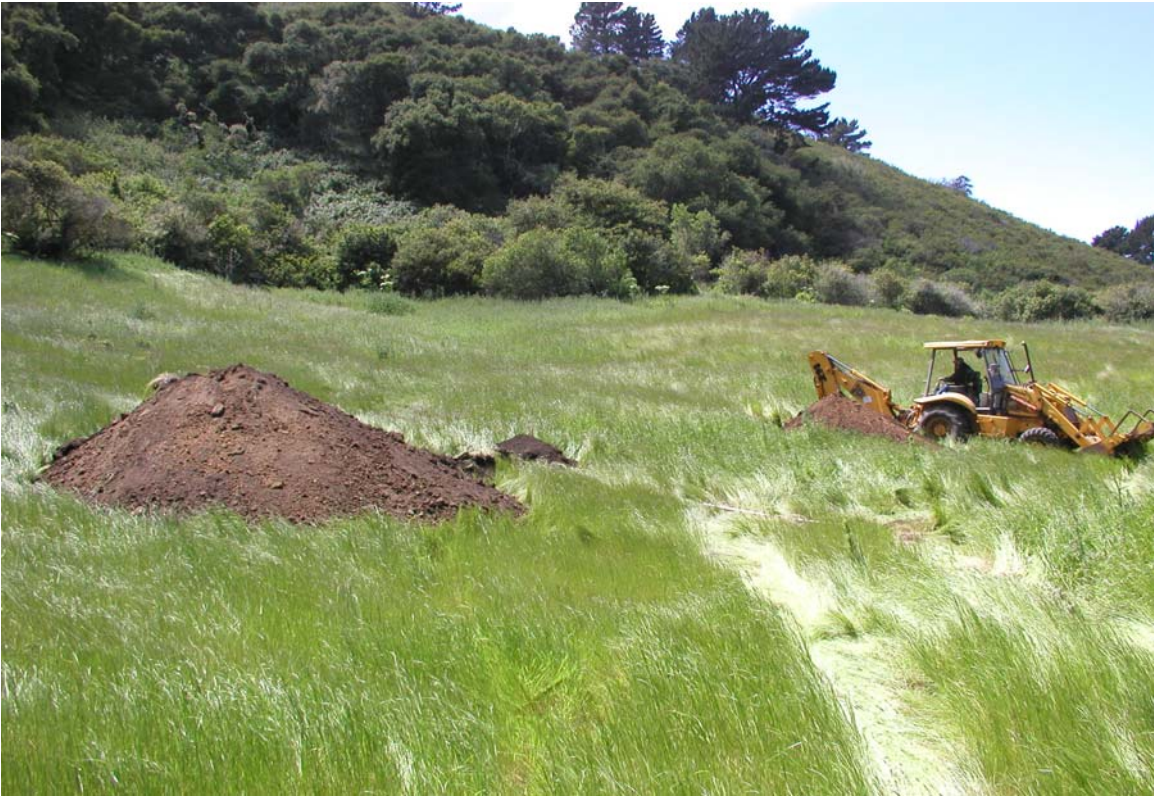
Photograph No. 17: View toward west across Lot 6 showing test pits TP-6 and TP-7.

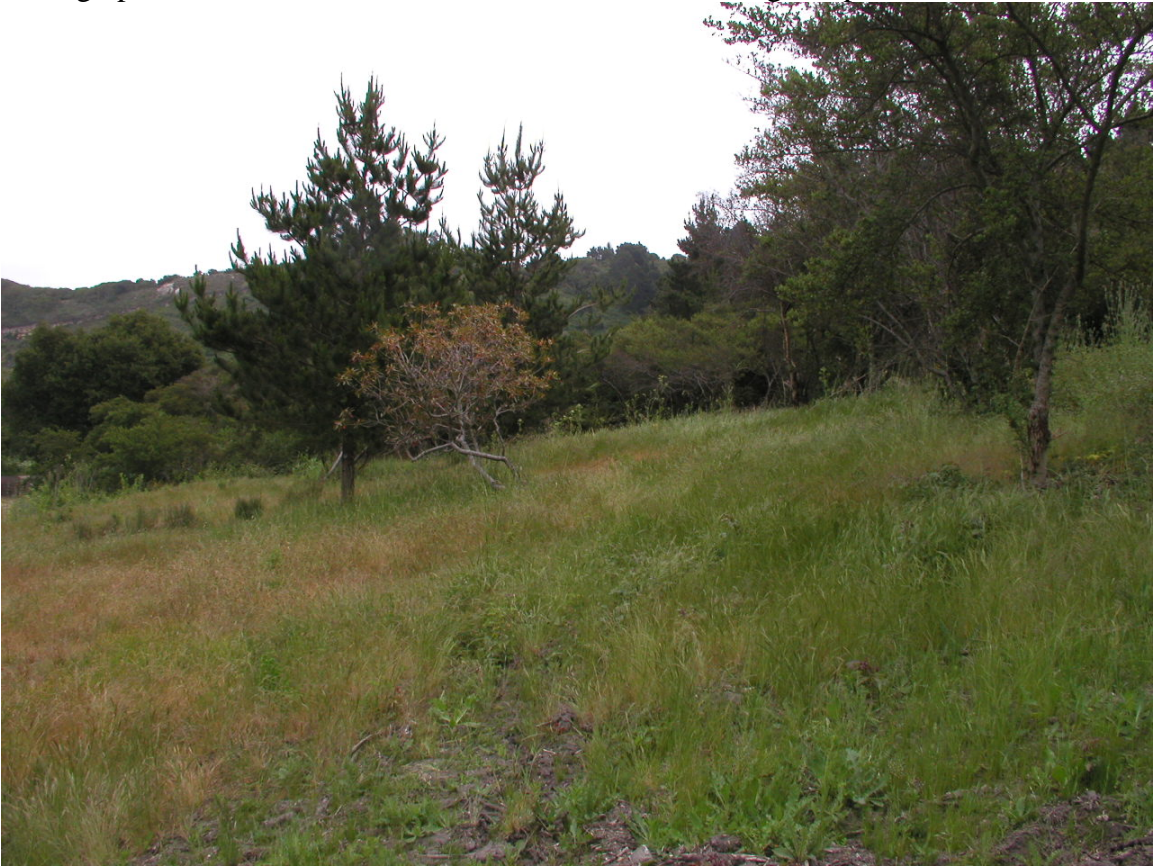
Photograph No. 18: View toward east across Lot 2.
