PORTER-VALLEJO MANSION/ PAJARO BRANCH LIBRARY REPAIRS

HRRB DRAWING SUBMITTAL
MONTEREY COUNTY

DECEMBER 07, 2023

29 BISHOP STREET PAJARO, CA 95076

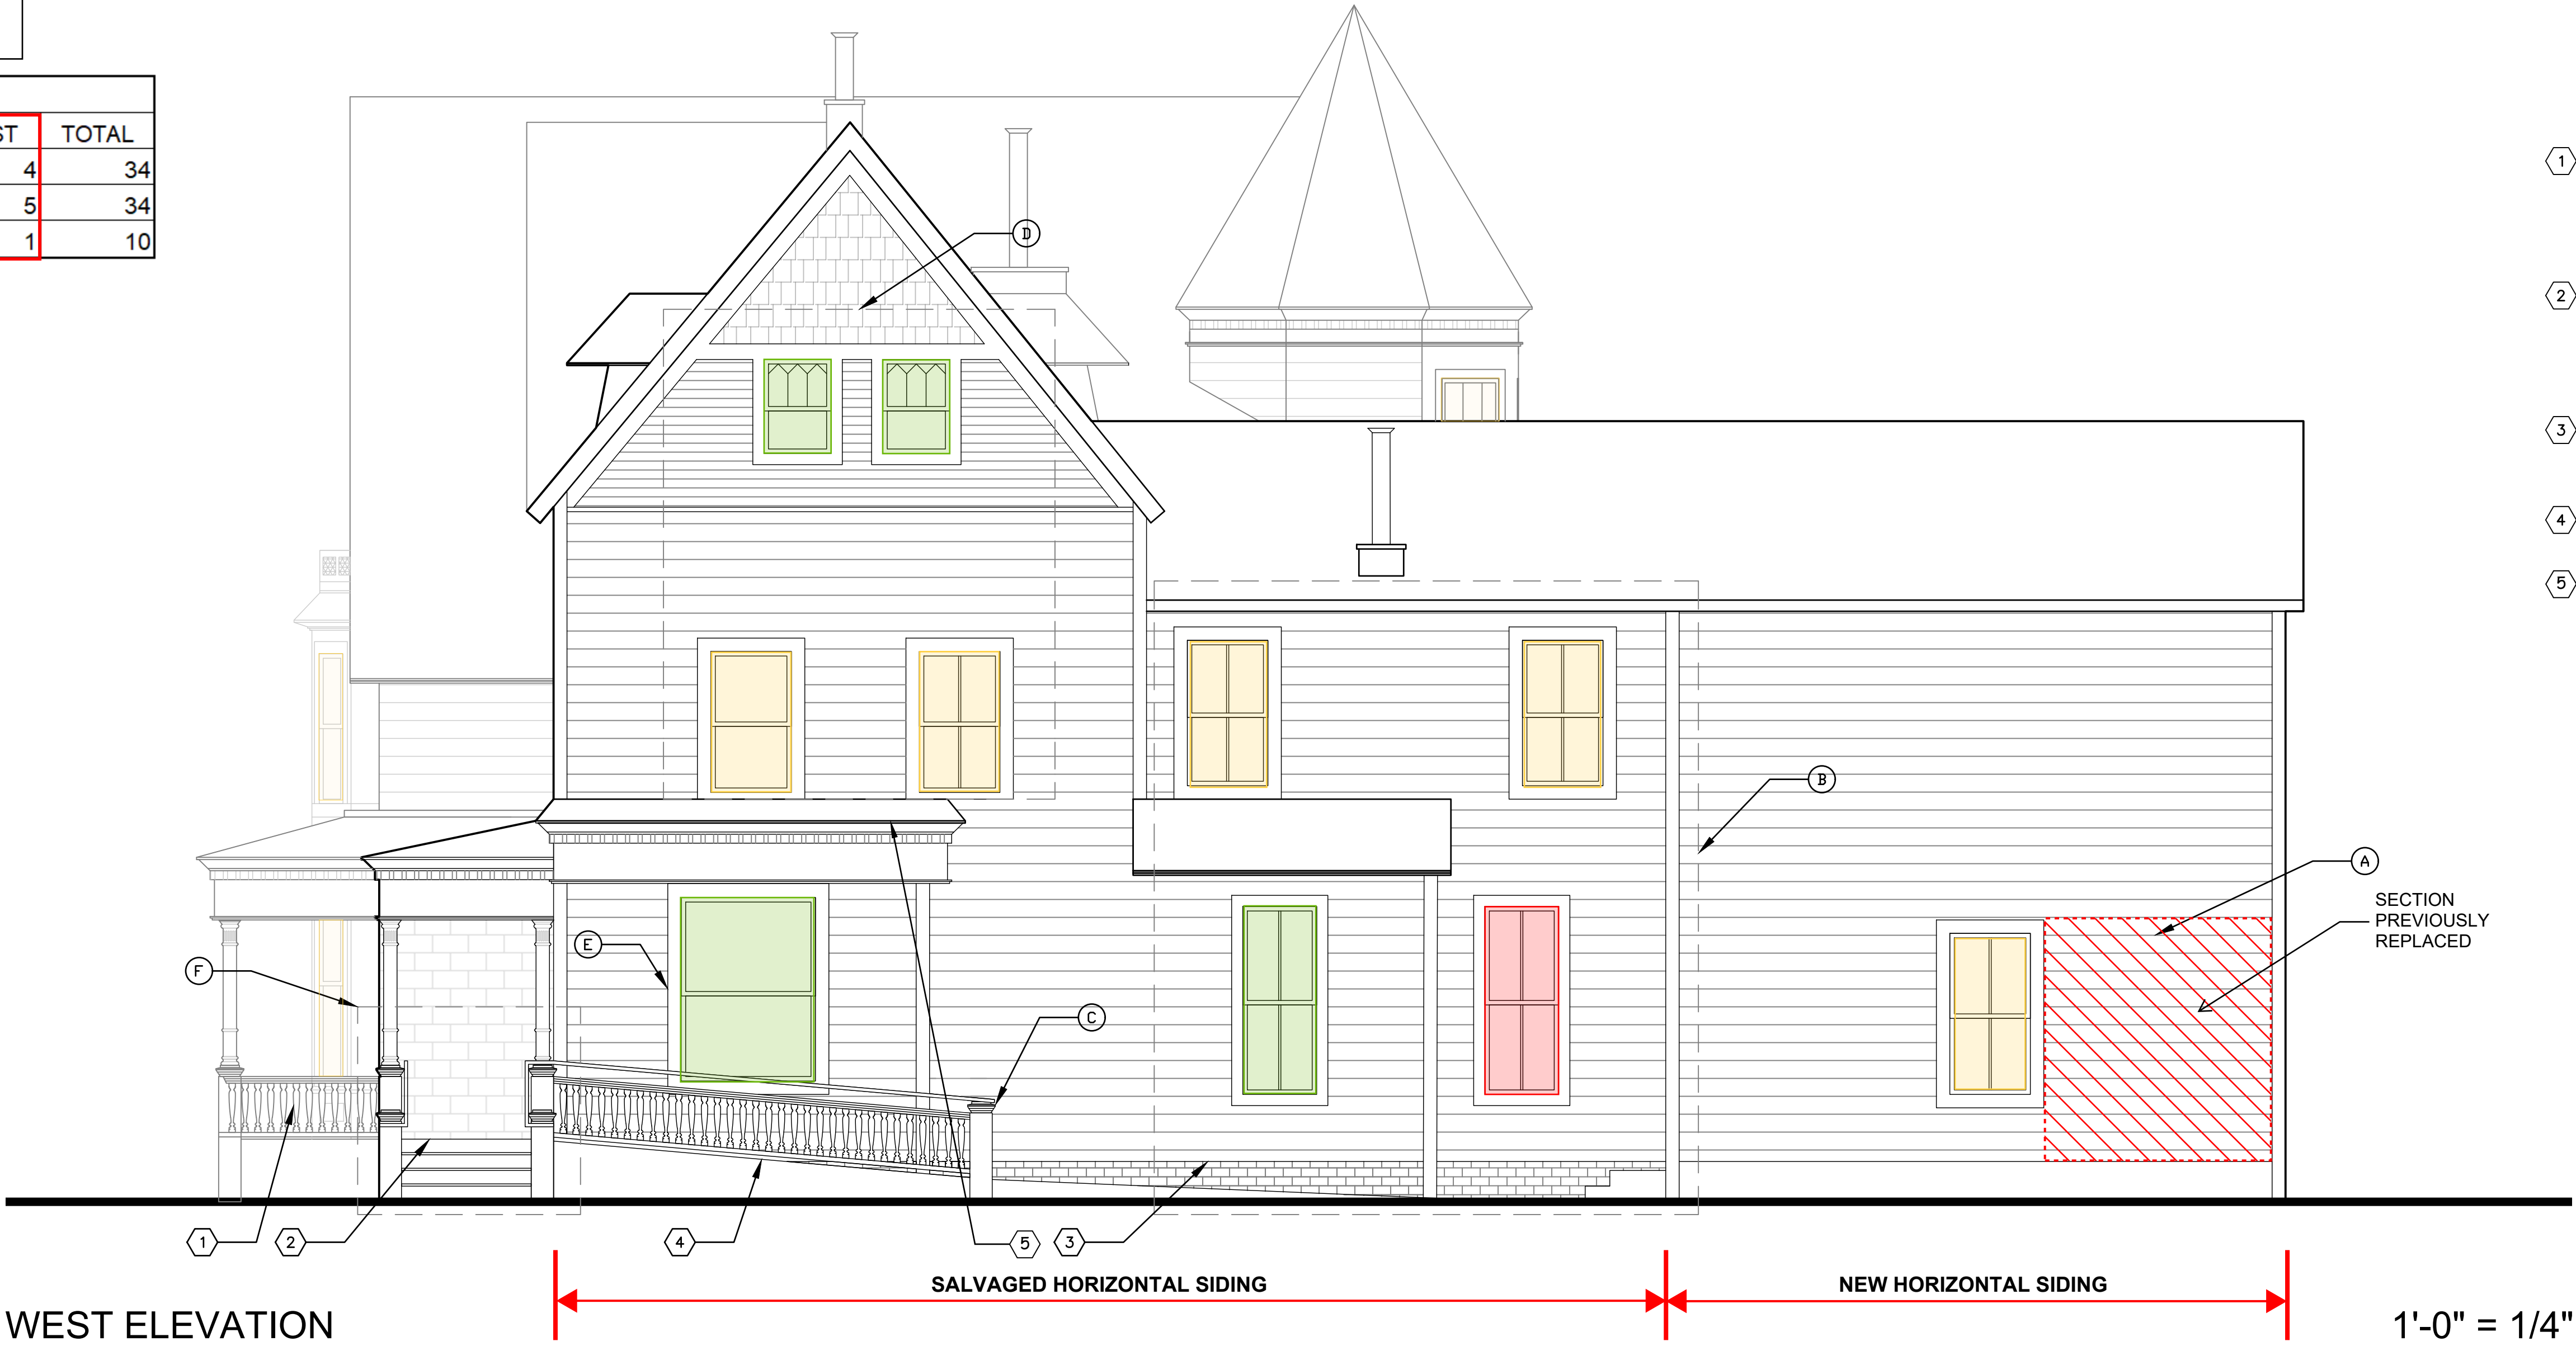
WINDOW CONDITION					
CONDITION	NORTH	EAST	SOUTH	WEST	TOTAL
GOOD	21	4	5	4	34
FAIR	7	14	8	5	34
POOR	1	2	6	1	10

POOR
WINDOW IS CRACKED OR HAS BB HOLE. SASH IS COMPROMISED, AND OR JAMBS ARE NOT HOLDING SASH IN PLACE. JAMB AND/OR SILL IS ROTTED OR MISSING.

THE WEST FACADE (EXCEPT FOR 1924 ADDITION) SIDING TO BE PLACED WITH 100% SALVAGED HORIZONTAL SHIPLAP SIDING. 1924 ADDITION SIDING TO BE REMOVED, SALVAGED, AND REPLACED WITH AMERICANA THERMALLY MODIFIED WOOD SIDING TO MATCH EXISTING PROFILE. ALL PRESERVATION SHALL BE IN ALIGNMENT & COMPLIANCE WITH THE HRRB PHASE II REPORT*

1. ALL CHIMNEYS ARE PLACEHOLDERS.
2. CONTRACTOR TO PROTECT ANY EXISTING FOUNDATION VENTS OR OPENINGS WITH 1/4" WIRE MESH MINIMUM.
3. SIDING TO BE REMOVED AND SALVAGED.
4. TRIM TO BE REMOVED AND SALVAGED.
5. ALL WINDOWS WHERE SHIP LAP SIDING IS REMOVED TO RECEIVE FLASHING ON ALL 4 SIDES.

1. EXISTING WOOD RAILINGS AND TURNED PICKETS TO BE REPAIRED AS NEEDED WASH WITH GENTLE BRUSH AND REPAINTED TO MATCH EXISTING. REPLACE IF DAMAGE IS TOO SEVERE TO MATCH EXISTING PROFILE.
2. WOOD DECKING TO BE REPLACED WITH AMERICANA THERMALLY MODIFIED WOOD, MILLED TO MATCH EXISTING WIDTH AND LAYOUT TO BE INSTALLED TO MATCH EXITING PATTERN
3. REPLACE FOUNDATION FASCIA BASEBOARDS WITH NEW TO MATCH EXISTING SIZING AND PAINTED COLOR.
4. EXISTING RAMP TO REMAIN AND REPAIRS TO MATCH EXISTING RAILING AND COLORS.
5. EXISTING GUTTERS TO REMAIN.

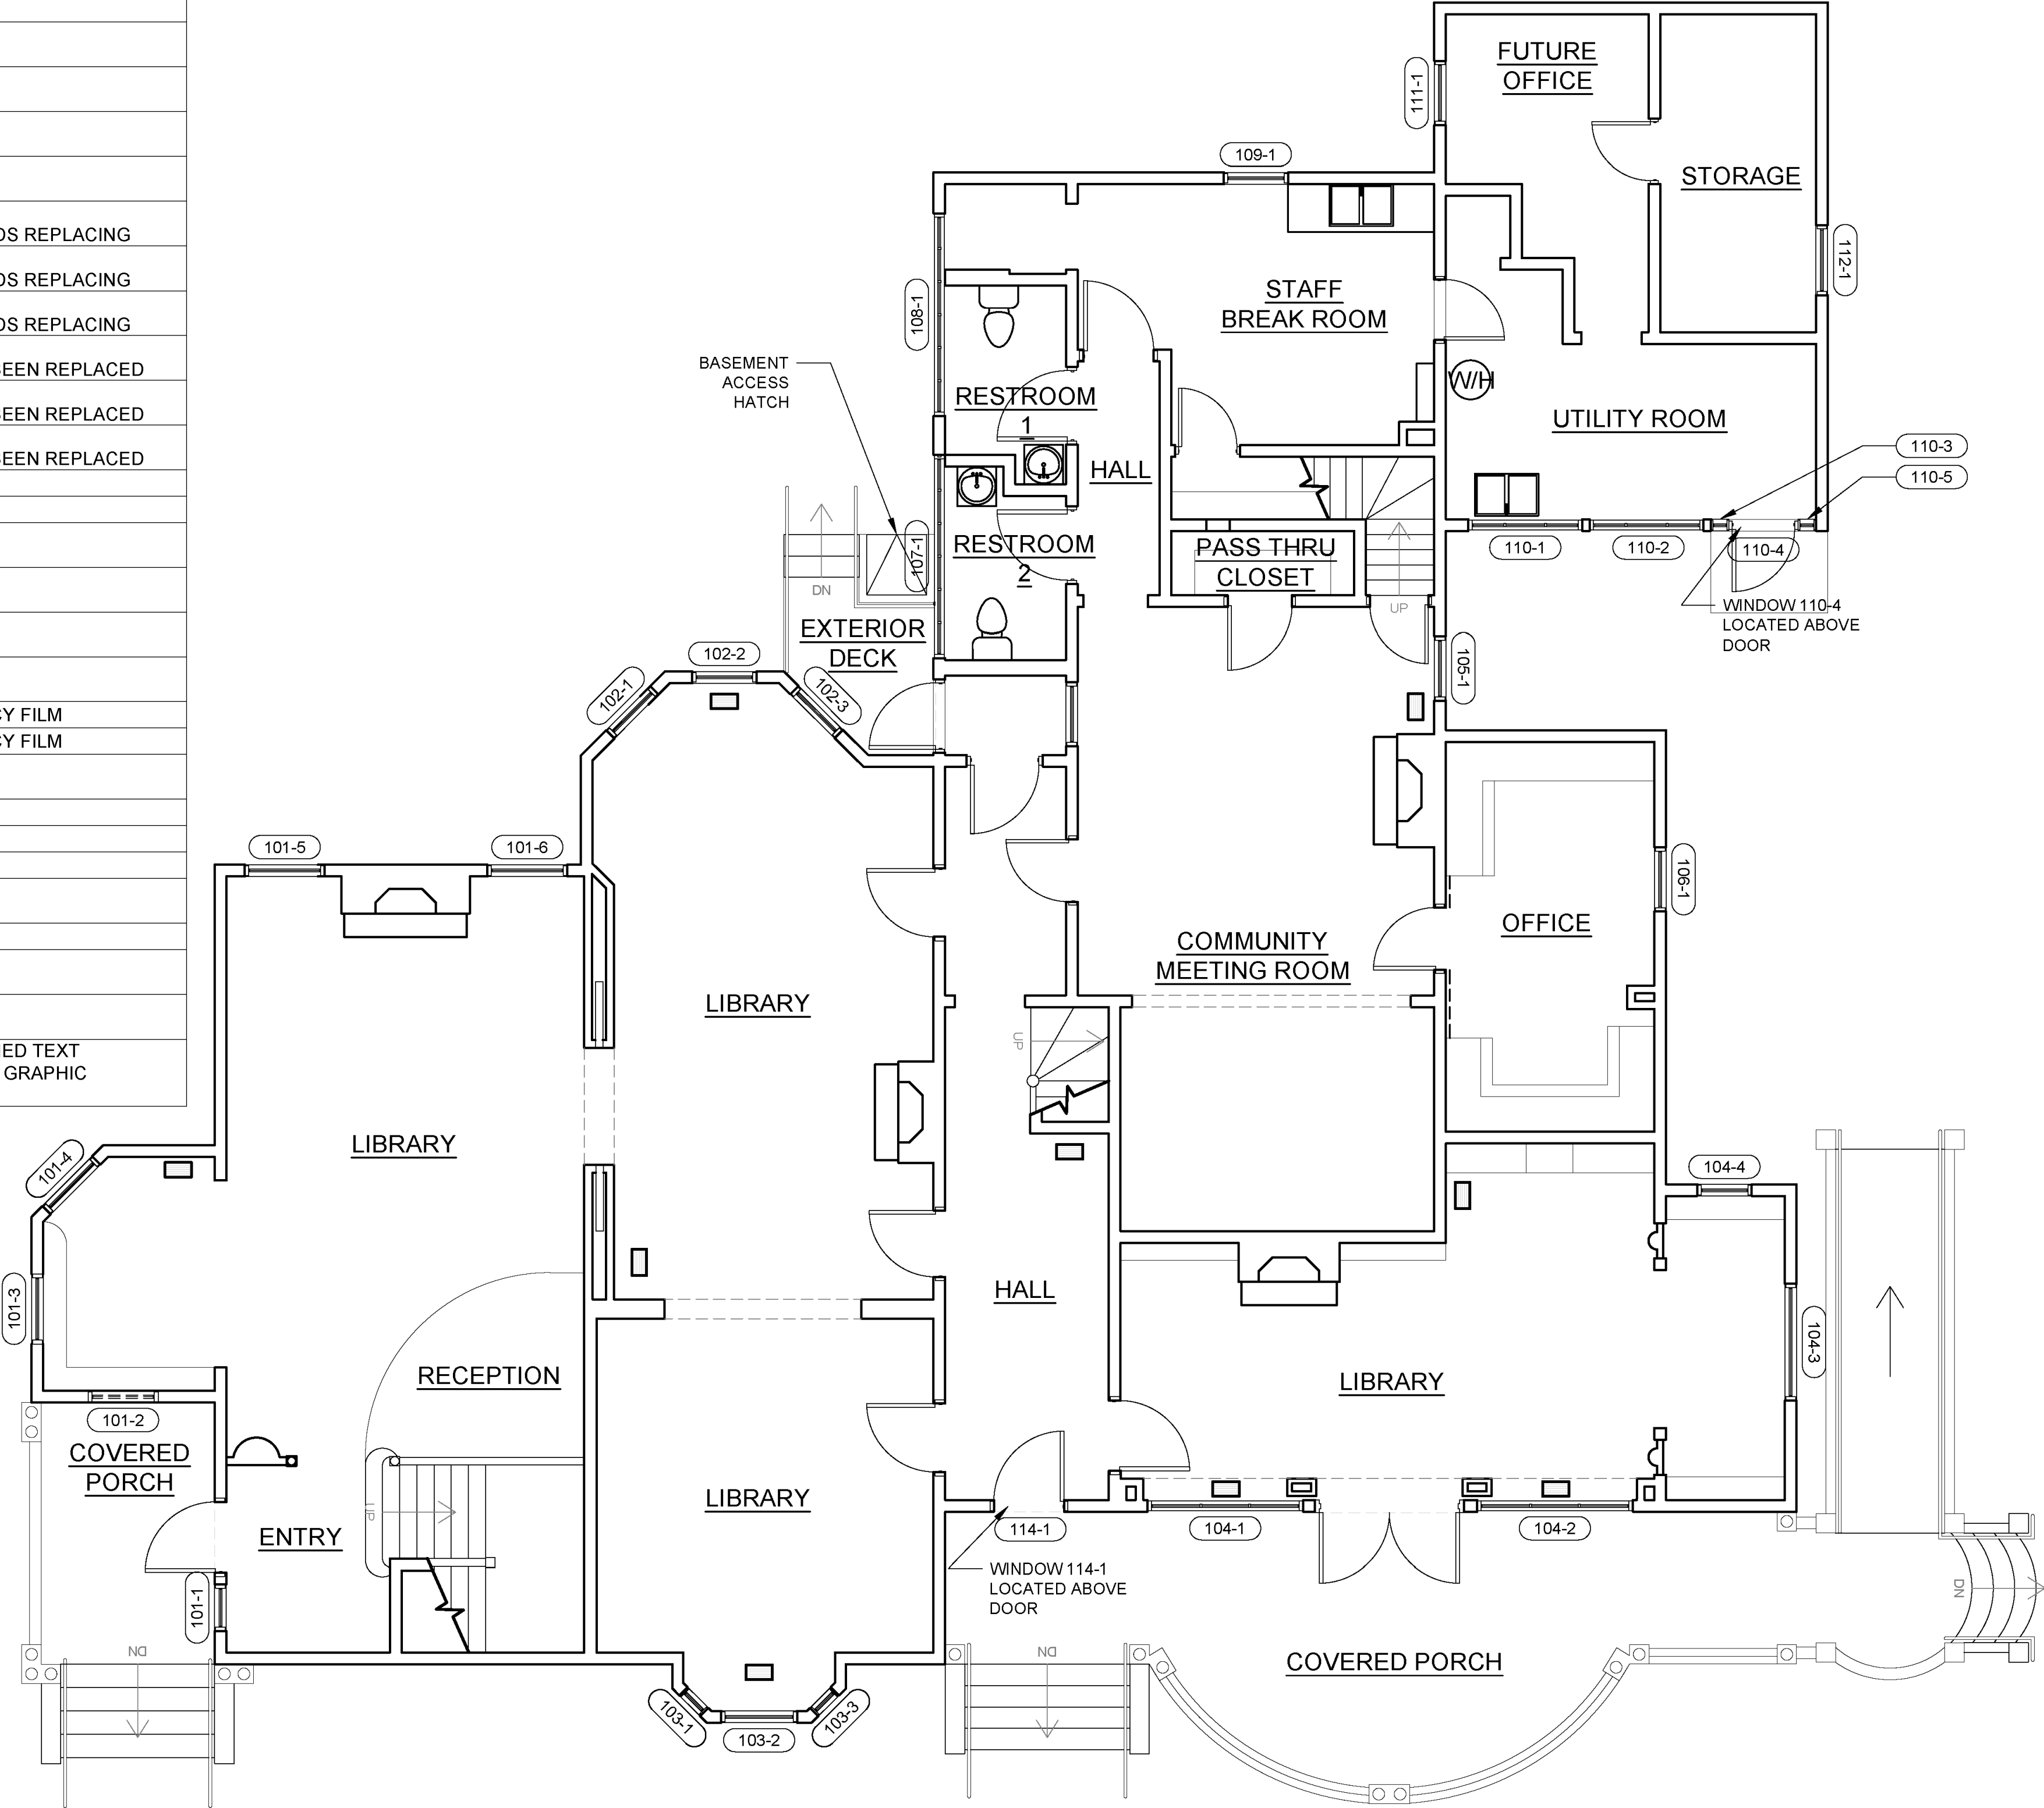
FIRST FLOOR PLAN - WINDOW TAGS

WINDOW MATRIX												
WINDOW TAG	DIMENSIONS			OPERABLE (Y/N)	OPERABLE TYPE	DESIGN FEATURE			ORIGINAL GLASS (Y/N)	VANDALISM GLASS (Y/N)	WINDOW CONDITION	COMMENT
	HEIGHT	WIDTH	SILL HEIGHT			LEADED GLASS (Y/N)	STAINED GLASS (Y/N)	OTHER				
101-1	2'-11 1/2"	1'-9 1/2"	3'-10 1/2"	N	-	N	N	-	N	Y	GOOD	
101-2	1'-2"	2'-11"	7'-6 1/2"	N	-	N	N	-	N	Y	GOOD	
101-3	2'-11"	4'-7"	4'-2"	Y	SINGLE HUNG	Y	Y	-	N	Y	GOOD	
101-4	2'-11"	6'-3"	2'-6"	Y	SINGLE HUNG	Y	Y	-	N	Y	FAIR	
101-5	3'-5"	4'-6"	4'-1 1/2"	Y	SINGLE HUNG	N	N	-	N	Y	FAIR	
101-6	3'-5"	4'-6"	4'-1 1/2"	Y	SINGLE HUNG	N	N	-	N	Y	FAIR	
102-1	6'-11"	2'-8"	2'-1"	N	SINGLE HUNG	N	N	-	N	Y	POOR	WINDOW STUCK SILL POOR - NEEDS REPLACING
102-2	6'-11"	2'-8"	2'-1"	N	SINGLE HUNG	N	N	-	N	Y	POOR	WINDOW STUCK SILL POOR - NEEDS REPLACING
102-3	6'-11"	2'-8"	2'-1"	N	SINGLE HUNG	N	N	-	N	Y	POOR	WINDOW STUCK SILL POOR - NEEDS REPLACING
103-1	7'-0"	1'-3"	1'-9"	N	SINGLE HUNG	N	N	-	N	Y	FAIR	WINDOW STUCK JAMB TRIM HAS BEEN REPLACED

103-2	7'-0"	3'-4"	1'-9"	N	SINGLE HUNG	N	N	-	N	Y	FAIR	WINDOW STUCK JAMB TRIM HAS BEEN REPLACED
103-3	7'-0"	1'-3"	1'-9"	N	SINGLE HUNG	N	N	-	N	Y	FAIR	WINDOW STUCK JAMB TRIM HAS BEEN REPLACED
104-1	5'-10"	6'-9"	2'-6"	N	-	N	N	-	N	Y	GOOD	
104-2	5'-10"	6'-9"	2'-6"	N	-	N	N	-	N	Y	GOOD	
104-3	6'-6"	4'-11"	2'-4"	Y	SINGLE HUNG	N	N	-	N	Y	GOOD	
104-4	6'-0"	3'-2"	3'-0"	Y	SINGLE HUNG	N	N	-	N	Y	FAIR	
105-1	5'-11"	2'-11"	2'-0"	Y	SINGLE HUNG	N	N	-	N	Y	POOR	
106-1	5'-9"	2'-11"	1'-8"	Y	SINGLE HUNG	N	N	-	N	Y	GOOD	
107-1	5'-7"	8'-0"	2'-0"	N	-	N	N	-	N	Y	EXCELLENT	FROSTED PRIVACY FILM
108-1	5'-7"	8'-0"	2'-0"	N	-	N	N	-	N	Y	EXCELLENT	FROSTED PRIVACY FILM
109-1	6'-11"	2'-9"	2'-1"	N	SINGLE HUNG	N	N	-	N	Y	GOOD	WINDOW STUCK
110-1	3'-4"	4'-0"	4'-1"	N	-	N	N	-	N	Y	GOOD	
110-2	3'-4"	4'-0"	4'-1"	N	-	N	N	-	N	Y	GOOD	
110-3	3'-3"	0'-8"	4'-1"	N	-	N	N	-	N	Y	GOOD	
110-4	0'-8"	2'-8"	ABOVE DOOR	N	-	N	N	-	N	Y	GOOD	
110-5	3'-3"	0'-8"	4'-1"	N	-	N	N	-	N	Y	GOOD

111-1	6'-0"	2'-10"	2'-4"	Y	SINGLE HUNG	N	N	-	N	Y	FAIR	
112-1	6'-0"	2'-10"	1'-7 1/2"	Y	SINGLE HUNG	N	N	-	N	Y	FAIR	
114-1	2'-0"	3'-0"	ABOVE DOOR	N	-	N	N	Y	Y	N	GOOD	FROSTED & ETCHED TEXT "J.PORTER" WITH GRAPHIC FLOURISHES

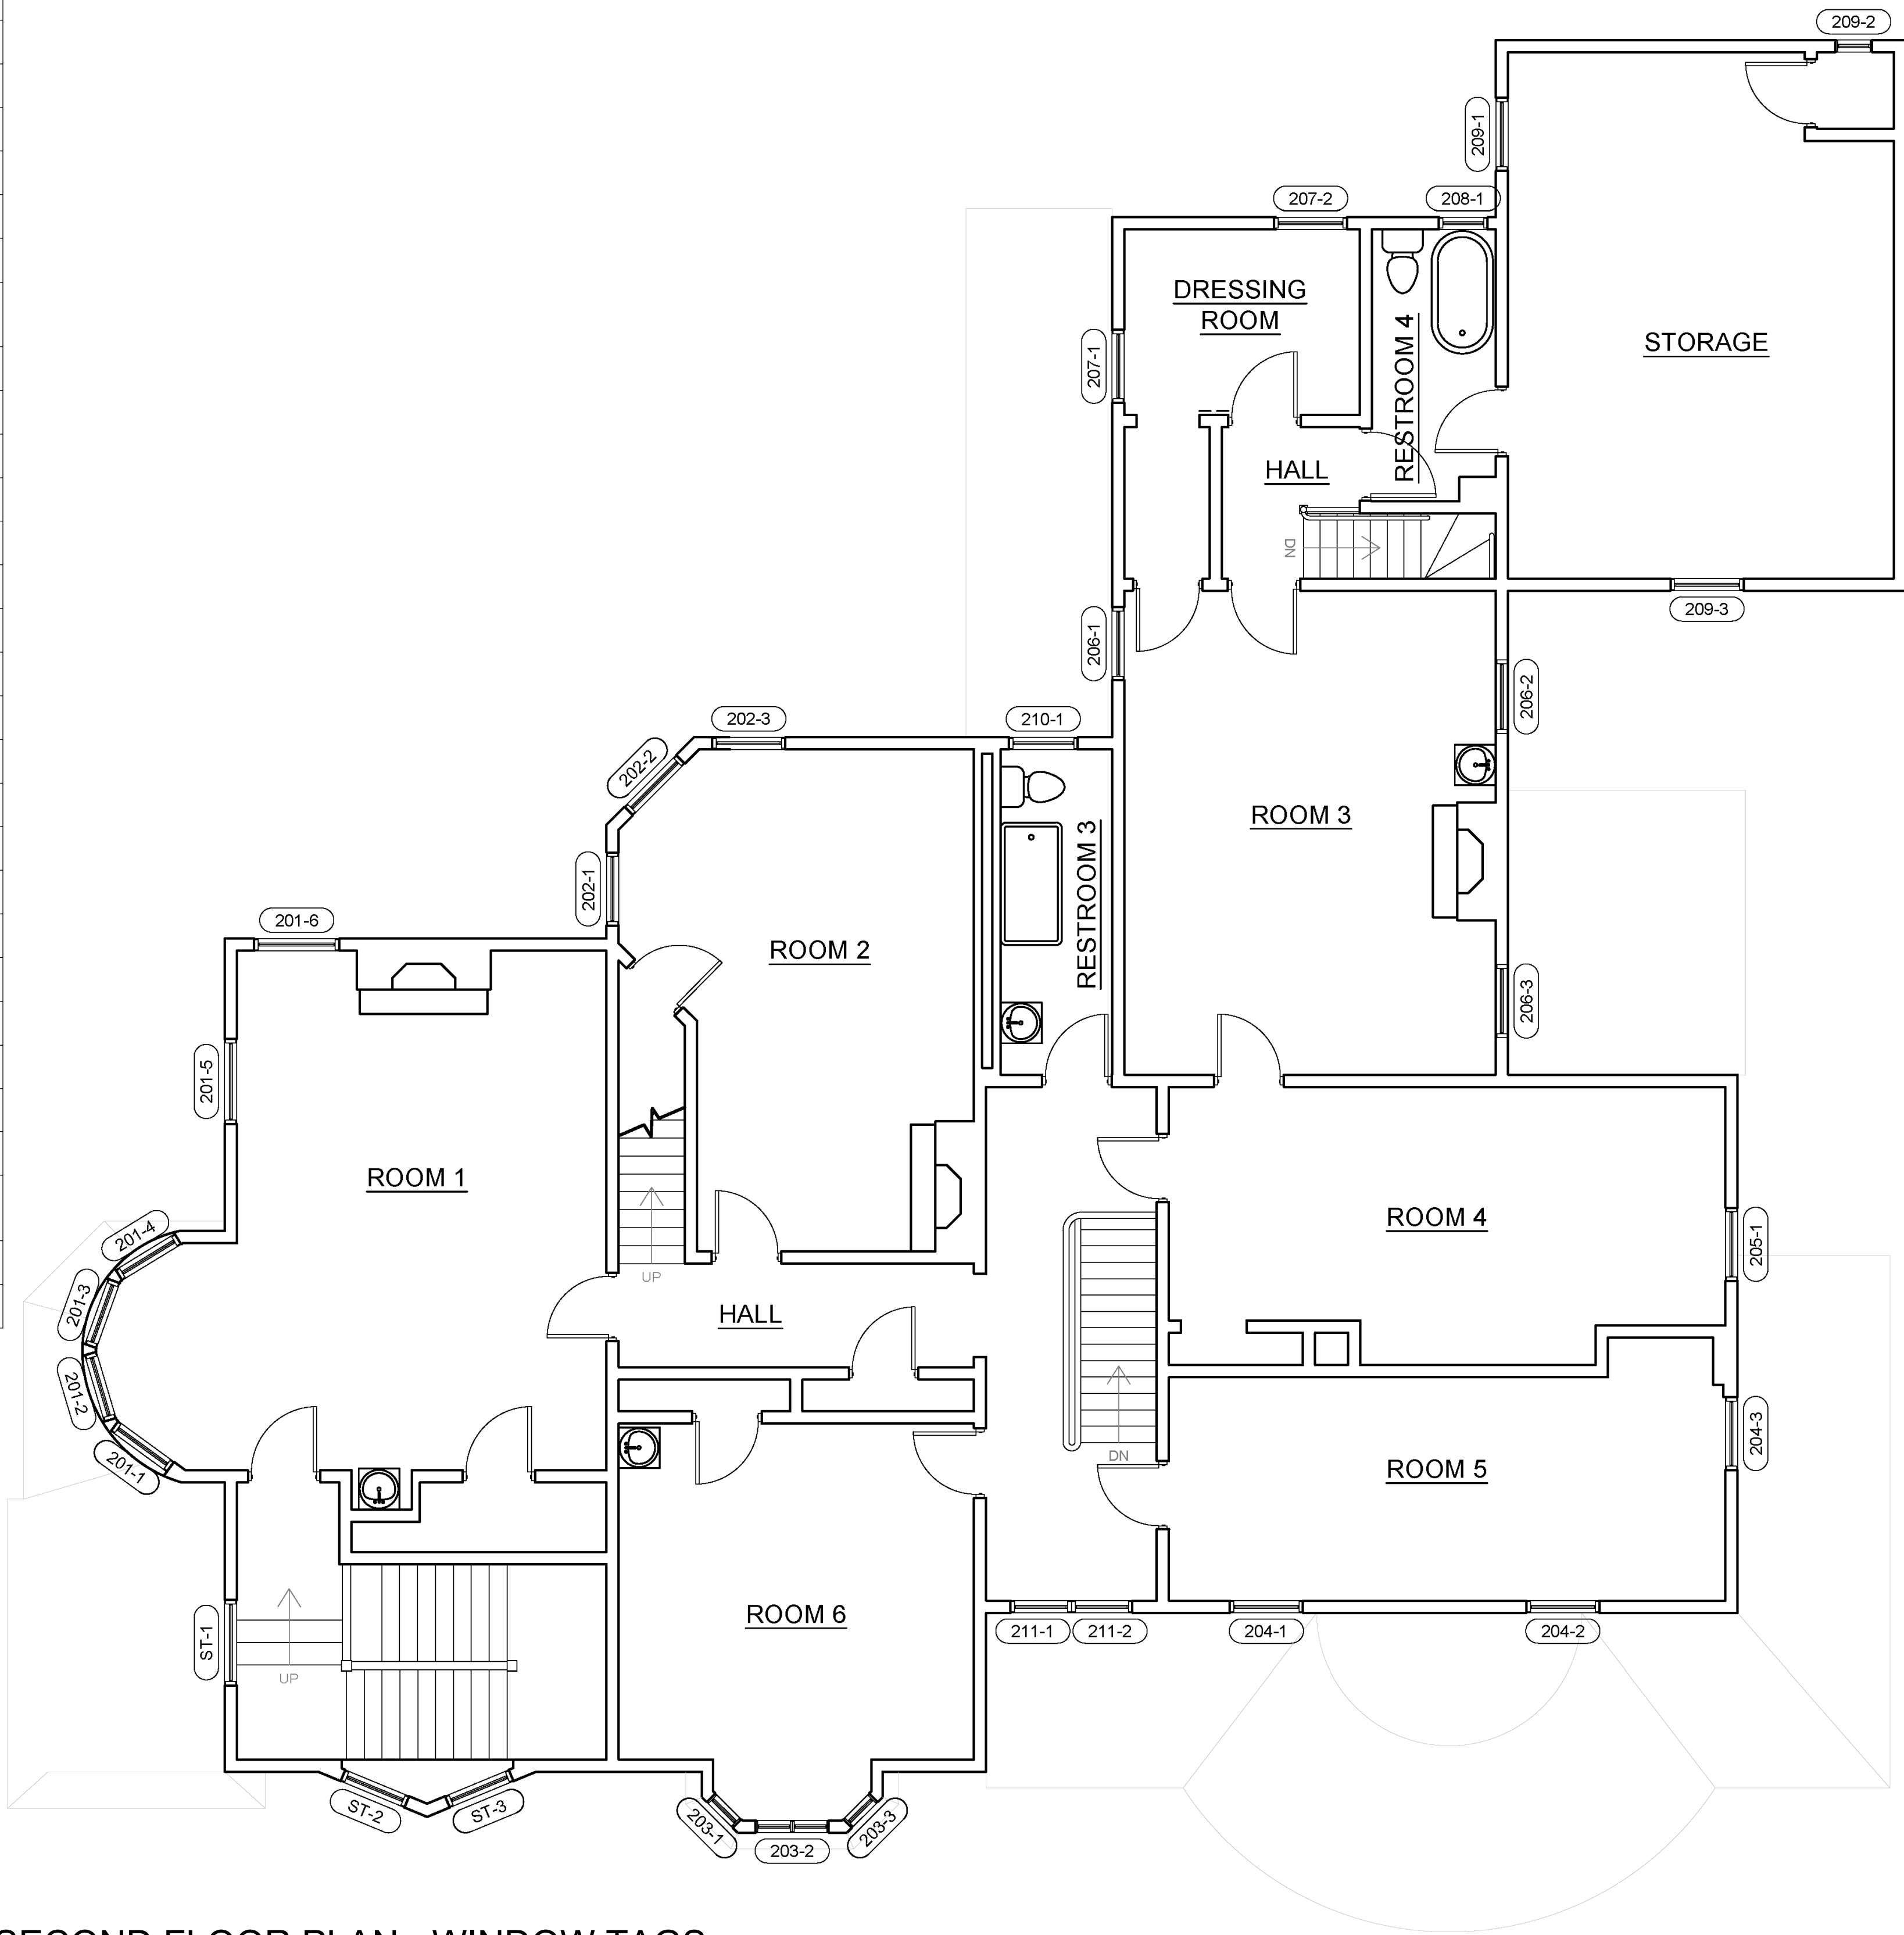
SECOND FLOOR PLAN - WINDOW TAGS

WINDOW MATRIX												
WINDOW TAG	DIMENSIONS			OPERABLE (Y/N)	OPERABLE TYPE	DESIGN FEATURE			ORIGINAL GLASS (Y/N)	VANDALISM GLASS (Y/N)	WINDOW CONDITION	COMMENT
	HEIGHT	WIDTH	SILL HEIGHT			LEADED GLASS (Y/N)	STAINED GLASS (Y/N)	OTHER				
ST-1	1'-9"	3'-4"	-	Y	HINGE SIDE	N	N	-	Y	N	POOR	ONE "DIAMOND" BROKEN & DUCT TAPED
ST-2	1'-9"	3'-4"	-	Y	HINGE SIDE	N	N	-	Y	N	FAIR	
ST-3	1'-9"	3'-4"	4'-5"	Y	HINGE BOTTOM	N	N	-	Y	N	FAIR	
201-1	4'-9"	2'-10"	2'-0"	Y	DOUBLE HUNG	N	N	-	N	Y	FAIR	OPAQUE FILM
201-2	4'-9"	2'-10"	2'-0"	Y	DOUBLE HUNG	N	N	-	N	Y	FAIR	OPAQUE FILM
201-3	4'-9"	2'-10"	2'-0"	Y	DOUBLE HUNG	N	N	-	N	Y	FAIR	OPAQUE FILM
201-4	4'-9"	2'-10"	2'-0"	Y	DOUBLE HUNG	N	N	-	N	Y	FAIR	OPAQUE FILM
201-5	1'-9"	3'-4"	4'-4 1/2"	Y	HINGE BOTTOM	N	N	-	N	Y	FAIR	OPAQUE FILM
201-6	5'-9"	3'-6"	2'-0"	Y	SINGLE HUNG	N	N	-	N	Y	POOR	OPAQUE FILM VERTICAL CRACK IN BOTTOM PANE
202-1	6'-4"	3'-6"	2'-0"	Y	SINGLE HUNG	N	N	-	N	Y	FAIR	SHADE FILM

209-2	1'-6"	1'-0"	4'-0"	N	-	N	N	-	N	Y	GOOD	
209-3	6'-11"	3'-0"	0'-5 1/2"	Y	DOUBLE HUNG	N	N	-	N	Y	POOR	
210-1	5'-10"	2'-7"	2'-1"	Y	SINGLE HUNG	N	N	Y	?	N	FAIR	SMALL CORNER CRACK TEXTURED GLASS INTERIOR SIDE - QUILTED GRID
211-1	2'-0"	2'-0"	2'-2"	Y	HINGE BOTTOM	N	N	-	N	Y	GOOD	
211-2	2'-0"	2'-0"	2'-2"	Y	HINGE BOTTOM	N	N	-	N	Y	GOOD

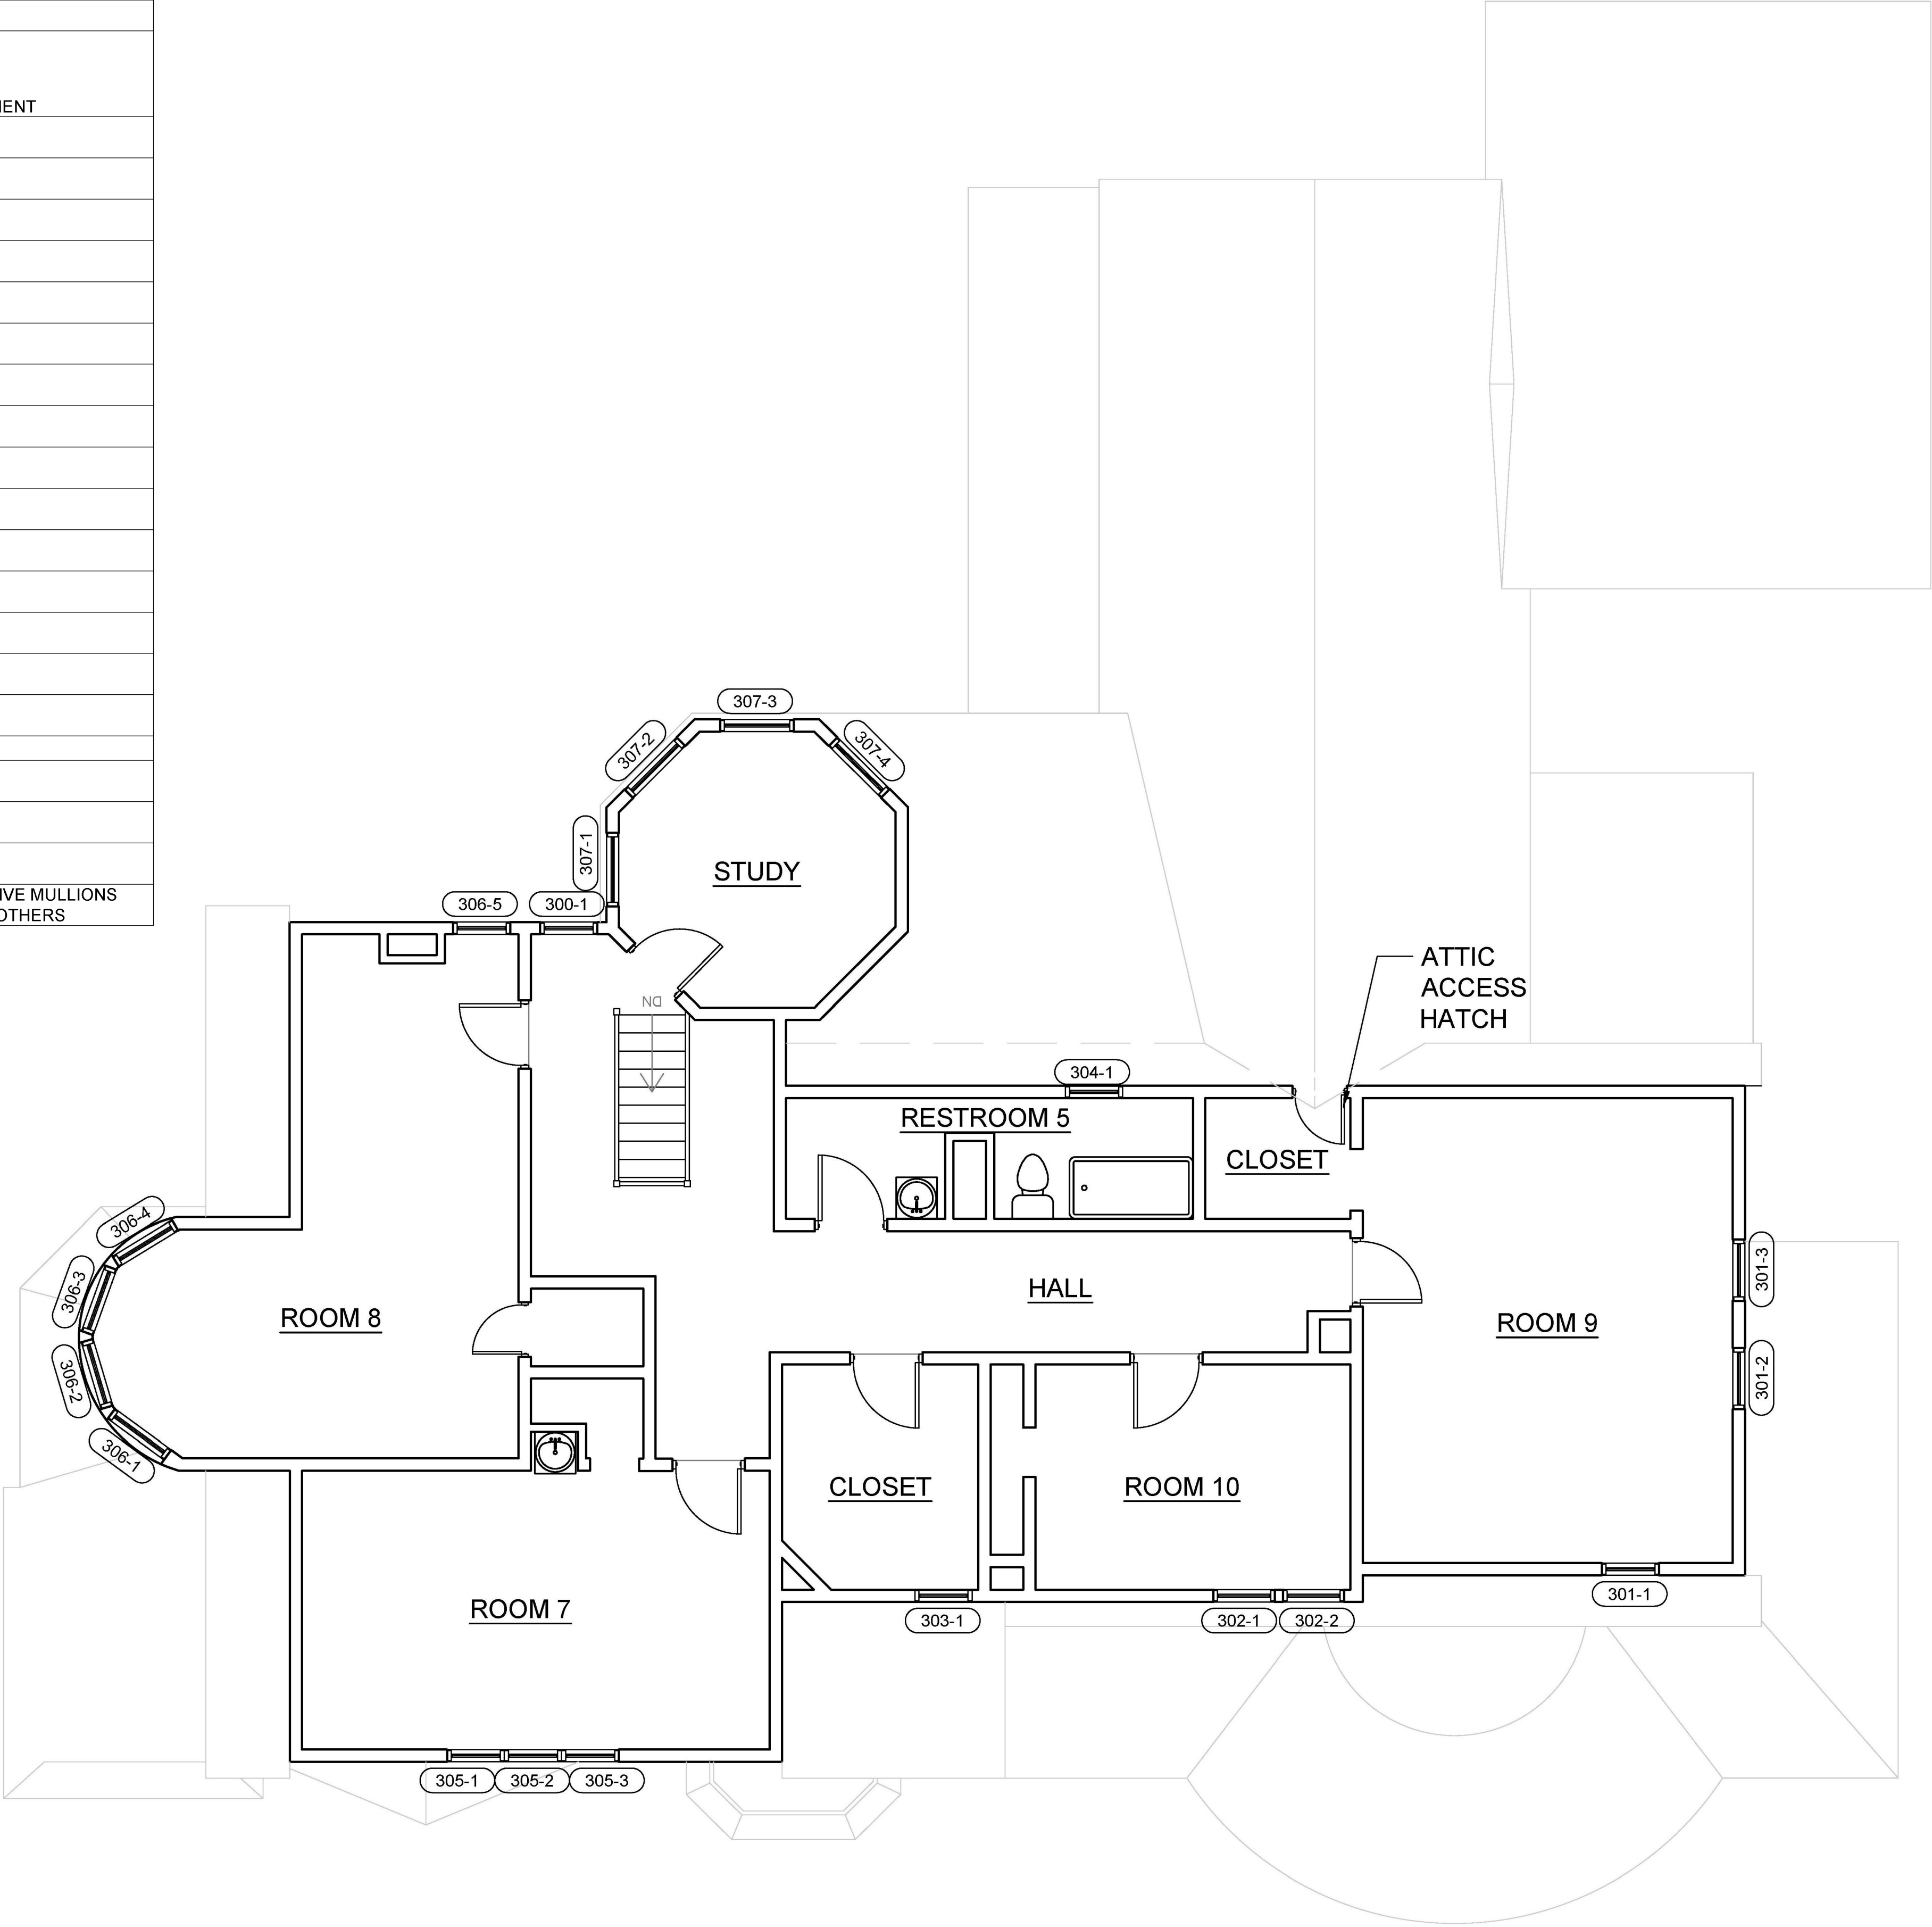
THIRD FLOOR PLAN - WINDOW TAGS

WINDOW MATRIX												
WINDOW TAG	DIMENSIONS			OPERABLE (Y/N)	OPERABLE TYPE	DESIGN FEATURE			ORIGINAL GLASS (Y/N)	VANDALISM GLASS (Y/N)	WINDOW CONDITION	COMMENT
	HEIGHT	WIDTH	SILL HEIGHT			LEADED GLASS (Y/N)	STAINED GLASS (Y/N)	OTHER				
300-1	3'-6"	2'-0"	3'-4"	Y	SINGLE HUNG	N	N	-	N	Y	FAIR	
301-1	1'-9"	2'-4"	4'-6"	Y	BOTTOM HINGE	N	N	-	N	Y	GOOD	
301-2	3'-10"	2'-7"	3'-0"	Y	SINGLE HUNG	N	N	-	N	Y	GOOD	
301-3	3'-10"	2'-7"	3'-0"	Y	SINGLE HUNG	N	N	-	N	Y	GOOD	
302-1	3'-11"	2'-8"	3'-0"	Y	SINGLE HUNG	N	N	-	N	Y	GOOD	
302-2	3'-11"	2'-8"	3'-0"	Y	SINGLE HUNG	N	N	-	N	Y	GOOD	
303-1	1'-9"	2'-4"	4'-6"	Y	BOTTOM HINGE	N	N	-	N	Y	GOOD	
304-1	1'-9"	2'-4"	4'-6"	Y	BOTTOM HINGE	N	N	-	N	Y	GOOD	
305-1	2'-0"	2'-2"	3'-4"	Y	SINGLE HUNG	N	N	-	N	Y	GOOD	
305-2	3'-6"	2'-0"	3'-4"	Y	SINGLE HUNG	N	N	-	N	Y	GOOD	
305-3	2'-0"	2'-2"	3'-4"	Y	SINGLE HUNG	N	N	-	N	Y	GOOD	
306-1	4'-0"	2'-10"	1'-4"	Y	DOUBLE HUNG	N	N	-	N	Y	FAIR	
306-2	4'-0"	2'-10"	1'-4"	Y	DOUBLE HUNG	N	N	-	N	Y	FAIR
