Fungal Assessment Report

1441 Schilling Place
Salinas, California

Prepared By:
S Tech Consulting, LLC

Date: May 18, 2015

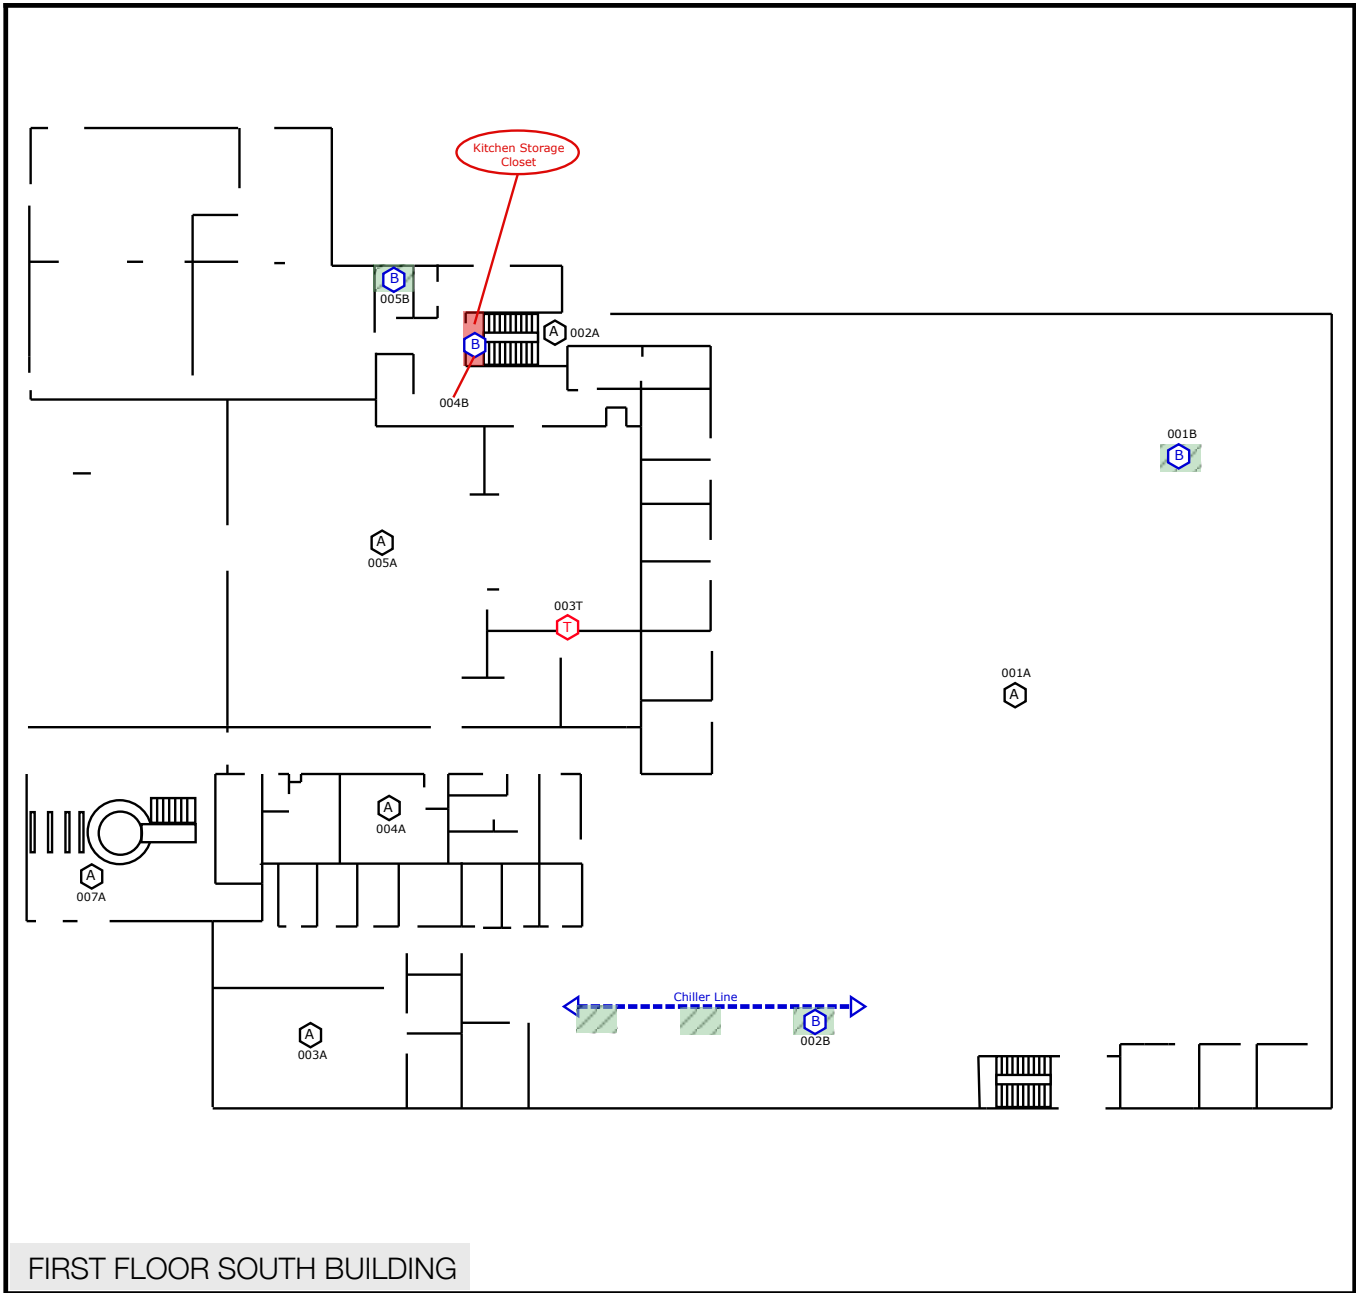
FIRST FLOOR SOUTH BUILDING

The first floor of the South Building had only minor areas of visible moisture intrusion, most of which are localized. Humidity ranged from 42.5% to 47.8% throughout the floor, considered acceptable. Olfactory observations did not indicate noticeable odors associated with moisture intrusion or mold presence.
