**Boccone/Igel Residence**  
**827 Elkhorn Road, Royal Oaks CA**  
**APN 181-159-009**

**Forest Resource Analysis/  
Construction Impact Assessment/  
Tree Protection Plan**

**Prepared for**  
**Norman Boccone/Victoria Igel**  
**Property Owners**

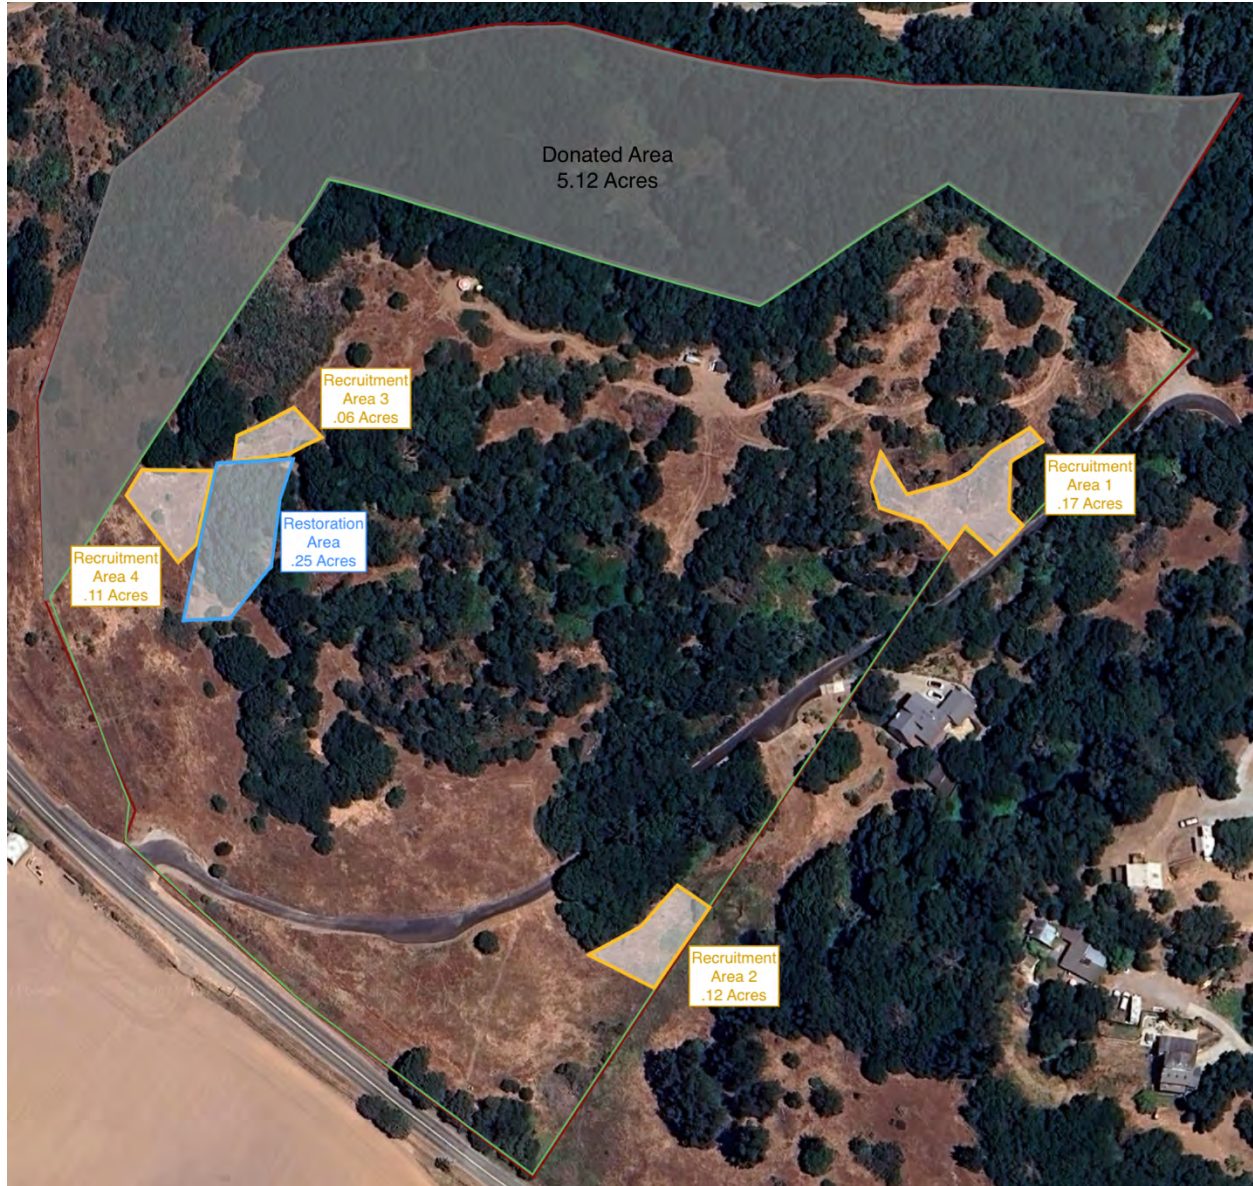
## Tree Recruitment, Replanting and Restoration Plan Map

<b>Boccone/Igel Property</b> <b>827 Elkhorn Road, Royal Oaks CA</b> <b>APN 181-151-00</b> <b>Area Designation Summary Table</b>		
<b>Designation</b>	<b>Map Highlight Color</b>	<b>Acreage</b>
Property Boundary	Lime Green Line	13.53
Land Donated to ESF	Green	5.12
Recruitment/Replanting	Yellow areas (#1-4)	.46
Restoration	Blue	.25
<b>Total Acreage of Mitigation Areas for Recruitment, Replanting and Restoration: .71 acres</b>

<b>Boccone/Igel Property</b> <b>827 Elkhorn Road, Royal Oaks CA</b> <b>APN 181-151-009</b> <b>Sapling Recruitment and Planting Summary Table</b>				
Replanting/Recruitment Area Number	Size (acres)	Sapling Recruitment Quantity	Sapling Replanting Quantity	Assigned Tag Numbers
1	.17	2	21	801 to 823
2	.12	3	12	824 to 838
3	.06	5	0	839 to 843
4	.11	5	7	844 to 855
TOTALS	.46	15 Saplings Recruited 40 Saplings Planted from Seed Collected from the Property, Propagated and Grown to Tree Pot Size

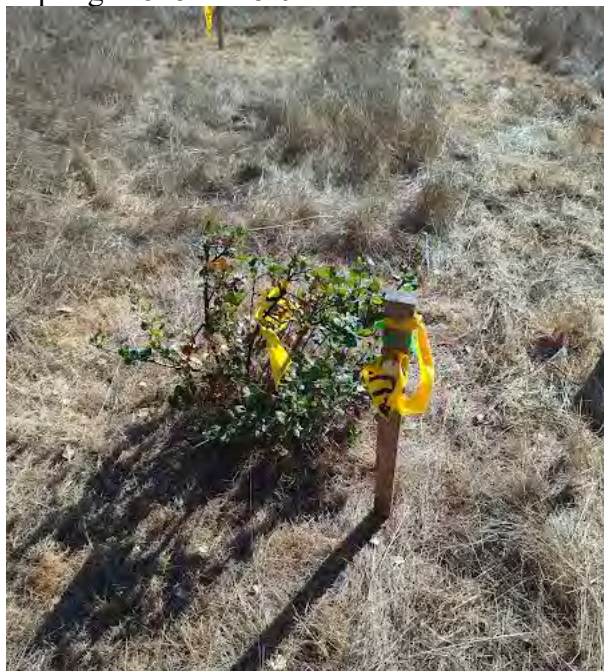
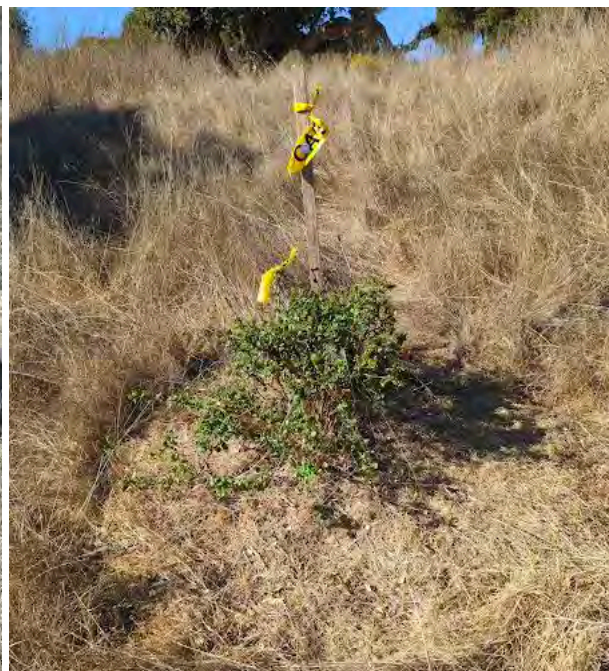
Saplings #818 and 819 located in Area 1.

- Fifteen, young saplings have been identified, numerically tagged and mapped in one of the four mapped “Recruitment” Areas.
- These small trees will be cleared of suppressive growth for a distance of 3’ from the tree trunk
- Above ground browse cages will be installed surrounding each recruited sapling

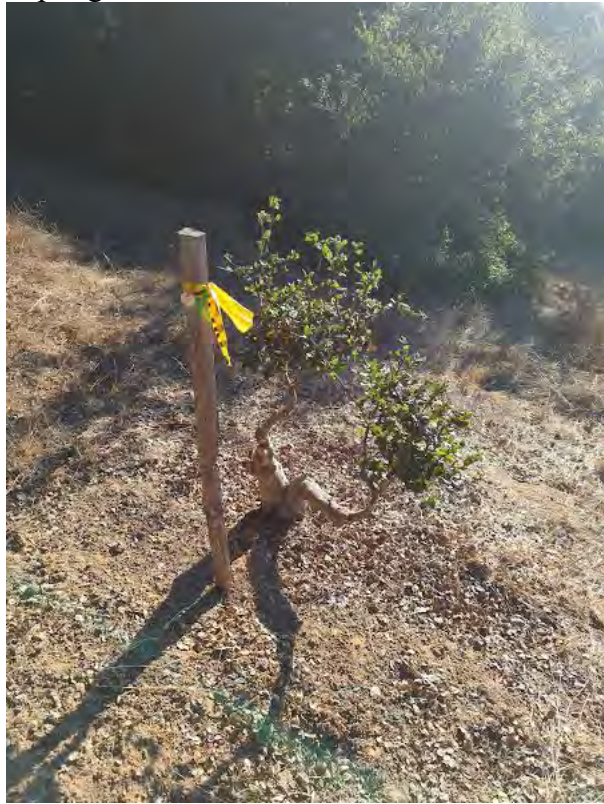
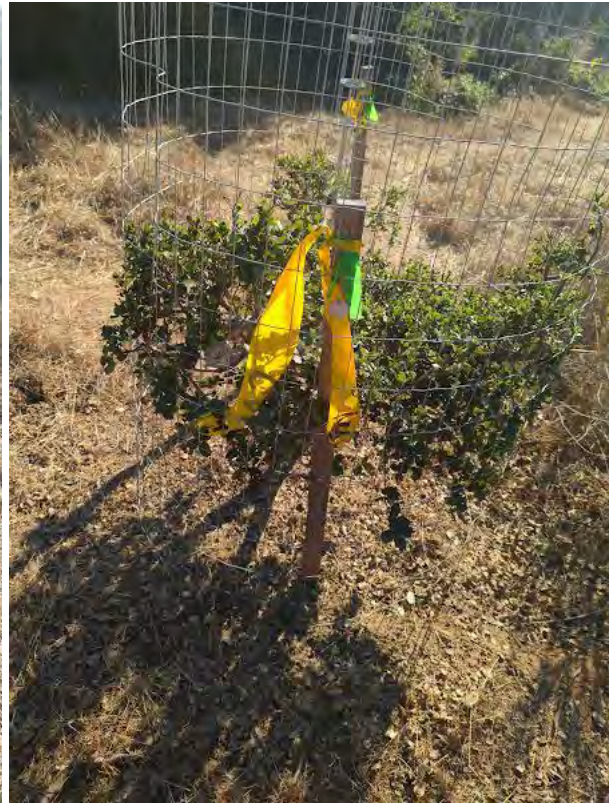
Saplings #826 and 828 located in Area 2.
