HARO, KASUNICH AND ASSOCIATES, INC.

Subject: Geologic and Coastal Bluff Recession Assessment Report

Reference: 35700 Highway 1, Big Sur, CA 93920
Monterey County APN 418-111-012

RECOMMENDED 50-YEAR BLUFF EROSION AND INSTABILITY SETBACK MAPS

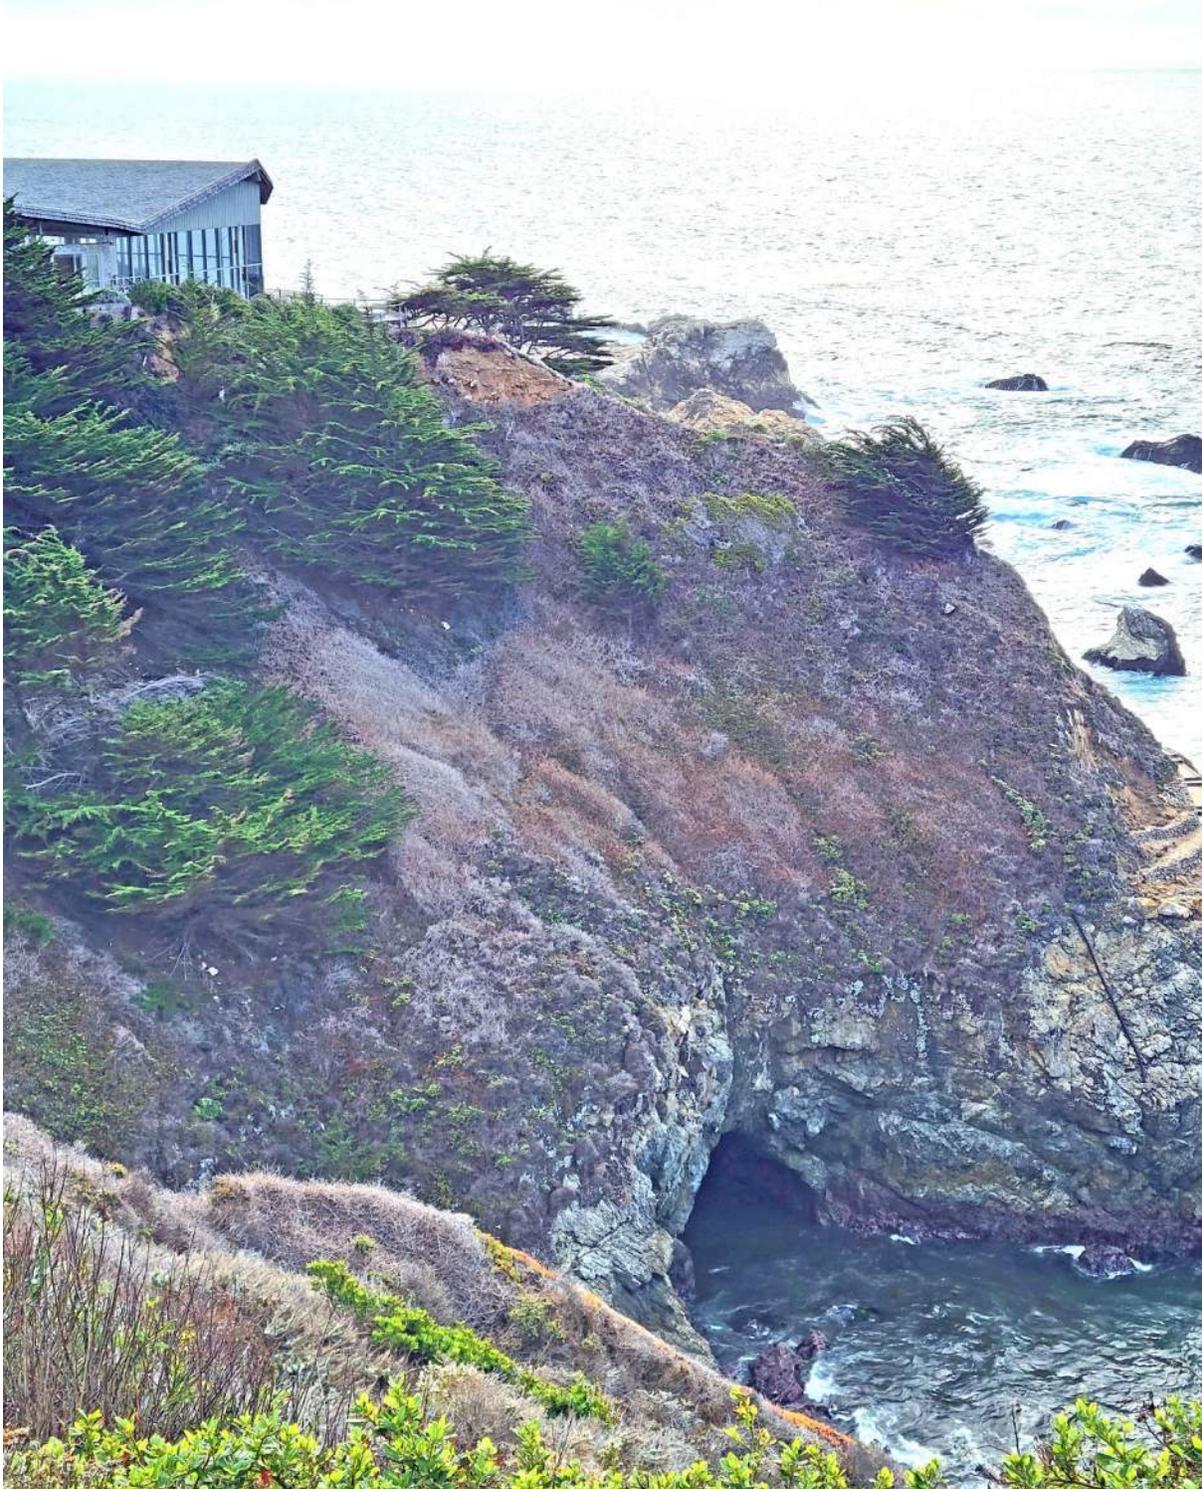
Photograph 3: November 2021 Photograph Looking Downcoast

The geologic conditions at the site are relatively simple, and as seen in the coastal bluff face; with erosion resistant granodiorite bedrock exposed in the bluff up to about an elevation of 50 feet NAVD88 or higher along the bluff. A large seacave exists in the granodiorite in the lowermost portion of the bluff facing the cove to the north. Photograph 3 below shows the bluff in that area and the mouth of the seacave.

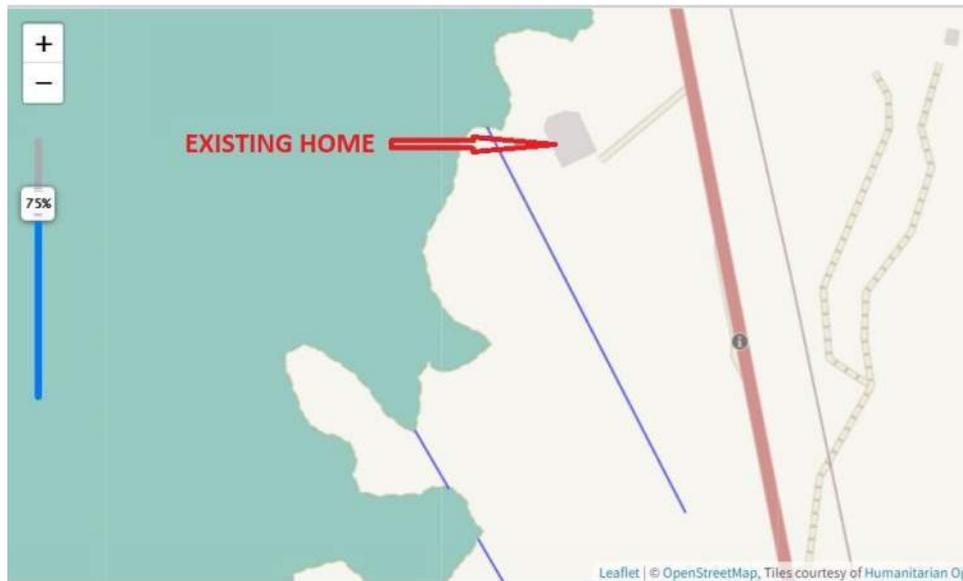
Figure 8: Monterey County GIS Map Showing Site with Local Inactive Fault In Relation to Existing Home at 37600 Highway 1

The published online Monterey County GIS Map (Figure 8) which shows a short discontinuous fault in the immediate vicinity of the property notes that fault as an inferred queried pre-Quaternary age fault mapped by Gary Greene in 1972. This fault does not pose a significant hazard to the existing home or a proposed new home, because based upon it's age it is classified as Inactive. Figure 8 shows this fault:

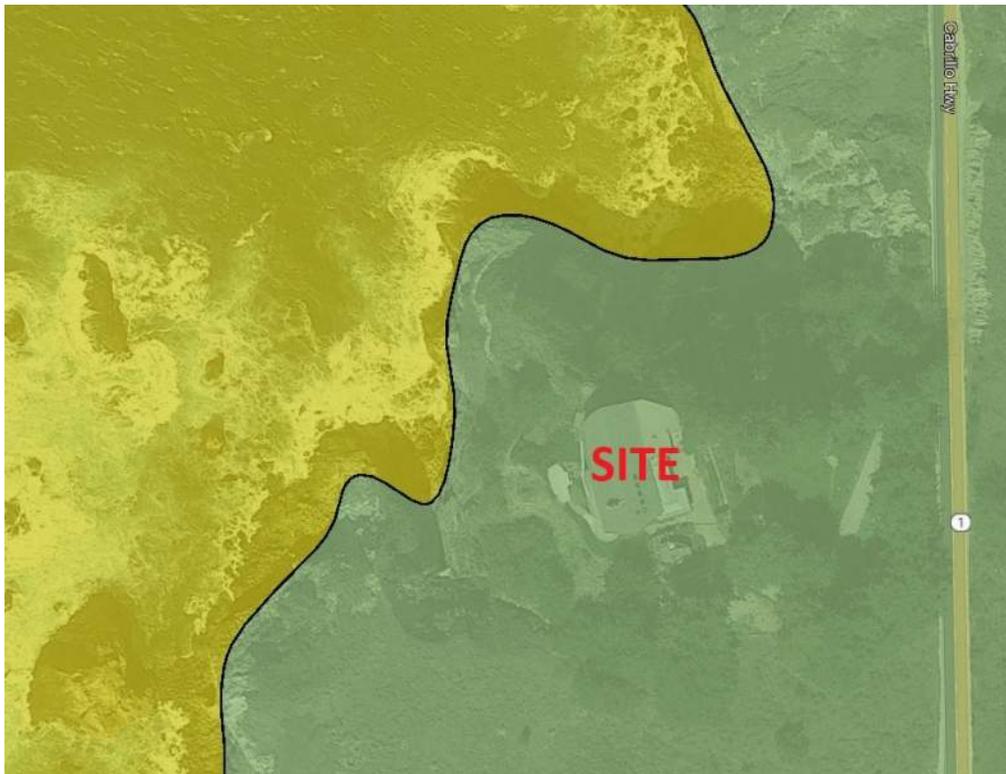
Figure 9: County of Monterey Tsunami Hazard Area Map

We have reviewed the 2021 Monterey County Tsunami Inundation Map for Emergency Planning for the Soberanes Point Quadrangle. This map shows that the line designating the limit of tsunami inundation is near the bluff edge based on comparison with the USGS Topographic Map and the Topographic Survey for the project. A partial copy of that map is shown in Figure 9 below, and shows that the existing home and the area where improvements are proposed is more than 100 feet inland of the hazard (potential inundation) zone. The limit of the mapped tsunami inundation appears to be 50 feet or more in elevation below the existing home.

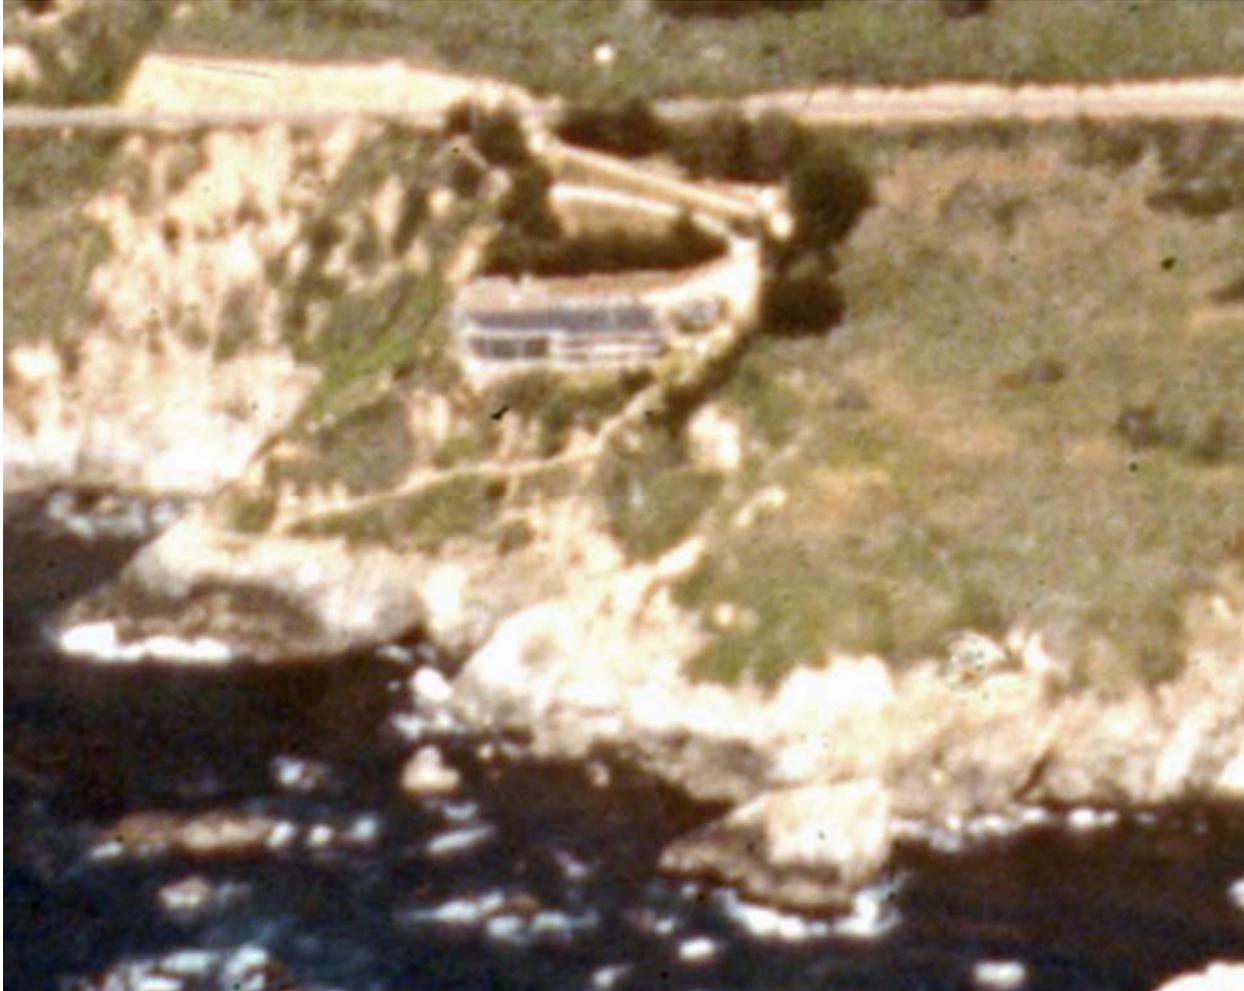
Photograph 15: Aerial Photograph from 1972
(courtesy of www.californiacoastline.org)

The 1972 photograph below shows the homesite in its pre-development condition.

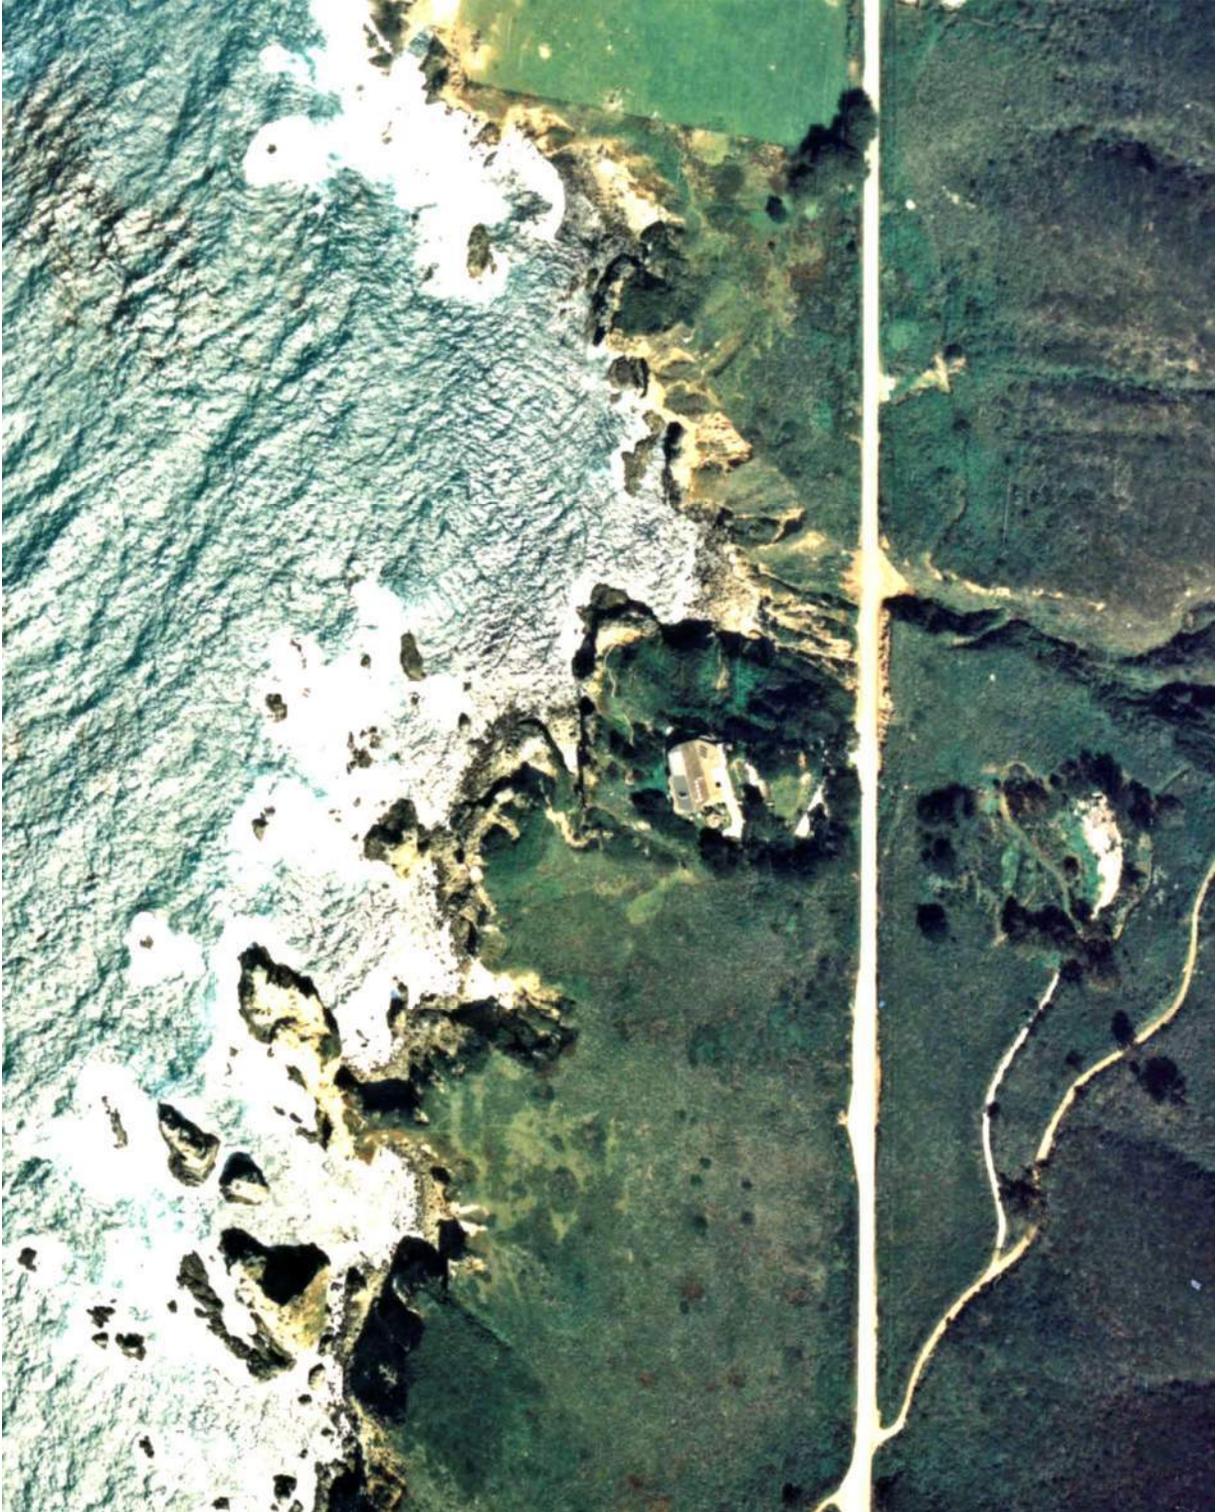
1986 Vertical Aerial Photograph of 37600 Highway 1

We also reviewed the configuration of the bluff as visible on 1986 and 1993 vertical aerial photographs from the University of California at Santa Cruz Map Library, and compared the 1986 conditions to the 2018 and 2021 conditions we observed on Google Earth satellite imagery. Appendix A in this Memorandum contains the 1986 aerial photograph and the 2018 Google Earth imagery that we utilized in our analysis that shows the historical conditions at the property. Unfortunately, the resolution of the 1986 aerial photograph that is presently available to us is less than desirable.
