MON-1 Coastlands II Project

Arborist Report

On State Route 1 in Monterey County District 5-MON-1-PM 44.3 Project Number 0521000188 / EA 05-1P210

August 2024

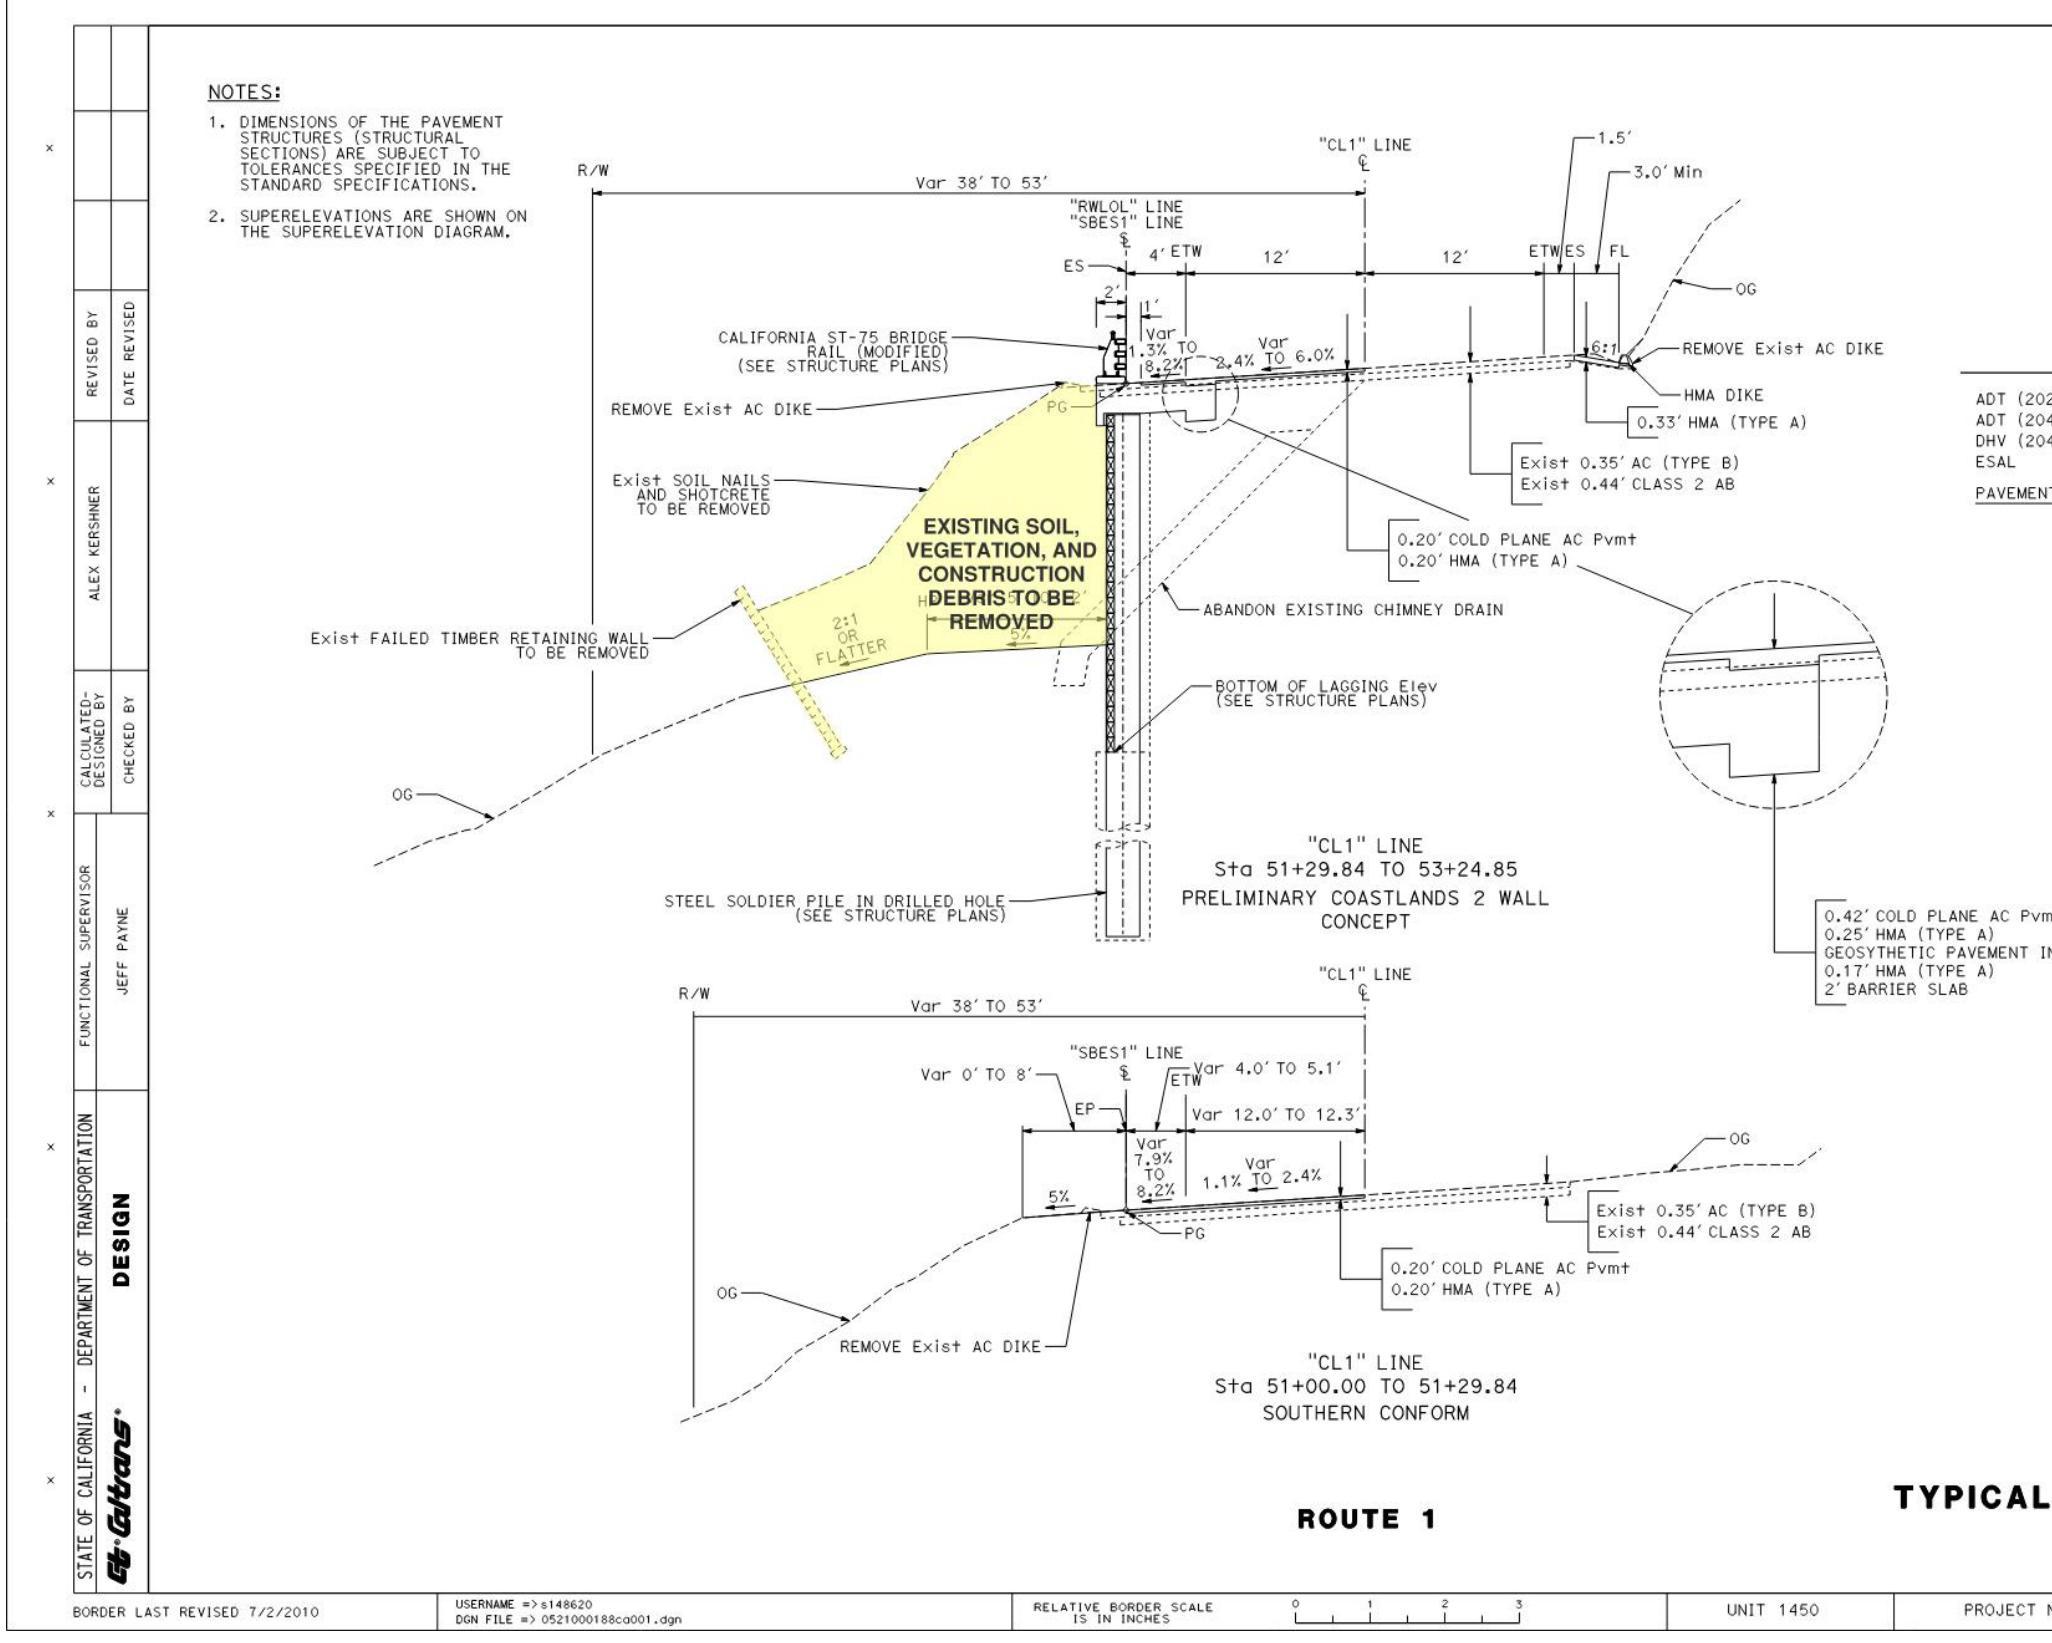
Figure 3. Site Section

Caltrans Staff engaged in several site visits to gather field data between January, 2023 and July, 2024. Data collected includes photographs and diameter at breast height measurements of the eight trees impacted by the proposed project. Site visits were conducted after the temporary soil nail wall was constructed. This wall covers much of the limit of disturbance with steel reinforced concrete, as outlined in blue in Figure 2. Additionally, the failed MSE timber retaining wall remains in place downslope of the temporary soil nail wall. Figure 3 includes a section of the proposed soldier pile wall and shows how it relates to the existing conditions. It illustrates why the failed MSE timber retaining wall and temporary soil nail wall are proposed to be demolished and removed along with a portion of existing soil to construct the solider pile wall. Existing site elements proposed to be demolished and removed are highlighted in yellow in Figure 3.
