**Tree Inventory, Assessment,
and
Protection Report**

**One Old Ranch Road
Carmel By-the-Sea, CA 93923
(Unincorporated Monterey County)**

Carmel Valley Ranch

October 10, 2024

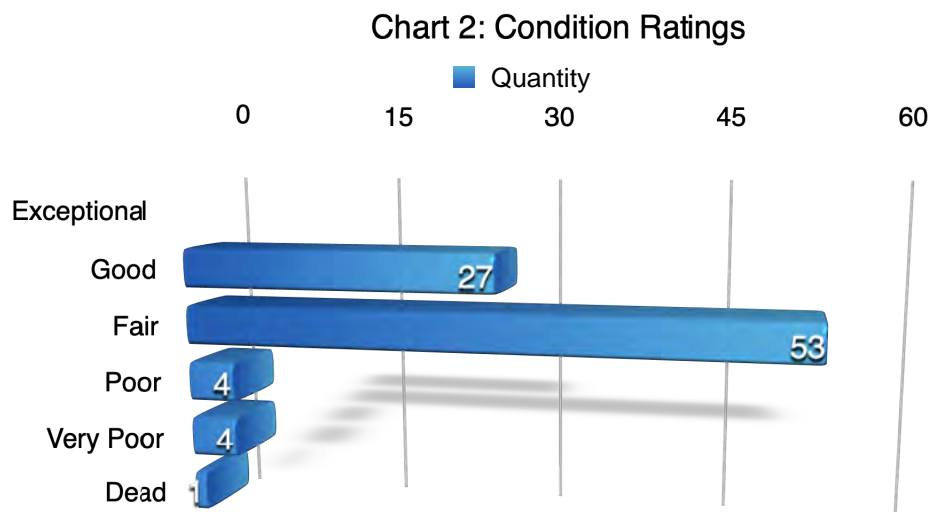
Twenty-seven (27) trees are in good condition, fifty-three (53) fair, four (4) poor, and four (4) are in very poor shape with one tree dead (Chart 2). One tree (#388) in very poor condition is a Landmark Tree. Trees in very poor condition (#355, #388, #1921, and #1923) should be considered for removal regardless of a development application.

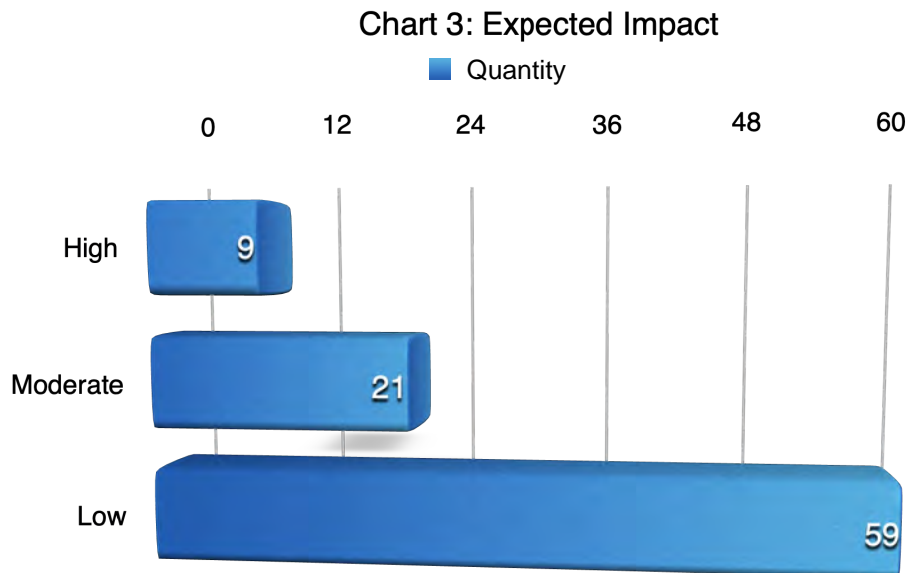
There are nine (9) trees expected to be highly impacted and removed which are as follows: #368, #370, #377, #867, #868, #872, #1907, #1917, and #1936 (Chart 3). Three (3) of these trees (#377, #867, and #1907) are Landmark Trees, two (2) trees (Japanese maple #1936 and crabapple #1917) are not protected. Twenty-one (21) trees could be moderately impacted and are close to the existing structures (Appendix A and B).

At this point there are three landmark trees indicated for removal and they should be replaced with one to one ratio of twenty-four inch box specimens or larger of the the same species (coast live oak). The smaller protected coast live oaks should be replaced with one to one ratio of four fifteen gallon specimens. The two tree not protected by the ordinance do not require replacement.
