THOMPSON WILDLAND MANAGEMENT

August 14, 2024

Ms. Tracy Piazza
58 Mt. Devon Road
Carmel, CA. 93923
APN: 241-142-002
Project File # PLN230339

Subject: 58 Mt. Devon Road Non-Permitted Tree Removal Assessment

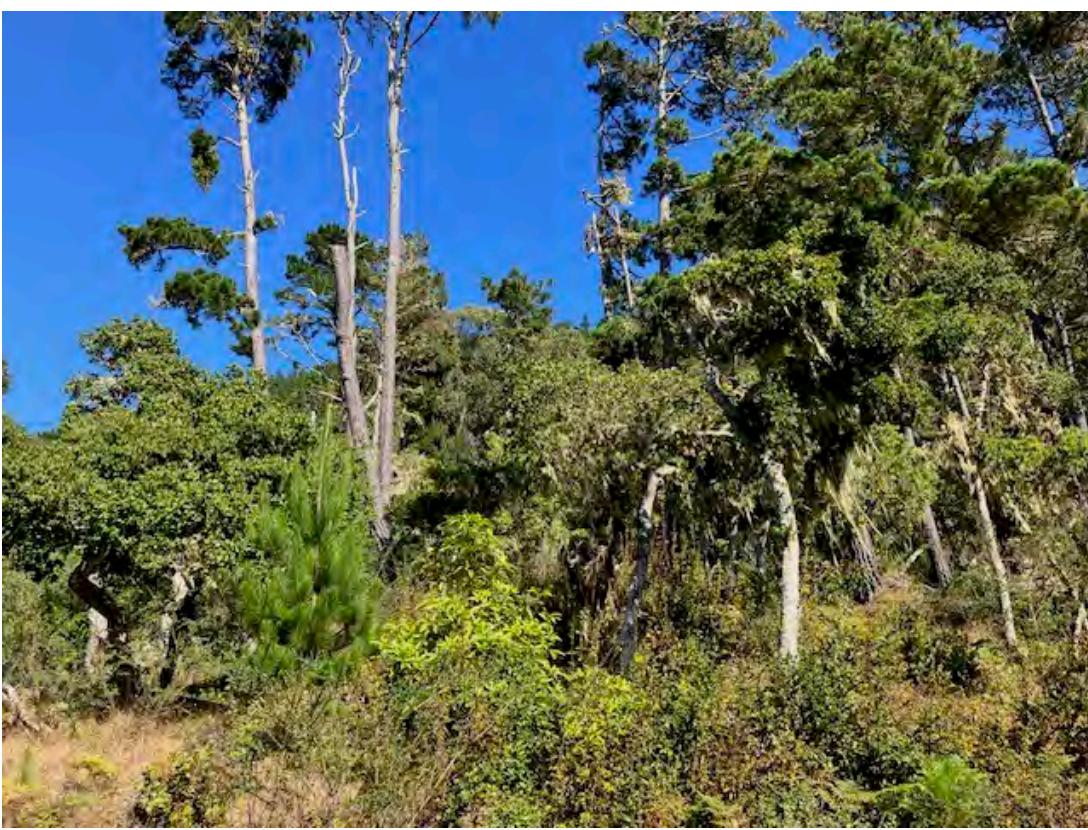
Figure 1. View of mixed pine and oak woodland south parcel from Mt. Devon Road.

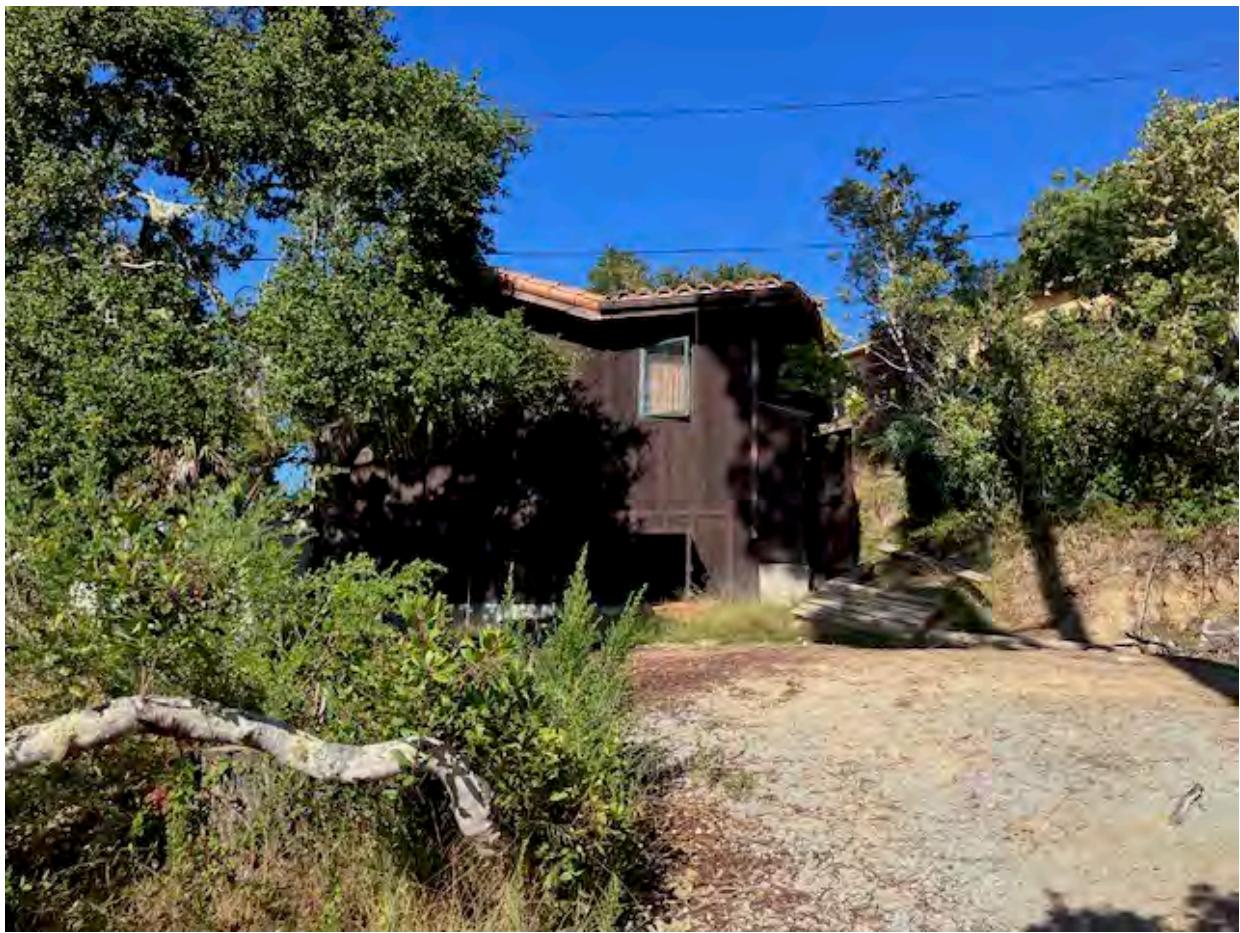
Figure 10. Structure is located at top of unpaved entrance. The main house and residence is barely visible in the background.
