COTTON, SHIRES & ASSOCIATES, INC. CONSULTING ENGINEERS AND GEOLOGISTS

#### MITIGATION OPTION 5C - REROUTE WATER TO NEW DETENTION BASIN

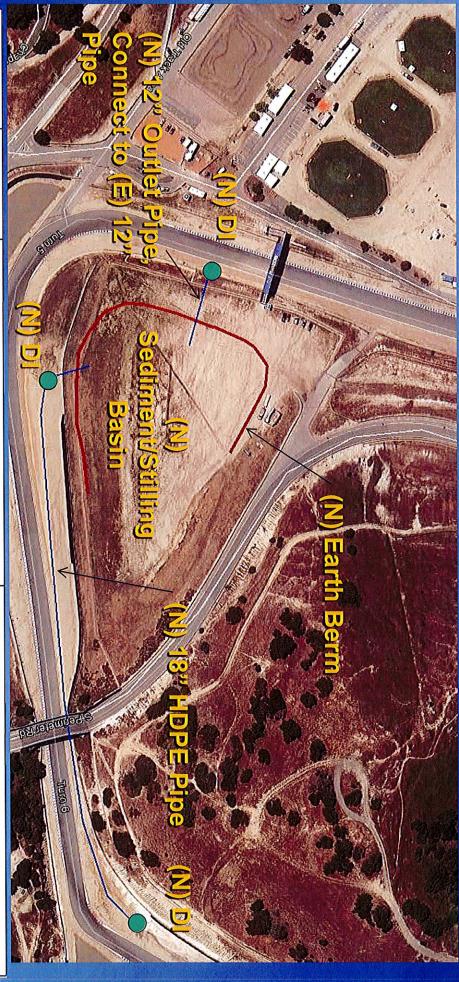
Same as Option 5A  New Basin  Same as Option 5A  Increased engineering costs to design and size the	Increased engineering costs to design and size the basin  Decrease of useable space	Same as Option 5A	\$902,096	SC - Bypass to New Basin
Option Pros Cons	Cons	Pros		Option
