Tree Resource Assessment
1145 Spyglass Hill Road
Pebble Beach CA

October 14, 2016

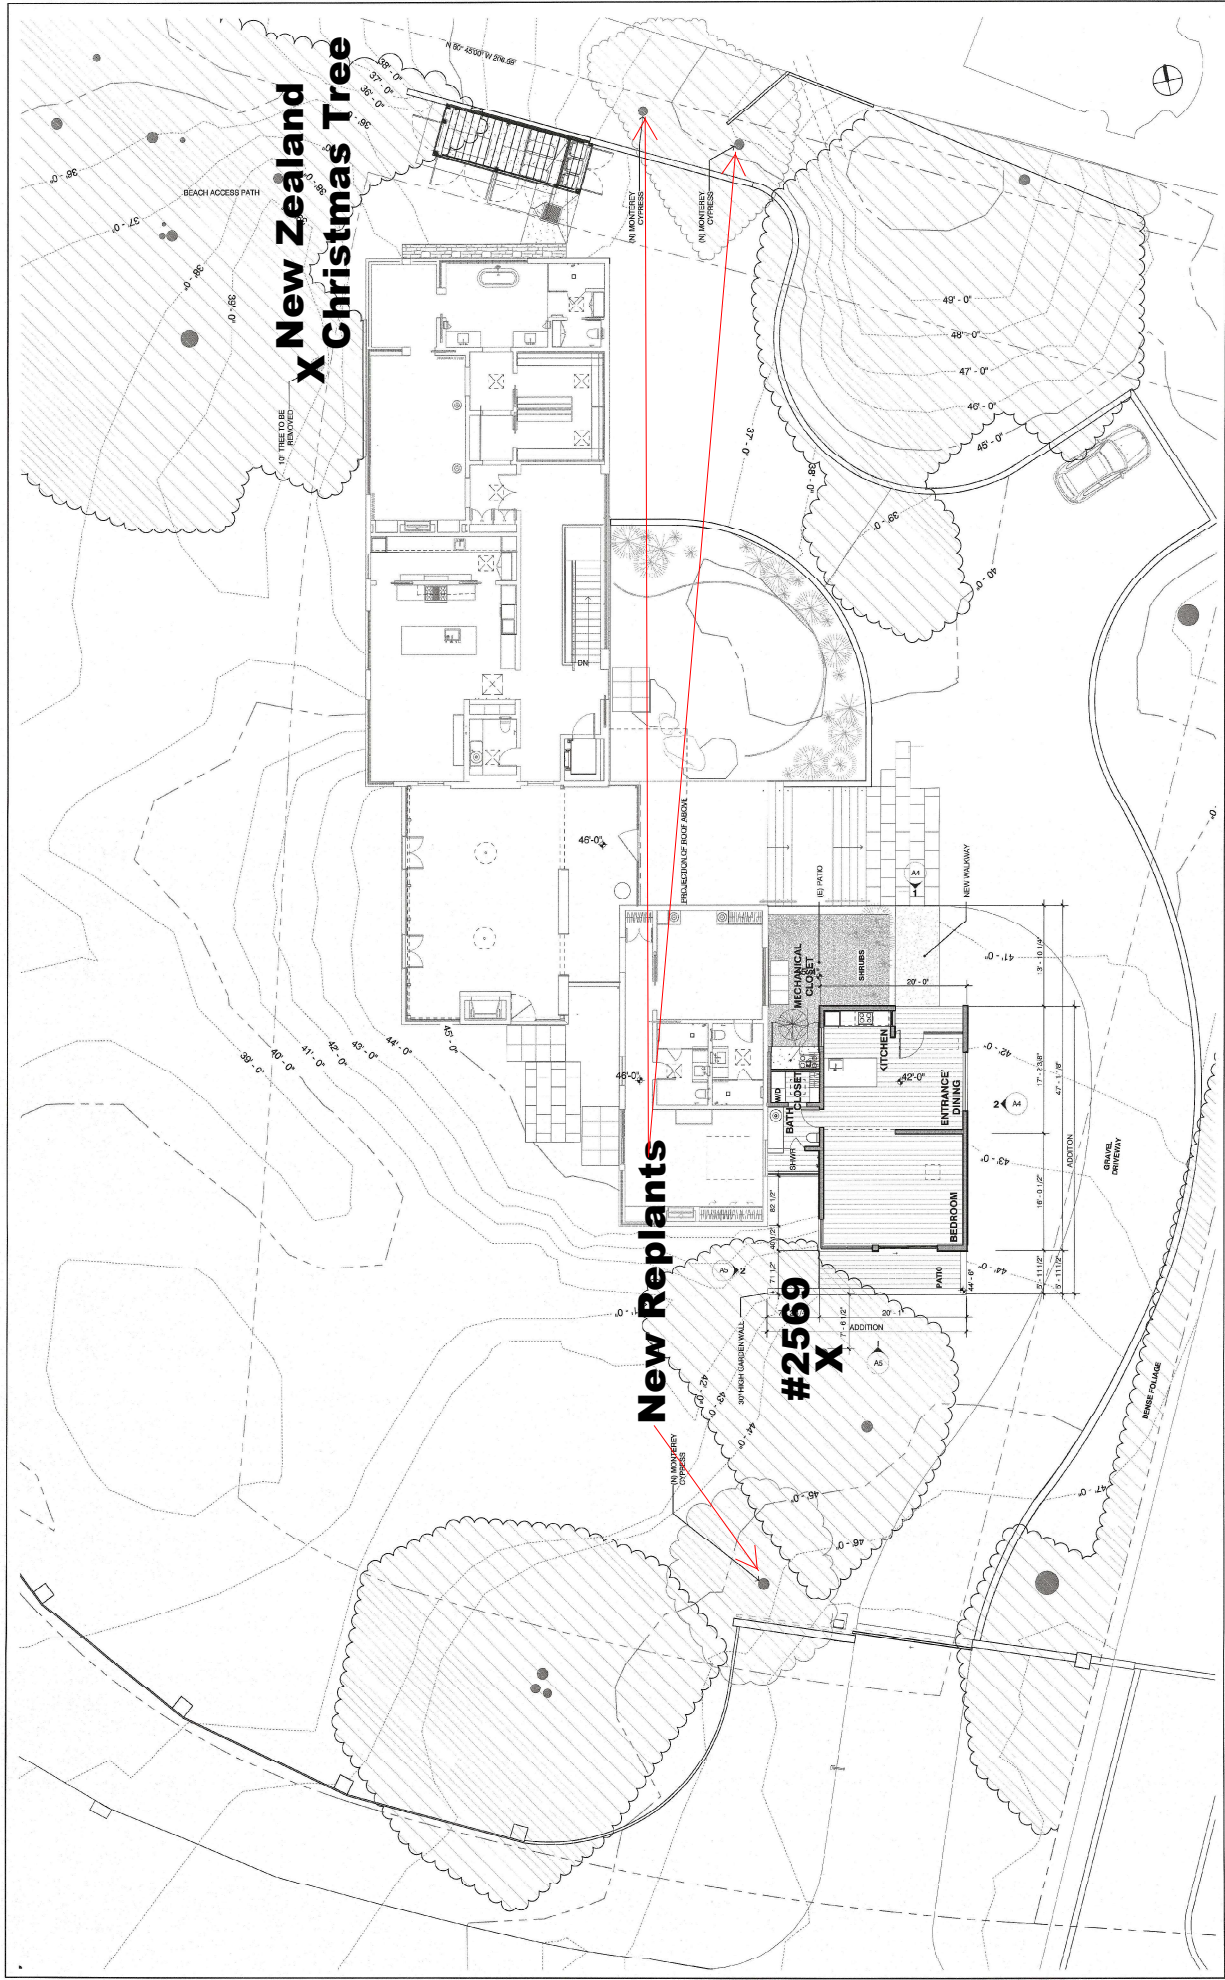
This proposal to construct an addition to the currently constructed residence, expands its footprint and require removal of two additional trees (#2569 a planted cypresses, and a 10" diameter New Zealand Christmas tree, which is a planted ornamental). The tree loss will be minimal for the case; the Cypress tree is a smaller component of a larger dominant tree, both trees which were planted, form a singular tree clustering. The smaller tree will be replaced in this area (as well as other adjacent areas) to supplement existing Cypress groupings; therefore the loss of Cypress canopy and foliage will not be significant. The ornamental New Zealand Christmas tree also will be removed to reduce competition for the remaining Cypress; thus the existing Cypress forested environment will be retained allowing the stand of trees to continue to exist and potentially regenerate over time. All remaining trees are expected to survive when properly protected and monitored. The remainder of the property contains tree cover, which remains. No watercourses are near the planned construction.
