# Exhibit E

# Tree Resource Assessment Patterson Residence

February 23, 2017

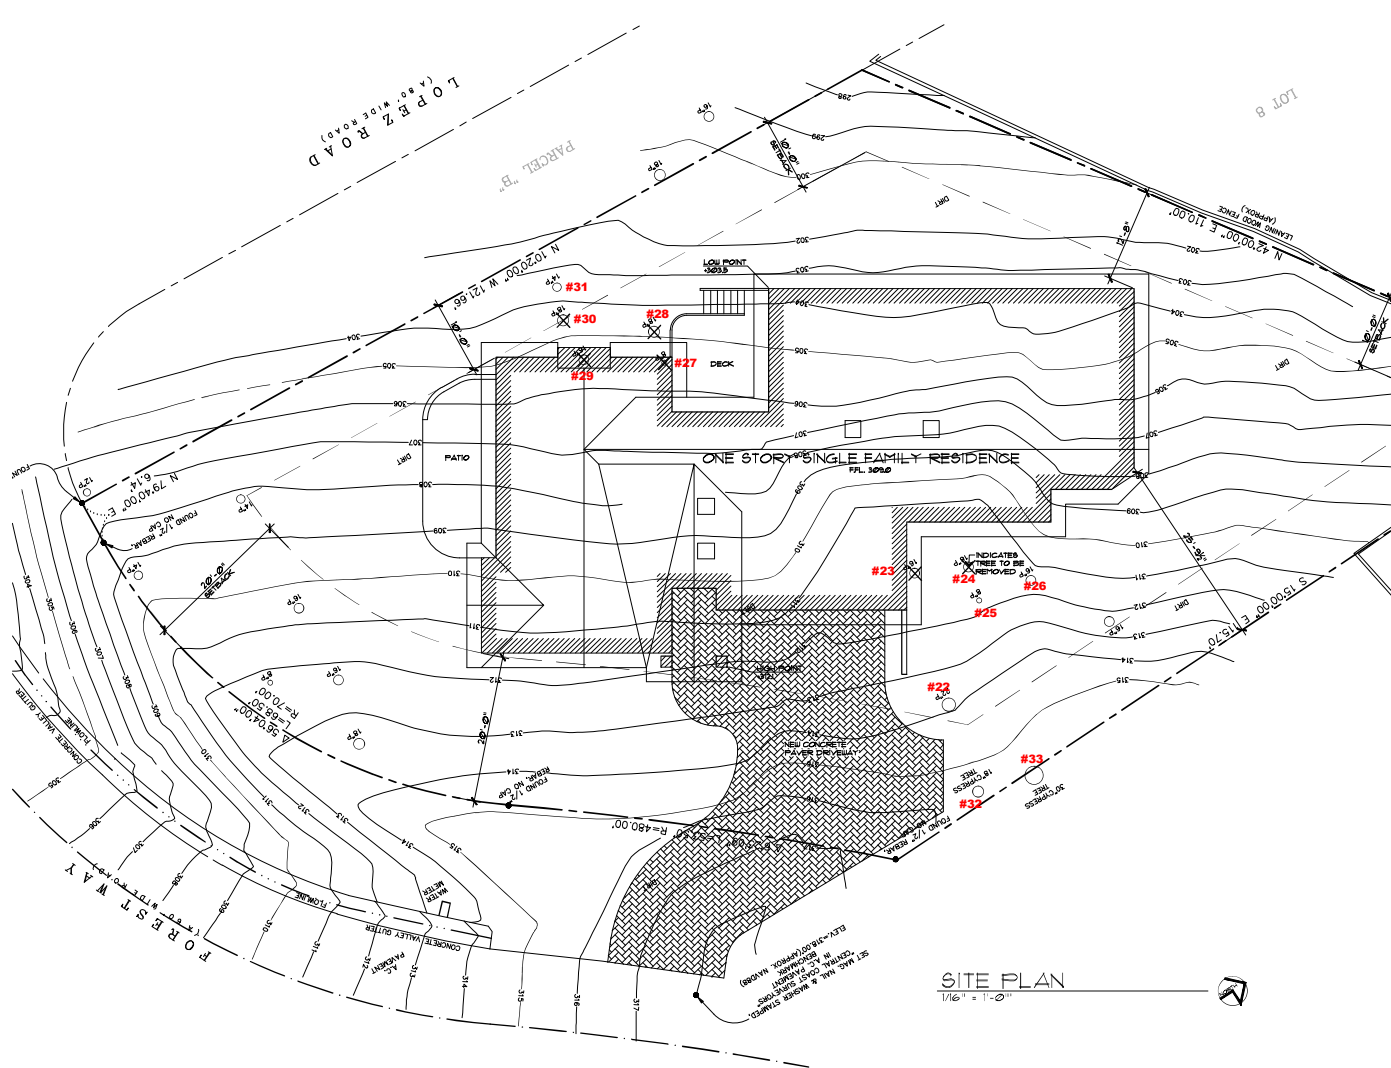
Trees #27-28

| ID# | Diameter | Species | Condition | Remove | Comments |
|---|---|---|---|---|---|
| 27 | 8 | M. Pine | Poor | X | In Building Footprint, Stem Decay |
