Mendoza Residence
17090 Wallace Court Aromas, CA
Tree Resource Assessment

Frank Ono
Urban Forester
Member Society of American Foresters #48004
ISA Certified Arborist #536

September 6, 2016

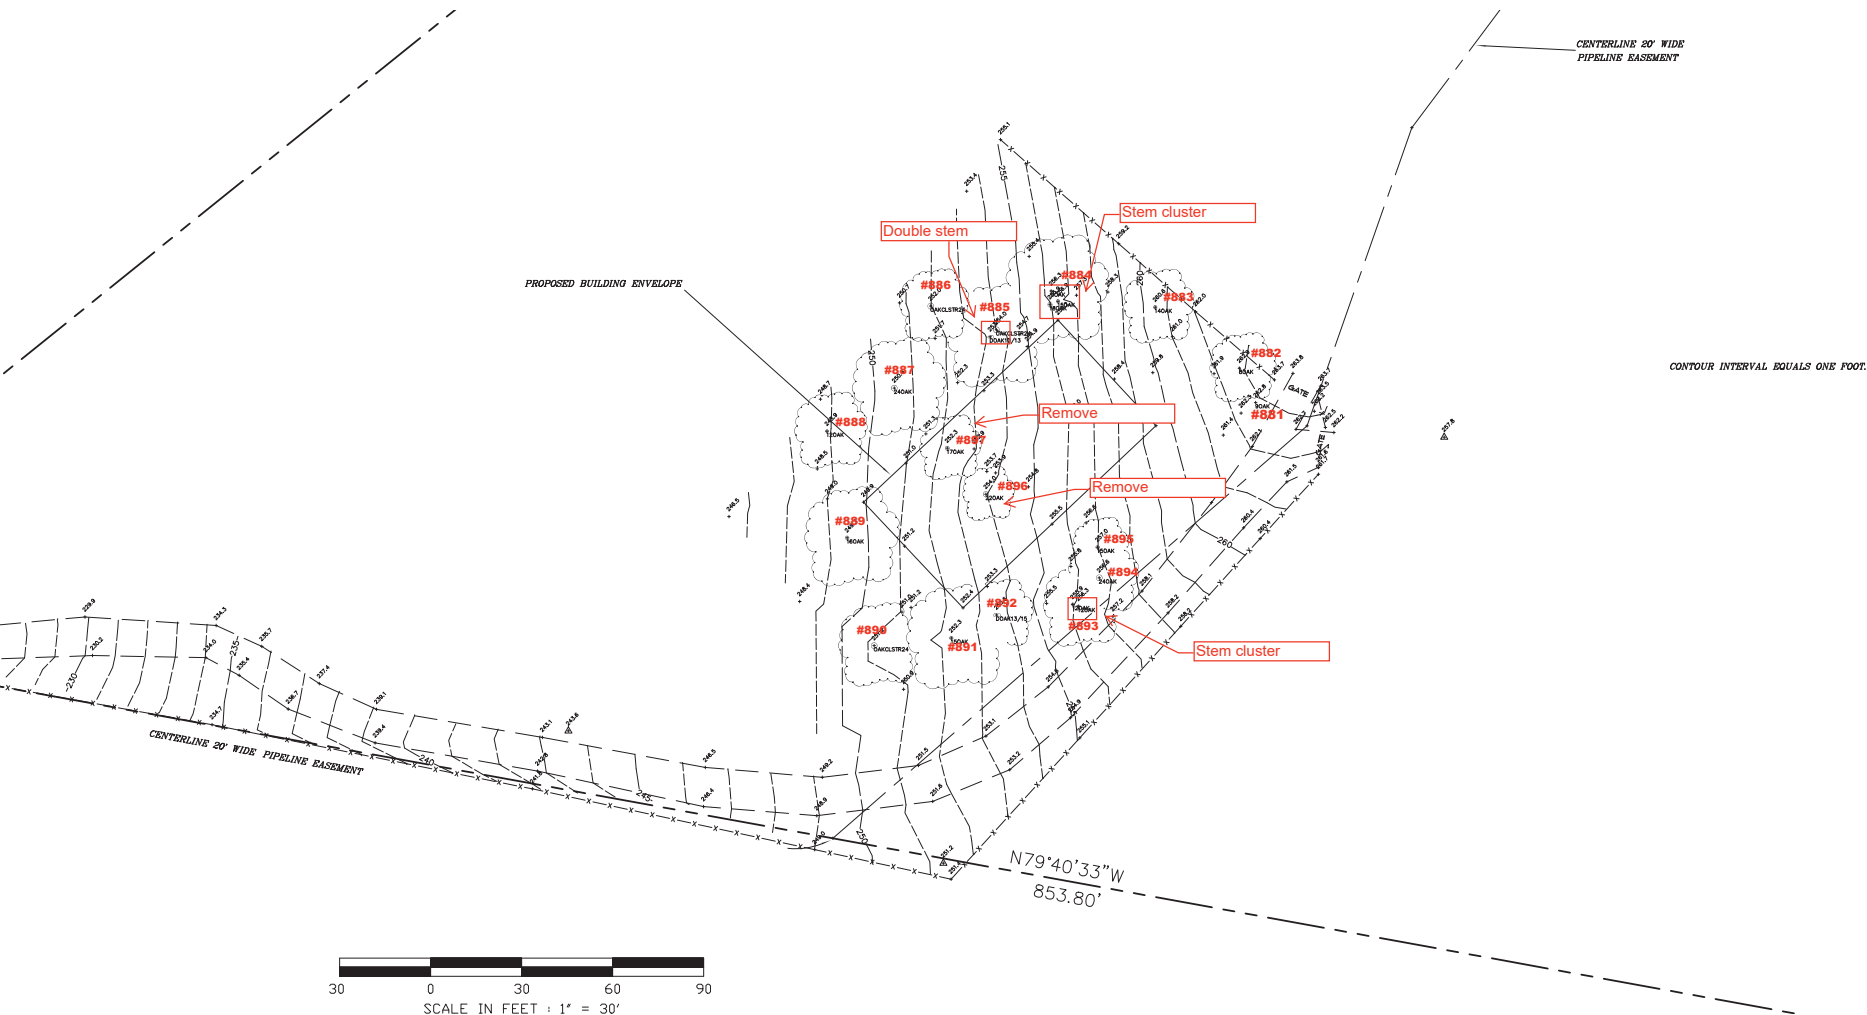
Tree #896

ID#	Diameter	Species	Condition	Remove	Comments
881	9"	Coast Live oak	Fair		
882	8"	Coast Live oak	Fair		
883	14"	Coast Live oak	Fair/Poor		Sunscald
884	9", 15", 18"	Coast Live oak	Fair/Poor		3 Stems and Sunscald
885	10" 13", 18"	Coast Live oak	Fair/Poor		4 Stems and Sunscald
886	24" Cluster	Coast Live oak	Fair/Poor		3 Stems and Sunscald
887	24"	Coast Live oak	Fair		
888	12"	Coast Live oak	Fair		
889	16"	Coast Live oak	Fair		
890	24" Cluster	Coast Live oak	Fair		4 Stems
891	15"	Coast Live oak	Fair		
892	13", 15"	Coast Live oak	Fair/Poor		Sunscald
893	12", 20"	Coast Live oak	Fair/Poor		South limb is leaning over the and Sunscald
894	24"	Coast Live oak	Fair		
895	15"	Coast Live oak	Fair/Poor		Topped and Sunscald
896	22"	Coast Live oak	Poor	X	Stem is cracking at the base
897	17"	Coast Live oak	Poor	X	Decay at the base of stem

Two trees are to be removed (#896 and #897) which are within the building envelope. The site may sustain additional oak replanting, therefore it is recommended replanting be with five gallon size or larger Coast live oak in locations near or adjacent the removed trees. In addition, the County also requires independent monitoring of replanted trees to insure replanting is successful (the term of monitoring is at County discretion, typically one –three years dependent on the type of permit). Remaining trees are outside the construction envelope and to be protected from construction impacts.
