# **Nacimiento Dam and San Antonio Dam Spillway Condition Assessment**

Chris Moss, P.E.  
Senior Water Resources Engineer

October 16, 2018  
Board of Supervisors Meeting

Nacimiento Dam Spillway Condition Assessment Report, June 2018  
by GEI Consultants, Inc.

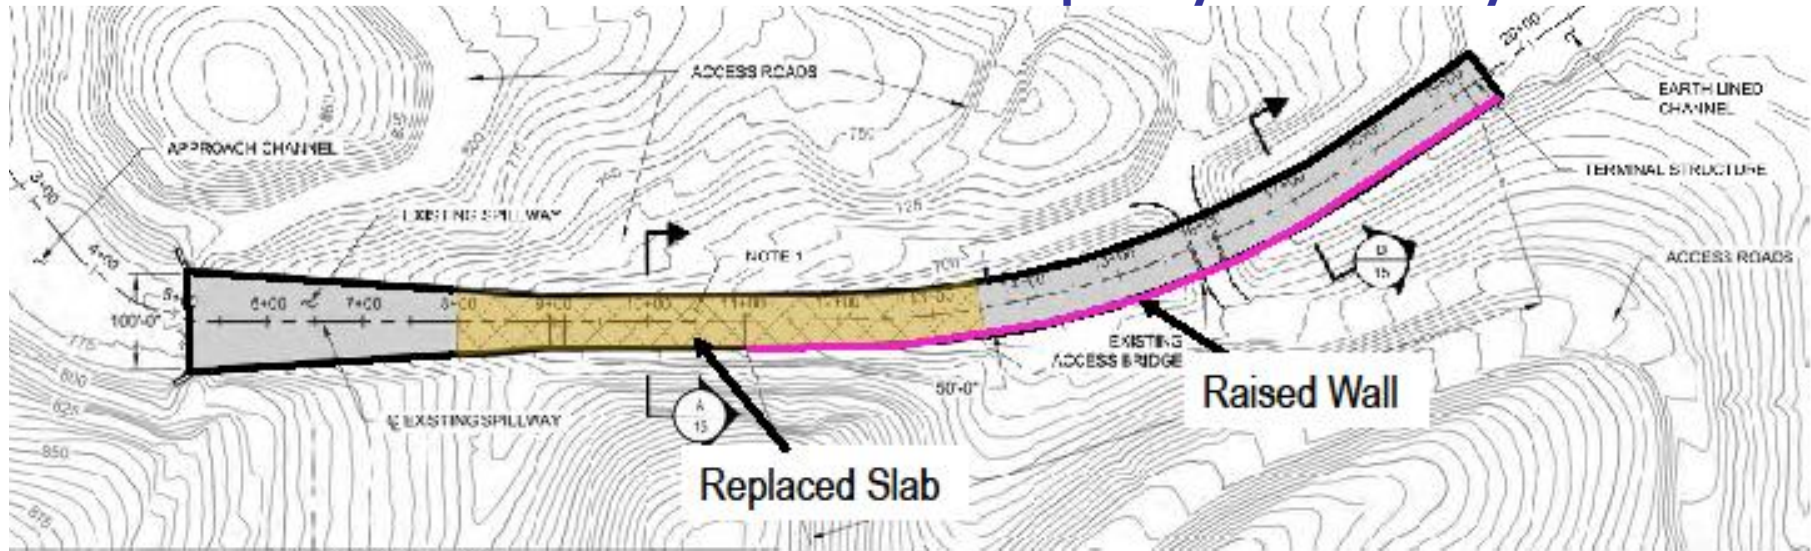
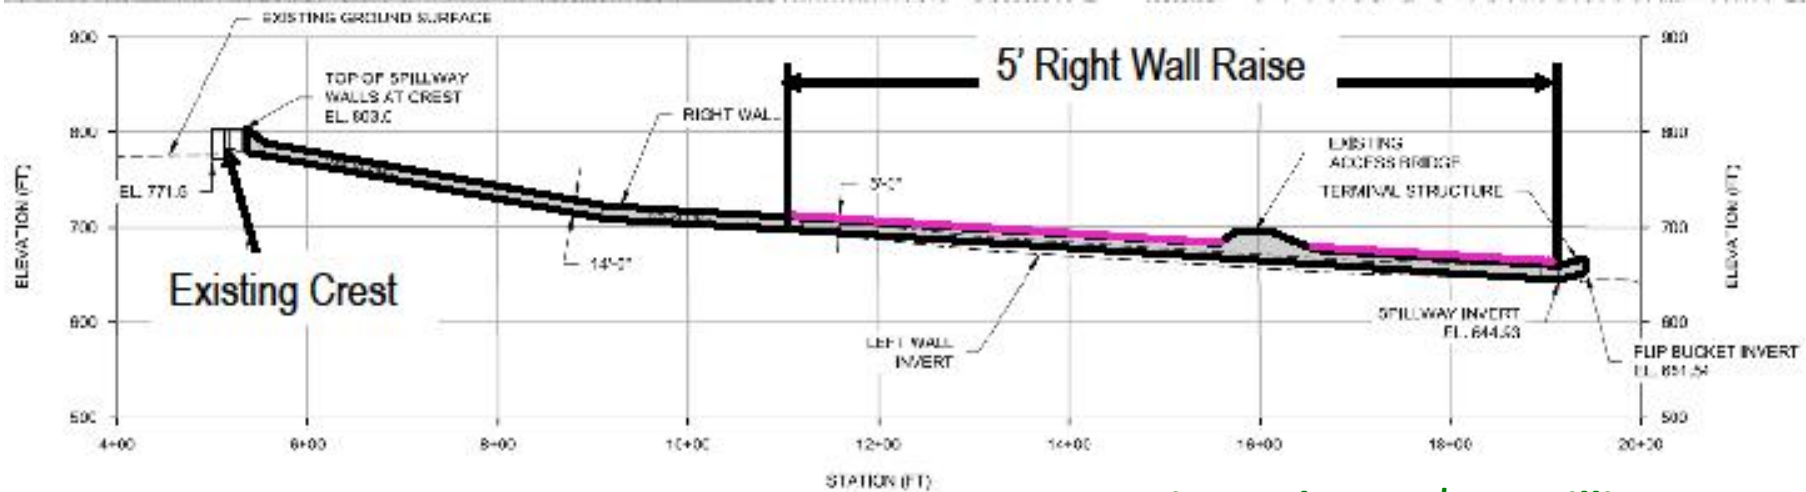
## Additional Needs to Obtain Basic Spillway Functionality

**Estimated Cost: \$4.7 million**

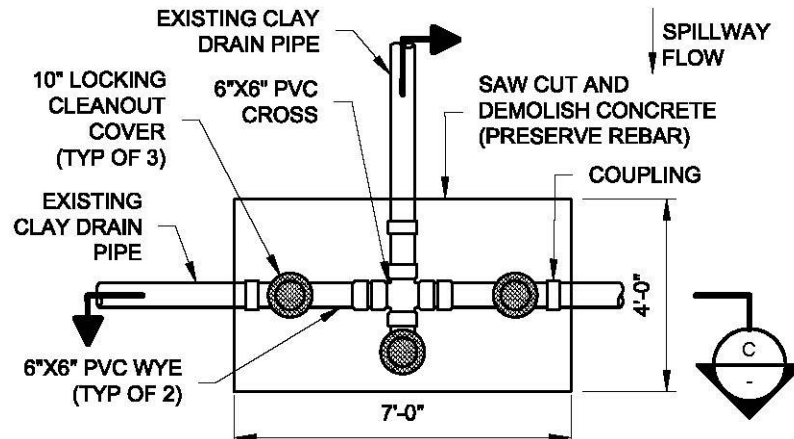
Additional Information from Inter-Lake Tunnel Project Work – GEI, April/July 2018  
**Additional Needs to Obtain Basic Spillway Functionality**
