August 14, 2024

Ms. Tracy Piazza  
58 Mt. Devon Road  
Carmel, CA. 93923  
APN: 241-142-002  
Project File # PLN230339

Subject: 58 Mt. Devon Road Non-Permitted Tree Removal Assessment

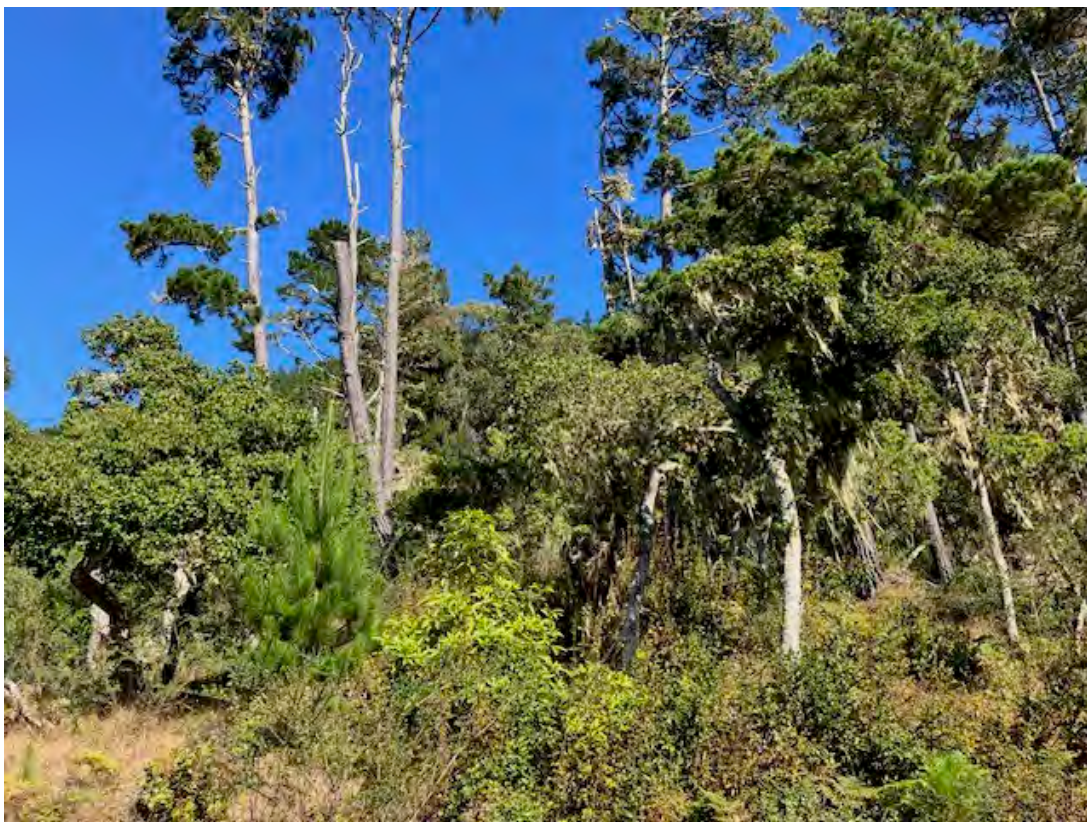
Figure 1. View of mixed pine and oak woodland south parcel from Mt. Devon Road.

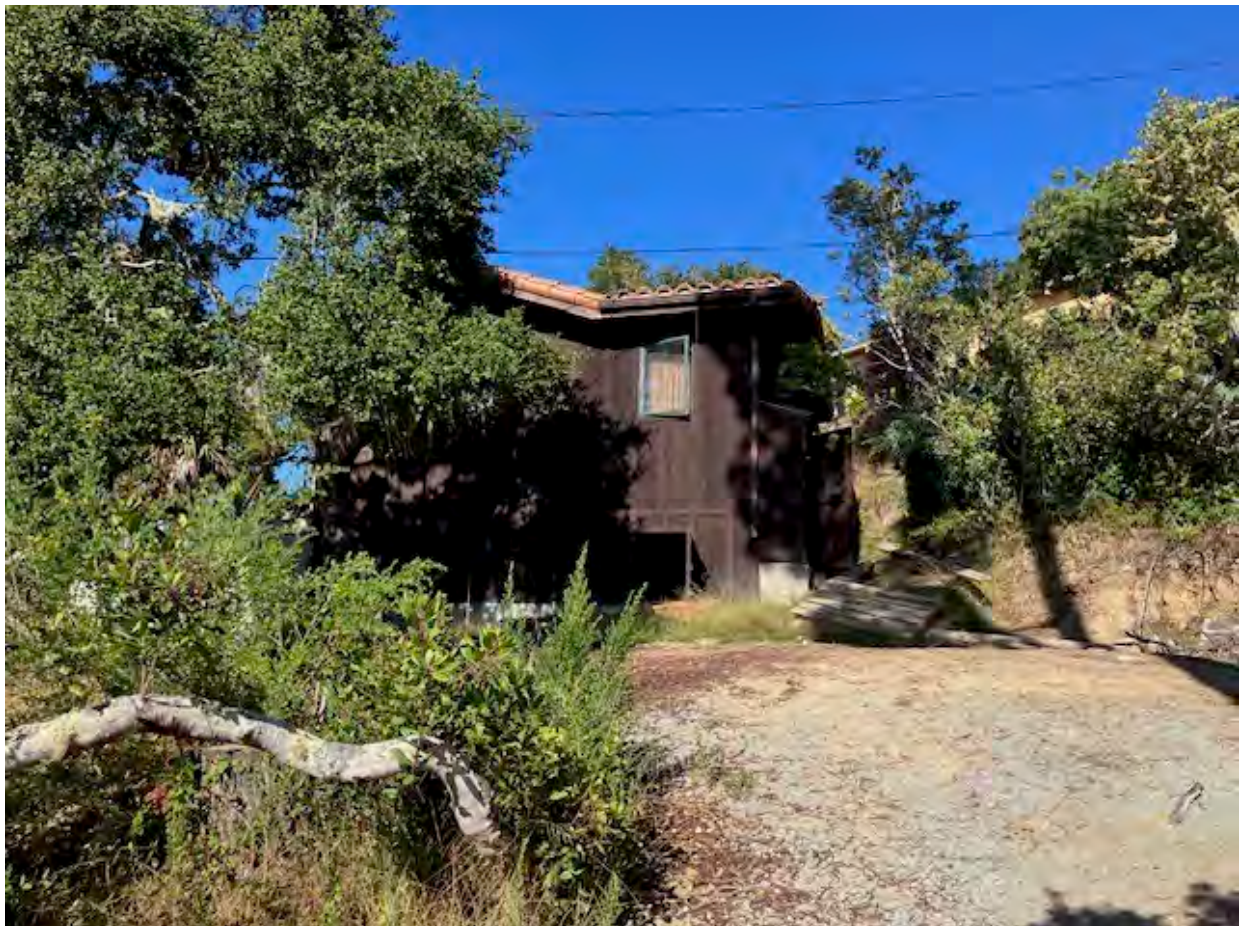
Figure 10. Structure is located at top of unpaved entrance. The main house and residence is barely visible in the background.
