This intent of this letter is to bring you up to date on the permitted discovery work under way at the historic Fan shell House, by noted American architect Mark Mills, located at 3137 17 Mile Dr., in Pebble Beach (APN# 008-263-001. The subject property was constructed in 1972. Constructed of slump stone blocks, the houses is segmental in design, taking a taking the form of a scalloped seashell, l in an arc shaped footprint, West to Northwest, just above the Pacific Ocean. The buildings style is Organic Modern. The structure has five bays, with massive glass windows framed with vertical steel members, piercing the roof and bolted in place. The radiating walls are set directly on the sand dunes.

Fanshell House • 3137 17 Mile Drive • Pebble Beach, California
Repair & Maintenance – August 2024

DESIGN REVIEW PHOTO SUBMITTAL- FANSHELL HOUSE

DOWLER RESIDENCE
3137 17 MILE DRIVE
PEBBLE BEACH, CA 93953

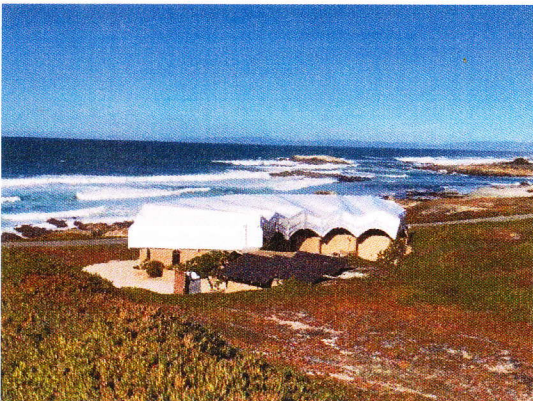
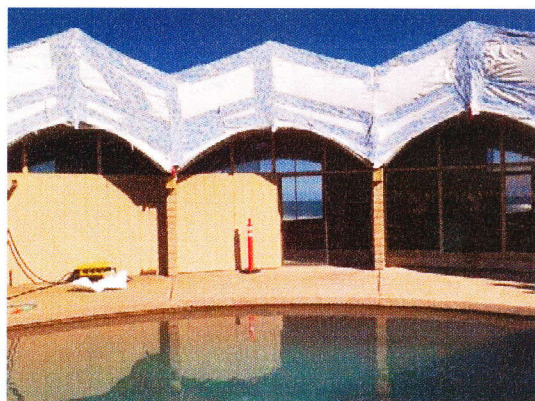
The most urgent task was to evaluate the roofing and mitigate the source of the extensive water intrusion and damage. Roof leakage had left significant effervescence stains on the slump stone CMU walls throughout the building. The supporting CMU columns showed significant cracking and degradation due to the coastal elements and water intrusion causing extensive corrosion of the reinforcing steel and spalling of the roof fascia.

The owner hired a contractor to proceed with investigating the damage to proceed with reroofing the structure. Removal of the original membrane led to a series of discoveries that caused the owner to pause and investigate further. Once the original roofing was removed a temporary cover was erected to weatherproof the roof allowing a more comprehensive study of the structure.

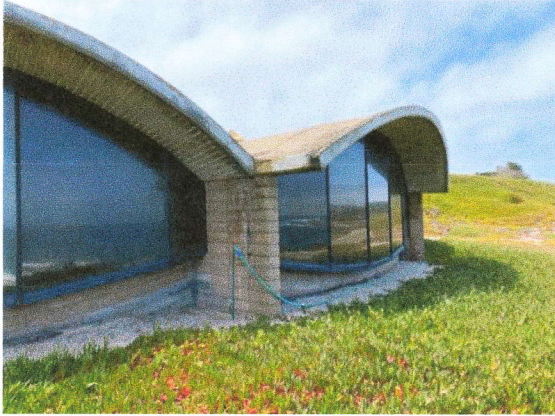
WINDOW WALL

The original west facing steel frame projected window wall has been significantly damaged by corrosion. The steel mullions are supported at the roof by bolts embedded in the concrete. The steel sections protrude through the concrete roof and as a result have corroded further damaging the roof. The mullions are attached with steel sections to the low CMU wall. The low wall is riddled with hairline cracks due to the stresses of the projected frames. Sill heights of the operable casement units in the bedrooms are too high for required egress.

The glazing has panes of differing colors due to replacements of dissimilar glass materials over the years and a surface tint treatment of select panes. When the house was purchased, there were cracked and broken panes that the new owner replaced. Some of which cracked again.

Due to extensive corrosion the steel frames are not serviceable. The glass window wall facing the ocean is a primary feature of the house that we wish to replace with insulating glass and thermally broken steel frames. We have researched extensively to find a manufacturer that can closely replicate the thinness of the existing windows and the mullion pattern. A modified structural support for the projected window wall is proposed to be contained entirely on the interior of the building so as not to modify the low wall. Given that the vaulted concrete roof structure is the primary significant feature of the house, few opportunities exist to increase the thermal performance of the building. The energy efficiency of the glass being the one element that can make a tangible improvement, without the loss of design features or intent, seems the most feasible treatment to create a more comfortable environment.
