THOMPSON
WILDLAND MANAGEMENT

October 2, 2025

Nunnelee Residence
3144 Spruance Road
Pebble Beach, CA. 93953
APN: 008-501-004-000

Subject: 3144 Spruance Road Pre-construction Tree Impact Assessment

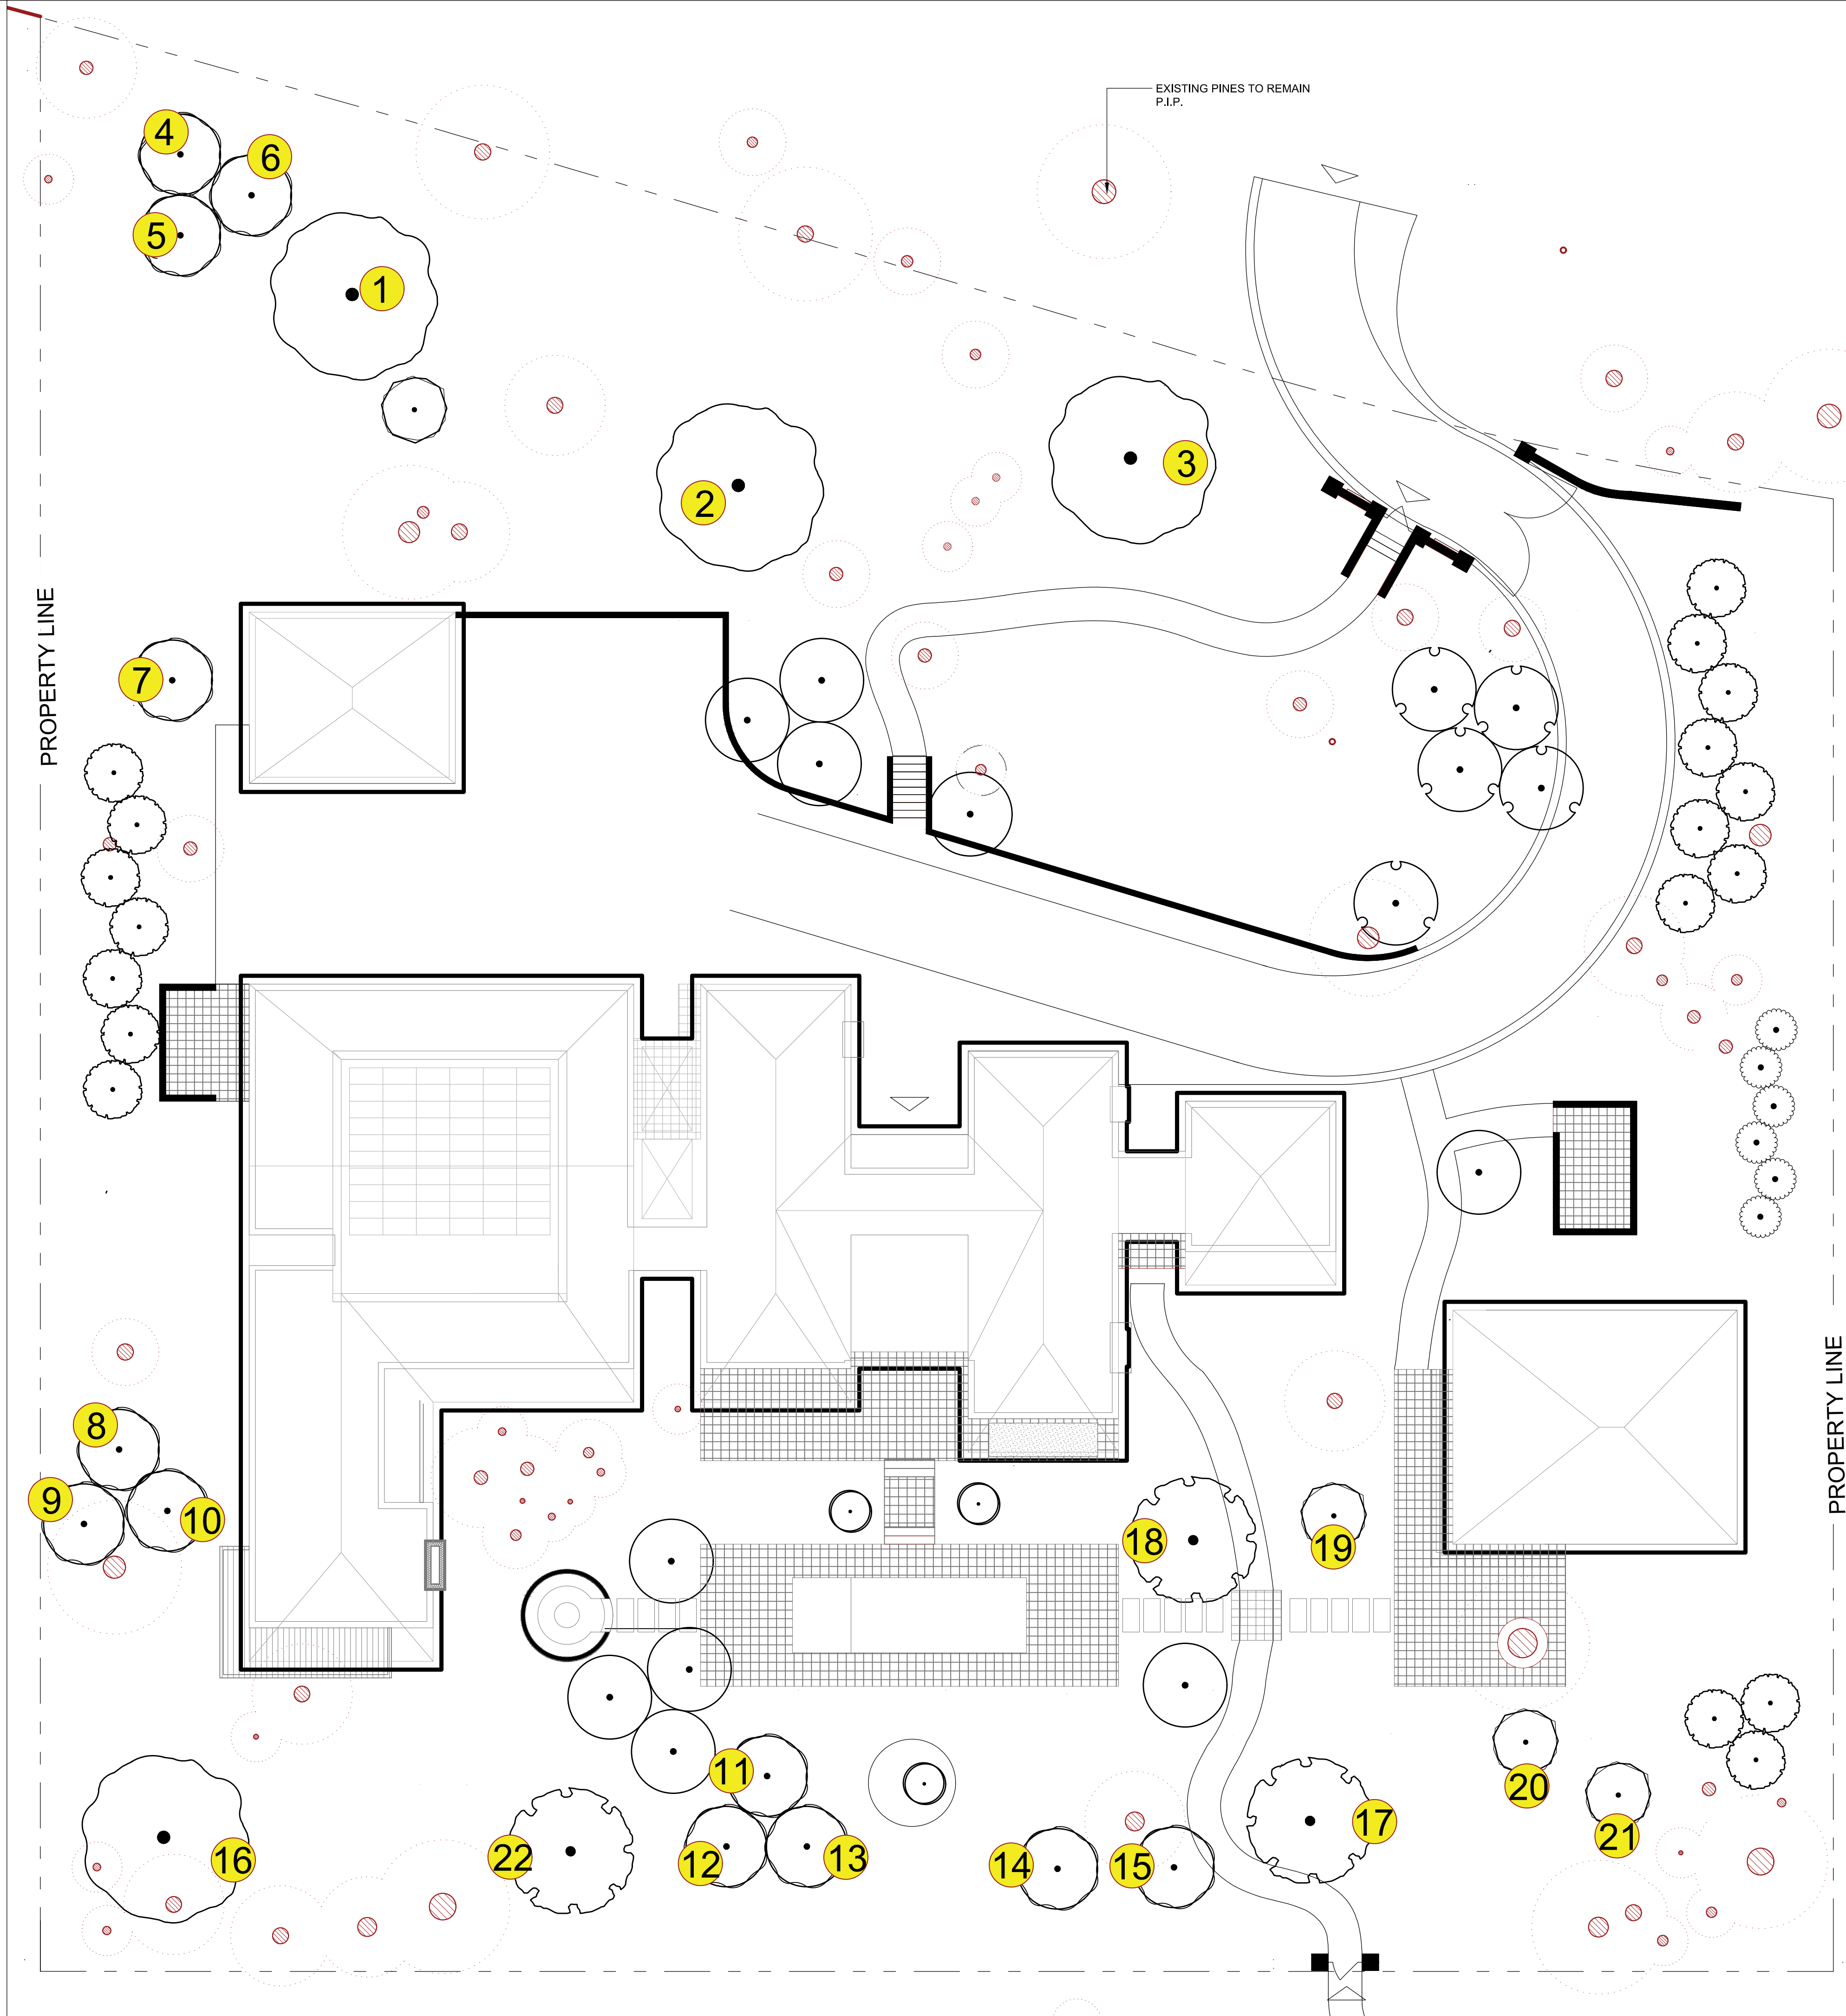
SHEET TITLE:
TREE REPLACEMENT PLAN

1 #1-#22 NATIVE TREES REQUIRED TO BE REPLACED AS EXISTING APPROVED PINES ARE REMOVED.

Lastly, in the interest of complying with *Monterey County Housing & Community Development Department-Planning Services* permit conditions and preserving and sustaining the health and character of woodland habitat, 22 replacement trees (i.e., 12 one to five-gallon native Monterey pine seedlings or saplings and 10 one to five-gallon coast live oak and/or Monterey cypress
