**GOLDING TED & STACEY SOUDERS GOLDING TRS (PLN230080)
RESOLUTION NO. 24--**

- 1) Finding the project qualifies for a Class 21 Categorical Exemption pursuant to Section 15321(a)(2), enforcement actions by regulatory agencies, with no exceptions to section 15300.2; and
- 2) Approving a Restoration Permit to partially clear Code Enforcement violation (22CE00202) to allow restoration of slopes in excess of 25% including approximately 88 cubic yards of fill, removal and relocation of approximately 385 cubic yards of wood chips and replacement of 25 Monterey pine and 10 Coast live oak trees.

RESTORATION PLAN TO RESOLVE CODE VIOLATION 22CE00202 TO ALLOW RESTORATION OF SLOPES OVER 25%.

TITLE PAGE / SITE PLAN
 GRADING RESTORATION AND WOOD CHIP DISPOSAL
 APN# 103-041-017-000
 CARMEL, CA

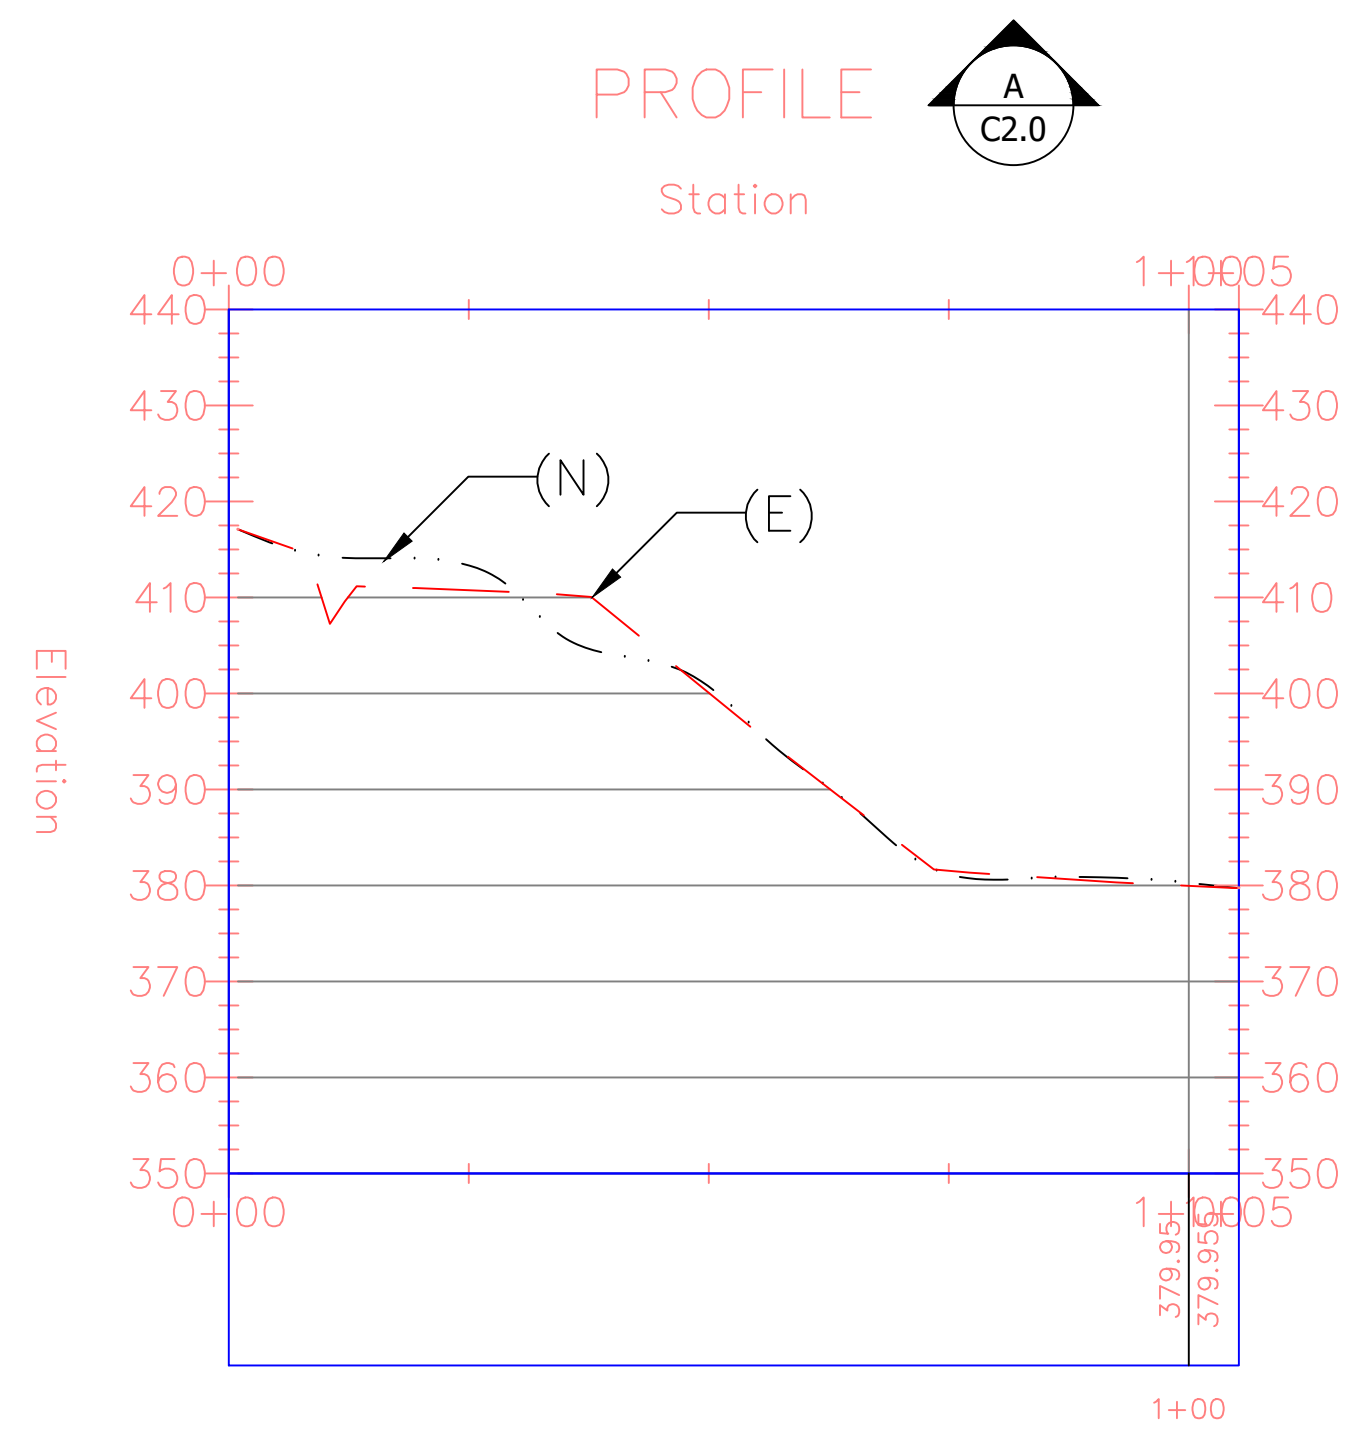
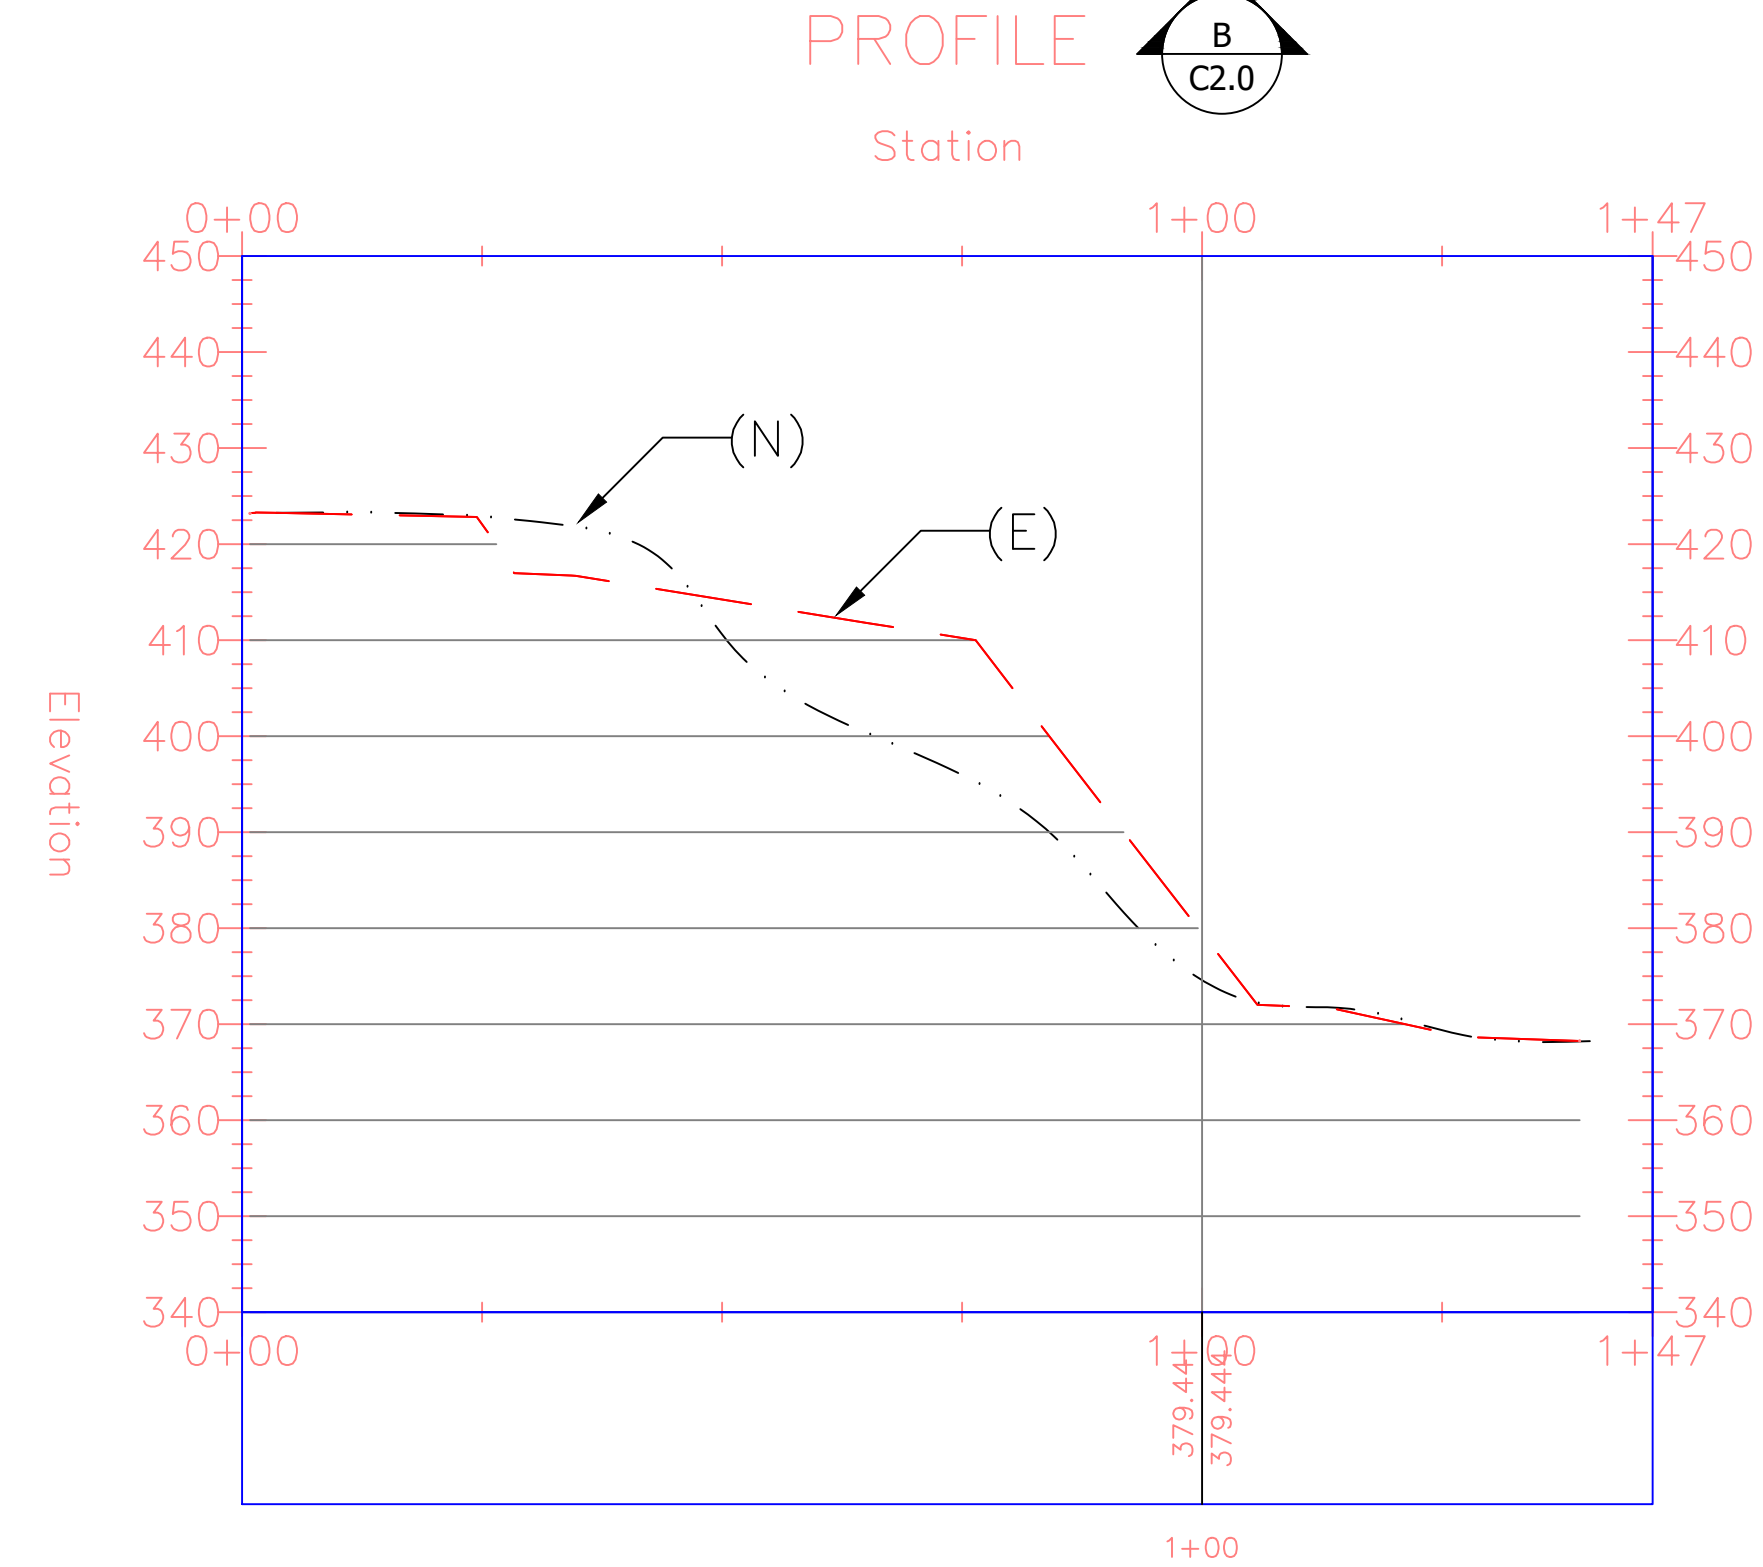
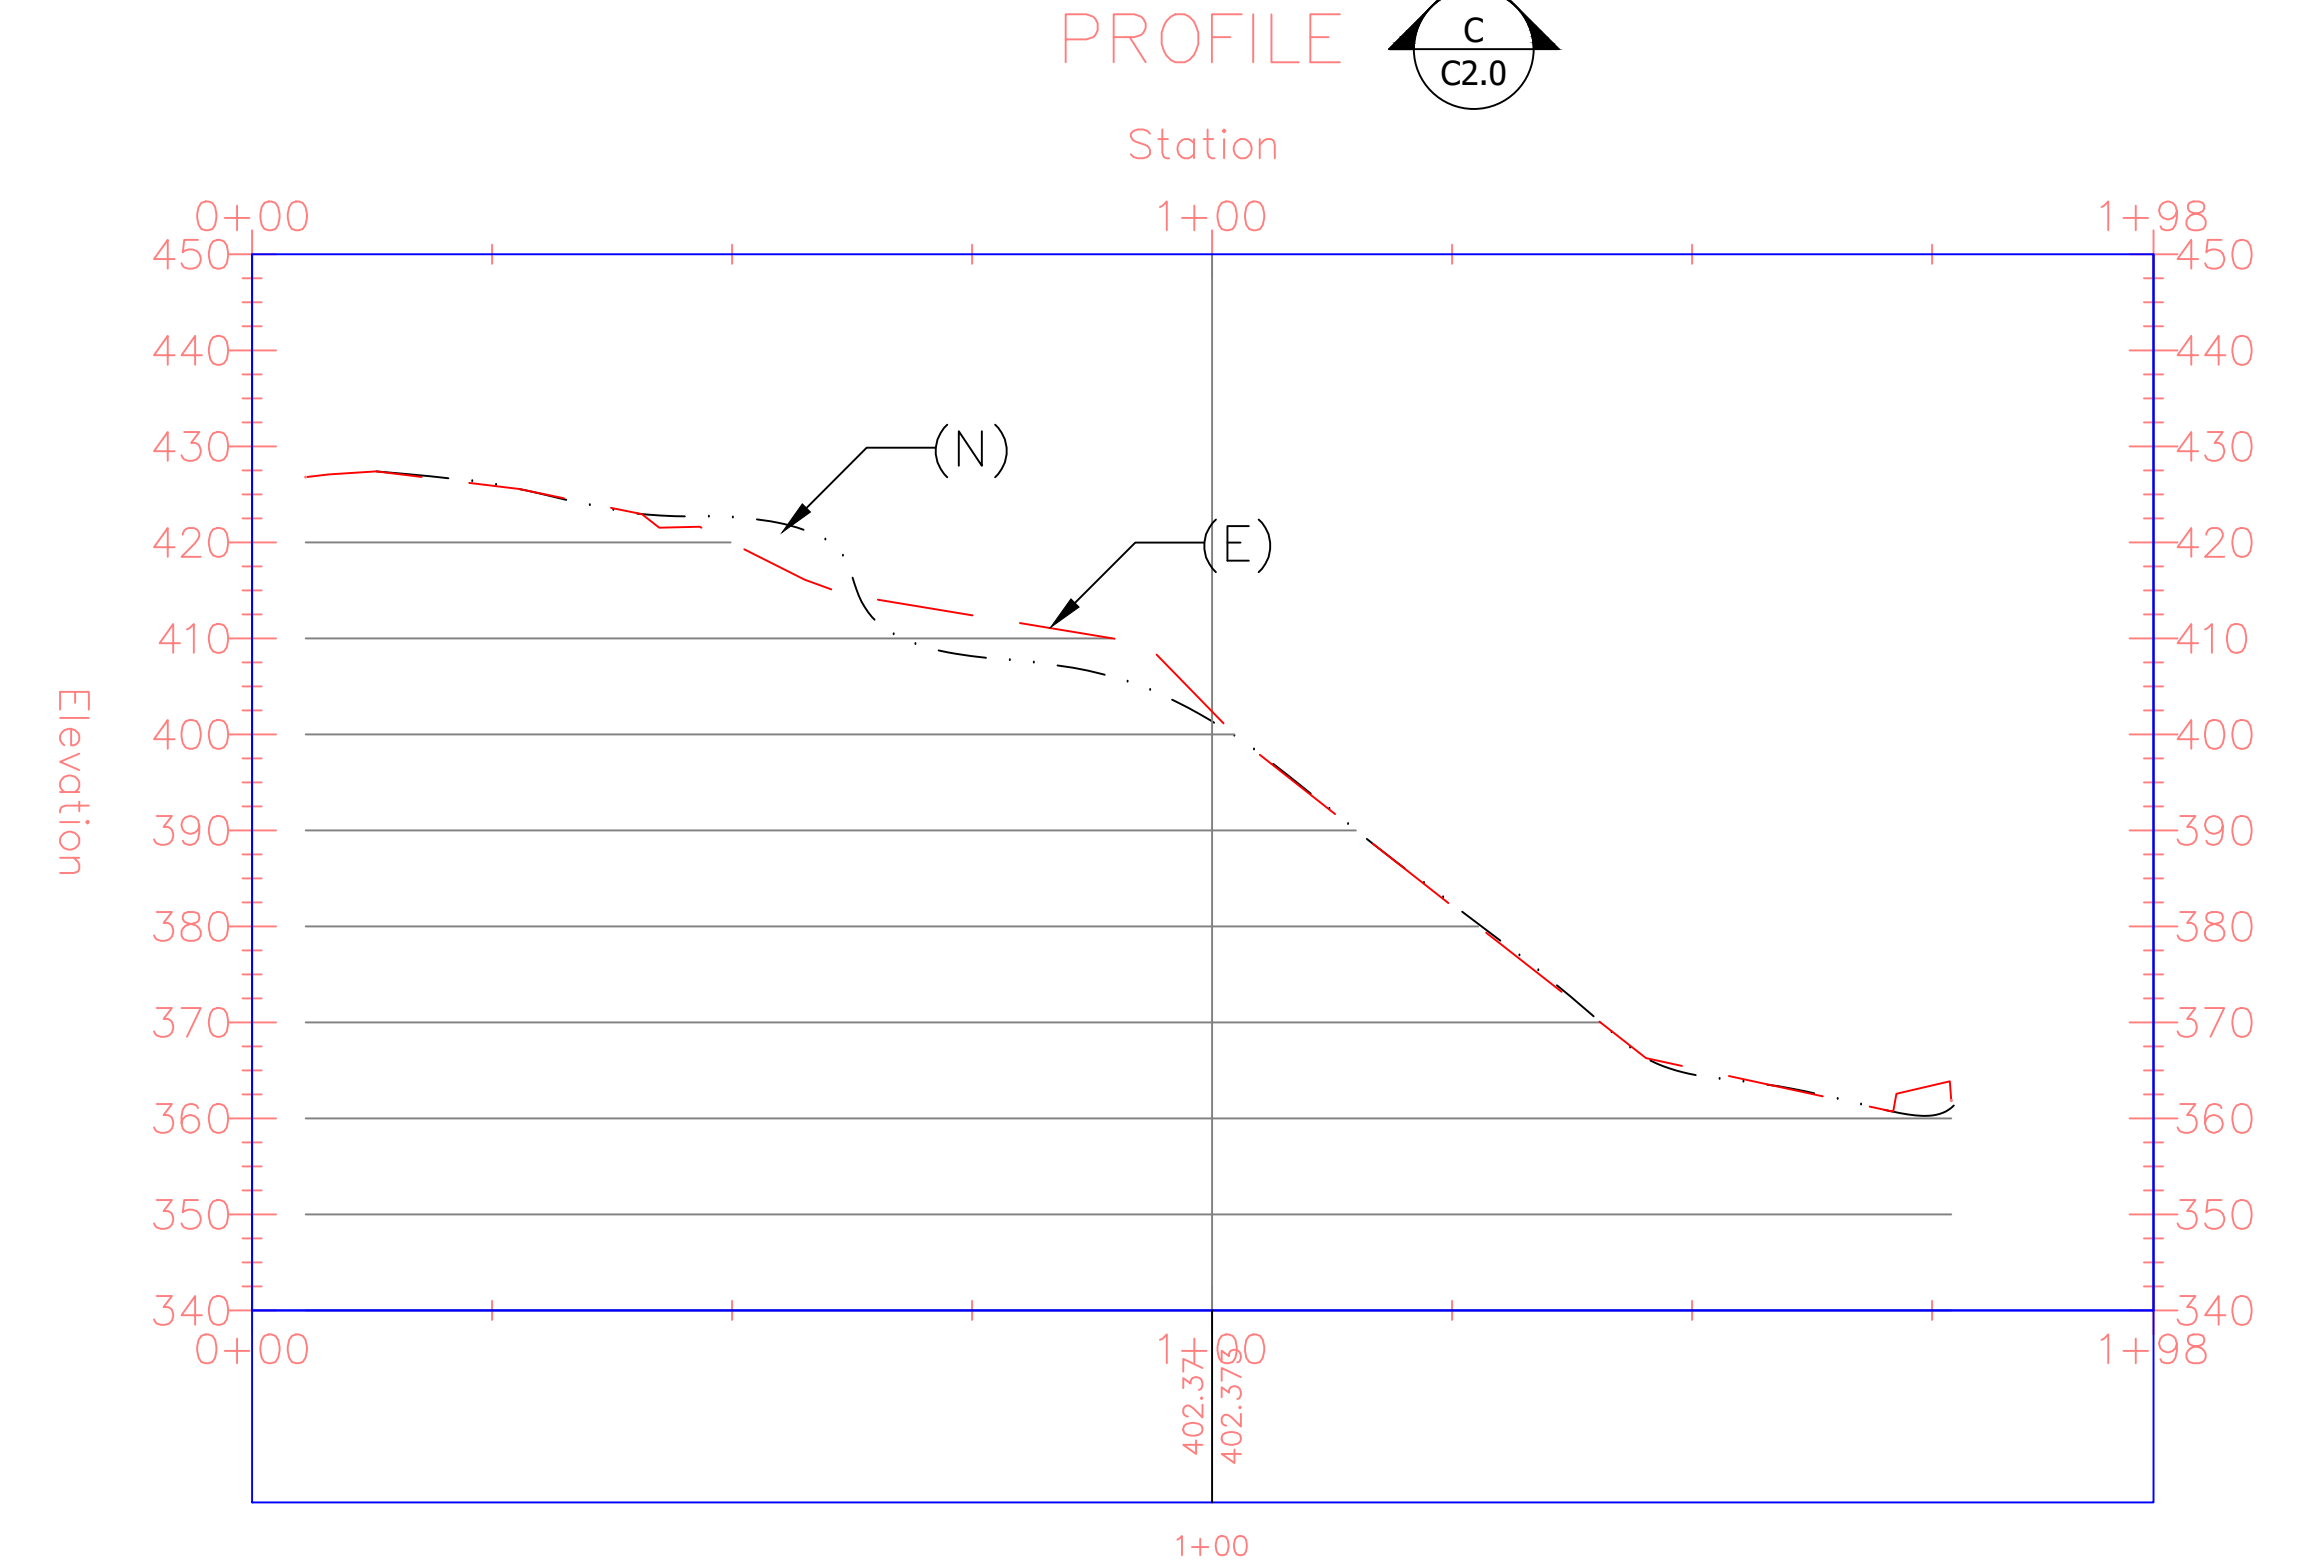
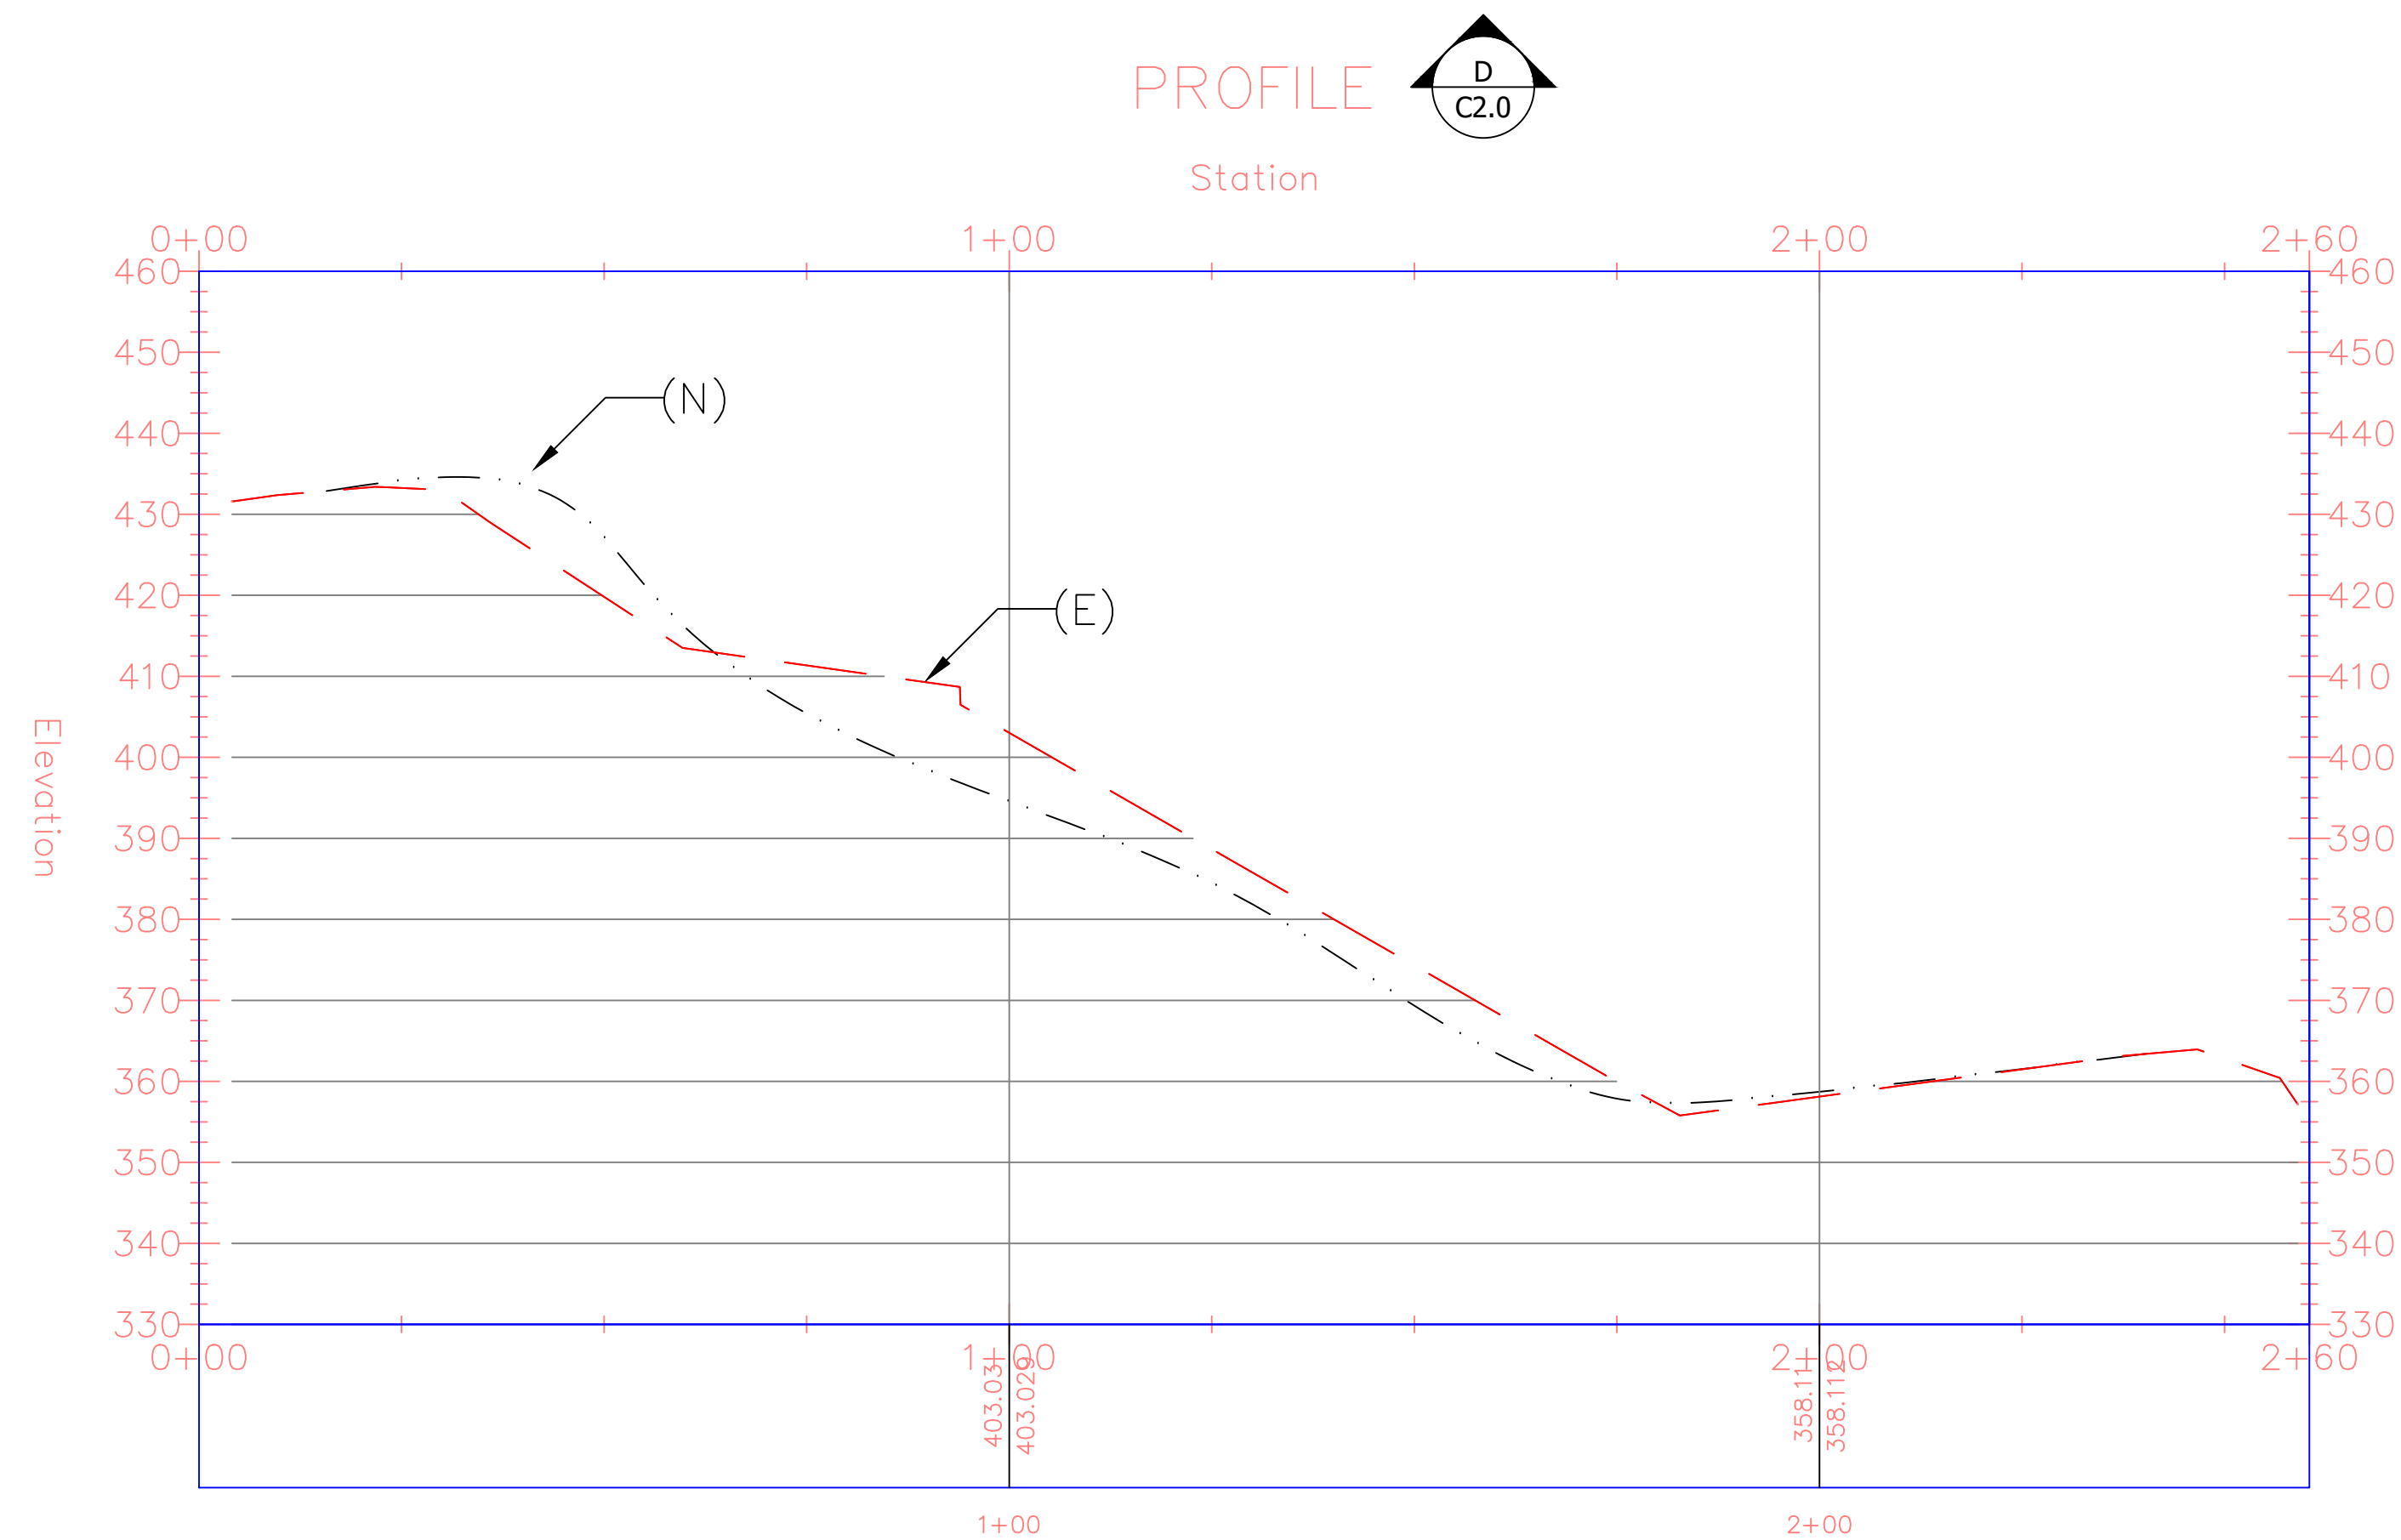
ELEVATIONS
GRADING RESTORATION AND WOOD CHIP DISPOSAL
APN# 103-041-017-000
CARMEL, CA

SLOPE ANALYSIS:

- PROFILE A - 35% SLOPE NATIVE GRADE
- PROFILE B - 28% SLOPE NATIVE GRADE
- PROFILE C - 28% SLOPE NATIVE GRADE
- PROFILE D - 23% SLOPE NATIVE GRADE

PROJECT RECOMMENDATION AND SCOPE TO RESOLVE SLOPE INSTABILITIES:

- 1) WOOD CHIPS HAVE BEEN DISPOSED ON HILLSIDES OF VARYING SLOPE INCLUDING SLOPES OF >25%. PARTIALLY BURYING TREE STUMPS AND RESULTING IN LOOSE FILL.

ENGINEERING RECOMMENDATION IS TO REMOVE APPROXIMATELY 385 CU/YDS OF WOOD CHIPS FROM THE HILLSIDE AND PLACE THEM ON THE LOWER PROPERTIES WHERE SLOPES ARE LESS THAN 5%. (SEE SHEET C3.0)

RECOMMENDATION IS TO REMOVE WOOD SHED AND FOUNDATION, FOLLOWED BY PROPERLY KEY IN SOIL AND REPLACE ENGINEERED FILL TO RESTORE HILLSIDE TO A NATURAL SLOPE.

ENGINEERING RECOMMENDATION IS TO USE NATIVE SOILS AND IMPORT SELECT FILL AS NEEDED TO RESTORE HILLSIDE PER CROSS SECTION DETAIL (SEE SHEET C3.0)

ALL WORK PROPOSED SHOULD BE ACCOMPLISHED BY A LICENSED CONTRACTOR WITH SUFFICIENT EQUIPMENT TO MOVE THIS MATERIAL IN AN EXPEDITIOUS MANNER. WORK SHOULD BE OBSERVED AND DOCUMENTED BY LICENSED CIVIL/GEOTECHNICAL ENGINEER TO OBSERVE FOR INSTABILITIES WHILE WORK IS UNDERWAY.

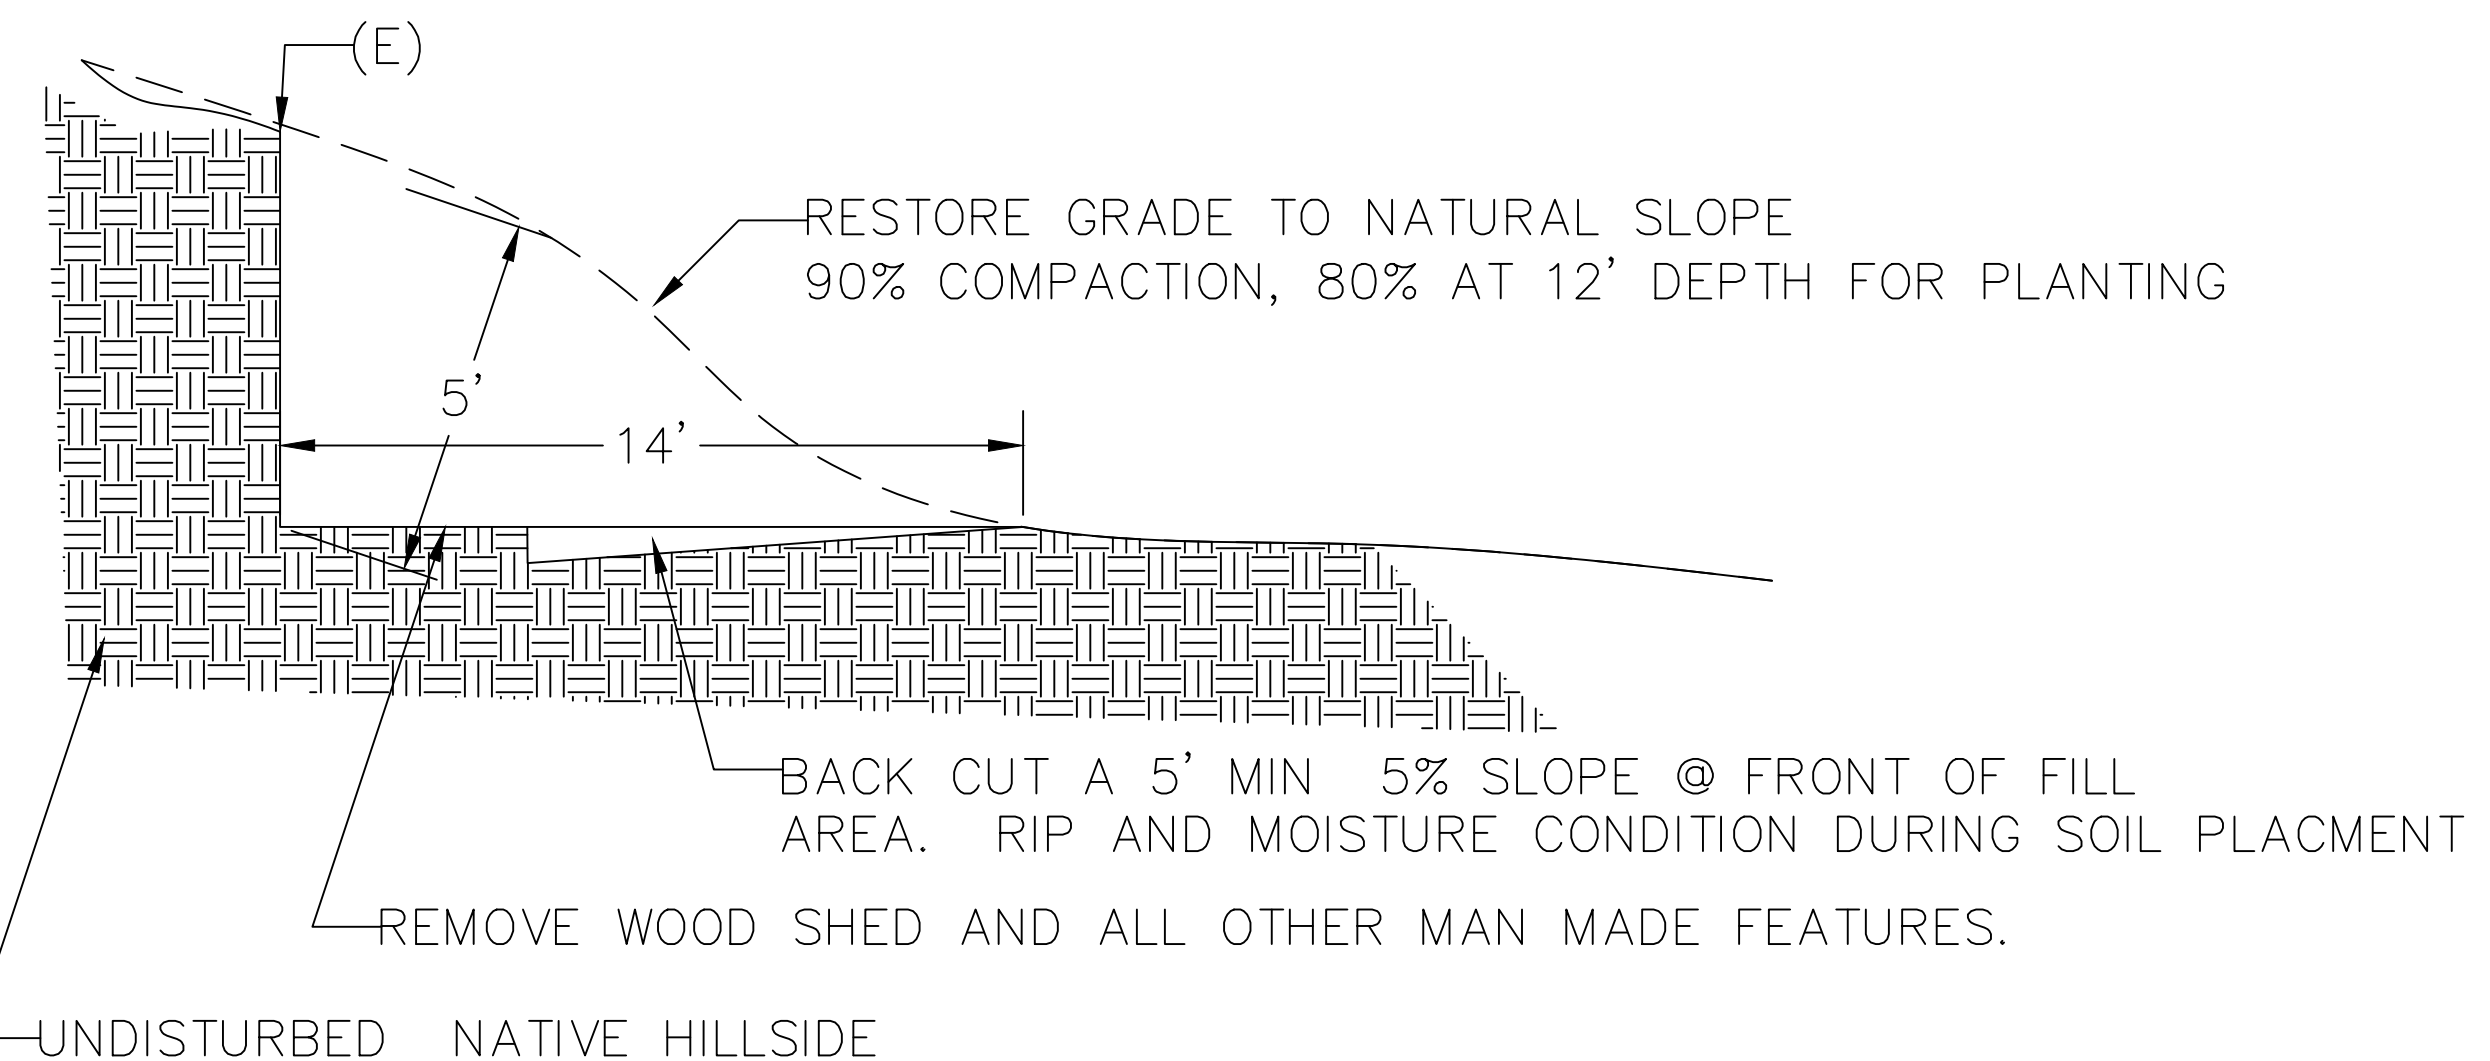
DETAILS
GRADING RESTORATION AND WOOD CHIP DISPOSAL
APN# 103-041-017-000
CARMEL, CA

SLOPE RESTORATION NOTES:

CUT SLOPE TO BE FULLY RESTORED TO THE APPROXIMATE NATURAL GRADE. ONLY SOIL THAT IS FREE OF ORGANIC MATERIAL IS SUITABLE FOR STRUCTURAL SLOPE REPAIR. IF NATURAL SOILS HAVE BEEN MIXED WITH WOOD CHIPS THEN OTHER ONSITE MATERIAL WILL BE REQUIRED, OR OFF SITE MATERIAL SUITABLE FOR STRUCTURAL FILL MAY BE REQUIRED.
