**GOLDING TED & STACEY SOUDERS GOLDING TRS (PLN230080)
RESOLUTION NO. 24--**

- 1) Finding the project qualifies for a Class 21 Categorical Exemption pursuant to Section 15321(a)(2), enforcement actions by regulatory agencies, with no exceptions to section 15300.2; and
- 2) Approving a Restoration Permit to partially clear Code Enforcement violation (22CE00202) to allow restoration of slopes in excess of 25% including approximately 88 cubic yards of fill, removal and relocation of approximately 385 cubic yards of wood chips and replacement of 25 Monterey pine and 10 Coast live oak trees.

RESTORATION PLAN TO RESOLVE CODE VIOLATION 22CE00202 TO ALLOW RESTORATION OF SLOPES OVER 25%.

TITLE PAGE / SITE PLAN
 GRADING RESTORATION AND WOOD CHIP DISPOSAL
 APN# 103-041-017-000
 CARMEL, CA

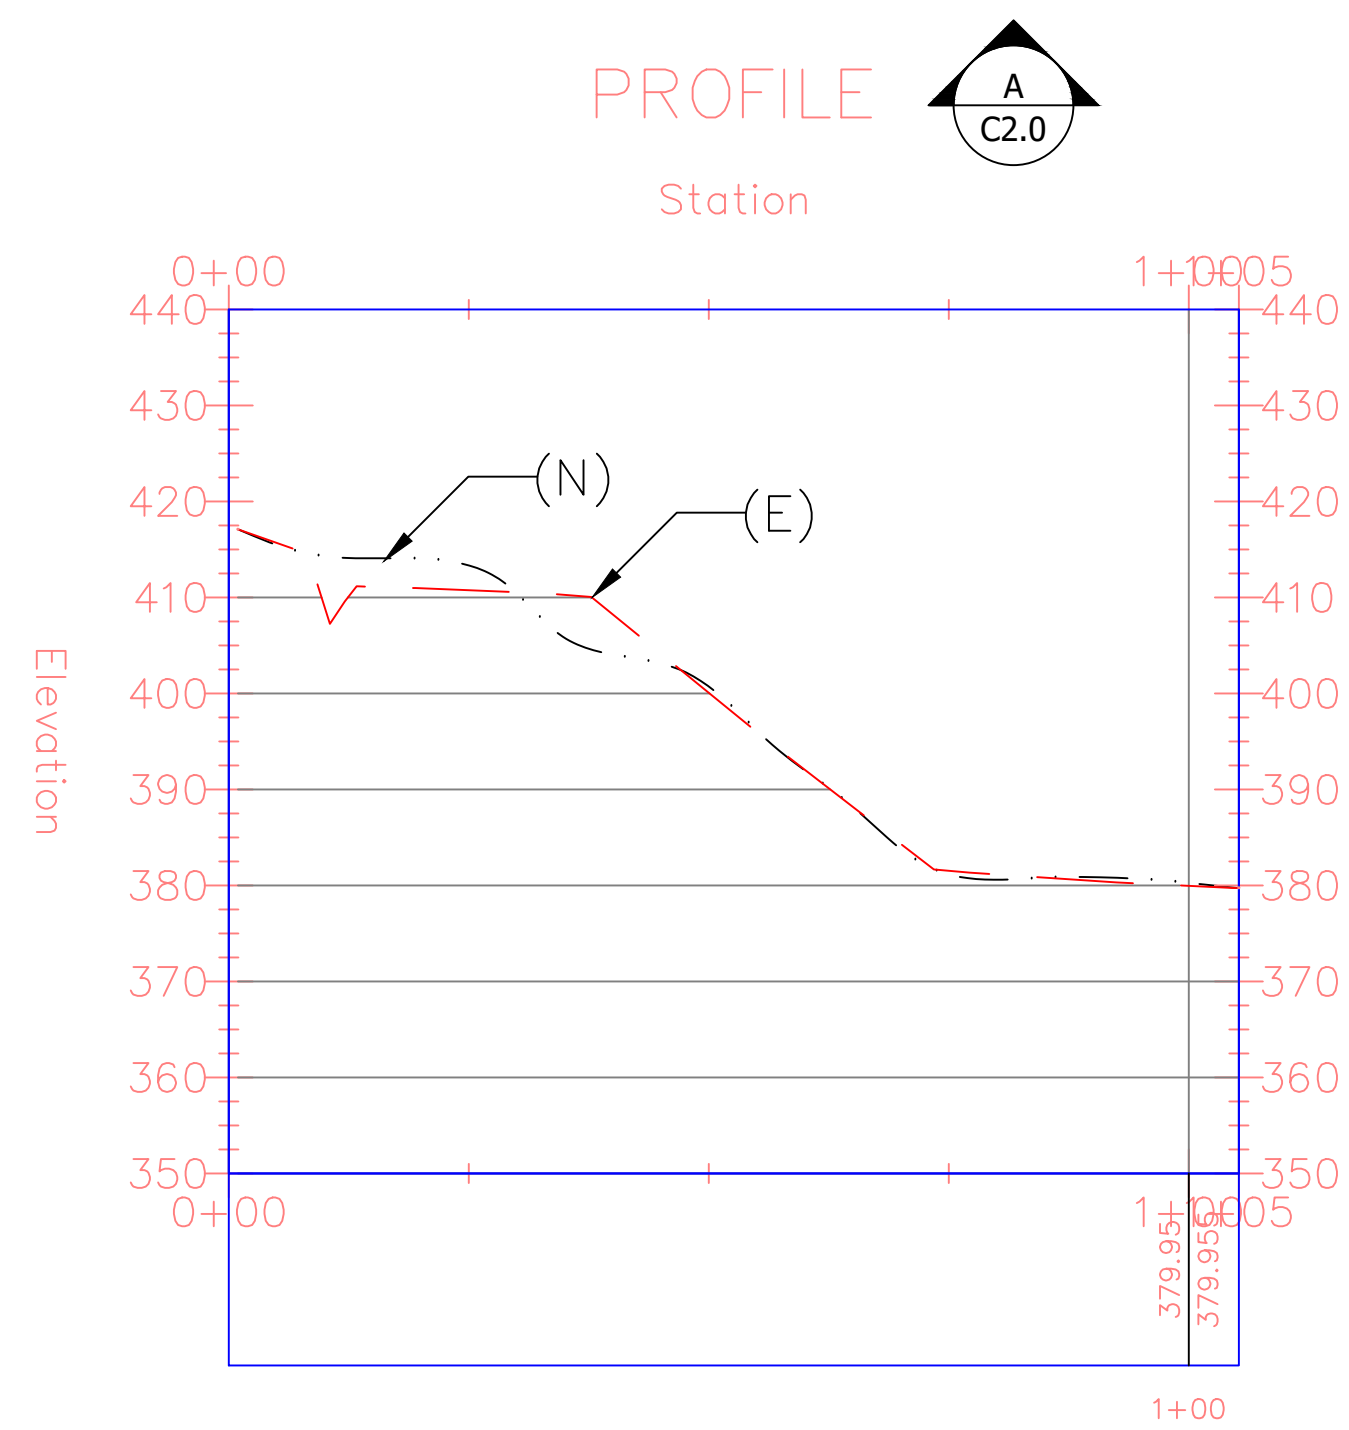
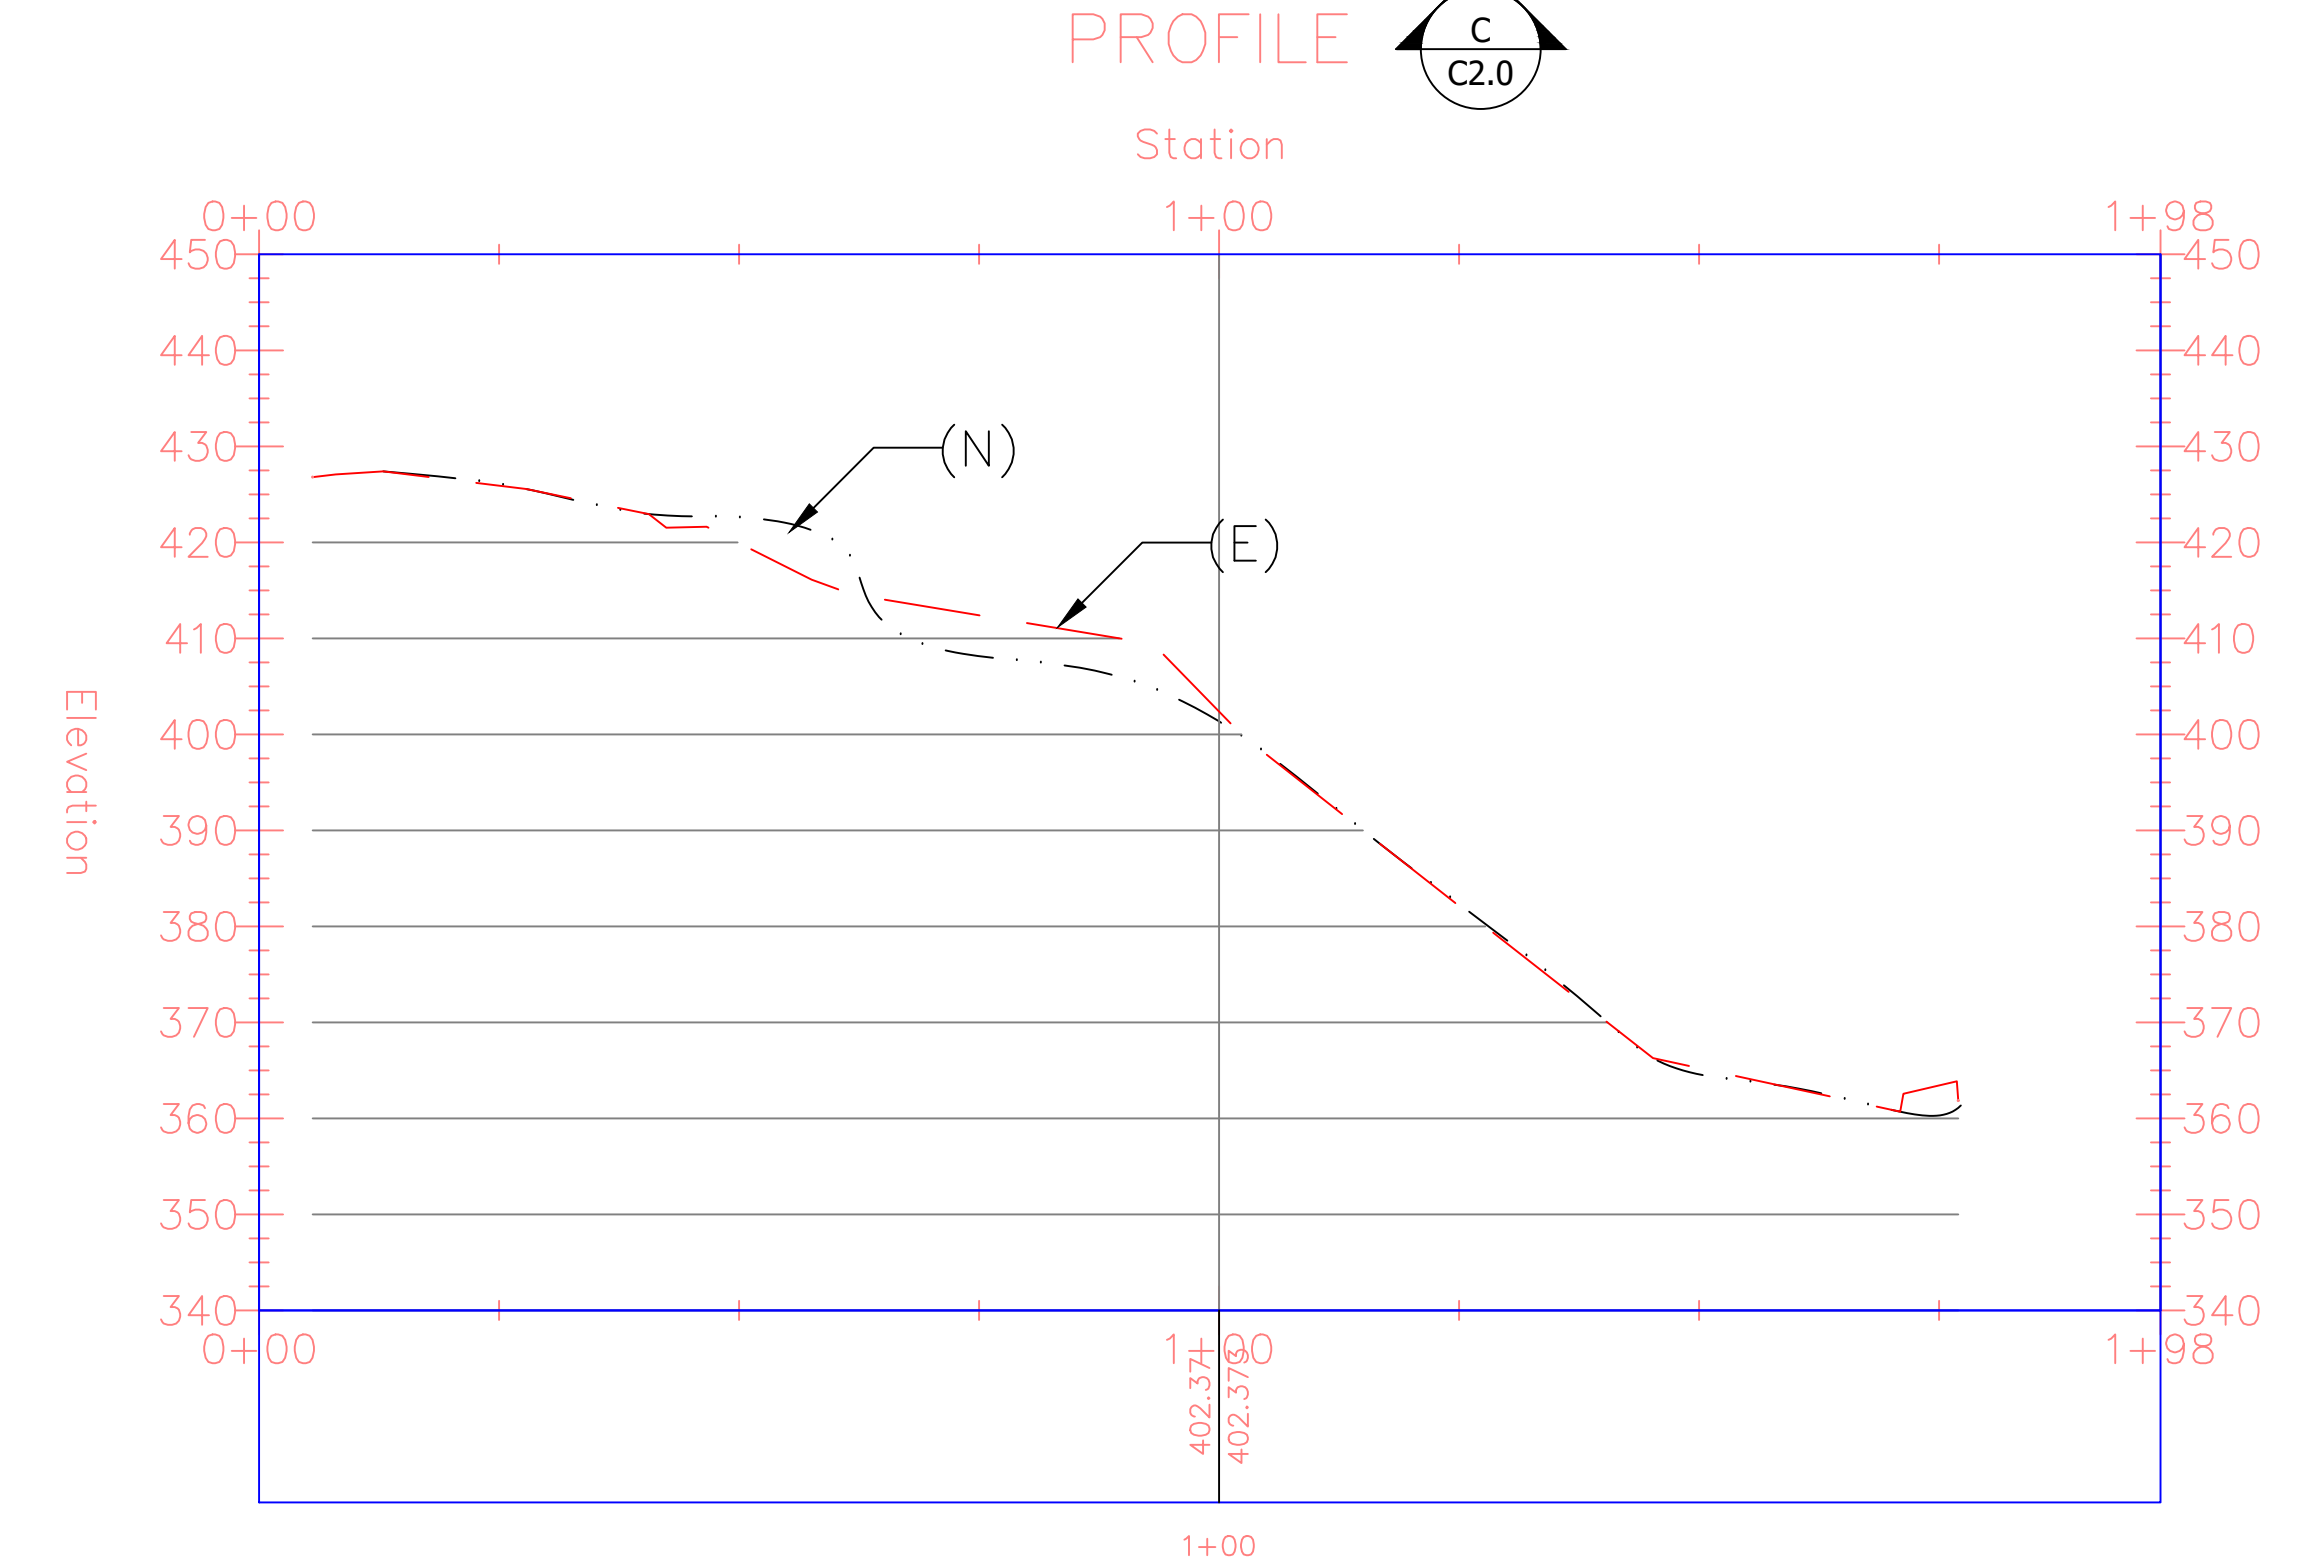
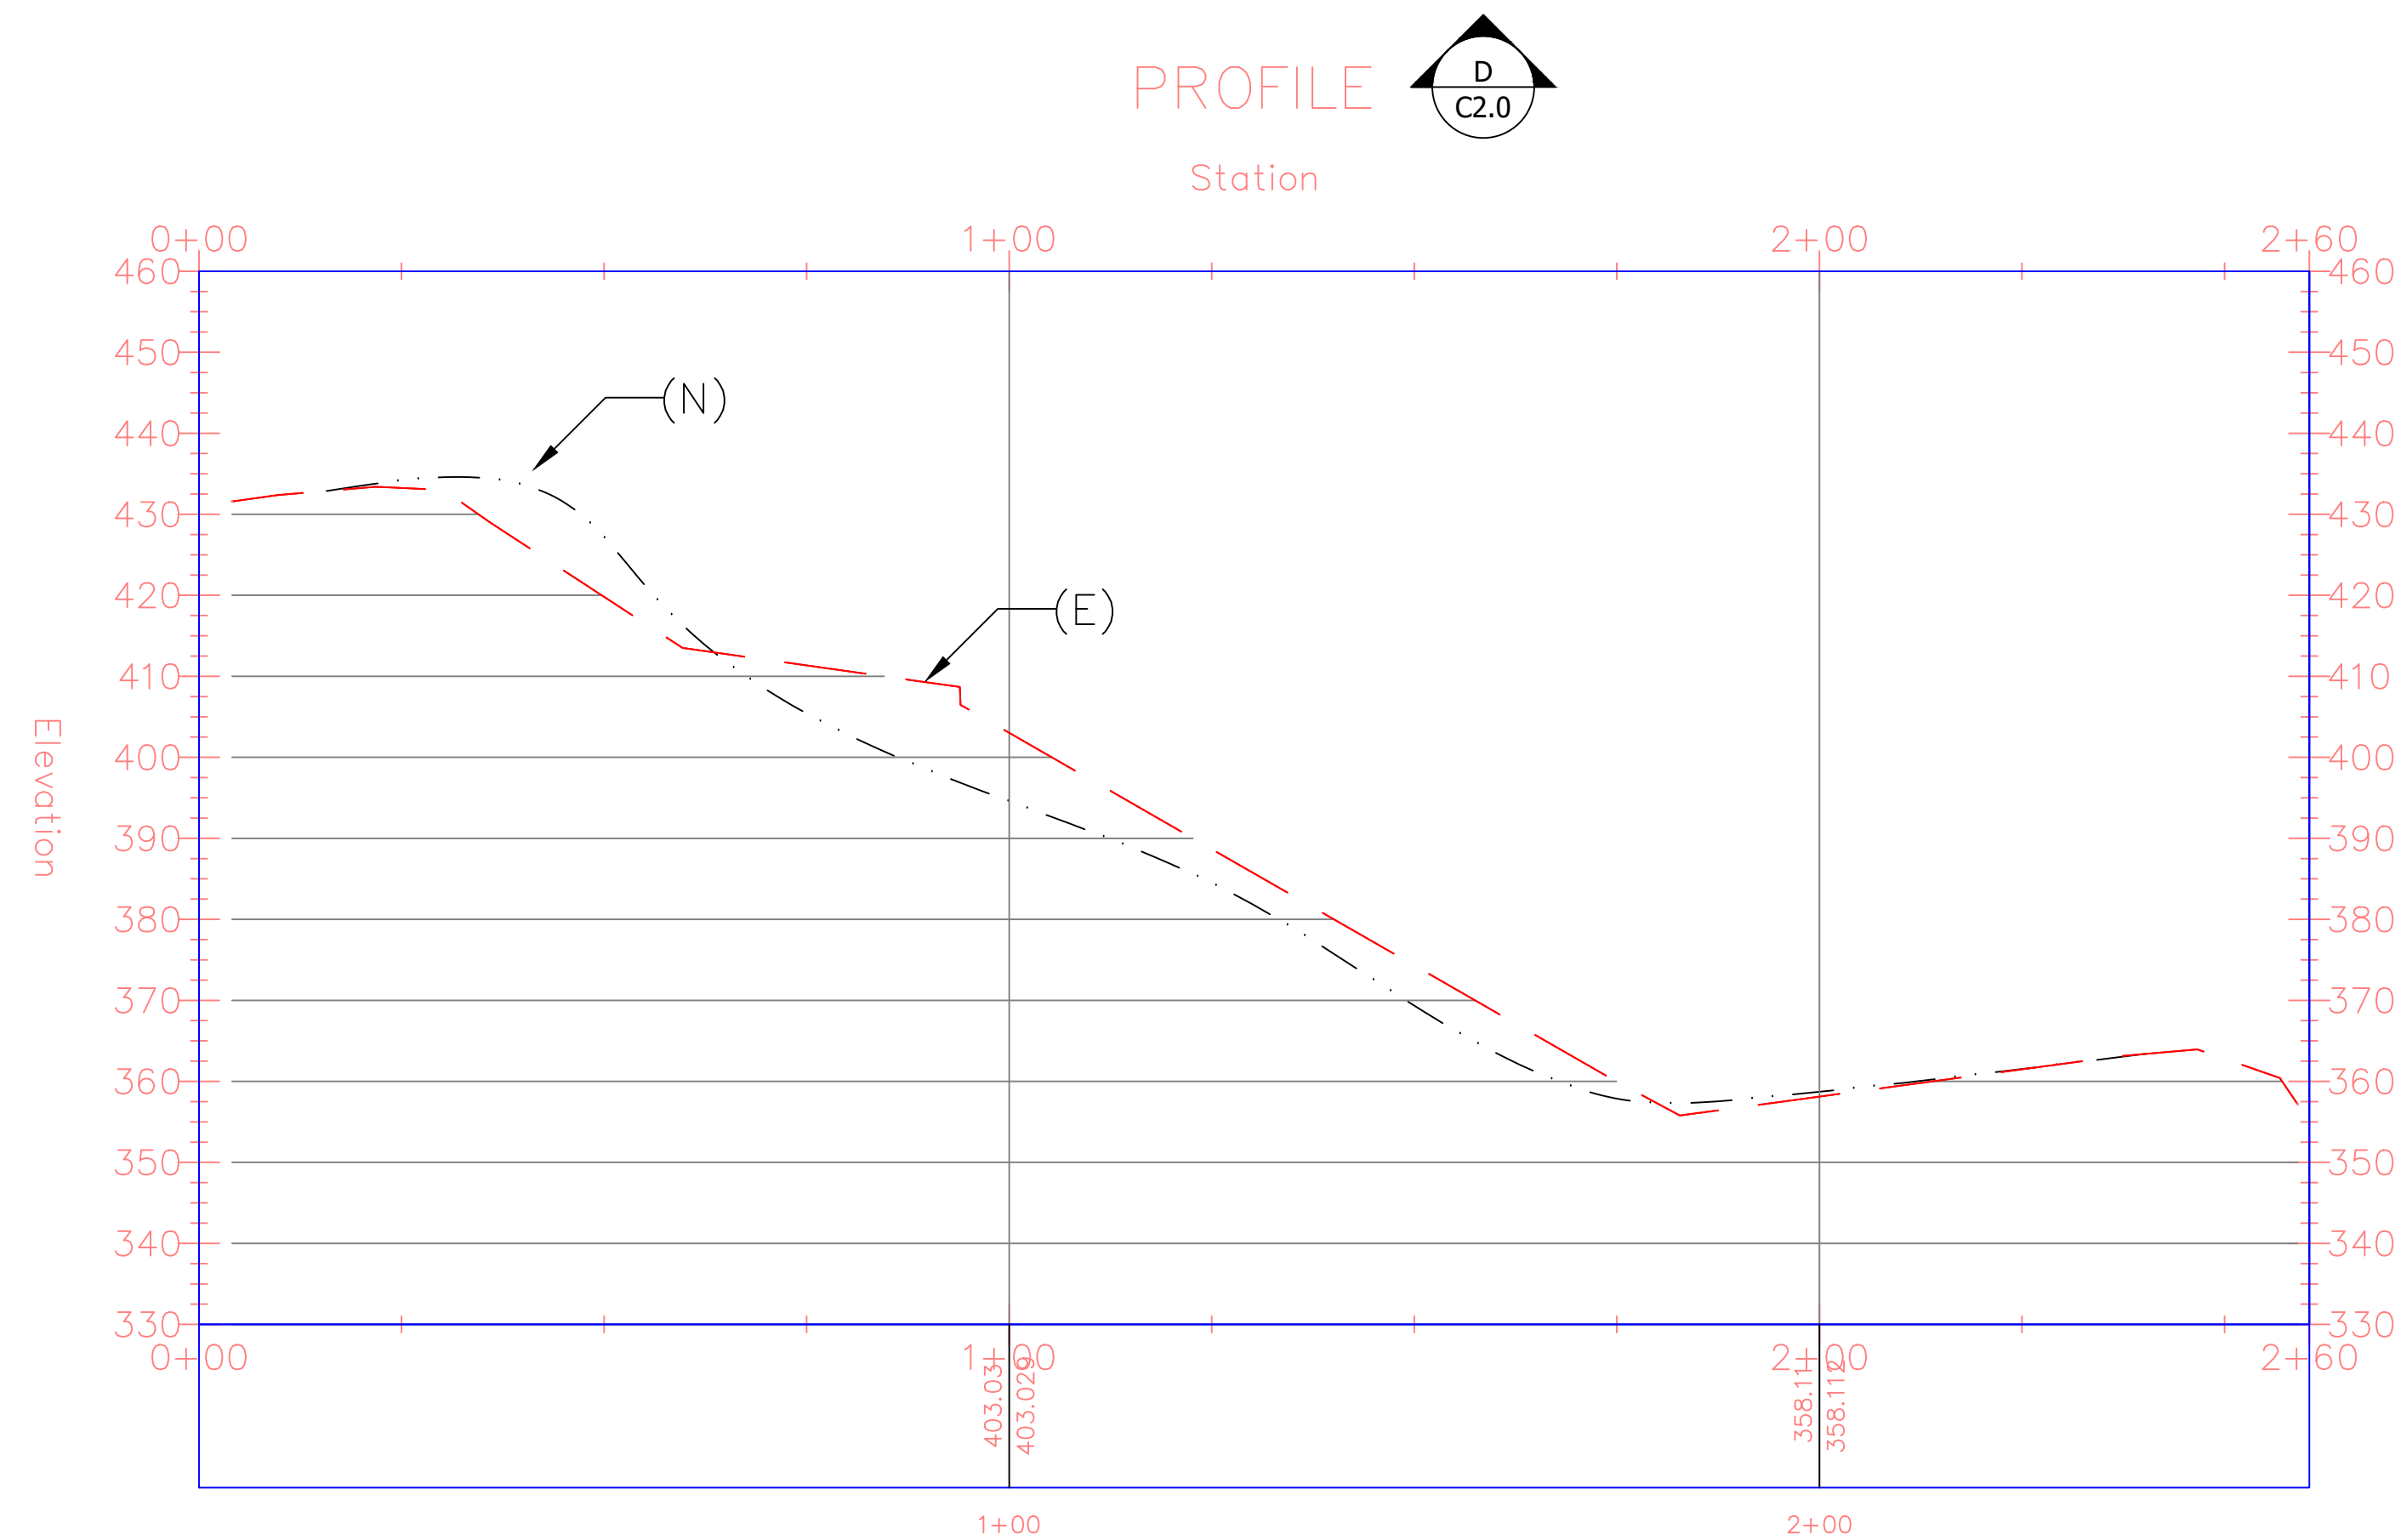
ELEVATIONS
GRADING RESTORATION AND WOOD CHIP DISPOSAL
APN# 103-041-017-000
CARMEL, CA

SLOPE ANALYSIS:

- PROFILE A - 35% SLOPE NATIVE GRADE
- PROFILE B - 28% SLOPE NATIVE GRADE
- PROFILE C - 28% SLOPE NATIVE GRADE
- PROFILE D - 23% SLOPE NATIVE GRADE

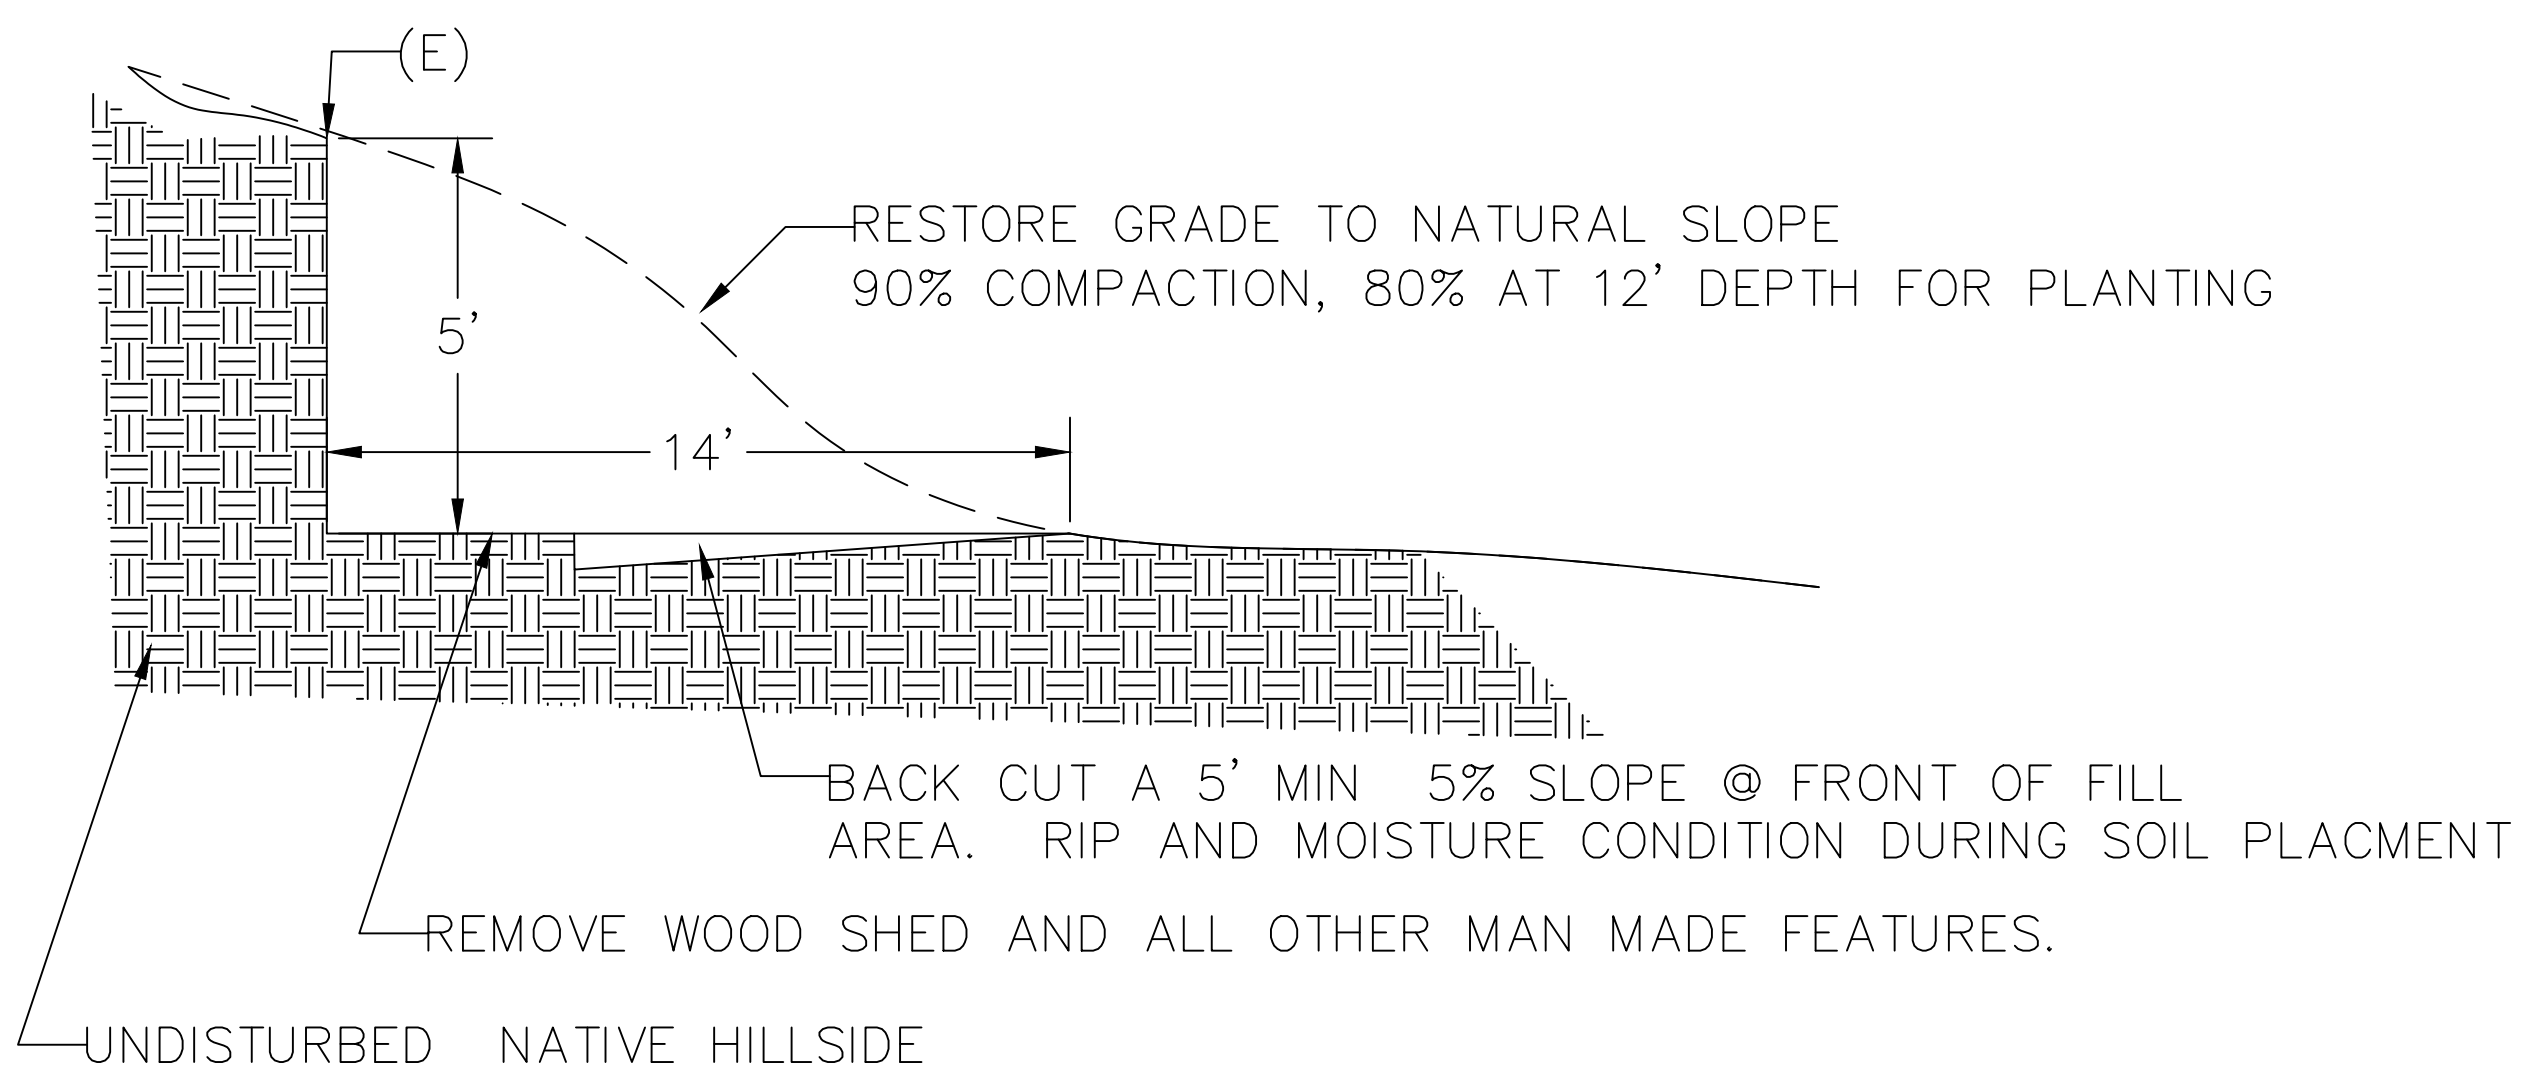
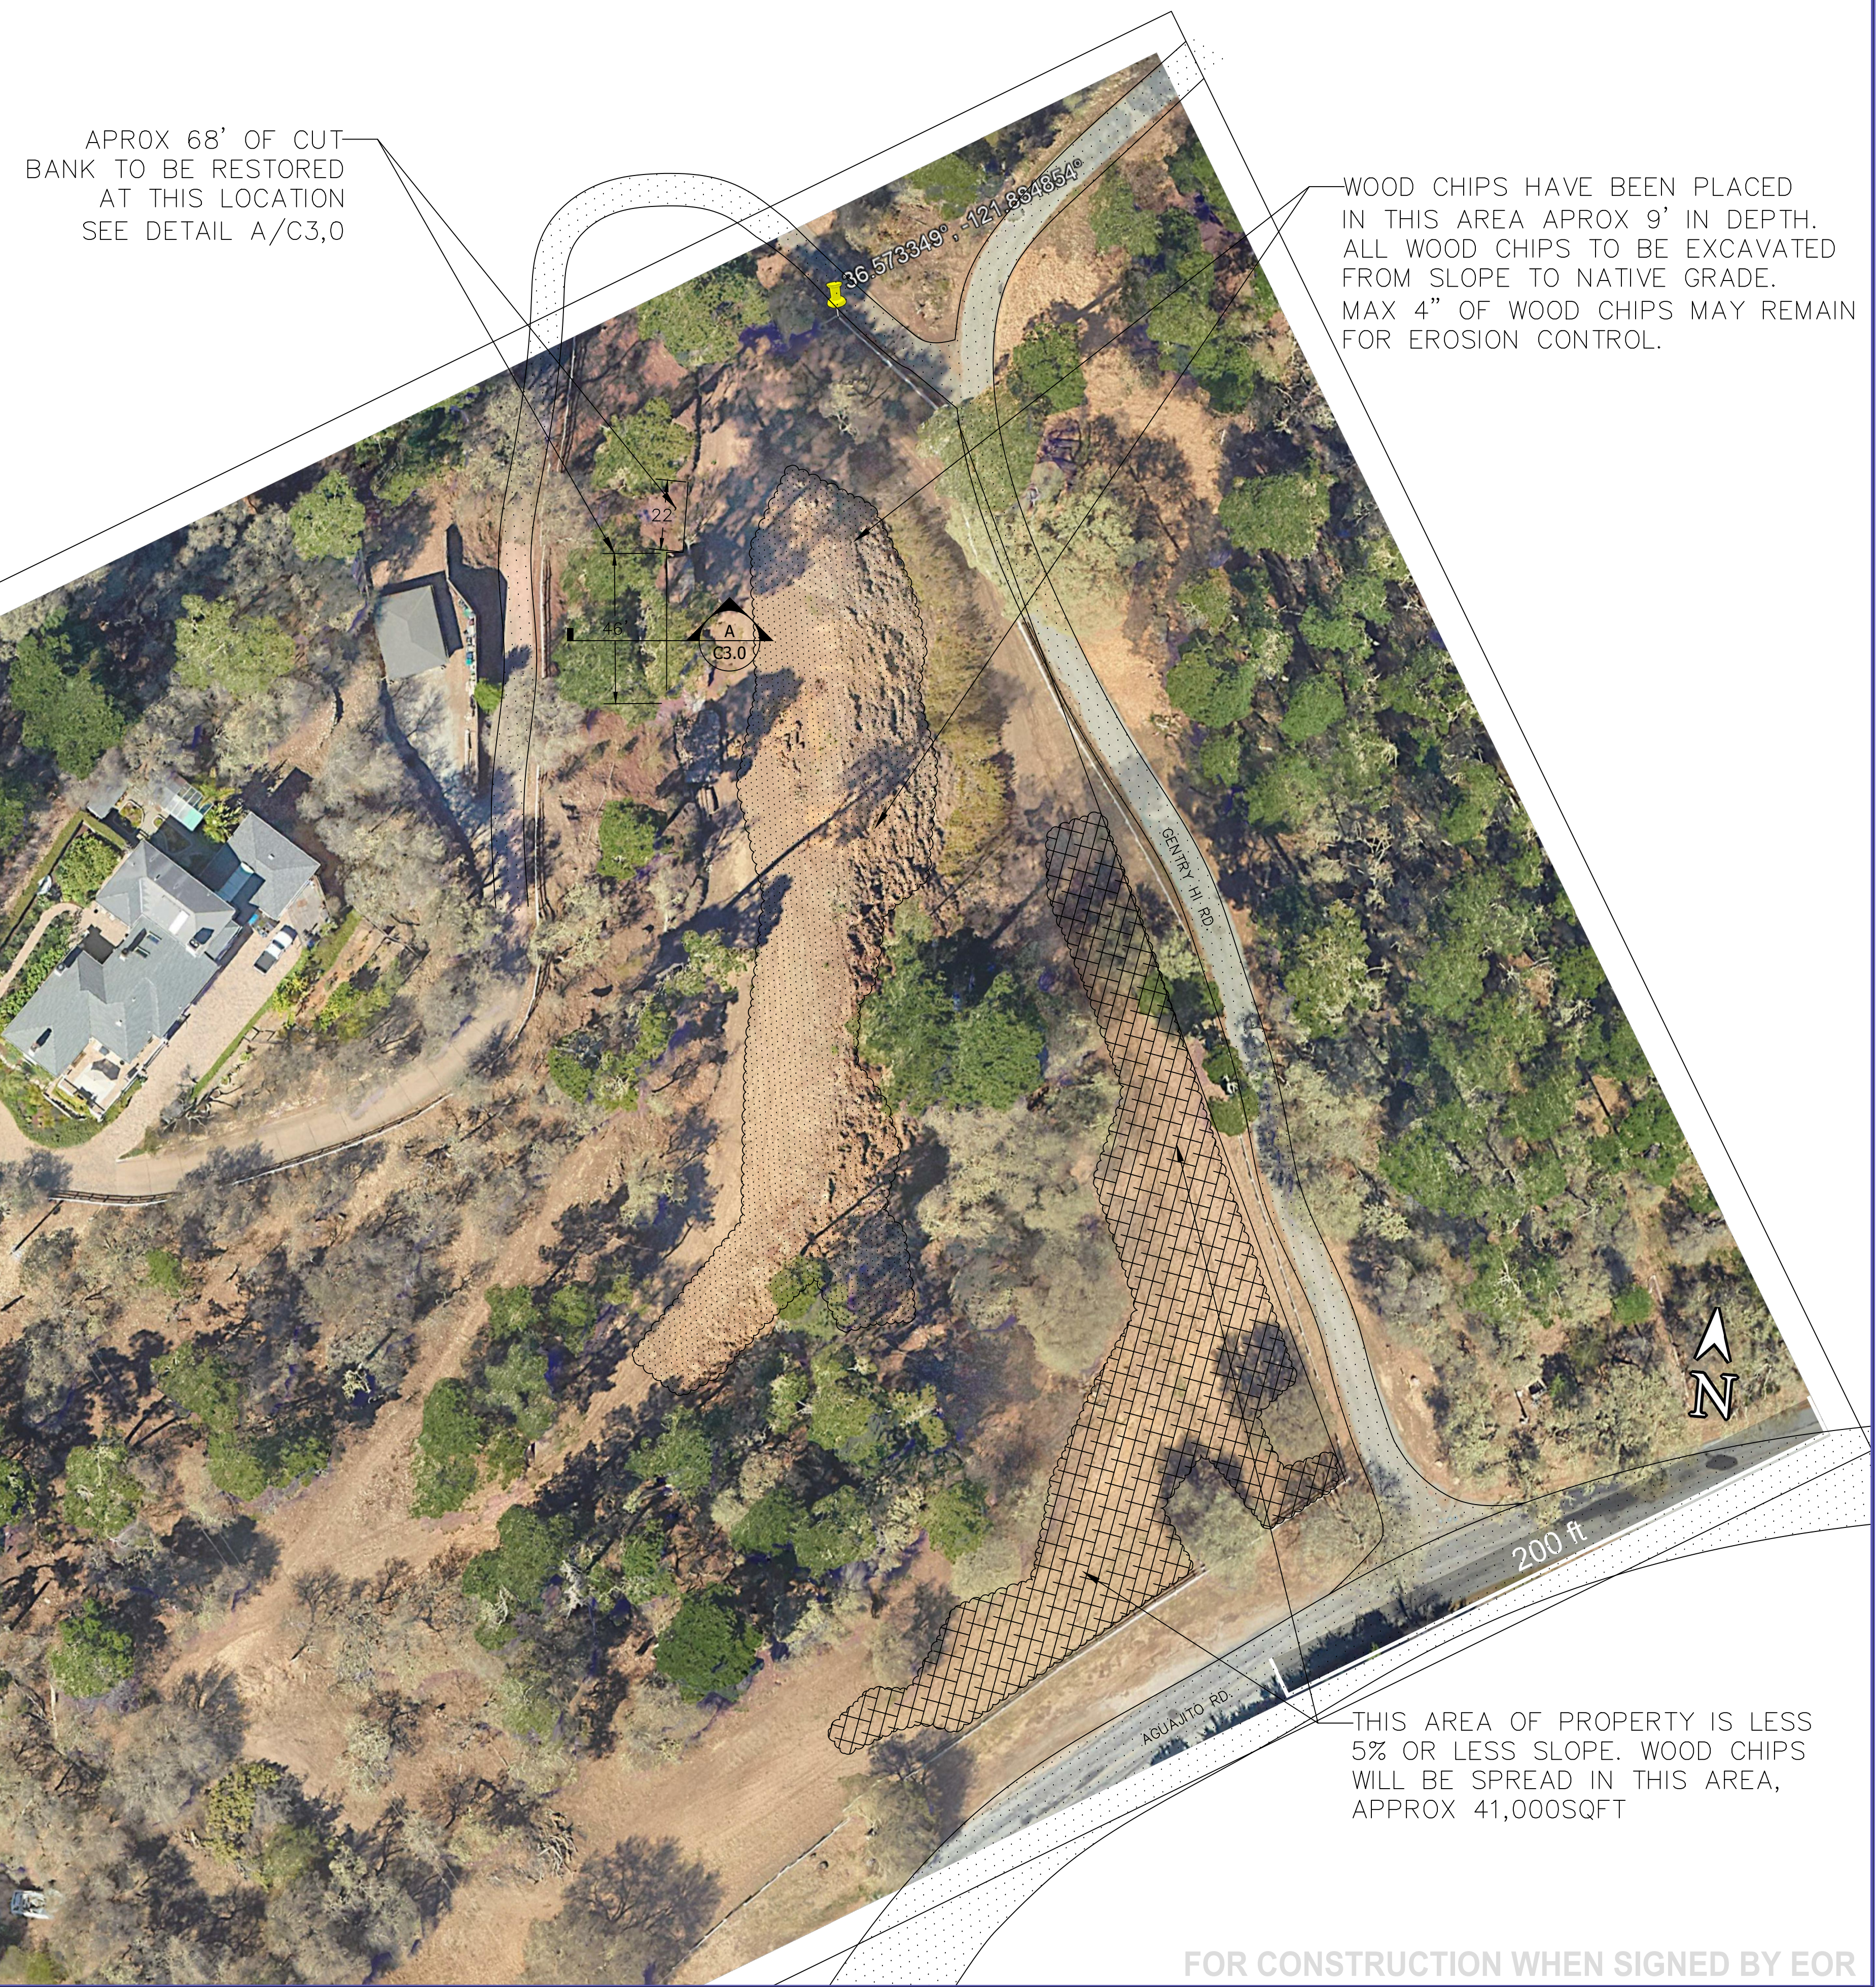
DETAILS
GRADING RESTORATION AND WOOD CHIP DISPOSAL
APN# 103-041-017-000
CARMEL, CA

NOTE:

CUT SLOPE TO BE FULLY RESTORED TO THE APPROXIMATE NATURAL GRADE. ONLY SOIL THAT IS FREE OF ORGANIC MATERIAL IS SUITABLE FOR SLOPE REPAIR. IF NATURAL SOILS HAVE BEEN MIXED WITH WOOD CHIPS THEN OTHER ONSITE MATERIAL WILL BE REQUIRED, OR OFF SITE MATERIAL SUITABLE FOR STRUCTURAL FILL MAY BE REQUIRED.

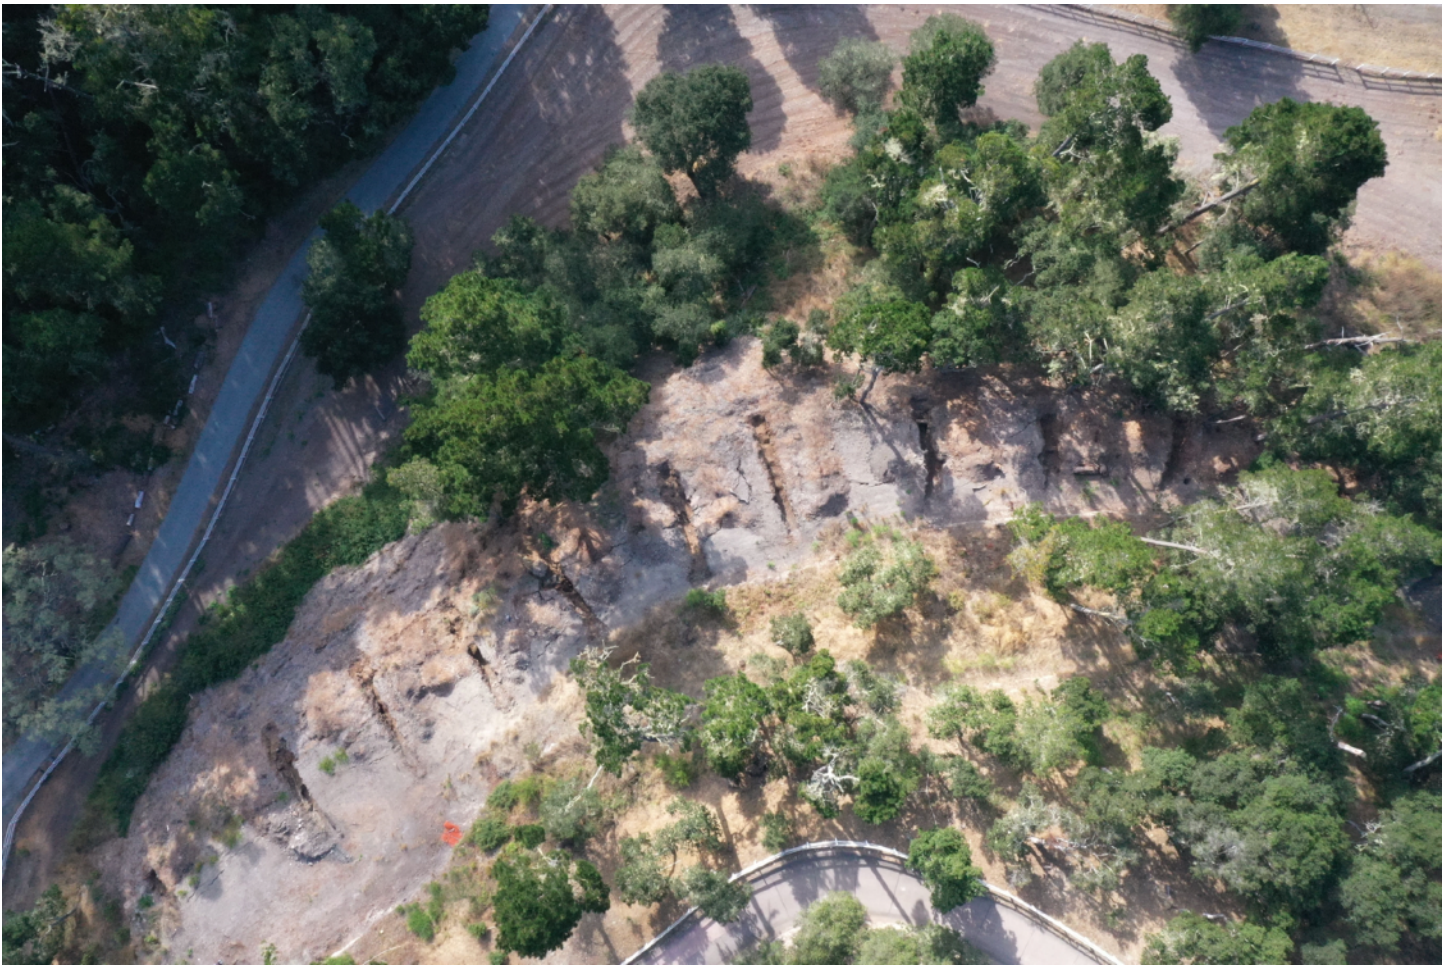
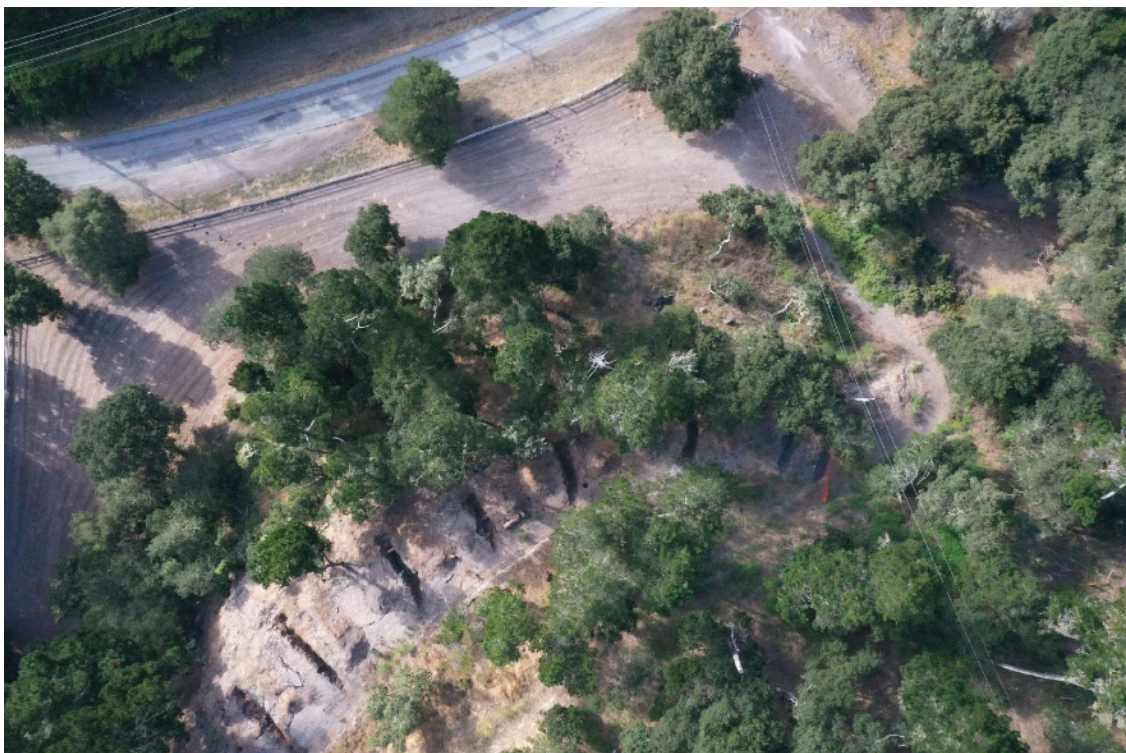
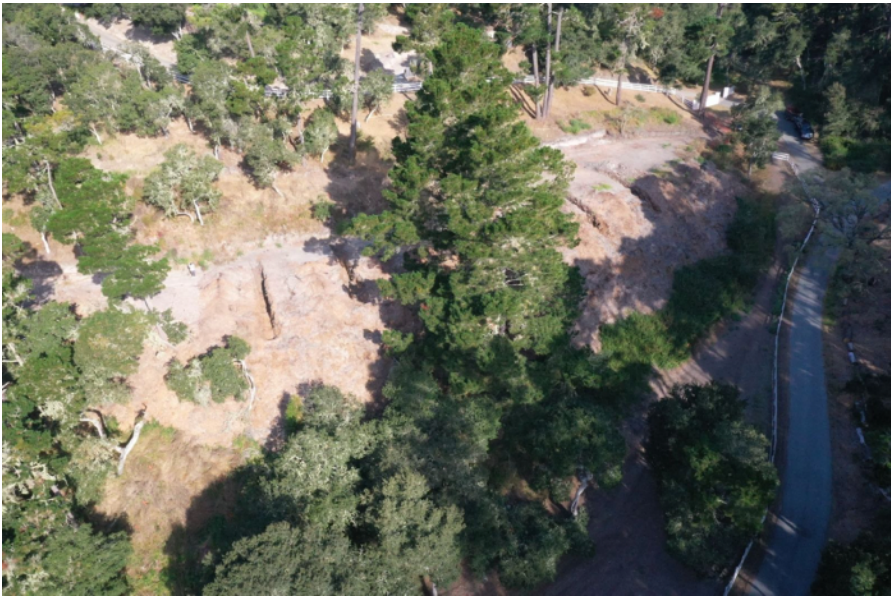
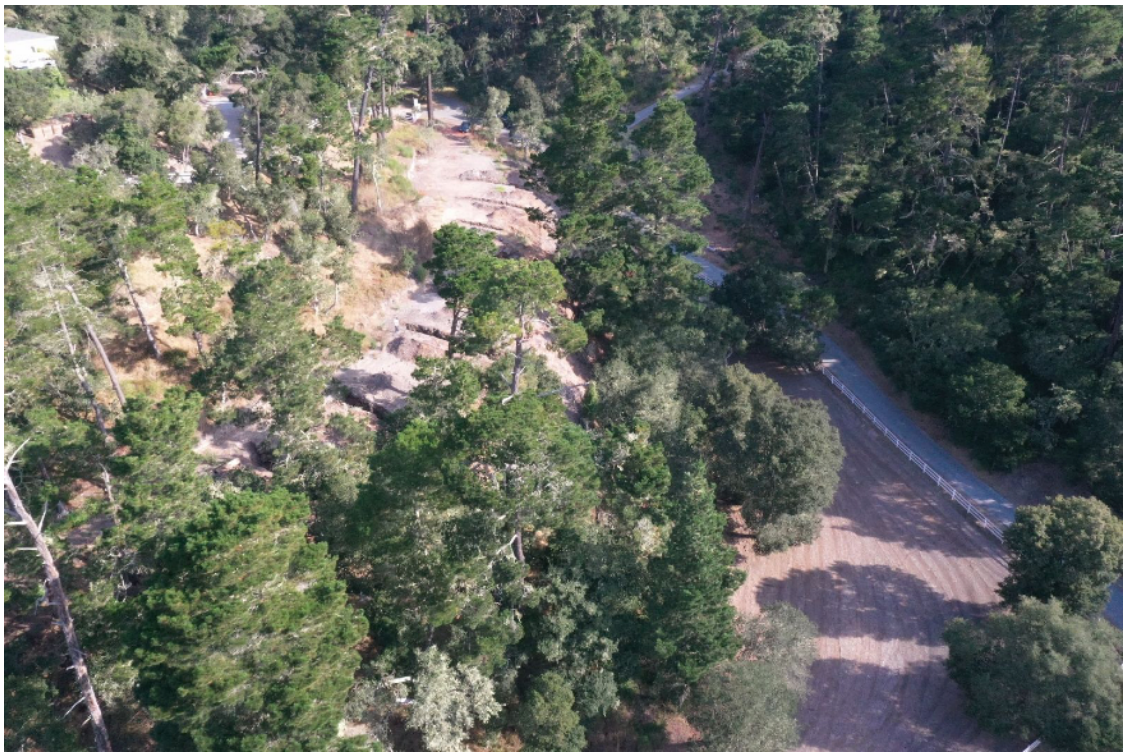
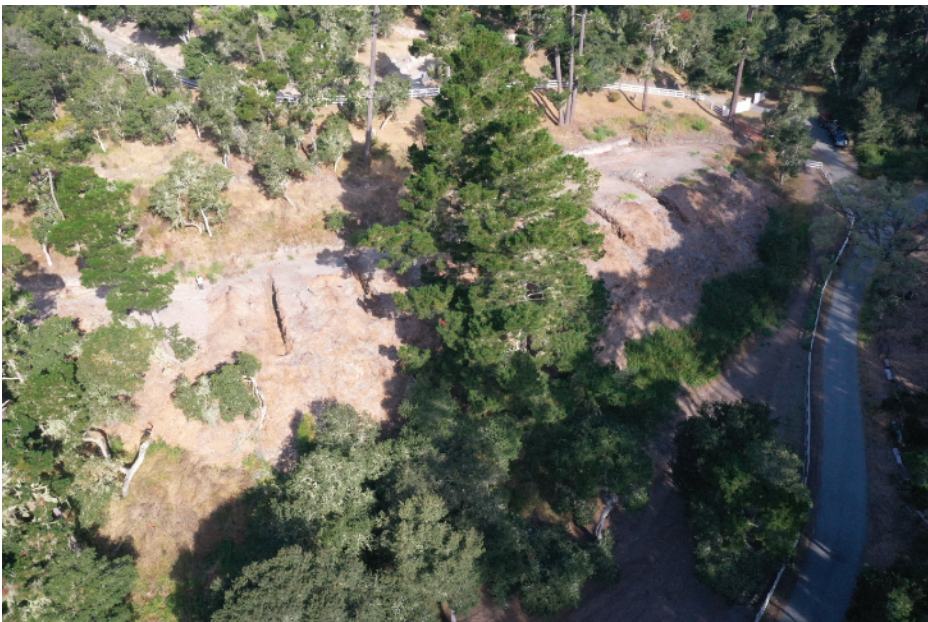
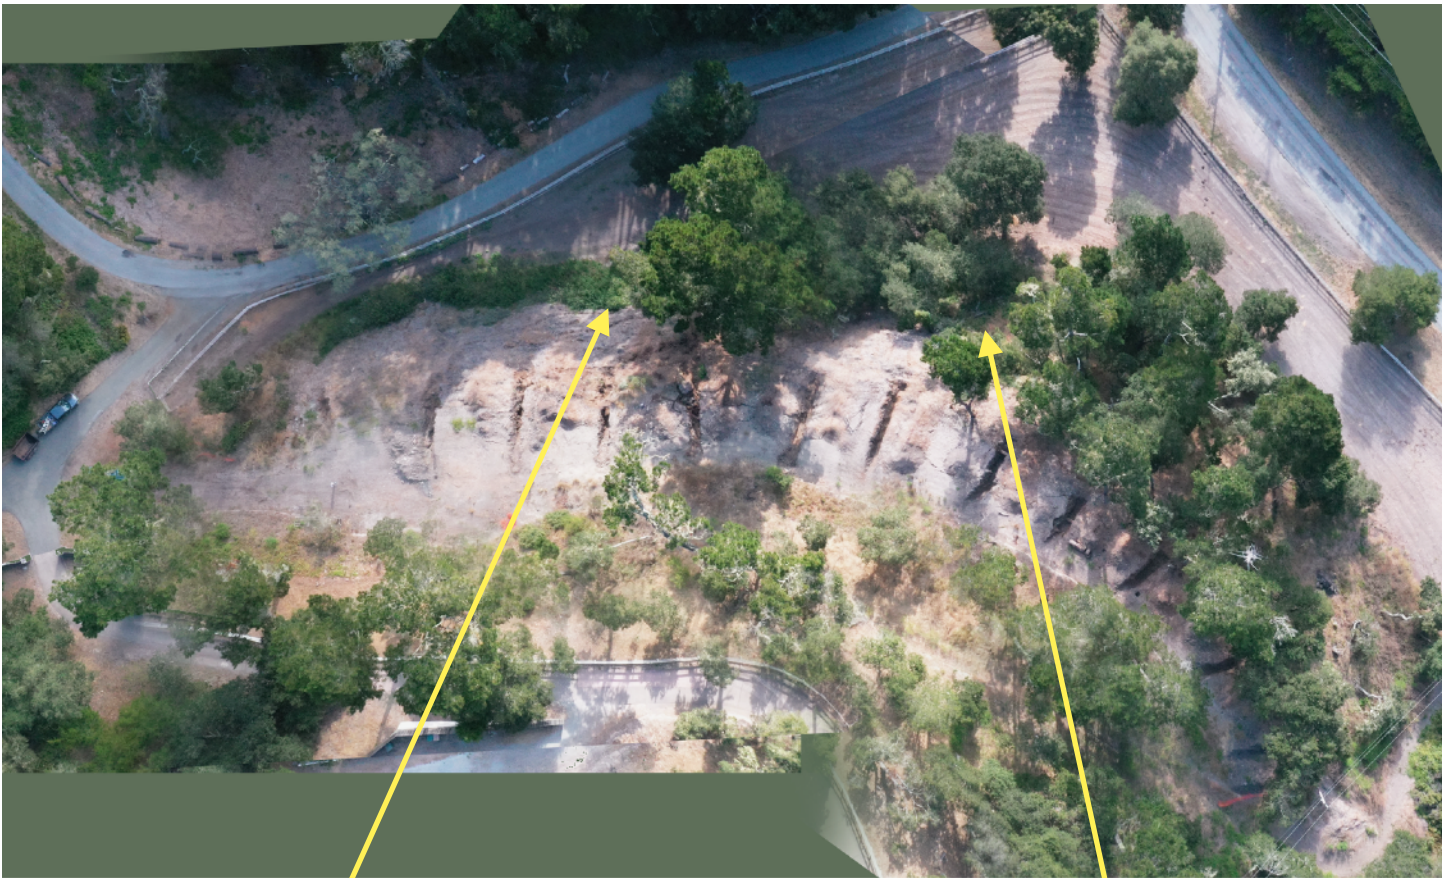
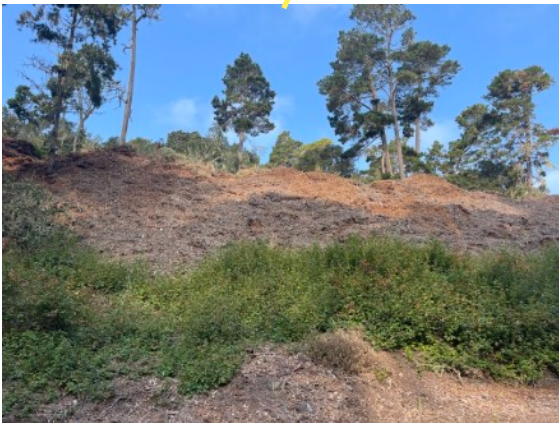
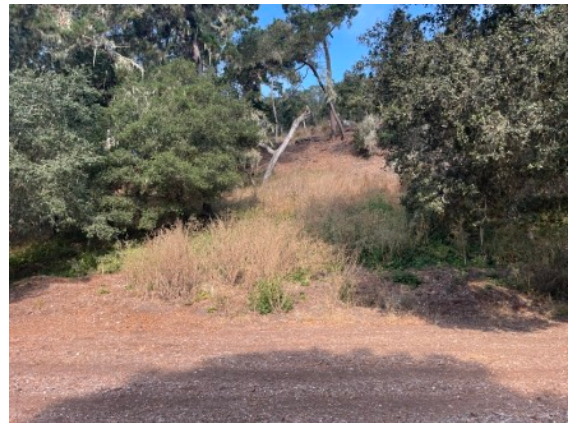
Drone files of the site showing exploratory digs and a fractured canopy of Monterey pines.
