**GOLDING TED & STACEY SOUDERS GOLDING TRS (PLN230080)
RESOLUTION NO. 24--**

- 1) Finding the project qualifies for a Class 21 Categorical Exemption pursuant to Section 15321(a)(2), enforcement actions by regulatory agencies, with no exceptions to section 15300.2; and
- 2) Approving a Restoration Permit to partially clear Code Enforcement violation (22CE00202) to allow restoration of slopes in excess of 25% including approximately 88 cubic yards of fill, removal and relocation of approximately 385 cubic yards of wood chips and replacement of 25 Monterey pine and 10 Coast live oak trees.

RESTORATION PLAN TO RESOLVE CODE VIOLATION 22CE00202 TO ALLOW RESTORATION OF SLOPES OVER 25%.

TITLE PAGE / SITE PLAN
 GRADING RESTORATION AND WOOD CHIP DISPOSAL
 APN# 103-041-017-000
 CARMEL, CA

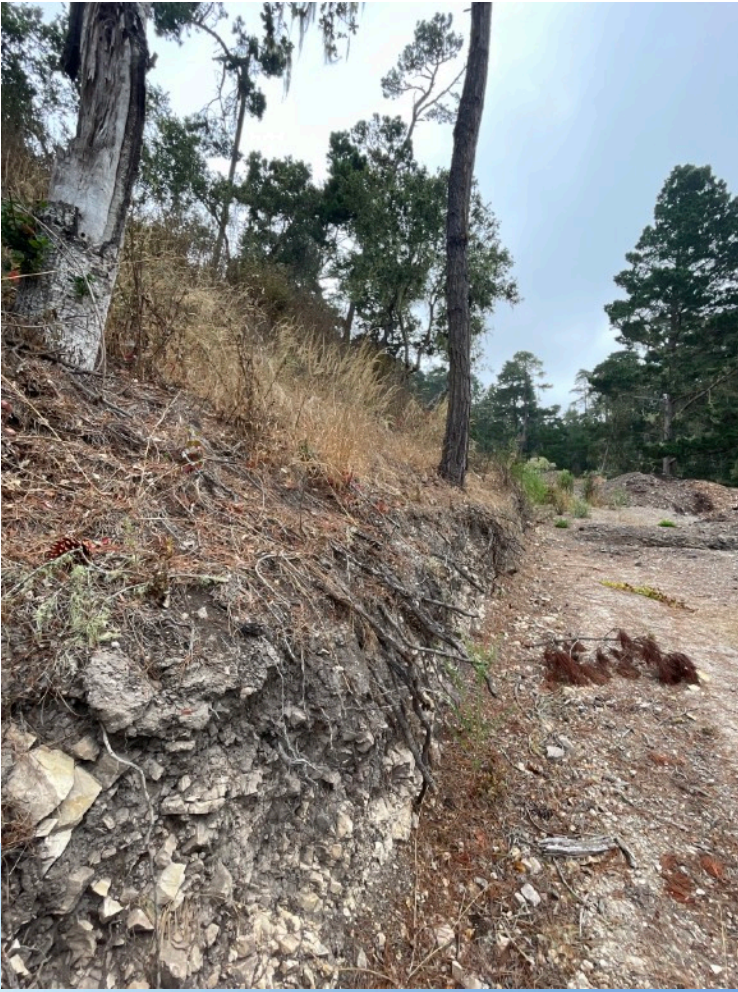
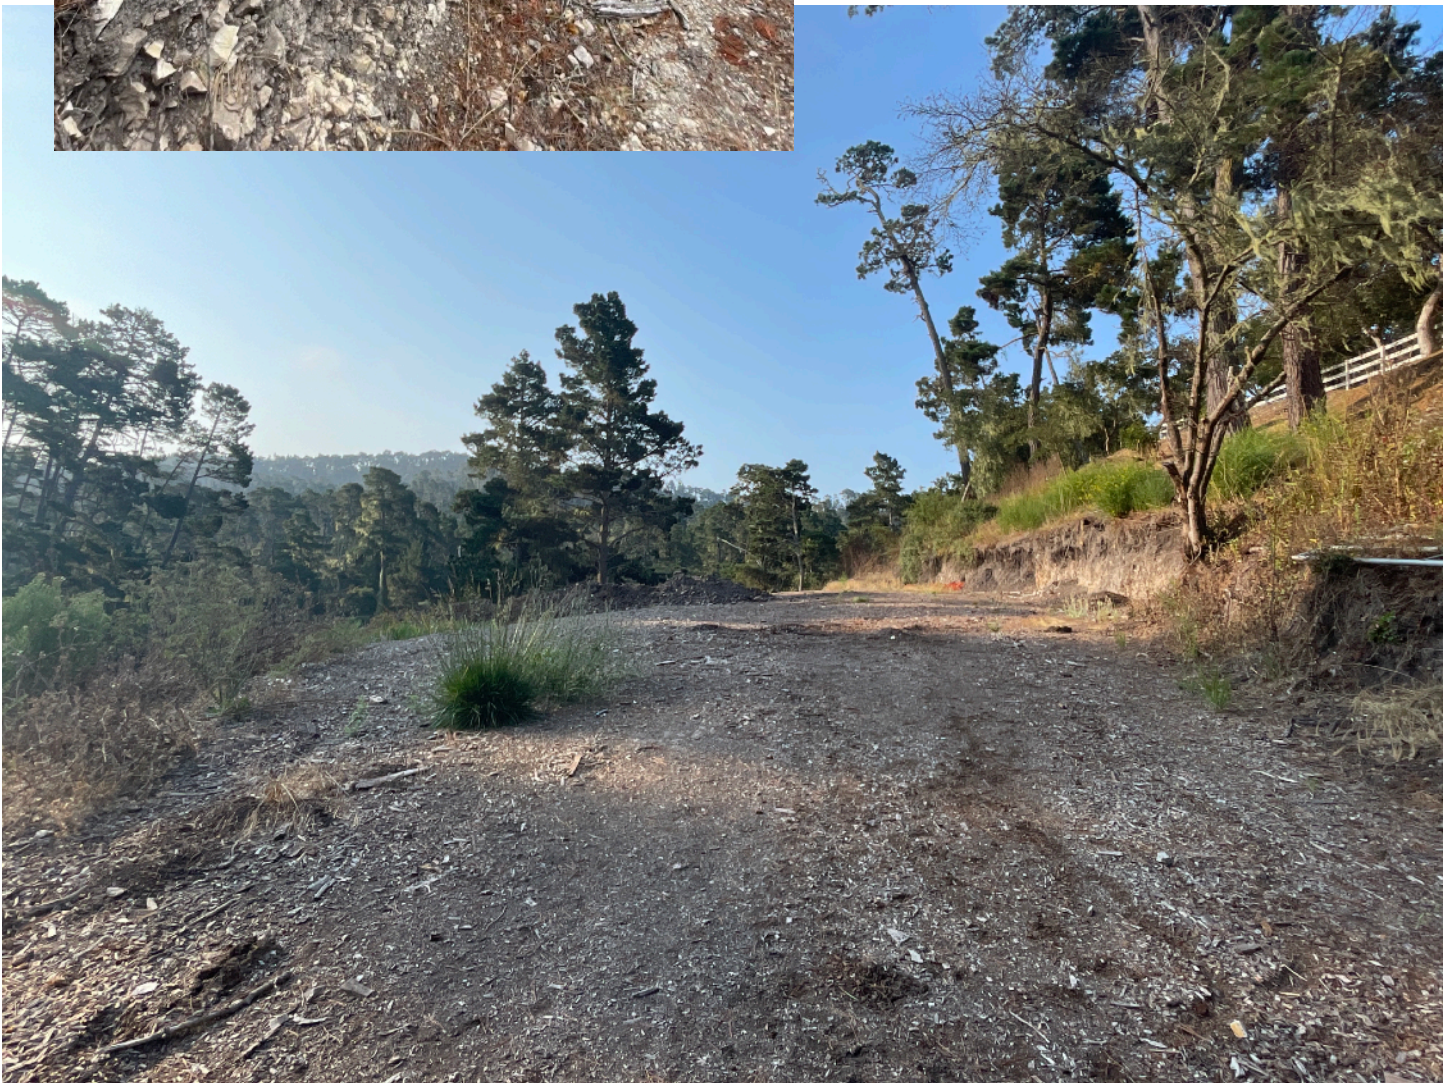
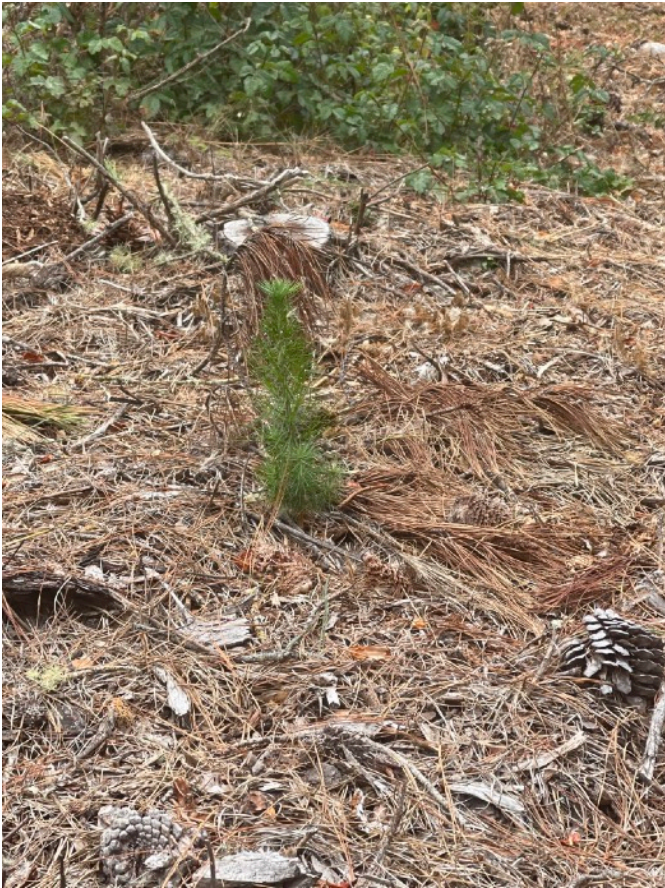
access locations with the least amount of impacts

Root disturbance has taken place with minimal impacts

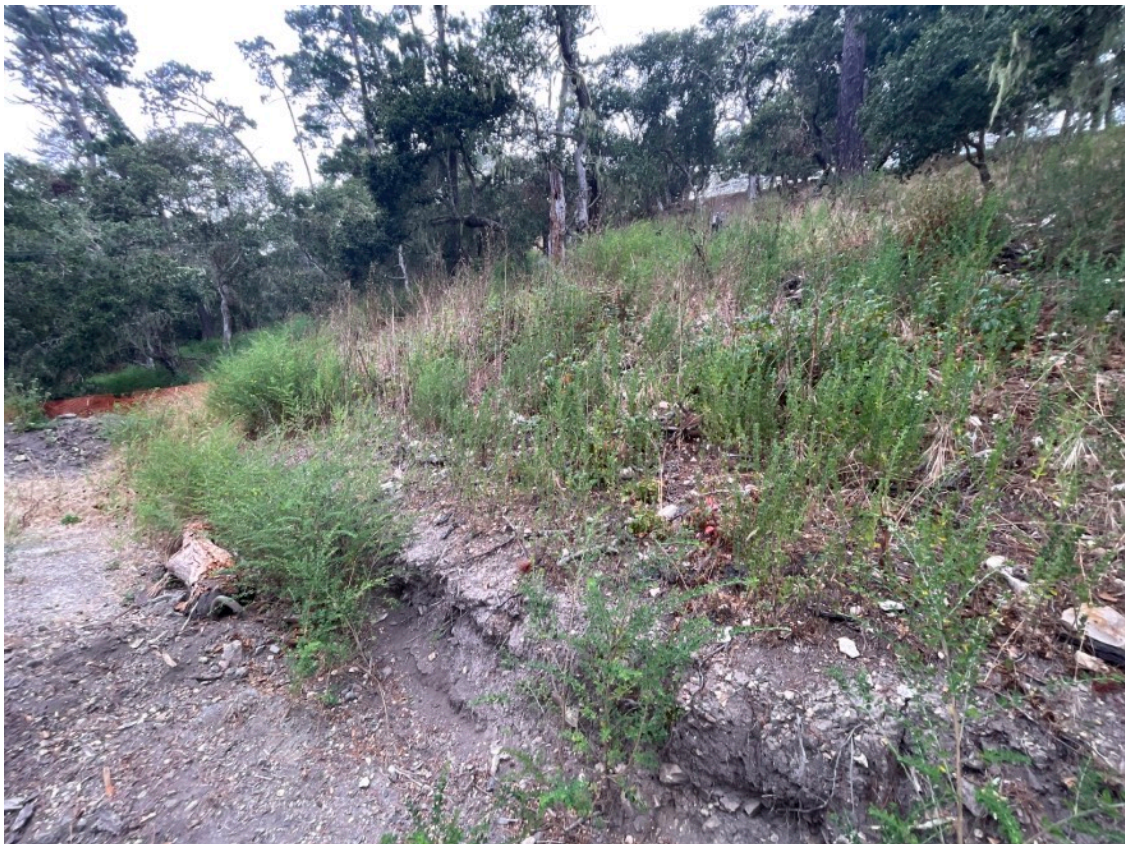
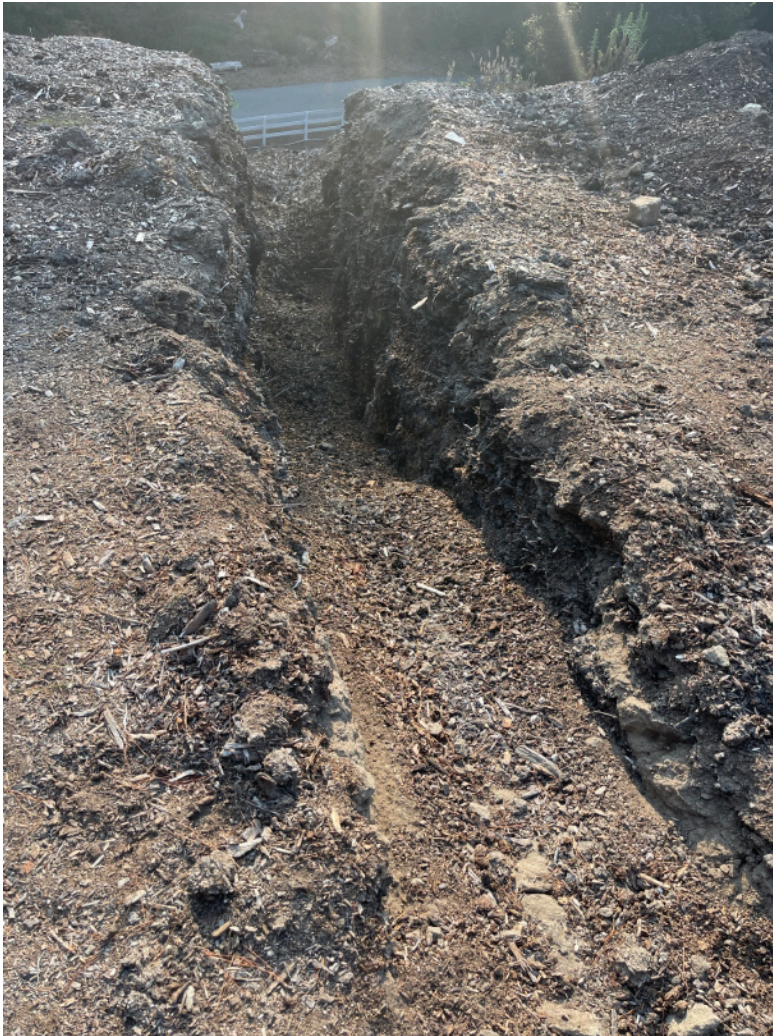
Native regeneration is basically non-existent and non-native species are becoming prevalent.

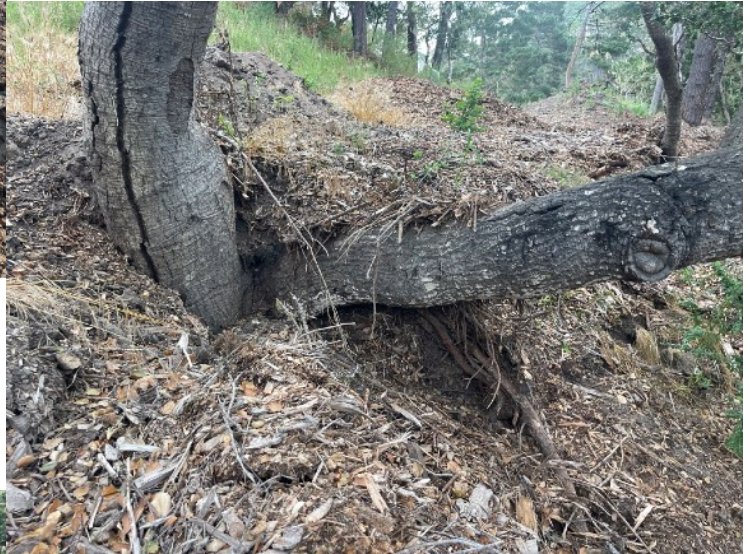
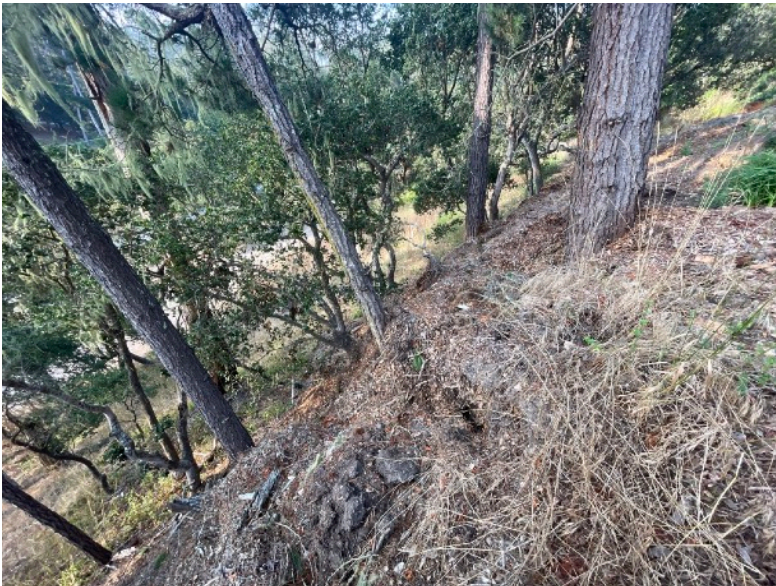
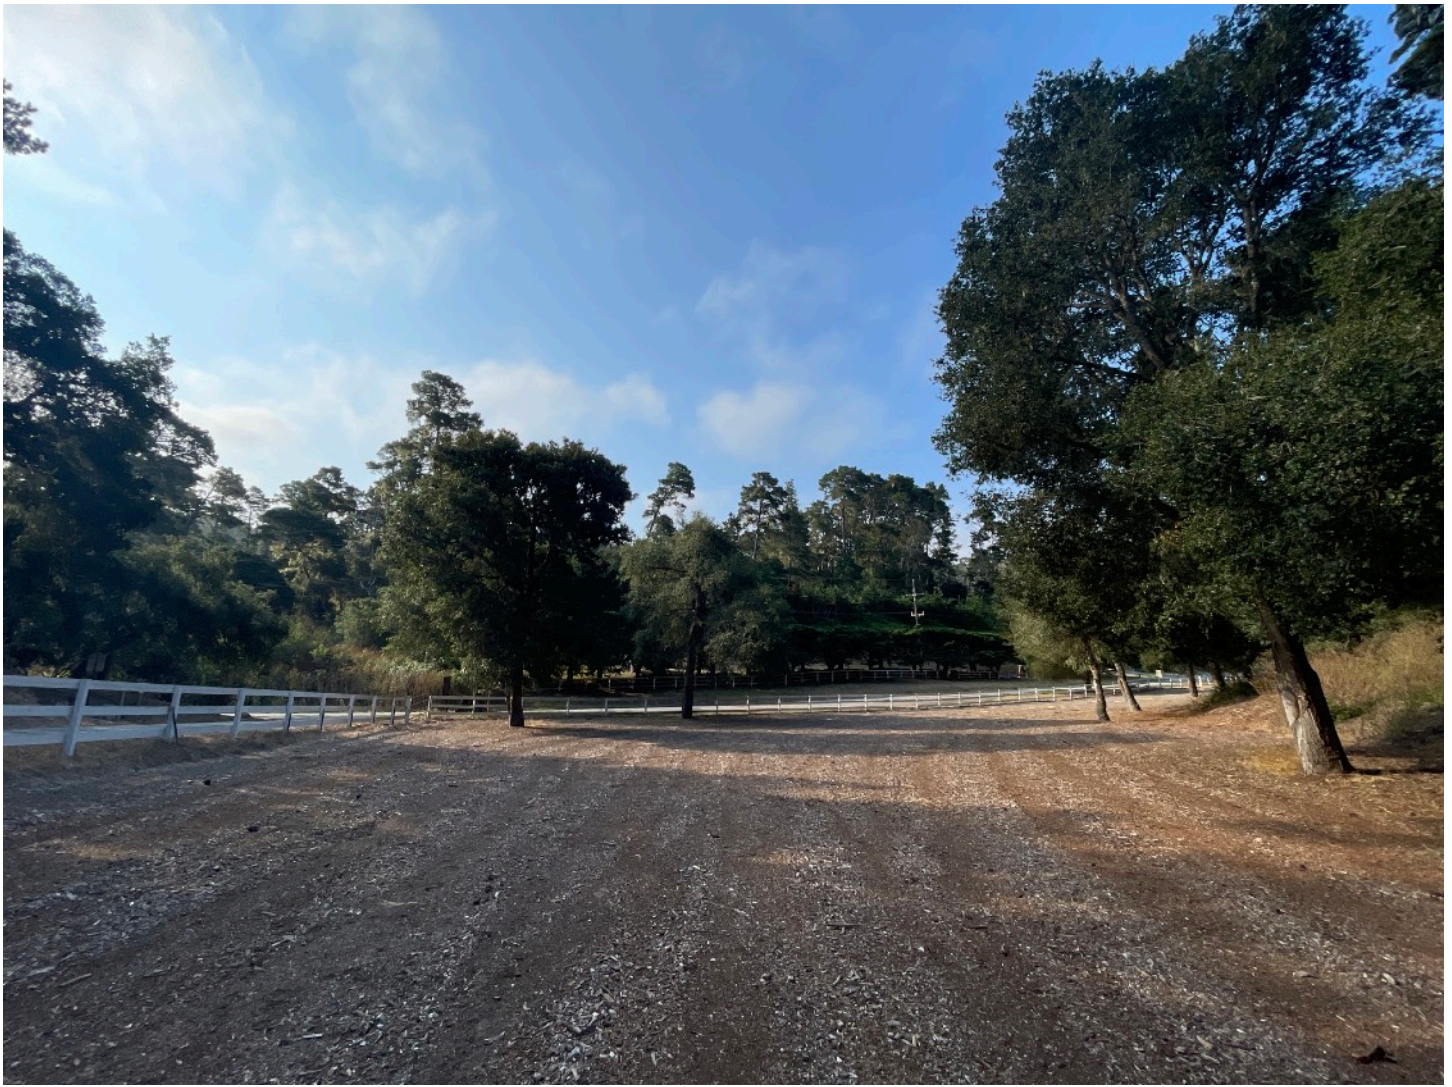
Exploratory digs have an accumulation of approximately 12 feet in depth with excessive buildup around trees that will have to be removed manually to minimize impacts.

Tree protection is required on the lower portion of the property prior to paving chips
