Exhibit C

RE: 1272 Viscaino Road -FMP Amendment -PLN220251

This letter is prepared to be an amendment to the forest management report dated September, 2021 for proposed construction at 1272 Viscaino Road due to slight changes to the design and condition of trees as they are in the thin soils. The design changes are as follows:

Drawing Title:
SITE STUDY PLAN & EXTERIOR LIGHT SPECIFICATIONS

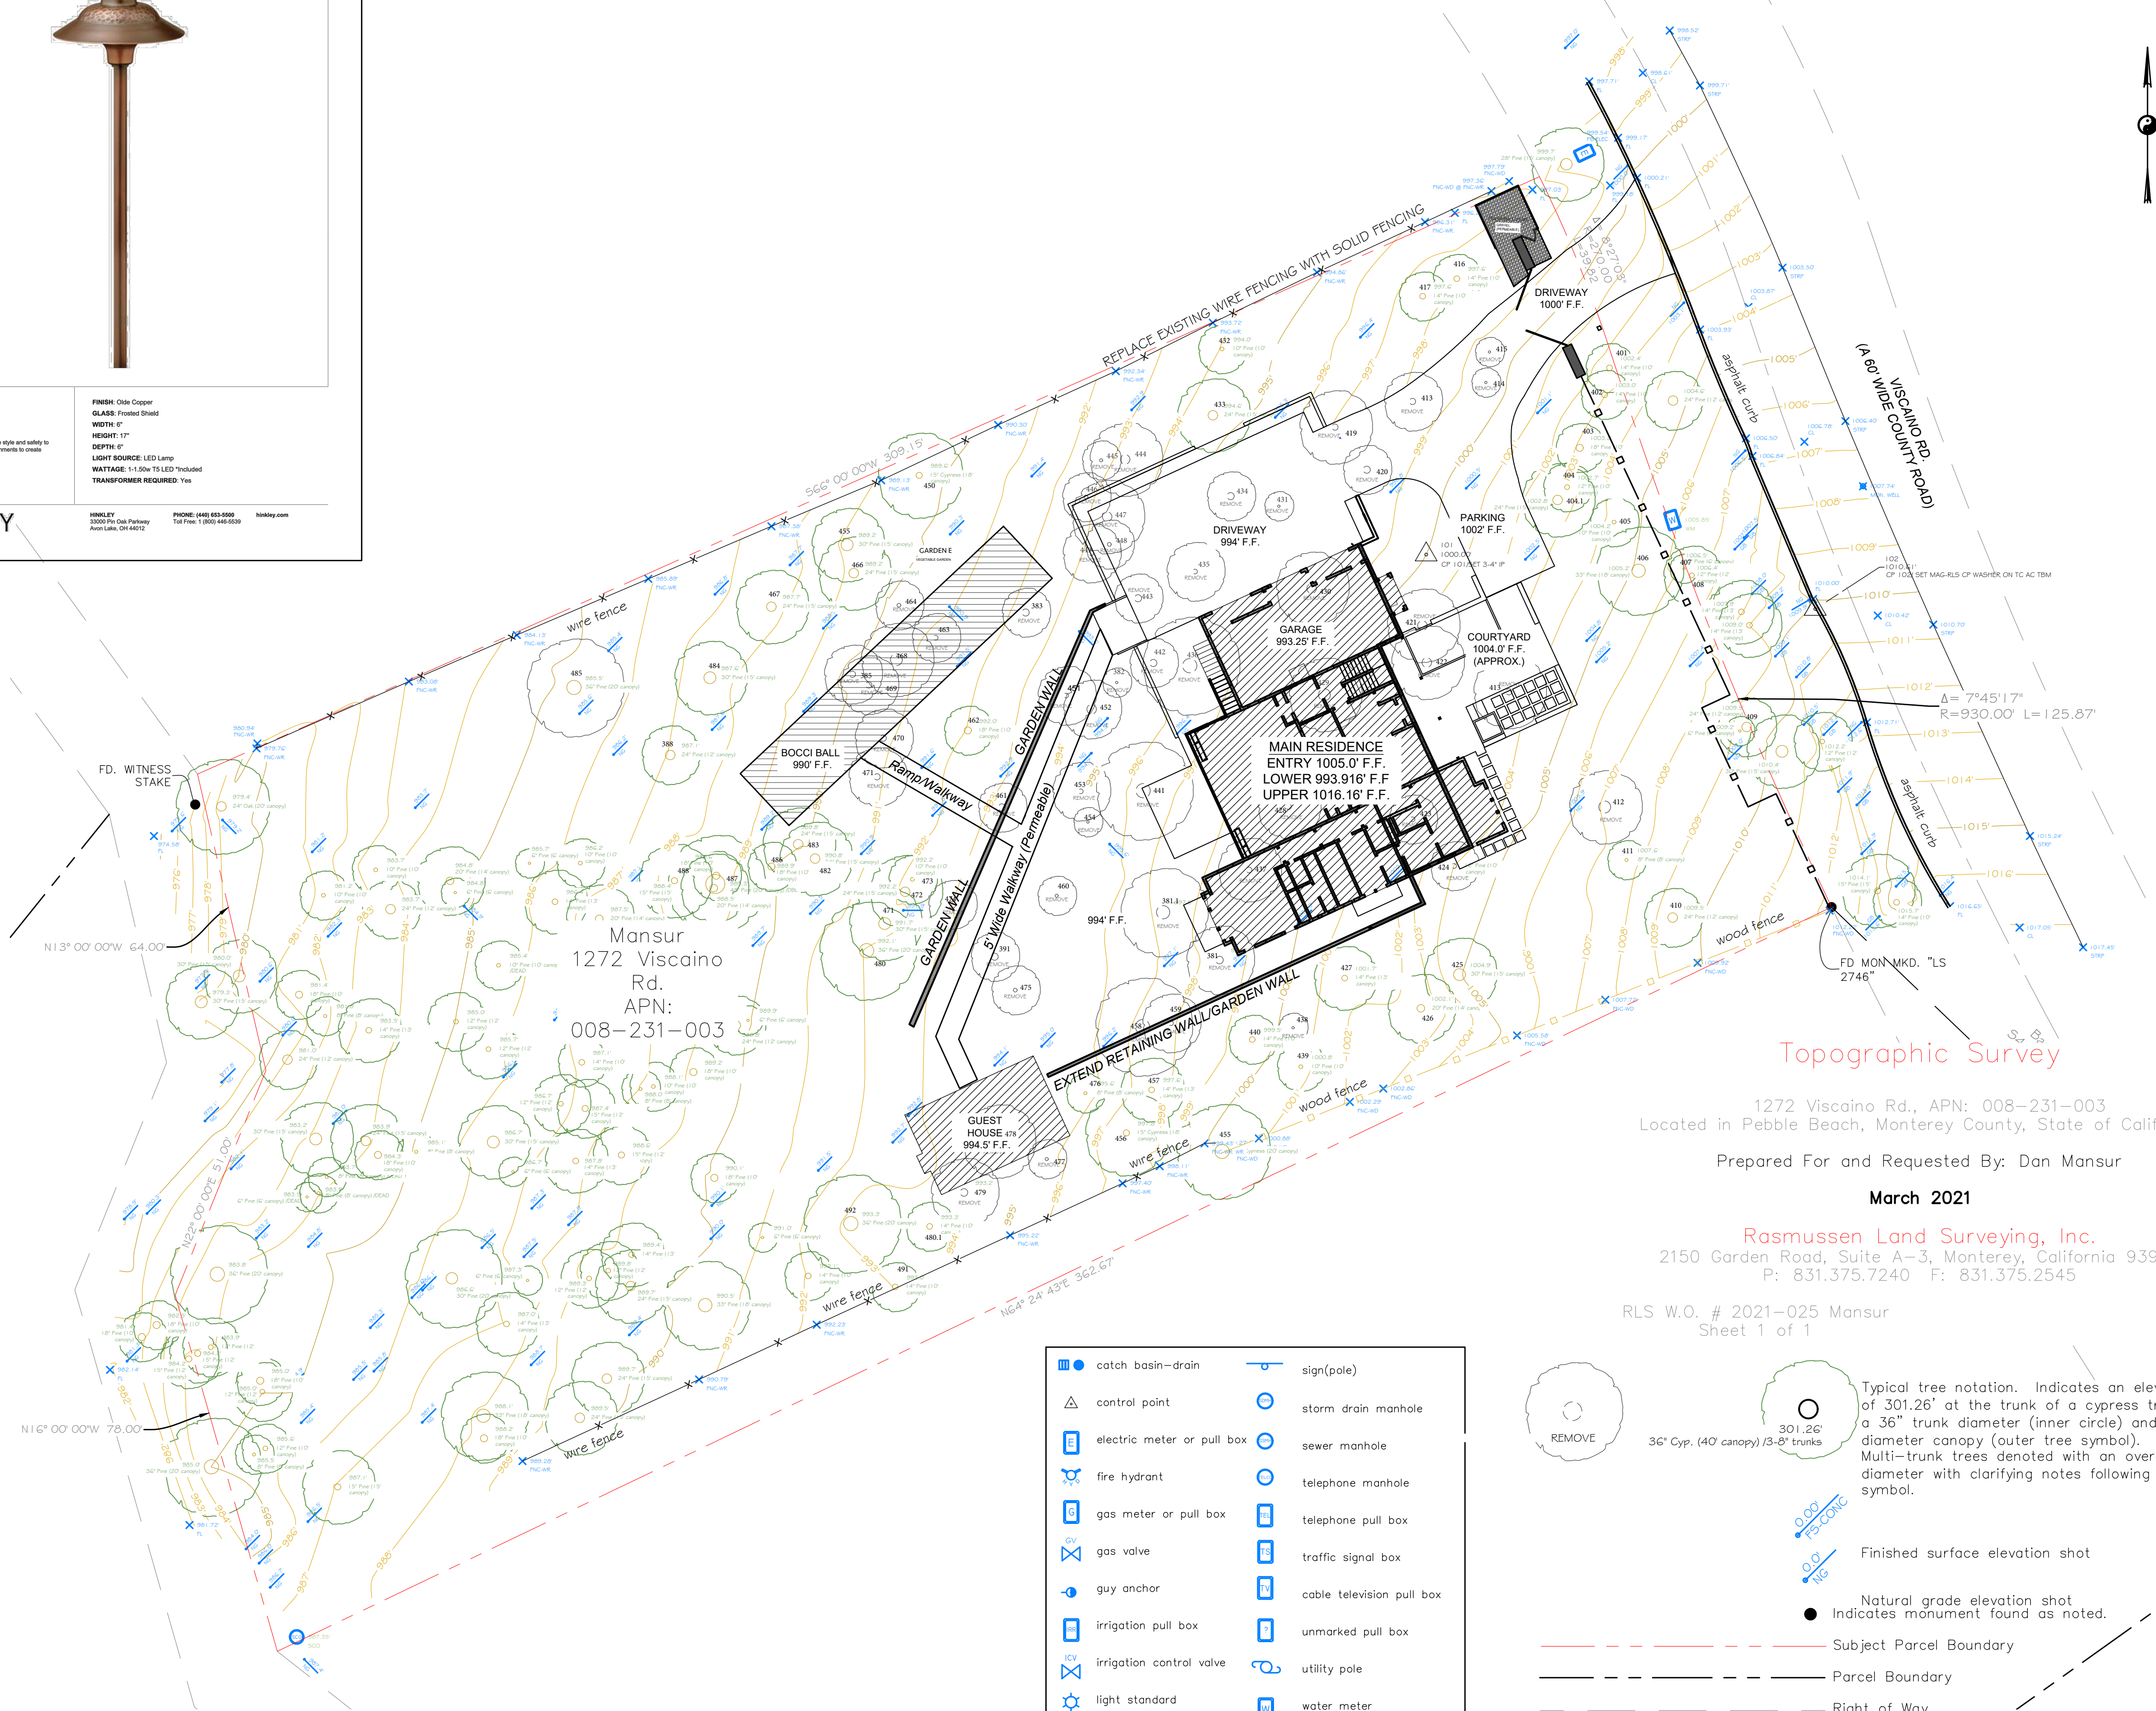
Topographic Survey

1272 Viscaino Rd., APN: 008-231-003
Located in Pebble Beach, Monterey County, State of California
Prepared For and Requested By: Dan Mansur
March 2021
Rasmussen Land Surveying, Inc.
2150 Garden Road, Suite A-3, Monterey, California 93942
P: 831.375.7240 F: 831.375.2545
RLS W.O. # 2021-025 Mansur
Sheet 1 of 1

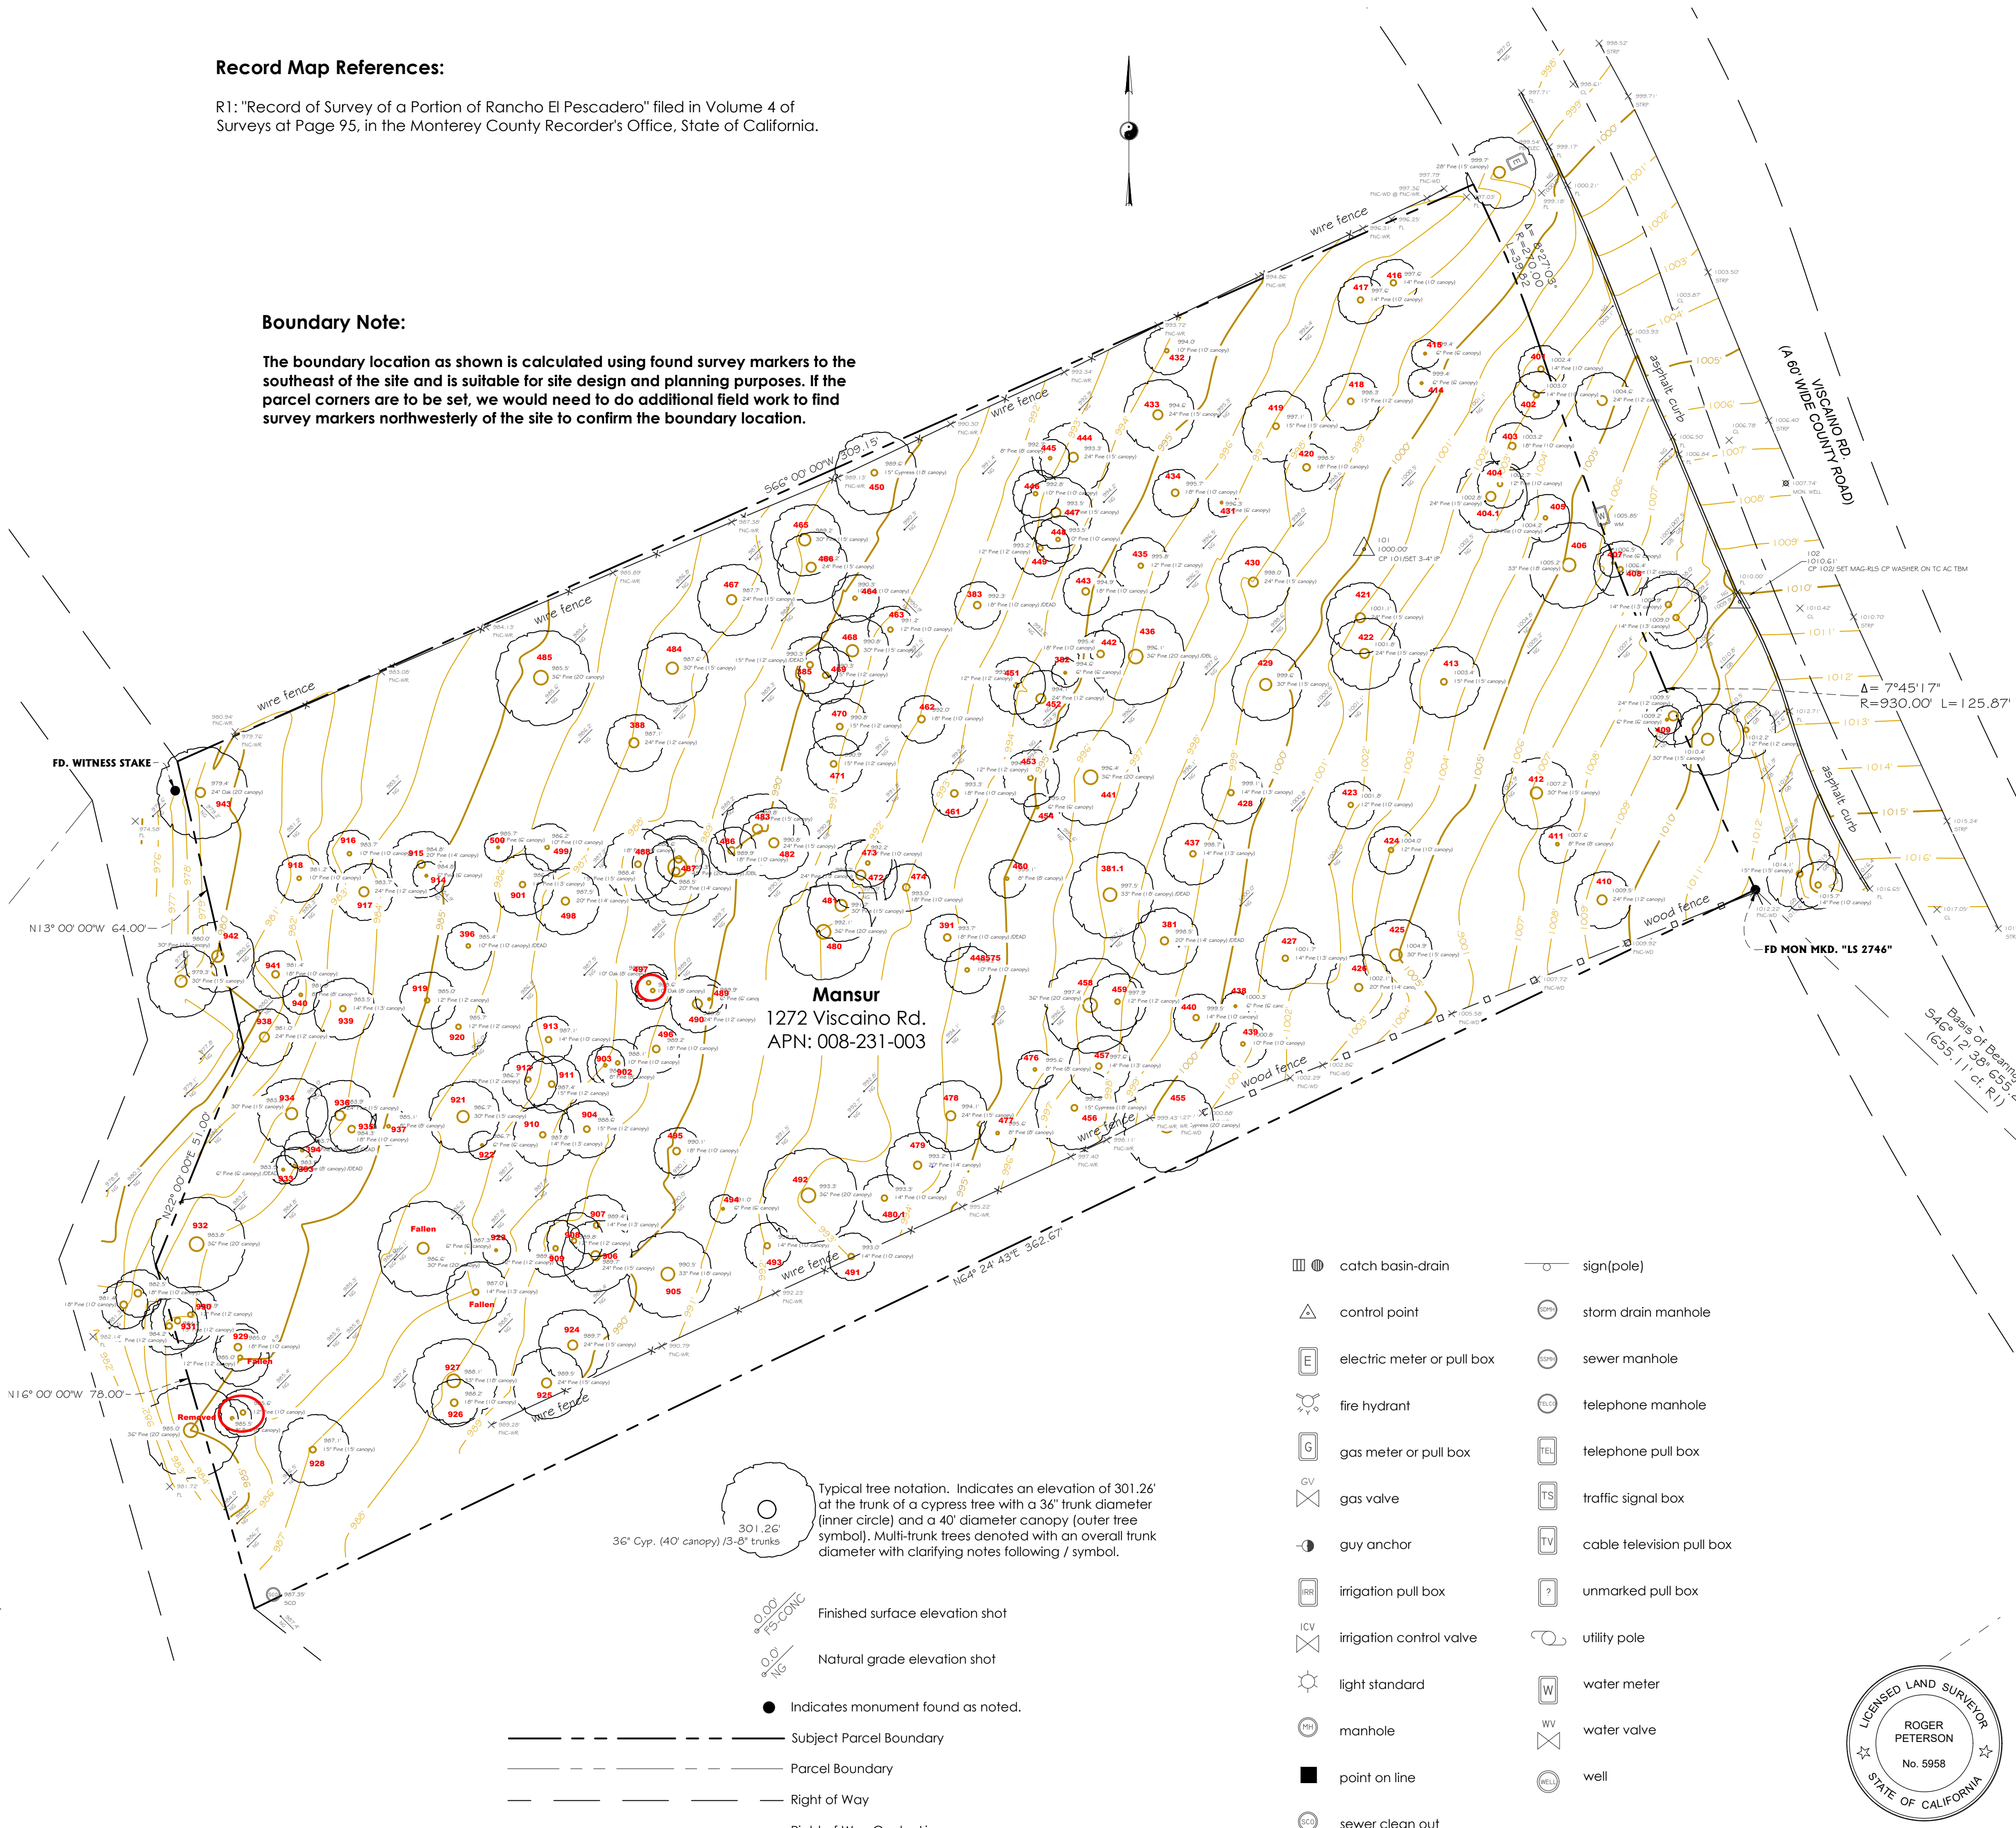
Boundary Note:

The boundary location as shown is calculated using found survey markers to the southeast of the site and is suitable for site design and planning purposes. If the parcel corners are to be set, we would need to do additional field work to find survey markers northwesterly of the site to confirm the boundary location.

Surveyor's Notes:

This map portrays the site of the time of the survey and does not show soils or geology information, underground conditions, easements, zoning or regulatory information or any other items not specifically requested by the property owner. There may be easements or other rights, recorded or unrecorded, affecting the subject property which are not shown hereon.
