**GEOTECHNICAL and
GEOLOGICAL HAZARDS
REPORT
for the proposed
RESIDENCE
LAURELES GRADE
CARMEL VALLEY, CALIFORNIA 93924
A. P. N. 416-051-016-000**

Project: Residence
 Laureles Grade
 Carmel Valley, California 93924
 A. P. N. 416-051-016-000

Subject: Geotechnical and Geological Hazards Report

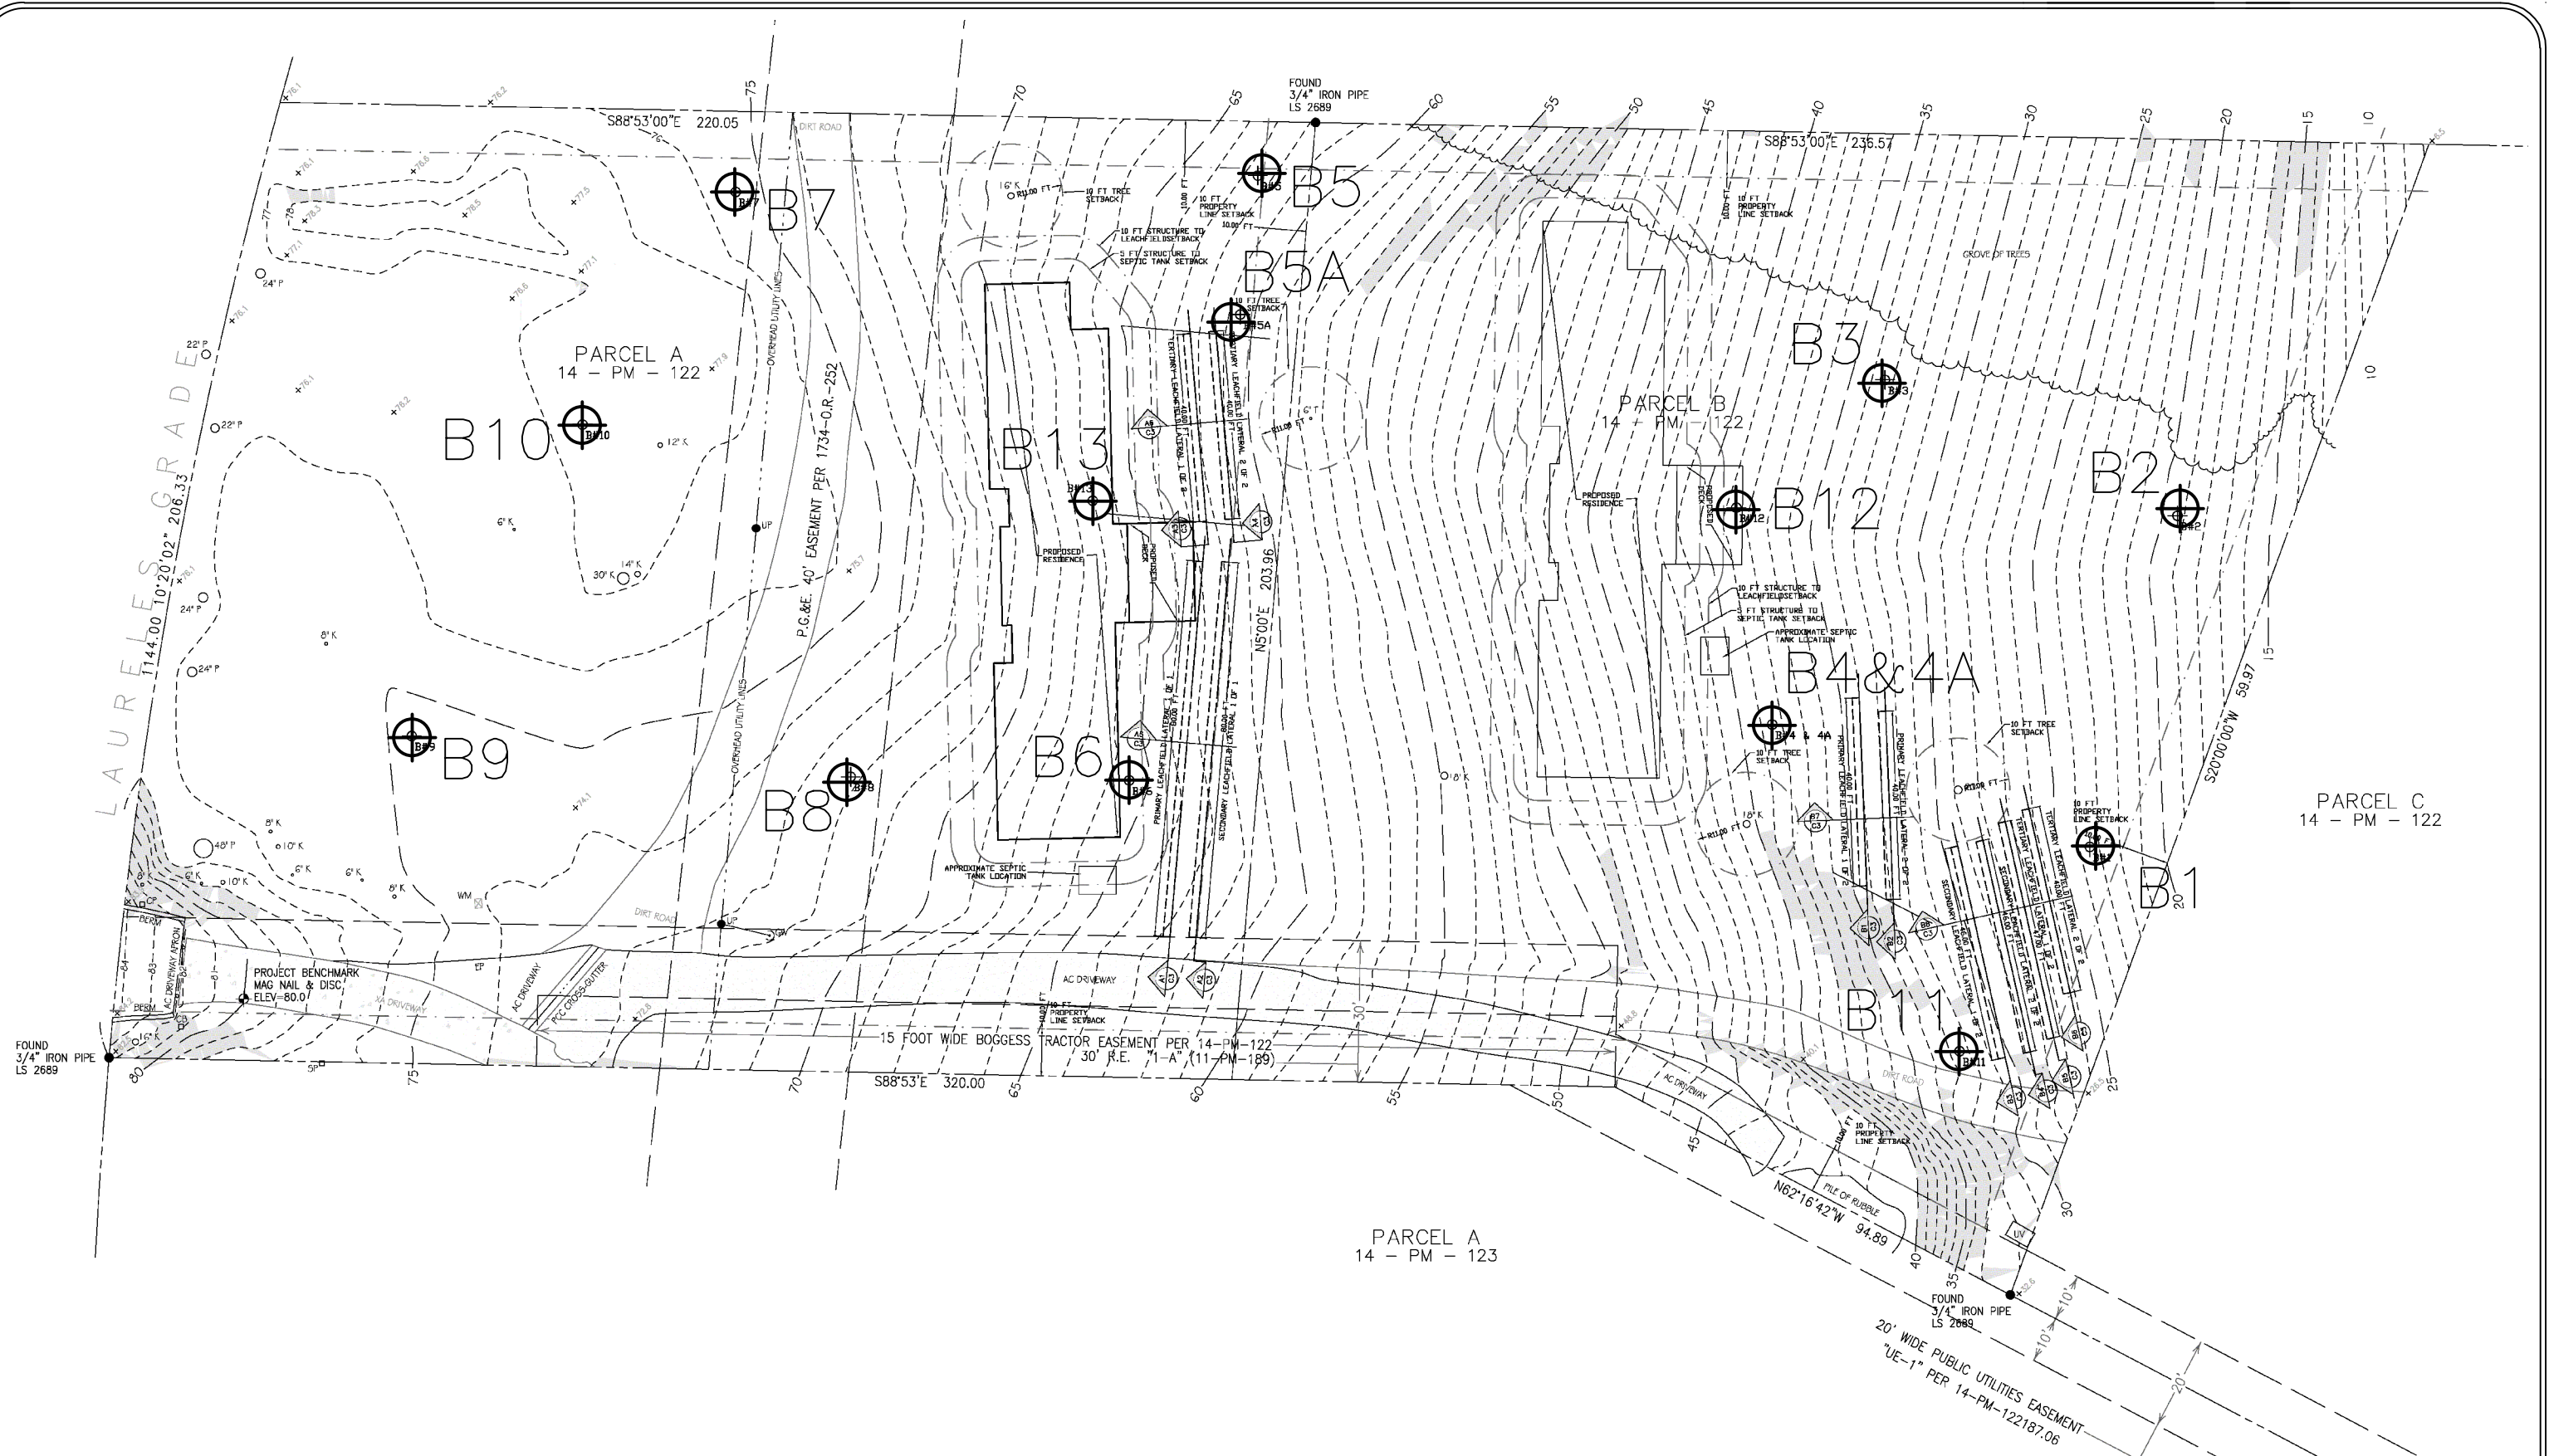
SITE PLAN with BORE LOCATIONS DISPLAYS TWO ADJACENT PROJECTS PROPOSED BY THE CLIENT. SITE EVALUATION, INVESTIGATION AND TESTING WERE COMPLETED IN UNISON FOR BOTH PARCELS. THIS REPORT ADDRESSES PARCEL B NOT TO SCALE
