**ZAMORA-ROCHA ARTURO ADRIAN ET AL (PLN230099)**

[PLN230099, Zamora-Rocha Arturo Adrian Et Al, 193 Strawberry Canyon Rd, Royal Oaks, North County Land Use Plan, Coastal Zone (APN: 129-261-013-000)]

RESTORATION PERMIT TO PARTIALLY CLEAR CODE ENFORCEMENT VIOLATION (23CE00097) FOR THE RESTORATION OF UNPERMITTED GRADING ON SLOPE GRATER THAN 25%; GRADING OF APPROXIMATELY 140 CUBIC YARDS OF CUT AND 130 CUBIC YARDS OF FILL AND VEGETATION REMOVAL. THE PROPERTY IS LOCATED AT 193 AND 195 STRAWBERRY ROAD, ROYAL OAKS (ASSESSOR'S PARCEL NUMBER 129-261-013-000), NORTH COUNTY LAND USE PLAN, COASTAL ZONE.

At your request, Haro, Kasunich and Associates, Inc. (HKA) has prepared this limited geotechnical investigation to provide grading and drainage recommendations for the restoration of the unpermitted grading at the referenced site in Royal Oaks, California.

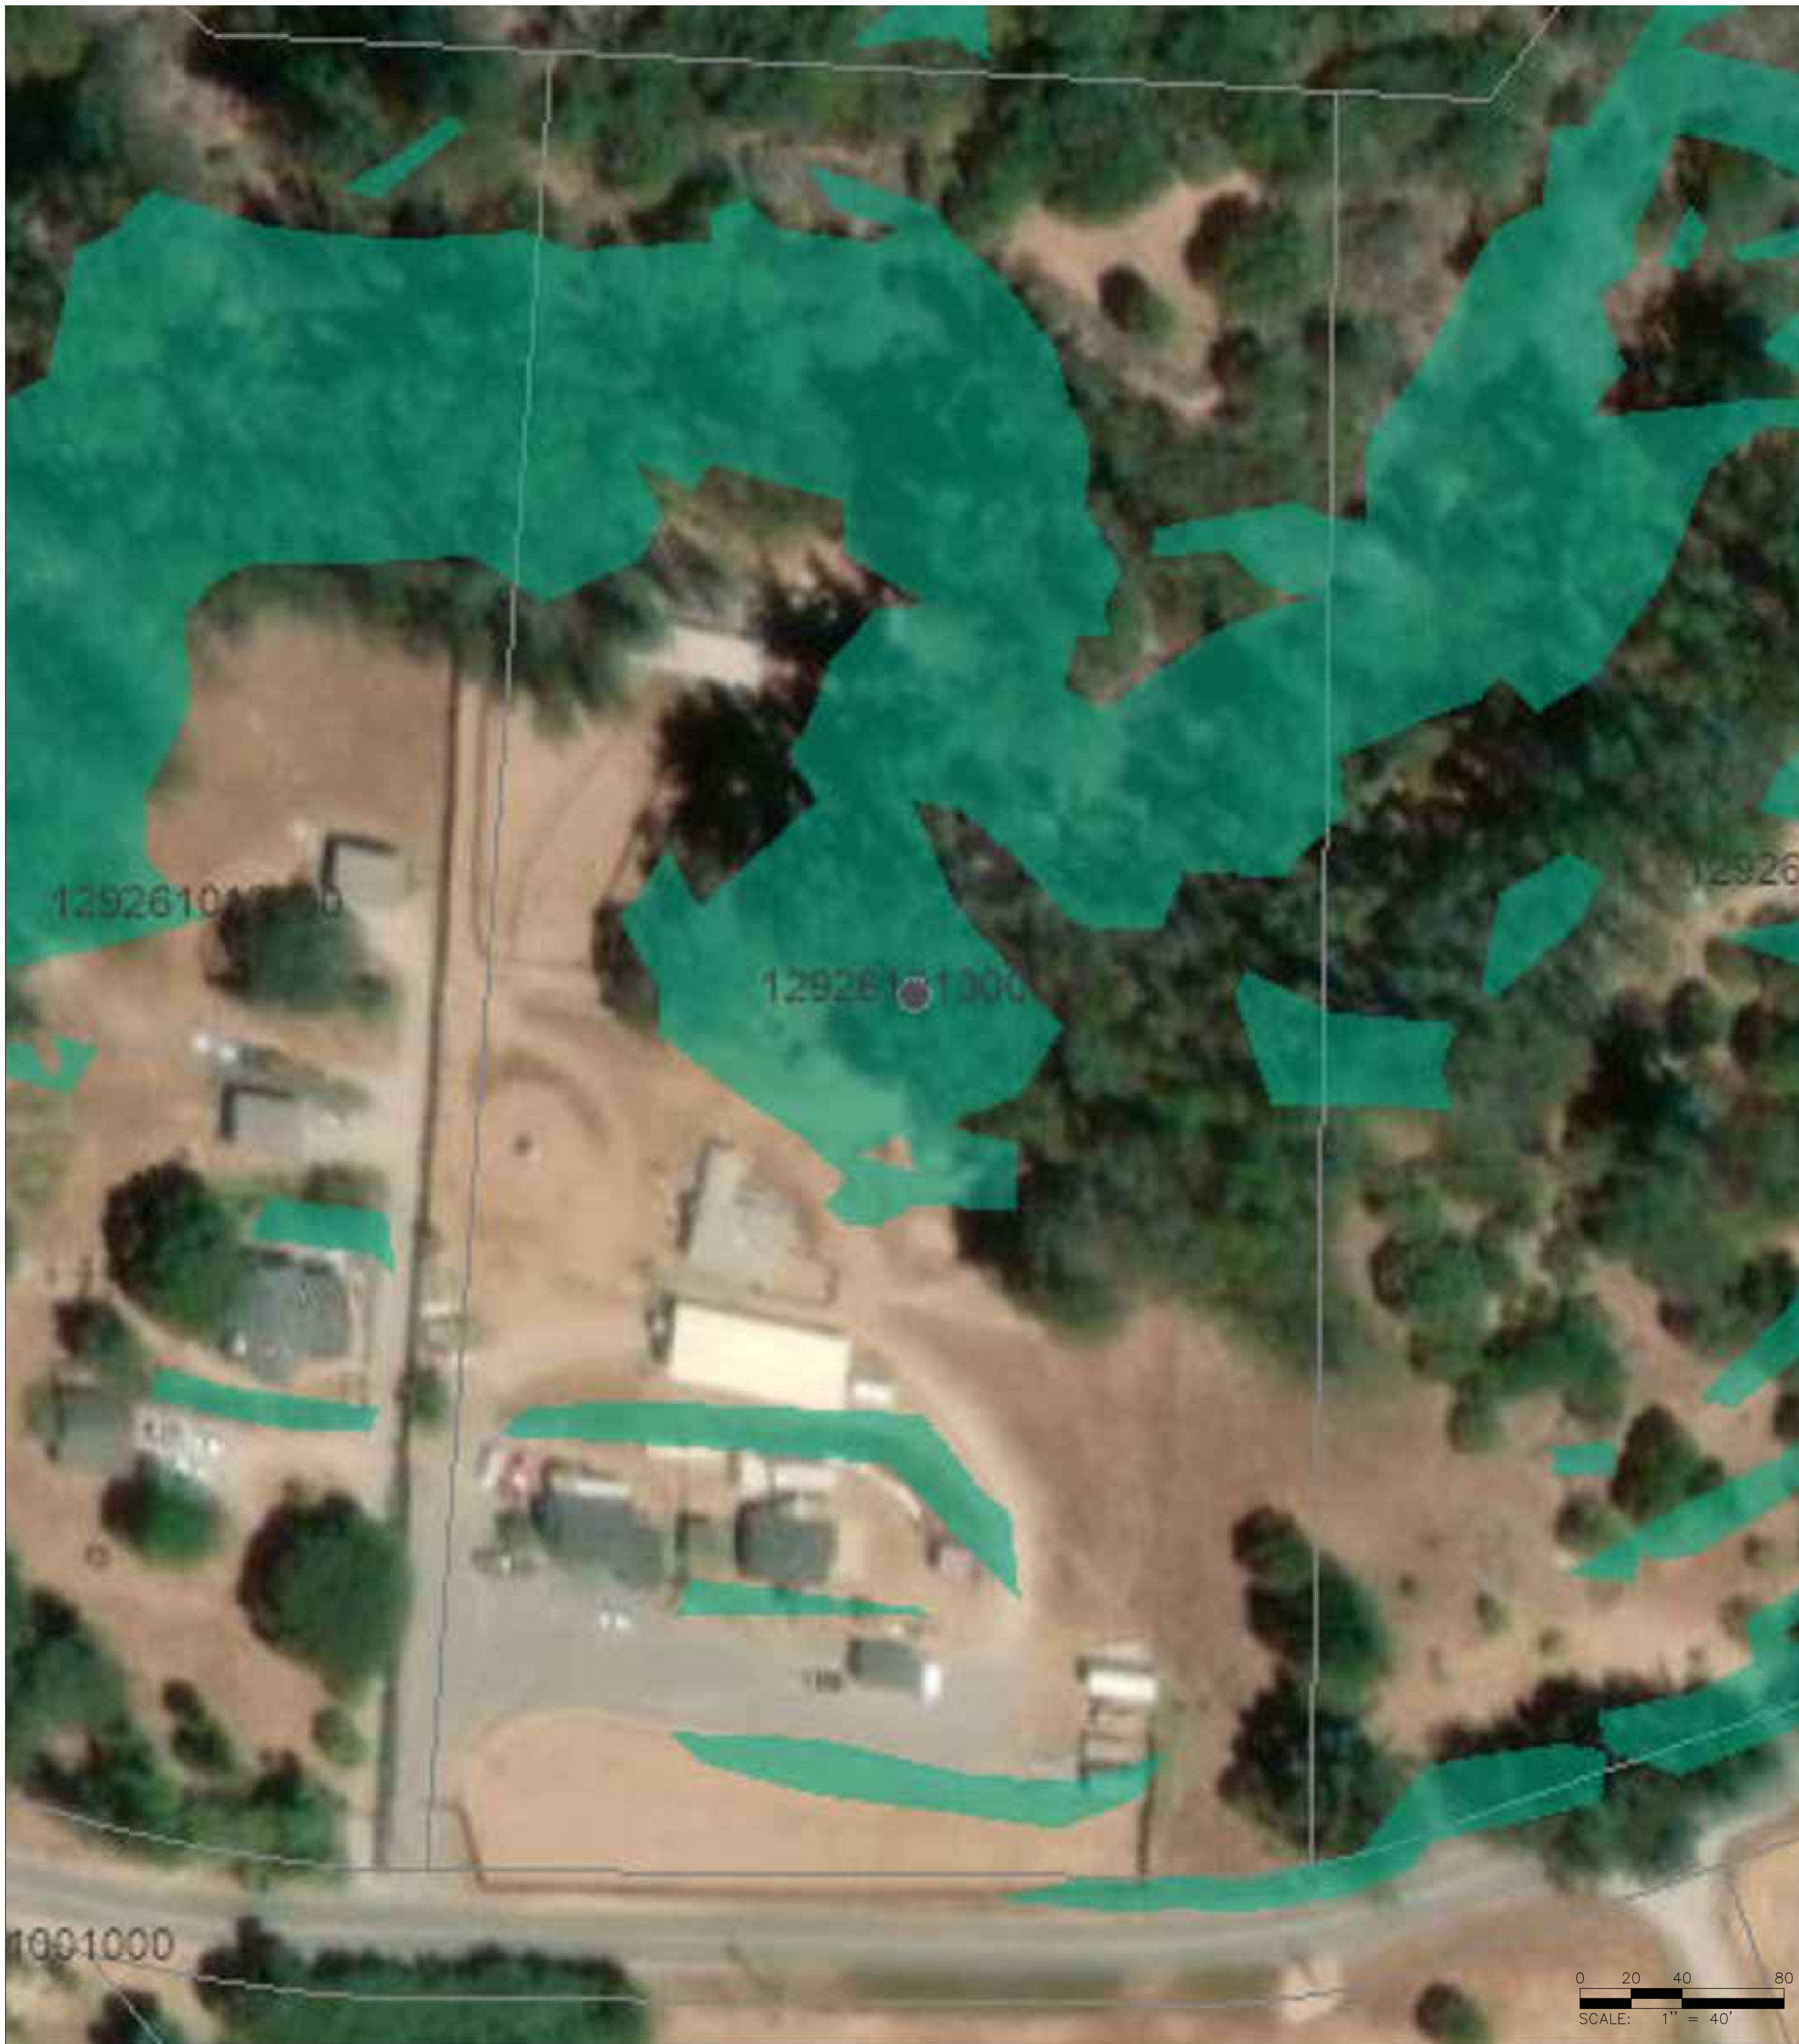
**SLOPE / DENSITY CALCULATION**  
 0-19.9% slope, 1 building per 1 acre.  
 20-29.9% slope, 1 building per 2 acres.  
 Parcel is 5.26 acres = 2 buildings fro 20-29%  
 and 5 for 0-19%, 3.5 blds average

- NOTES:  
 1. BASE MAPS FROM GOOGLE EARTH PRO AND MONTEREY COUNTY GIS  
 2. CONTOURS GENERATED FROM CROSS SECTIONS SURVEYED, USING CIVIL 3D

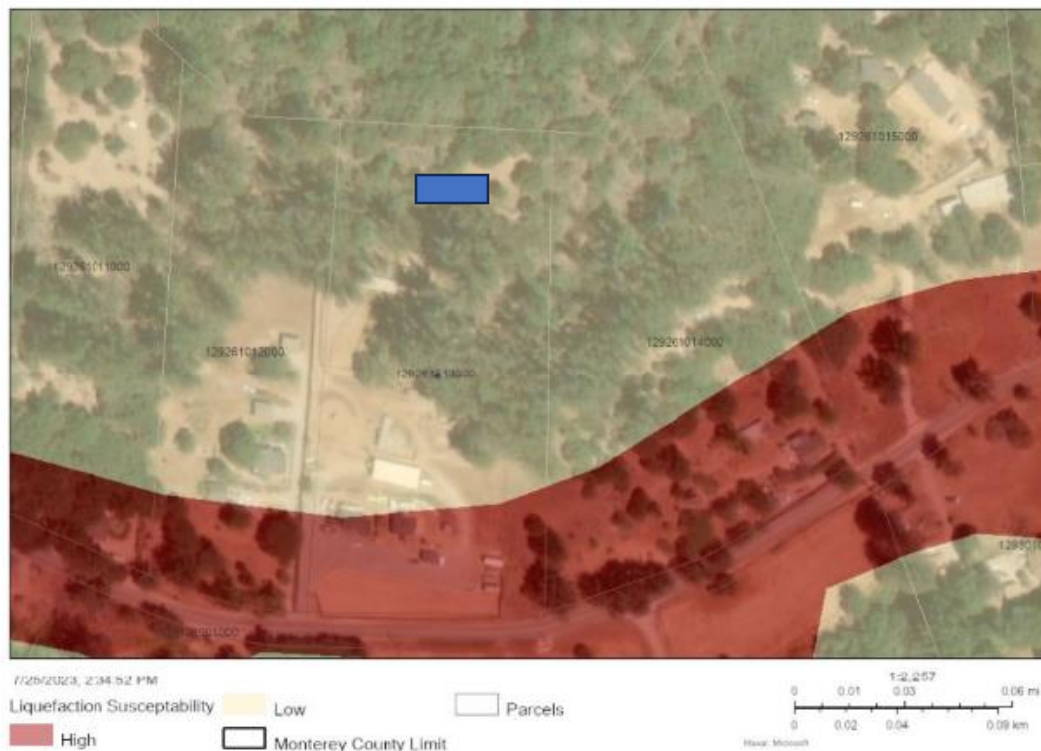
- Liquefaction: The GIS shows that the areas closer to Strawberry Road have a high potential for liquefaction. The proposed corrective grading will take place on the north side of the property, mapped as LOW POTENTIAL for liquefaction. See picture below:

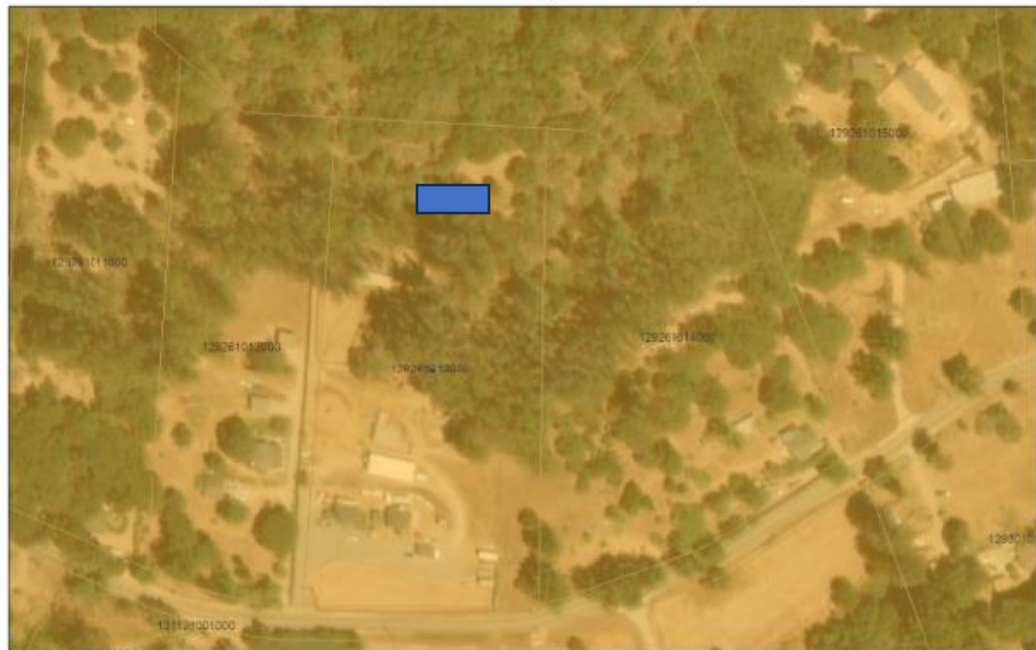
- Landslide susceptibility: The GIS shows the area with a moderate potential for landslides. See picture below:

During our site evaluation, there were no signs of localized land sliding. The proposed grading plan will flatten slopes to a 3:1 gradient that will remain stable.

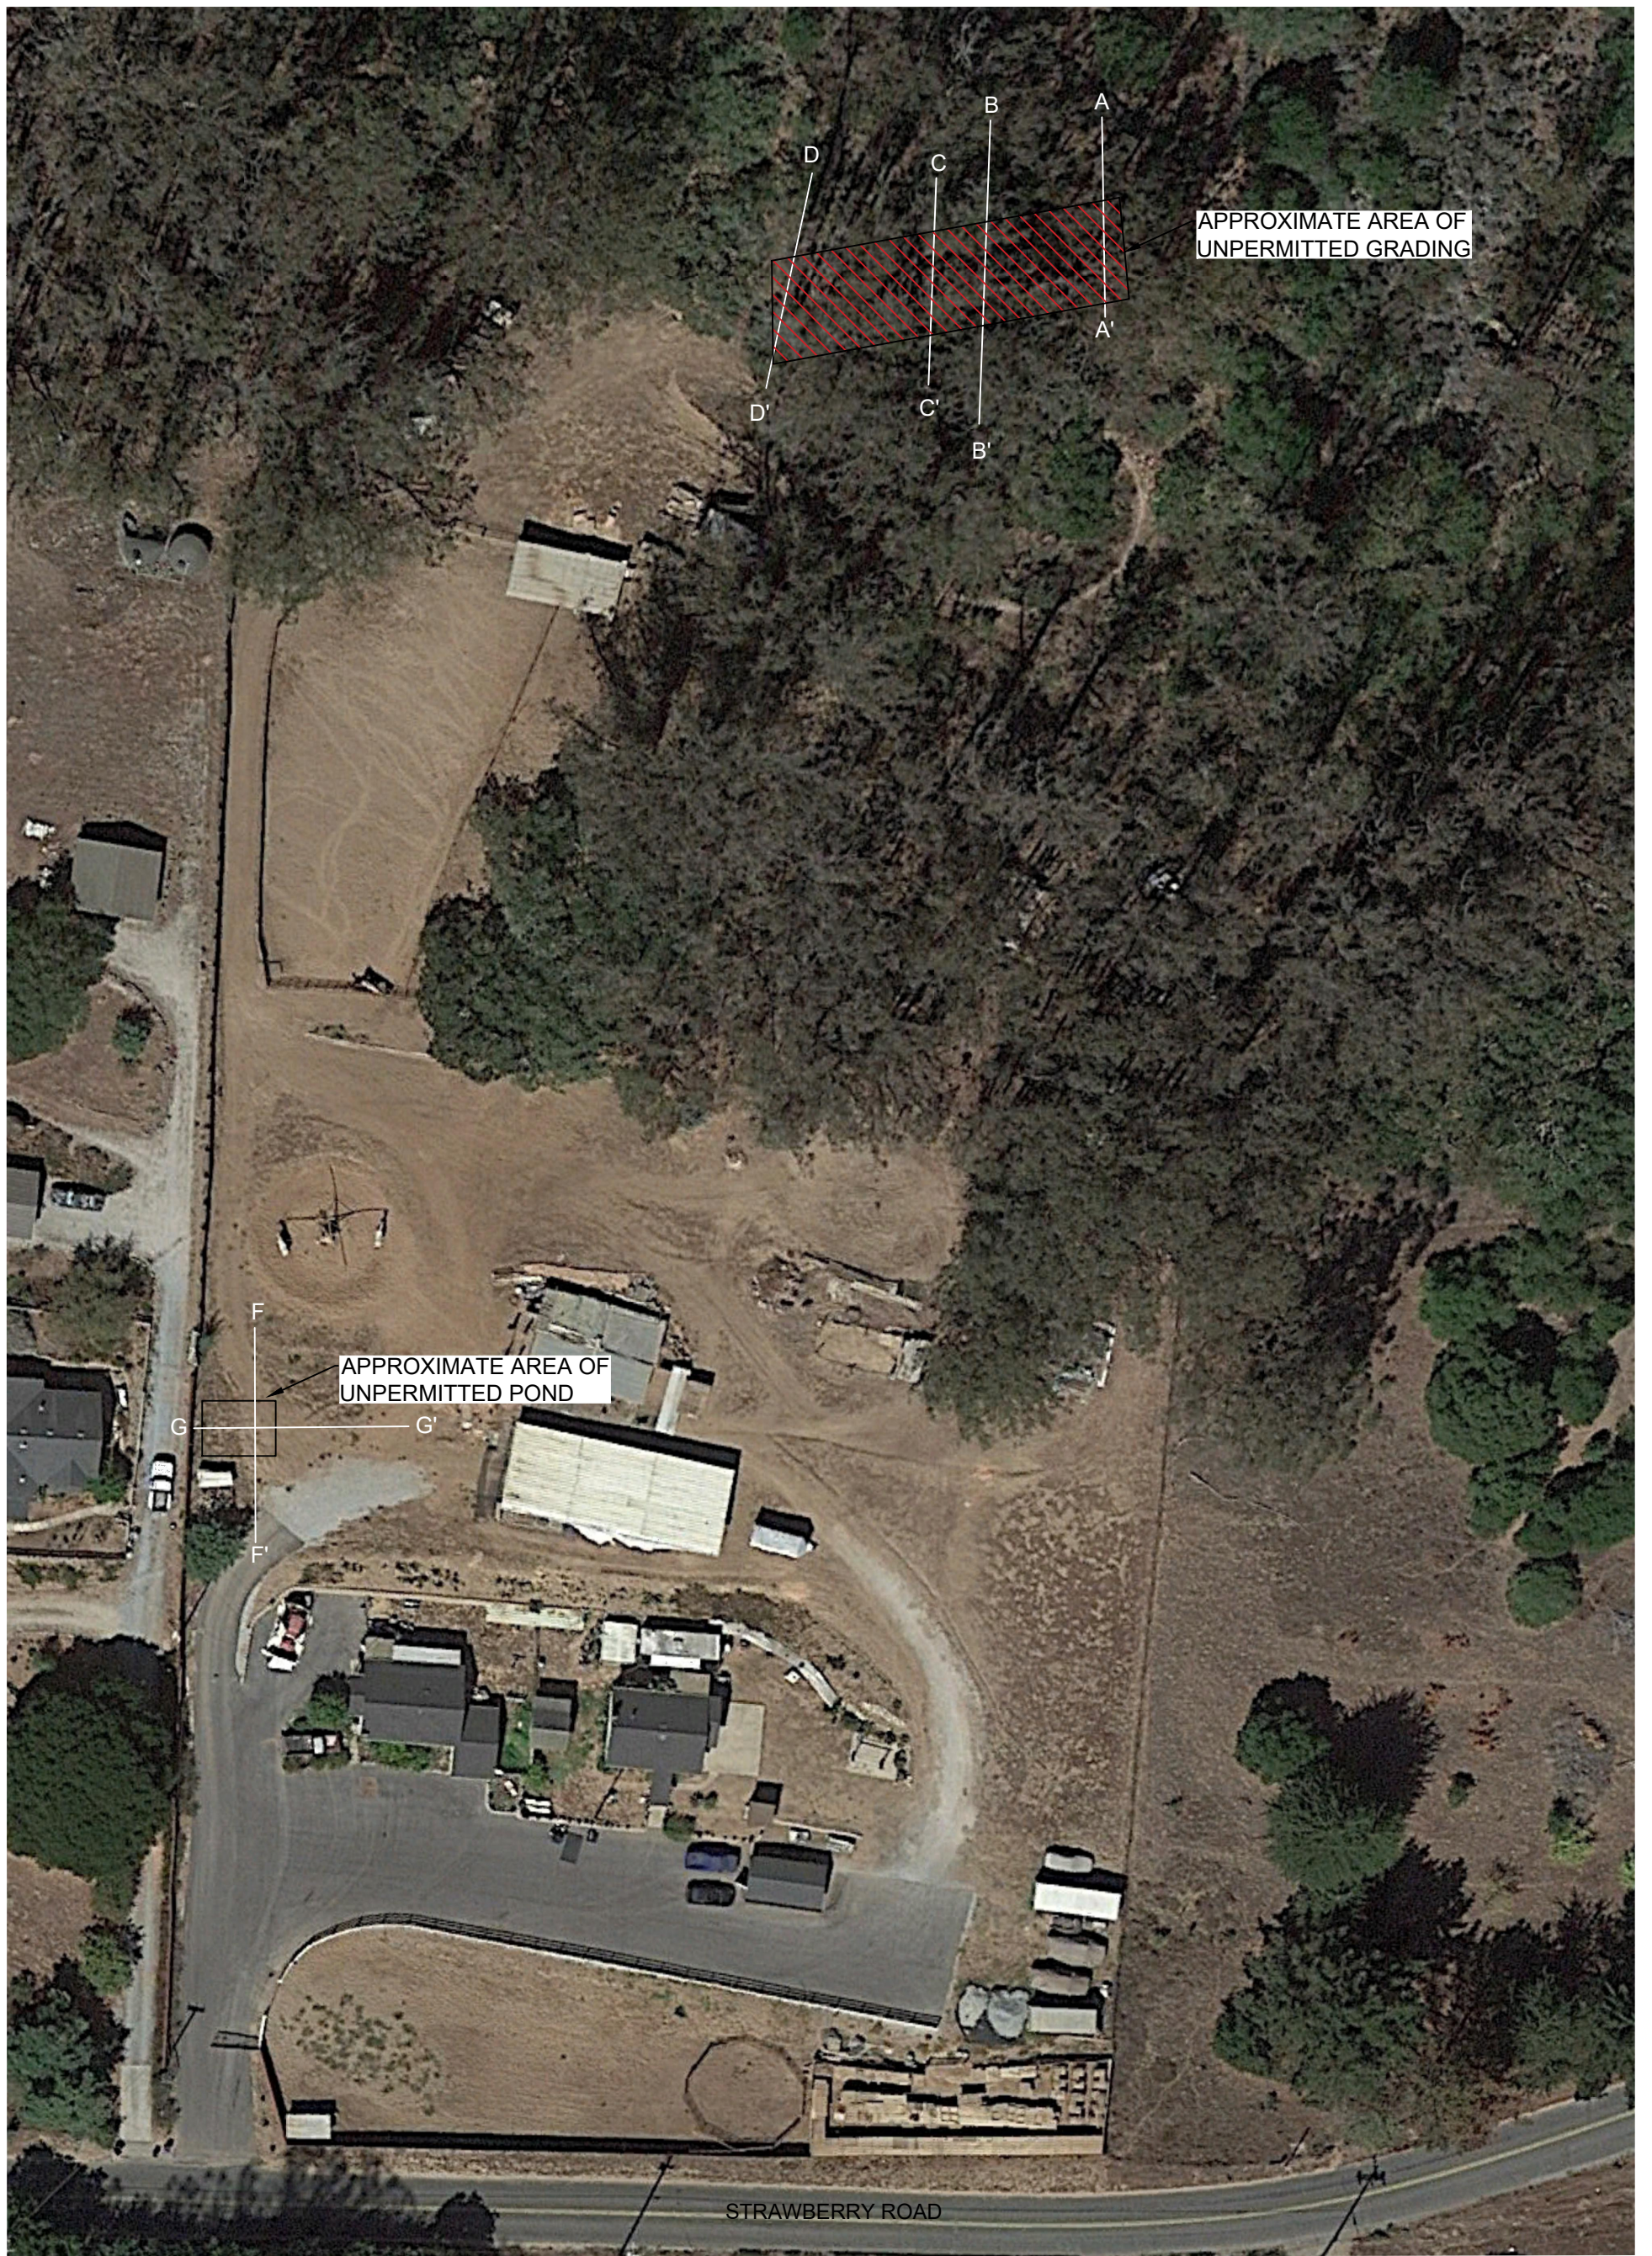
**FIGURE NO. 1**

1. BASE MAP FROM GOOGLE EARTH PRO
2. CROSS SECTIONS LOCATIONS APPROXIMATE FROM MEASUREMENTS IN THE FIELD USING HANDHELD LASER LEICA DISTO.

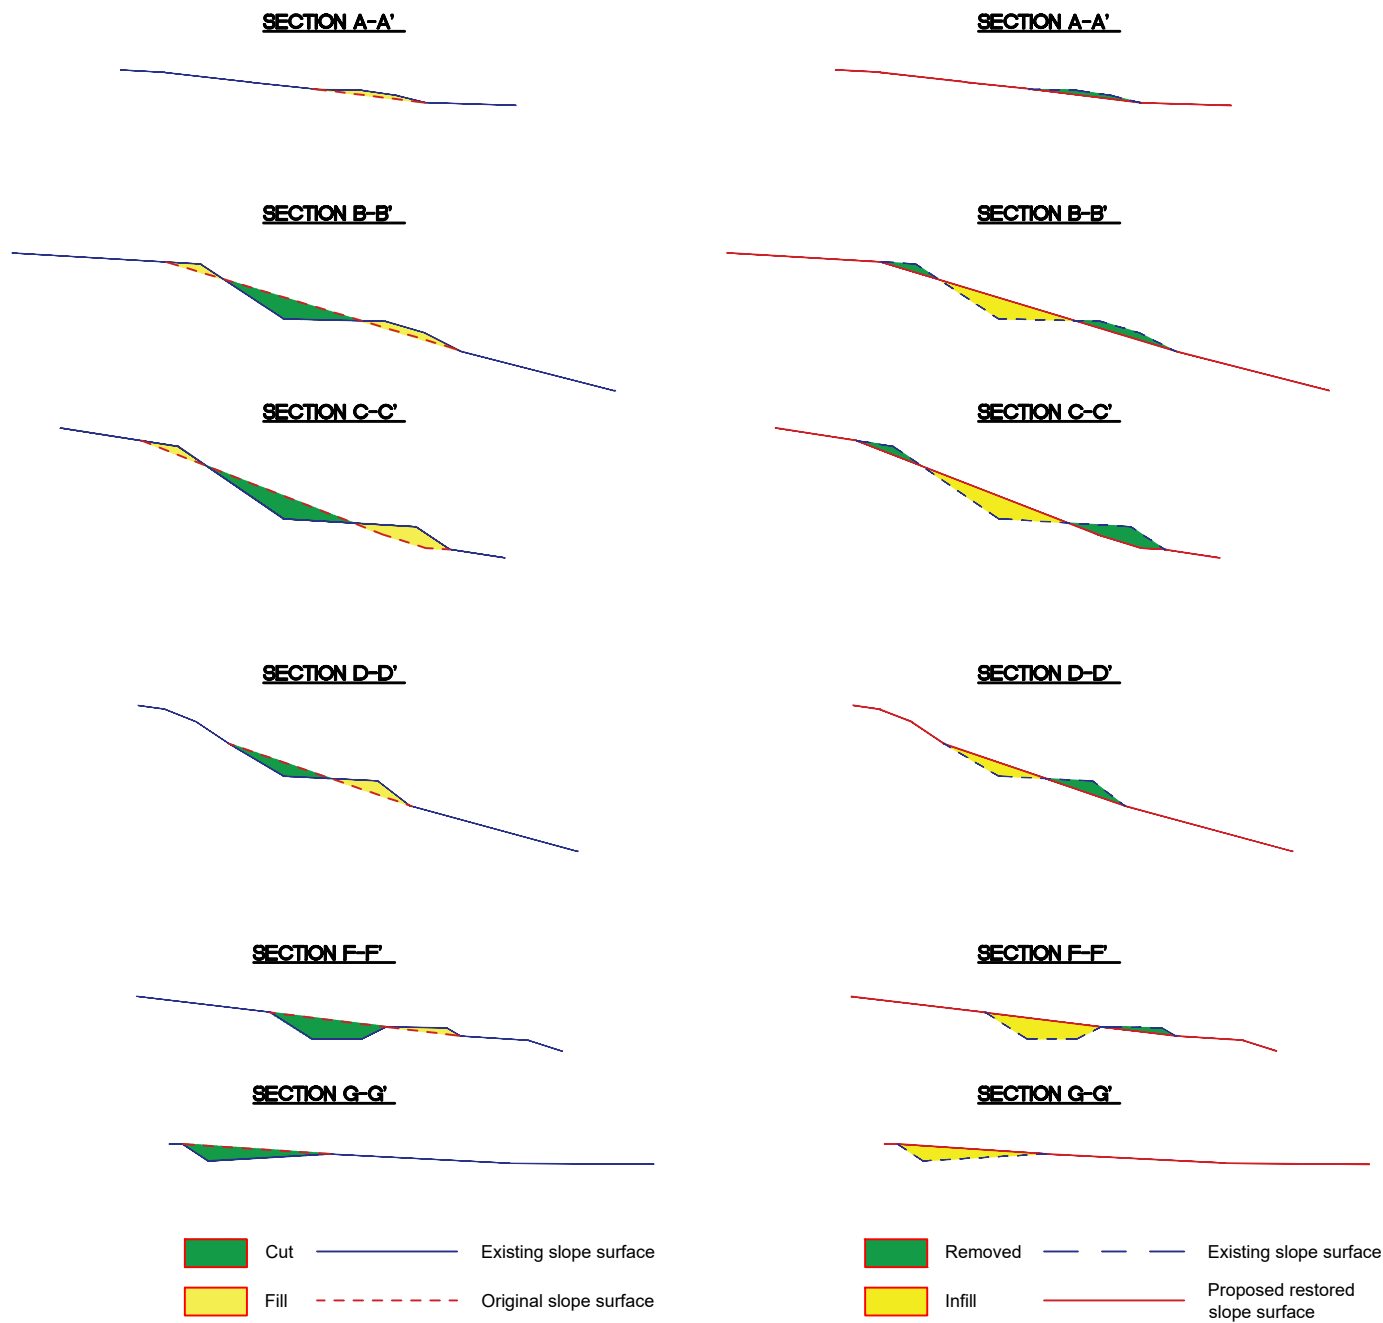
**FIGURE NO. 2**

EXISTING CONDITIONS

SECTIONS AFTER RESTORATION

1. Approximate cut volume: 140 approximate fill volume 130 cy.
2. The restoration plan is intended for the period of April 15th to May 15th 2023. Restoration grading should be done between April 16th and May 7th. Erosion control seeding should be done between May 7th and May 15th.
3. Seed and straw mulch should be used on disturbed areas to establish erosion control protection for stabilized 3:1 H:V restored slope surfaces. Seed and straw mulch shall consist of spreading seed (a minimum of 5 lbs/1000 sq. ft.) over disturbed areas and then placing a uniform layer of straw (2-3 bales/1000 sq. ft.) over the seeded slope surface, incorporating it into the soil with a studded roller. The seed shall be annual winter barley and the straw shall be derived from rice, barley or wheat.
4. Hand spray the seeded area twice a week after May 15th if germination of seeds has not occurred.
