# Exhibit C

## Storesund Consulting

Re: Vega Road Project Geotechnical Evaluation

<u>TITLE</u>	<u>PAGE</u>
Cover letter .....	Front
Location and Description .....	1
Scope of Investigation .....	1
Regional Geology .....	2
Faults and Seismicity .....	3
Site Geology .....	4
Conclusions and Recommendations .....	5
Bibliography .....	8
Site Location Plan .....	Figure 1
Regional Geologic Map (Dupré and Tinsley) .....	Figure 2
Wind Rose Diagram Based on Eolian Dune Depositional Orientation (Dupré) .....	Figure 3
Regional Fault Trace Map .....	Figure 4
Seismic Hazard Zone Map .....	Figure 5
Liquefaction Potential Map .....	Figure 6
Flood Plain (100-Year Frequency) .....	Figure 7
Geologic Site Map .....	Figure 8
Generalized Geologic Cross-Section .....	Figure 9
Location of Seismograph Lines Sketch Map .....	Figure 10
Seismograph Profile Line 1 .....	Figure 11
Seismograph Profile Line 2 .....	Figure 12
Seismograph Profile Line 3 .....	Figure 13
Seismograph Profile Line 4 .....	Figure 14
Seismograph Profile Line 5 .....	Figure 15

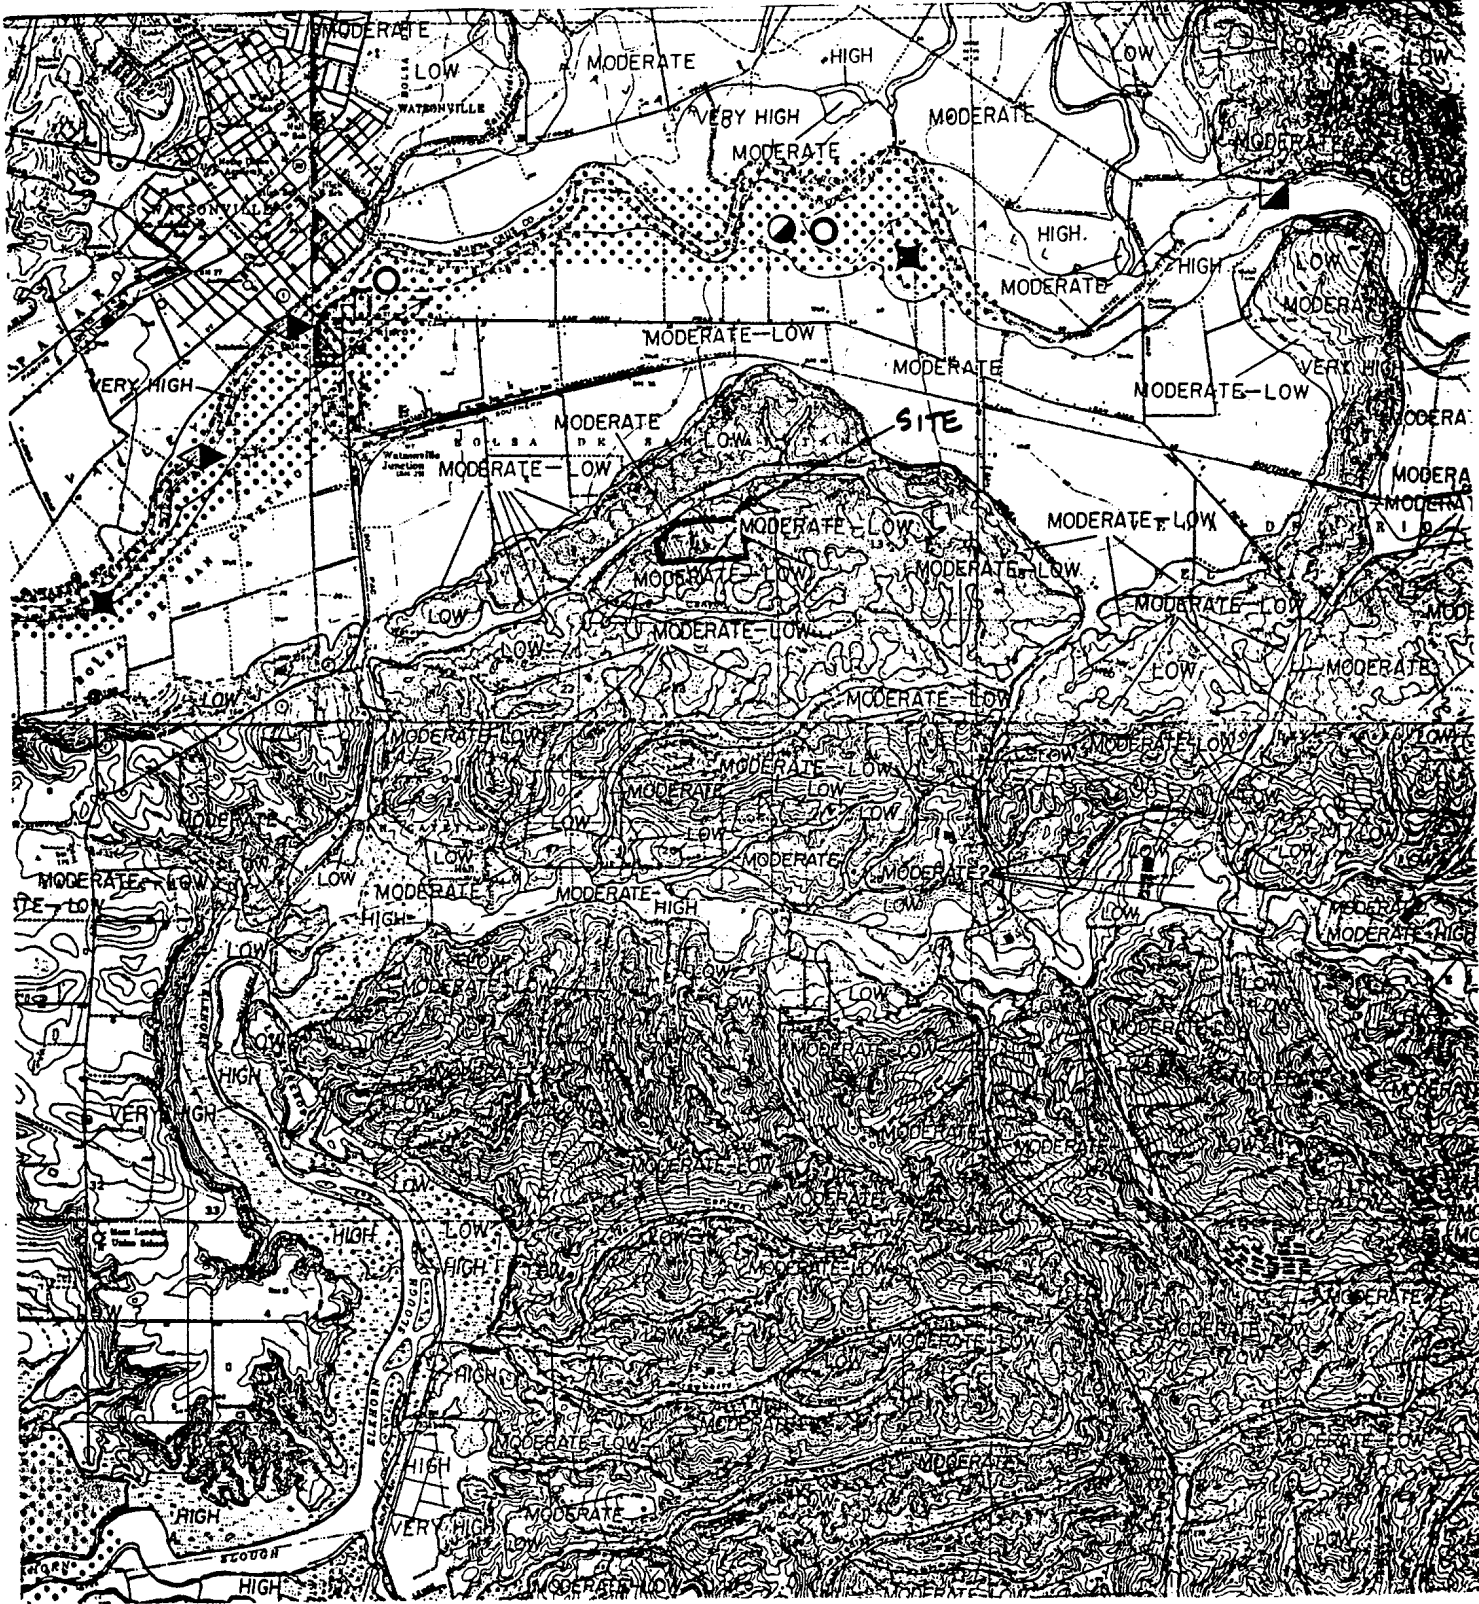
FIGURE NO. 6

LIQUEFACTION POTENTIAL MAP

Liquefaction potential for the property is rated as moderate-low, except near Vega Road (see Figure No. 6). Based on our investigation, we do not consider liquefaction a hazard at this site due to the absence of shallow groundwater. Bore Hole No. 1 at Lot No. 1 located in the Vega Road area, rated as moderate, did not encounter any free groundwater to a depth of 12 feet; hence is also rated as low.

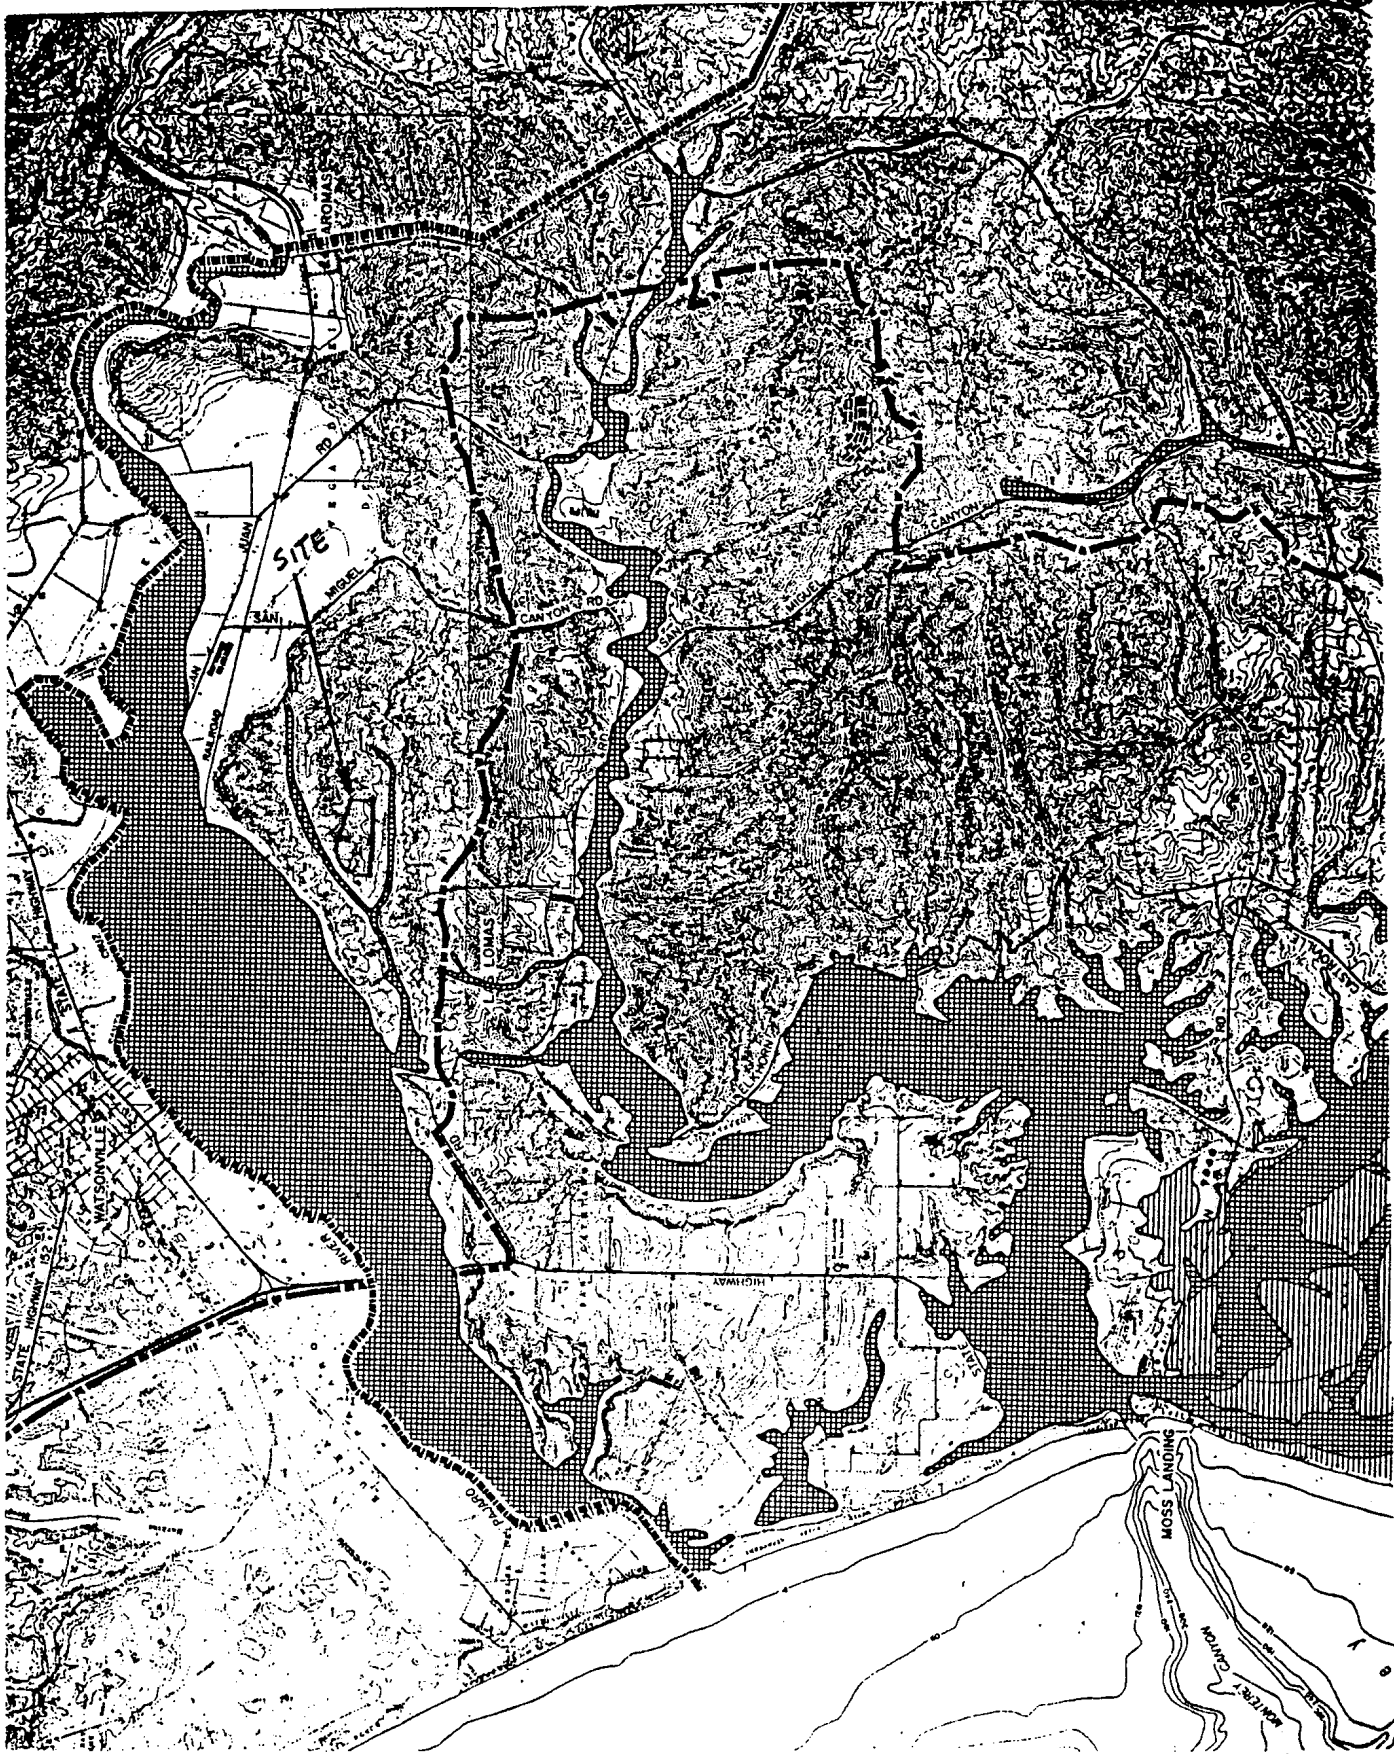
FIGURE NO. 7

FLOOD PLAIN (100-YEAR FREQUENCY)

Lot No. 1 is the only area of the property which may extend into the 100-Year Frequency Flood Zone along Vega Road shown on Figure No. 7. The building envelope should be located above this elevation.
