# Attachment K

Subject: Biological assessment for 26338 Valley View Avenue in Carmel

REGIONAL BORING SITE MAP 26338 Valley View, APN 009-463-017 Carmel-By-The-Sea, California	
SCALE: NTS	<b>HARO, KASUNICH &amp; ASSOCIATES, INC.</b> GEOTECHNICAL AND COASTAL ENGINEERS 116 E. LAKE AVENUE, WATSONVILLE, CA 95076 (831) 722-4175
DRAWN BY: AK	
DATE: DEC 2017	
REVISED:	
JOB NO. M11382	<b>FIGURE NO. 2</b>
SHEET NO.

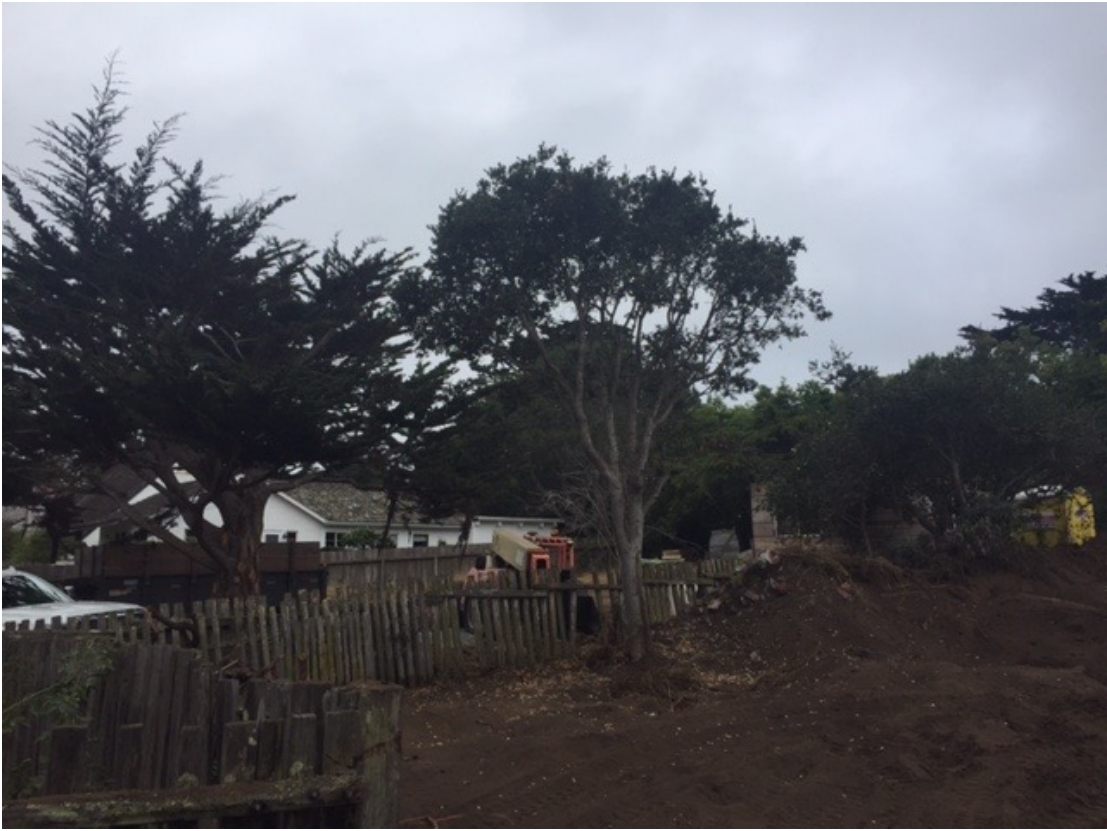
Figure 1. Previously disturbed and impacted property at 26338 Valley View Ave does not support any sensitive or protected biological resources. Immature oak tree is located in center of photo. Resources are limited to a few native tree/plant species, as well as some non-native introduced plant species.

This biological evaluation was conducted by performing a thorough walk through and visual assessment of the subject property, and reviewing property development plans and maps (refer to the *Exhibit A. Site Plans* for property features and characteristics). Where possible the characteristics and conditions described in this report are depicted in the accompanying photographs located at the end of the report (refer to *Figures 1 & 2*).

in a urban woodland residential community of Carmel (refer to attached photos, *Figures 1 & 2*). This undeveloped and ruderal property has been previously impacted and disturbed by grading activities. Homes in this community are located in relatively close proximity to one another and natural open space is generally absent in this particular area.

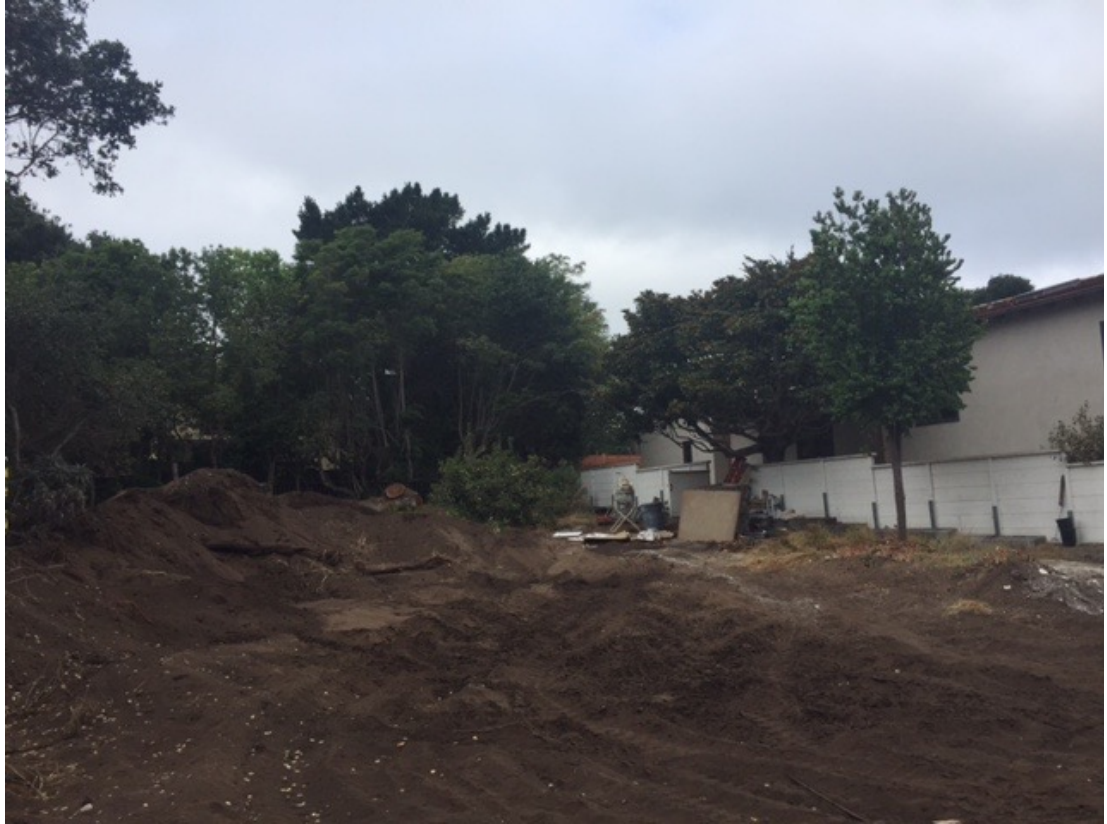
Figure 2. Another view of disturbed property that does not support any sensitive or protected biological resources. Introduced ornamental trees are located in background along perimeter of property.

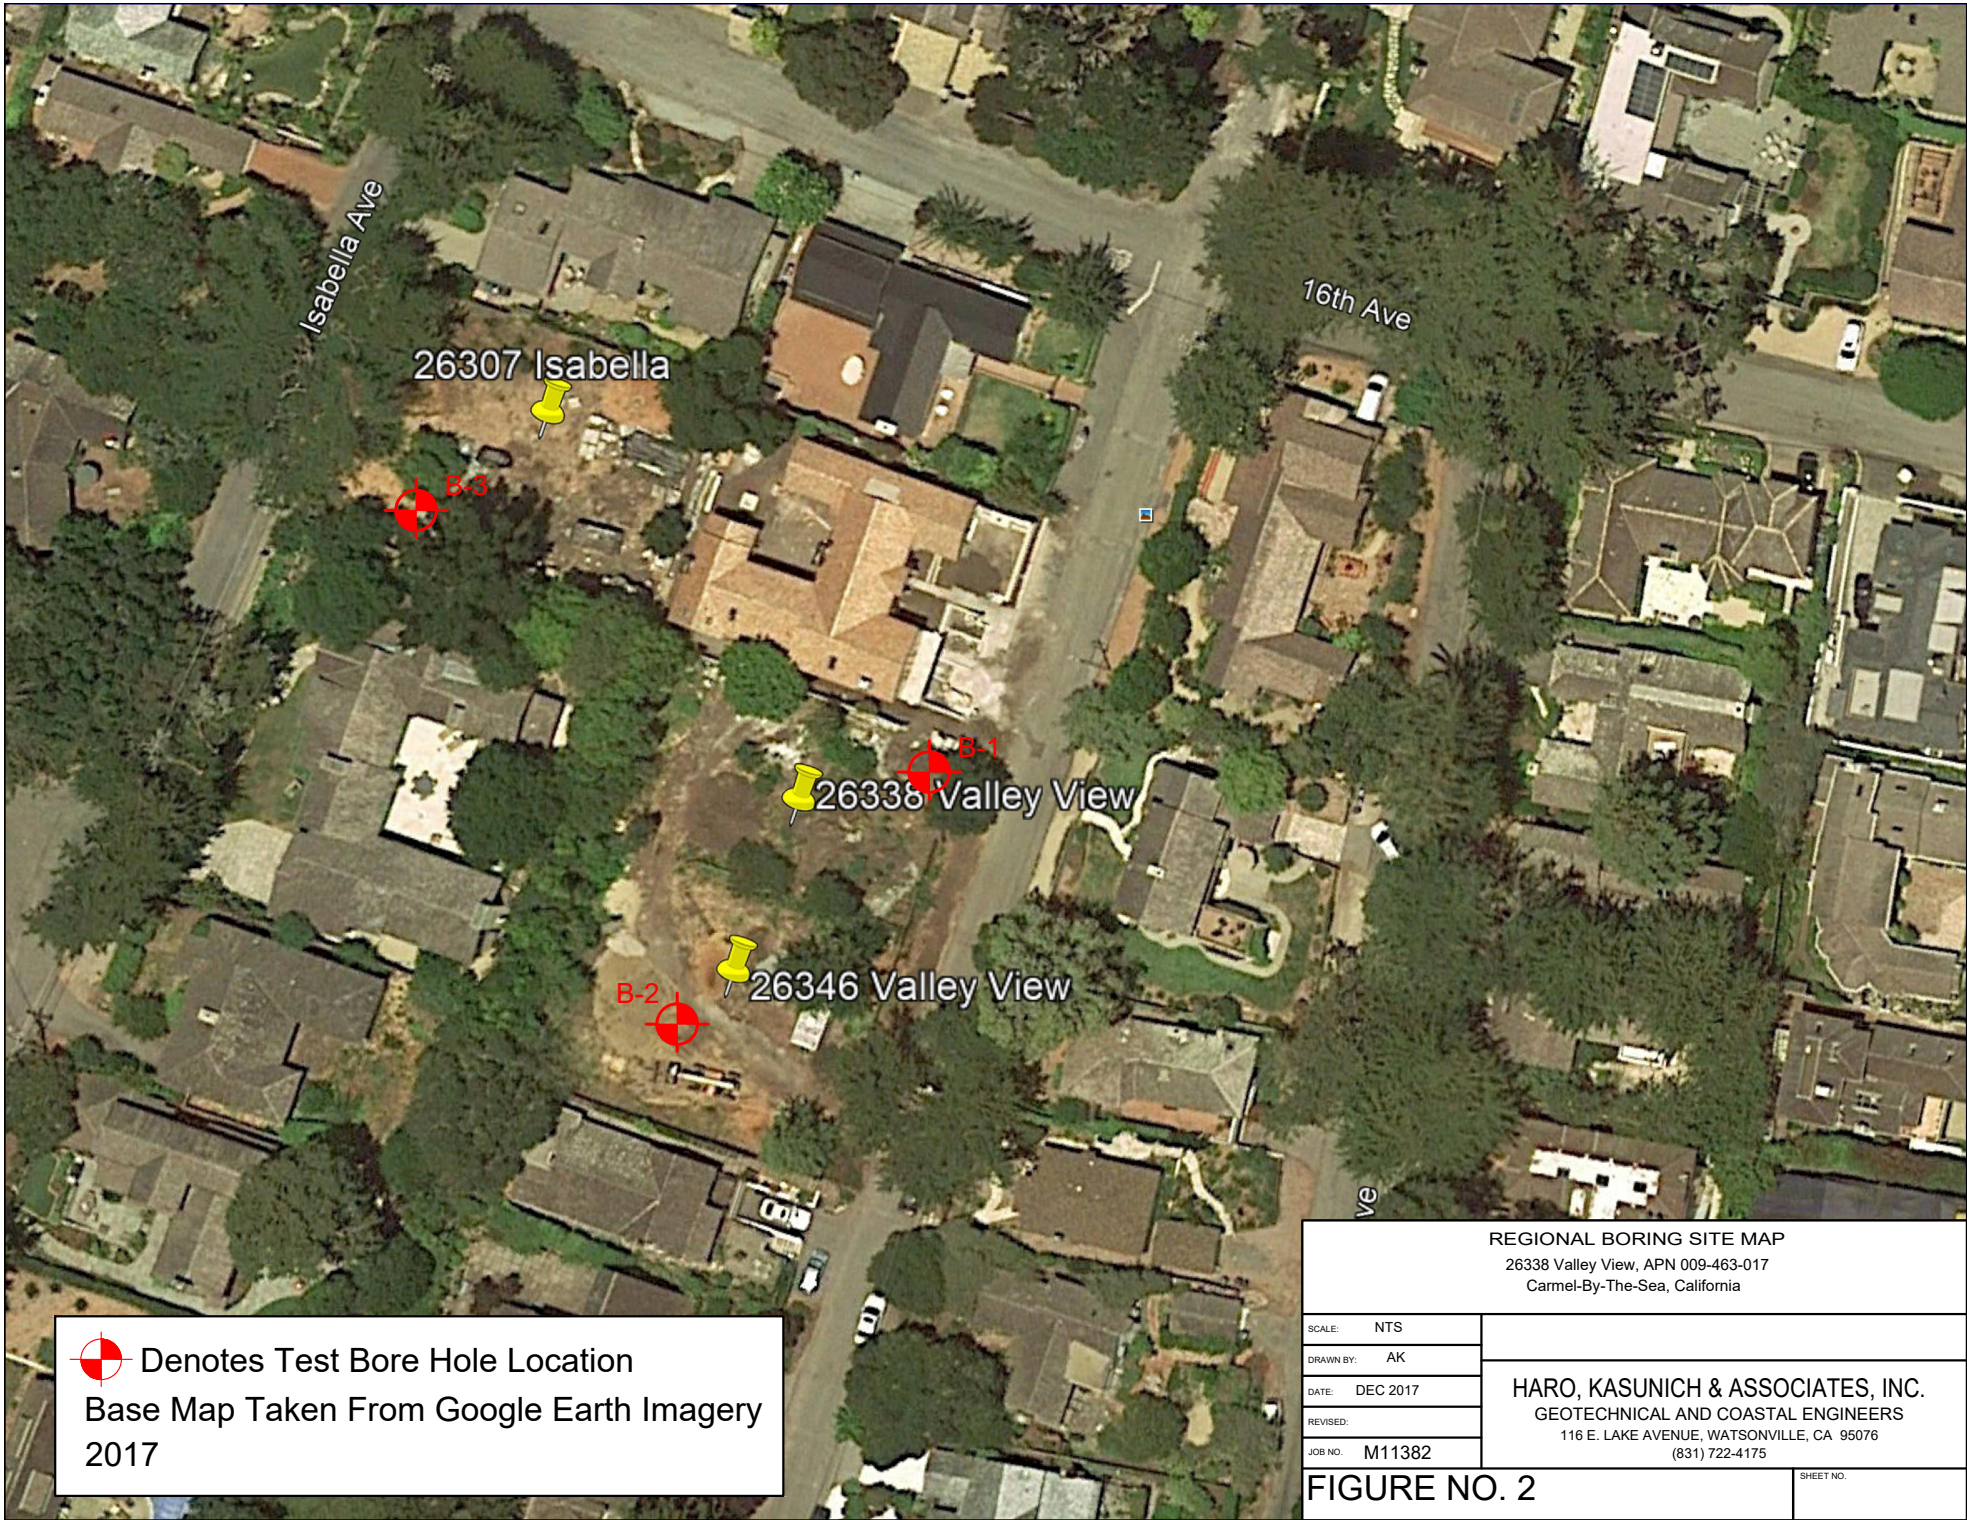
Denotes Test Bore Hole Location  
 Base Map Taken From Google Earth Imagery  
 2017

Subsurface conditions were investigated on 9 October 2017. The boreholes were co-logged with project Engineering Geologist, Craig Harwood. The approximate locations of the test bore holes are indicated on the boring site maps, Figures 2 & 3, in Appendix A. The test borings were advanced using 6-inch diameter continuous flight-auger equipment mounted on a truck.

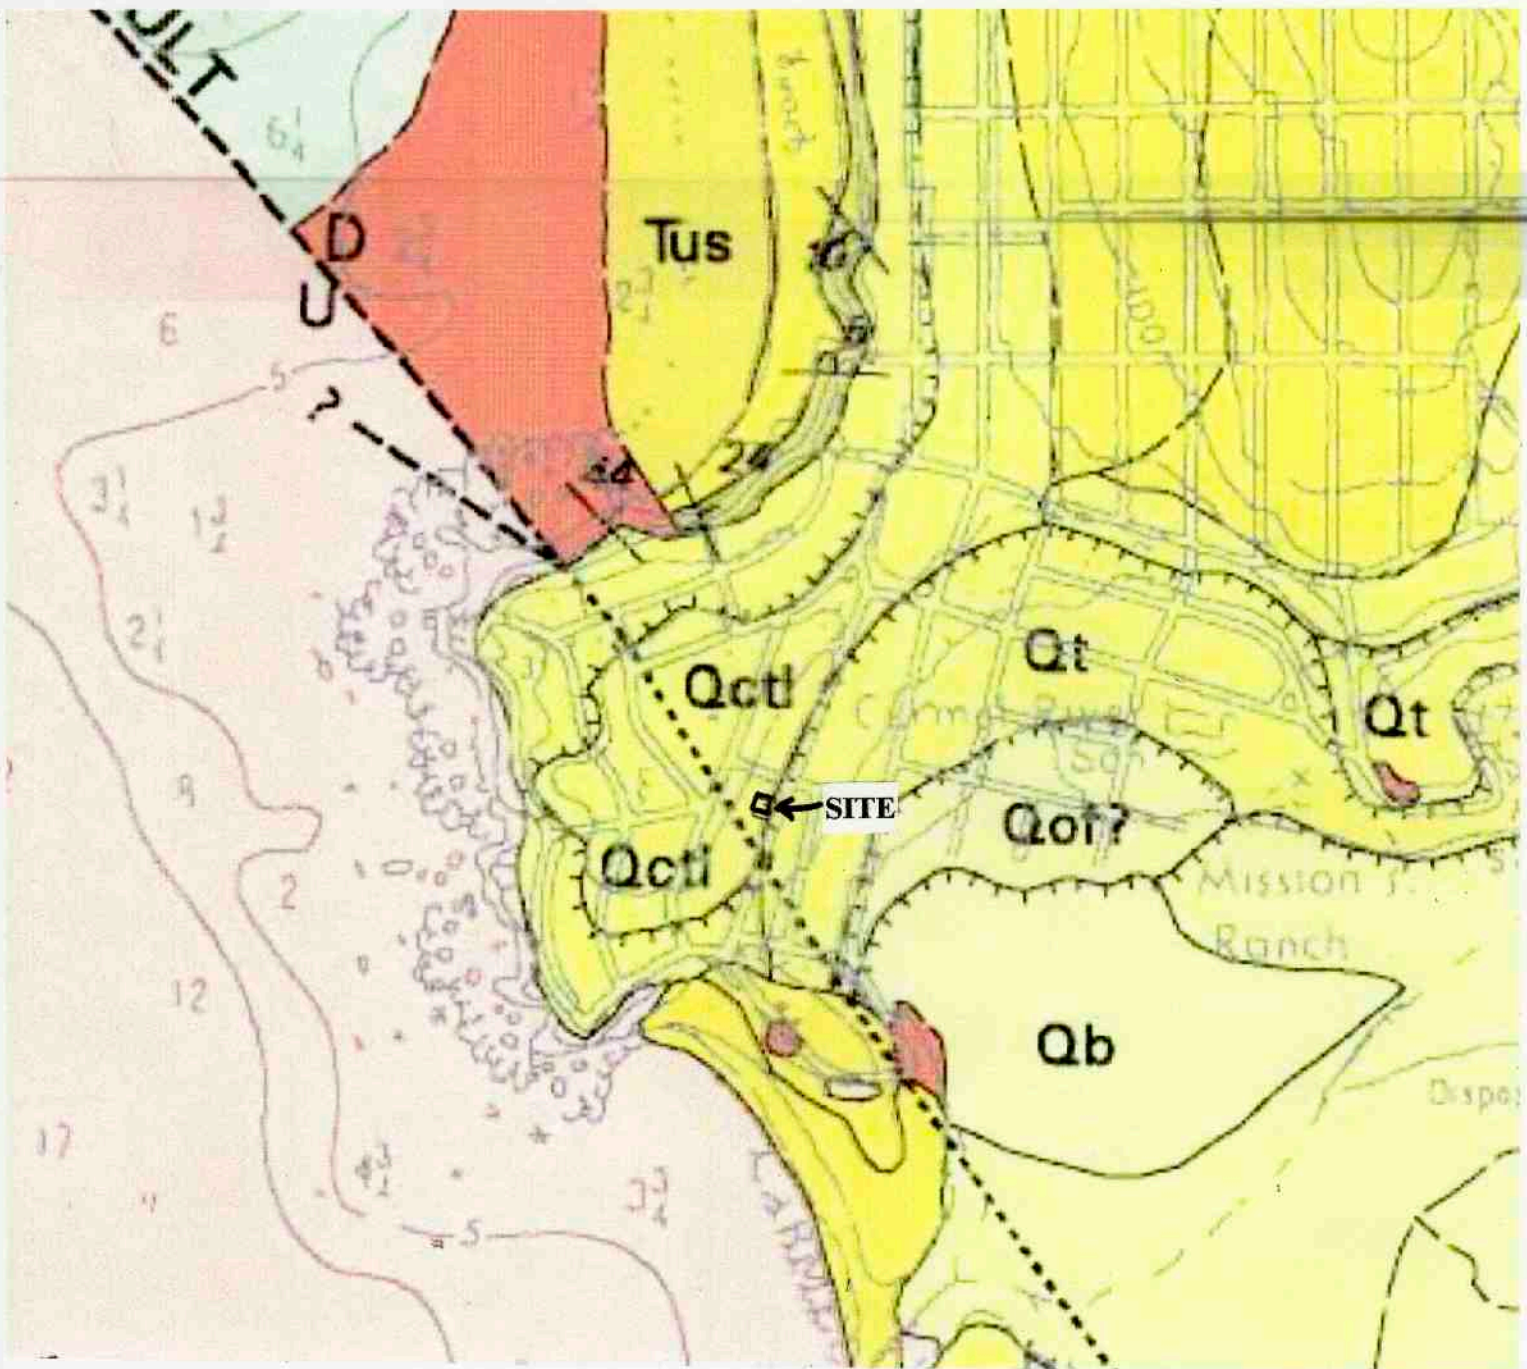
# REGIONAL GEOLOGIC MAP

**Explanation (Adapted from Clark et al. 1974)**

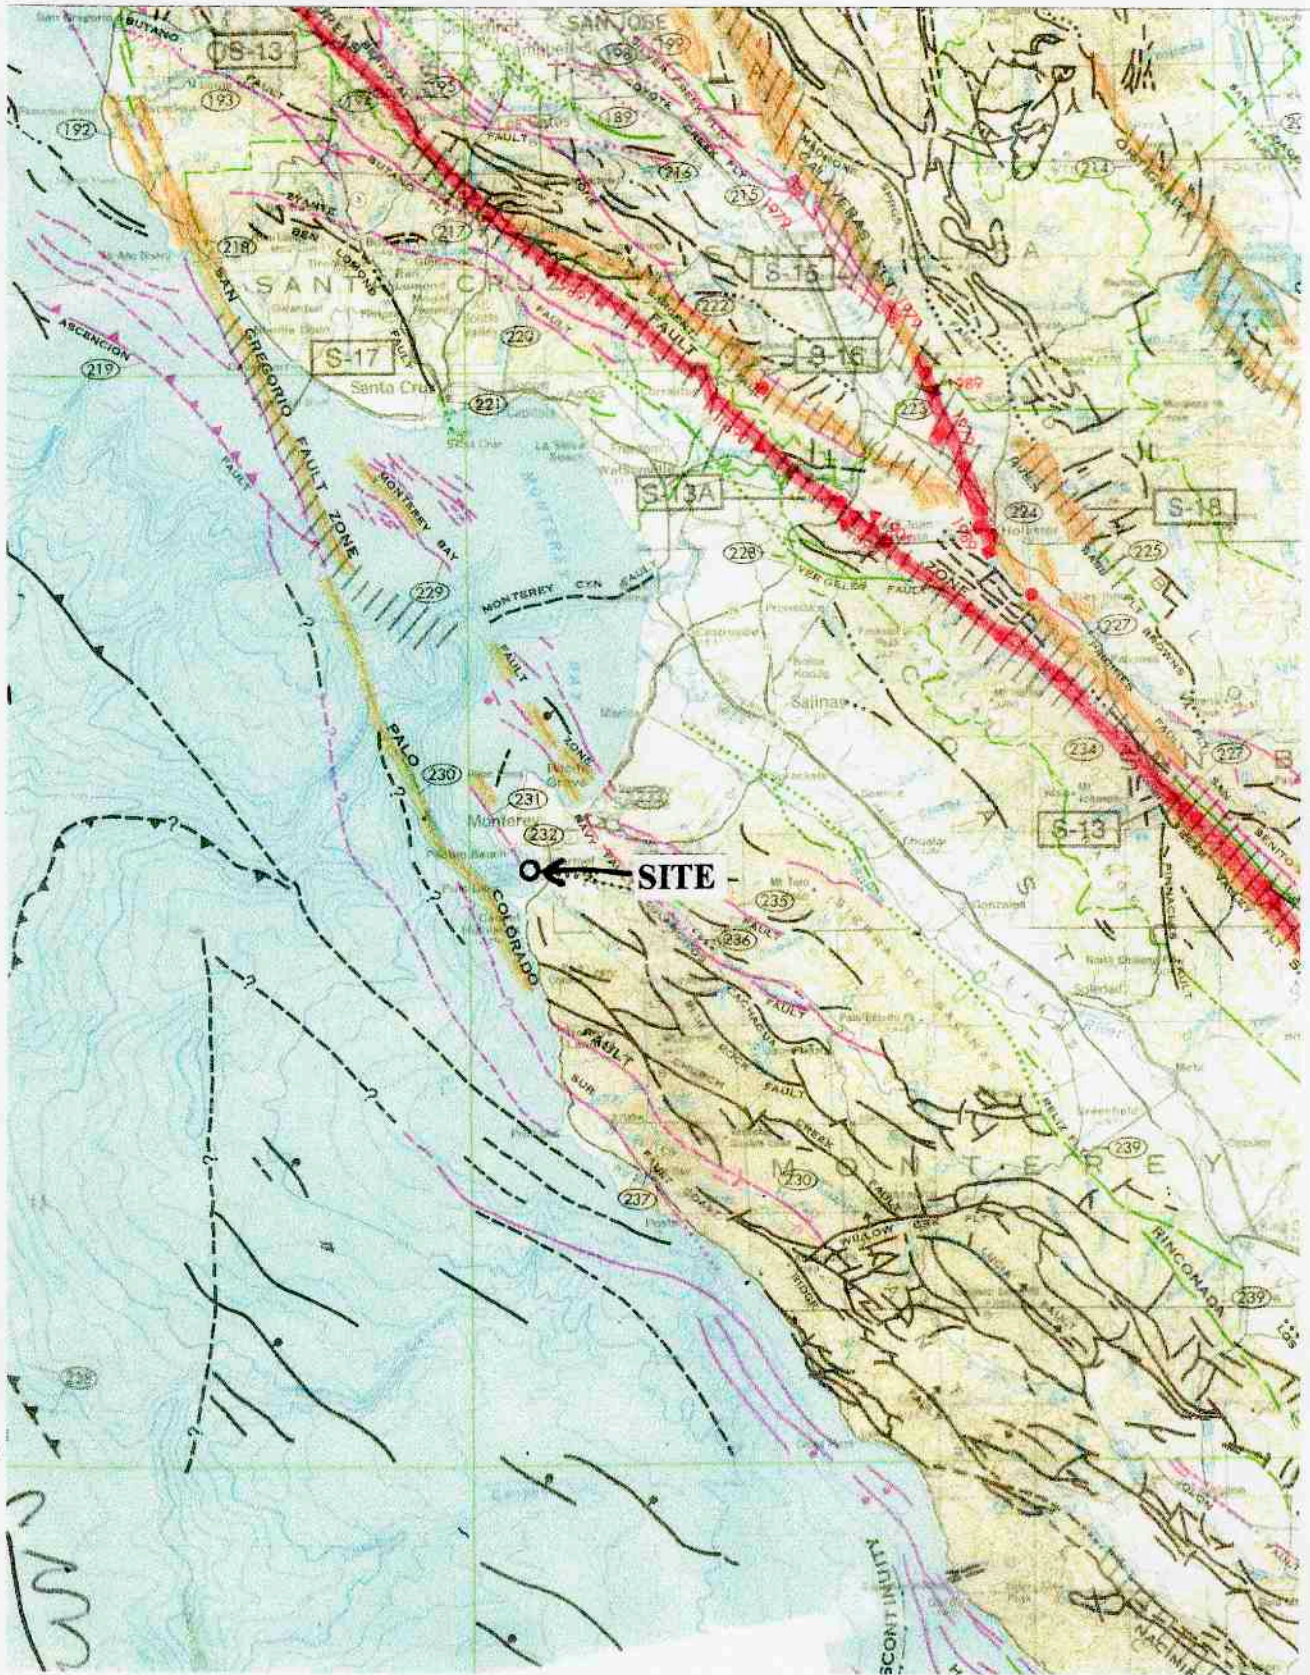
# REGIONAL FAULT MAP

Source: Jennings, 1994

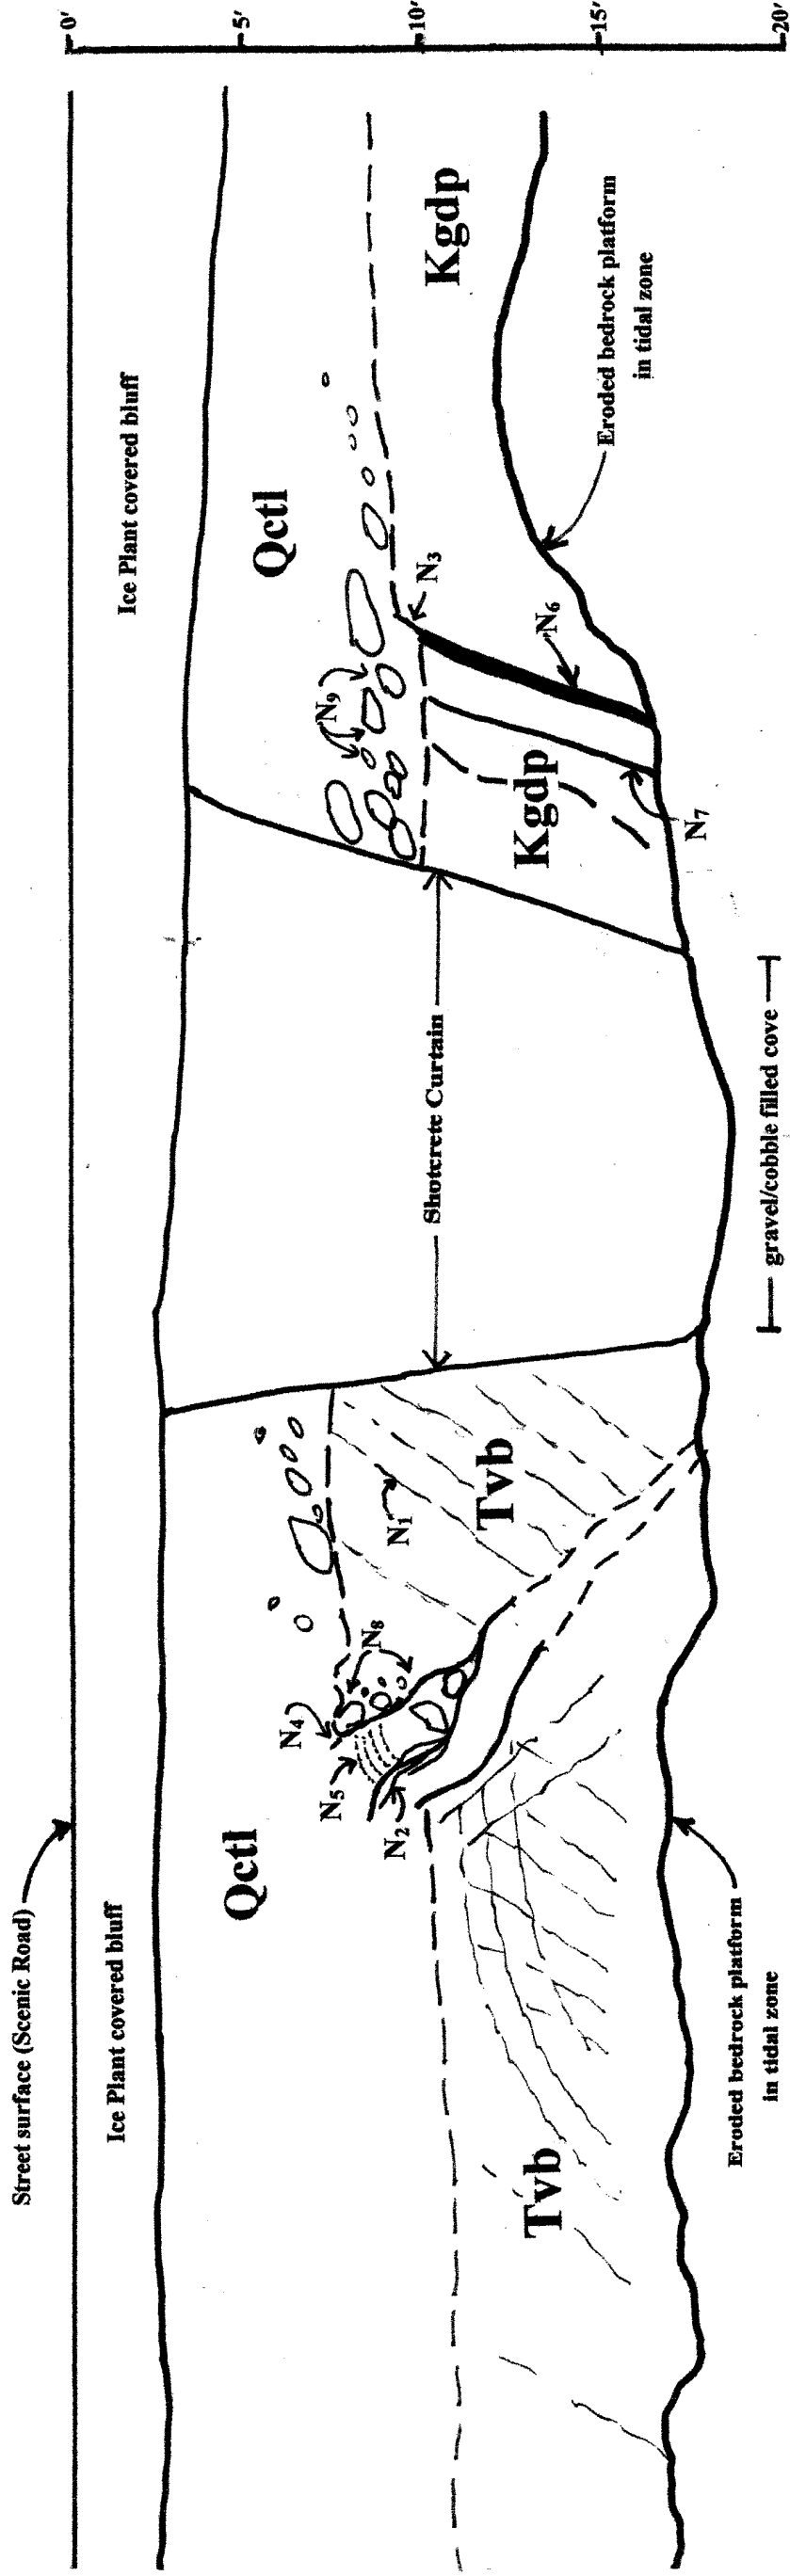
# Log of Fault Exposure

Primary Fault Zone

## Explanation

**Qct1** Lighthouse Coastal Terrace (Pleistocene): silty sand with gravel and clay, cobbles concentrated within fault zone.

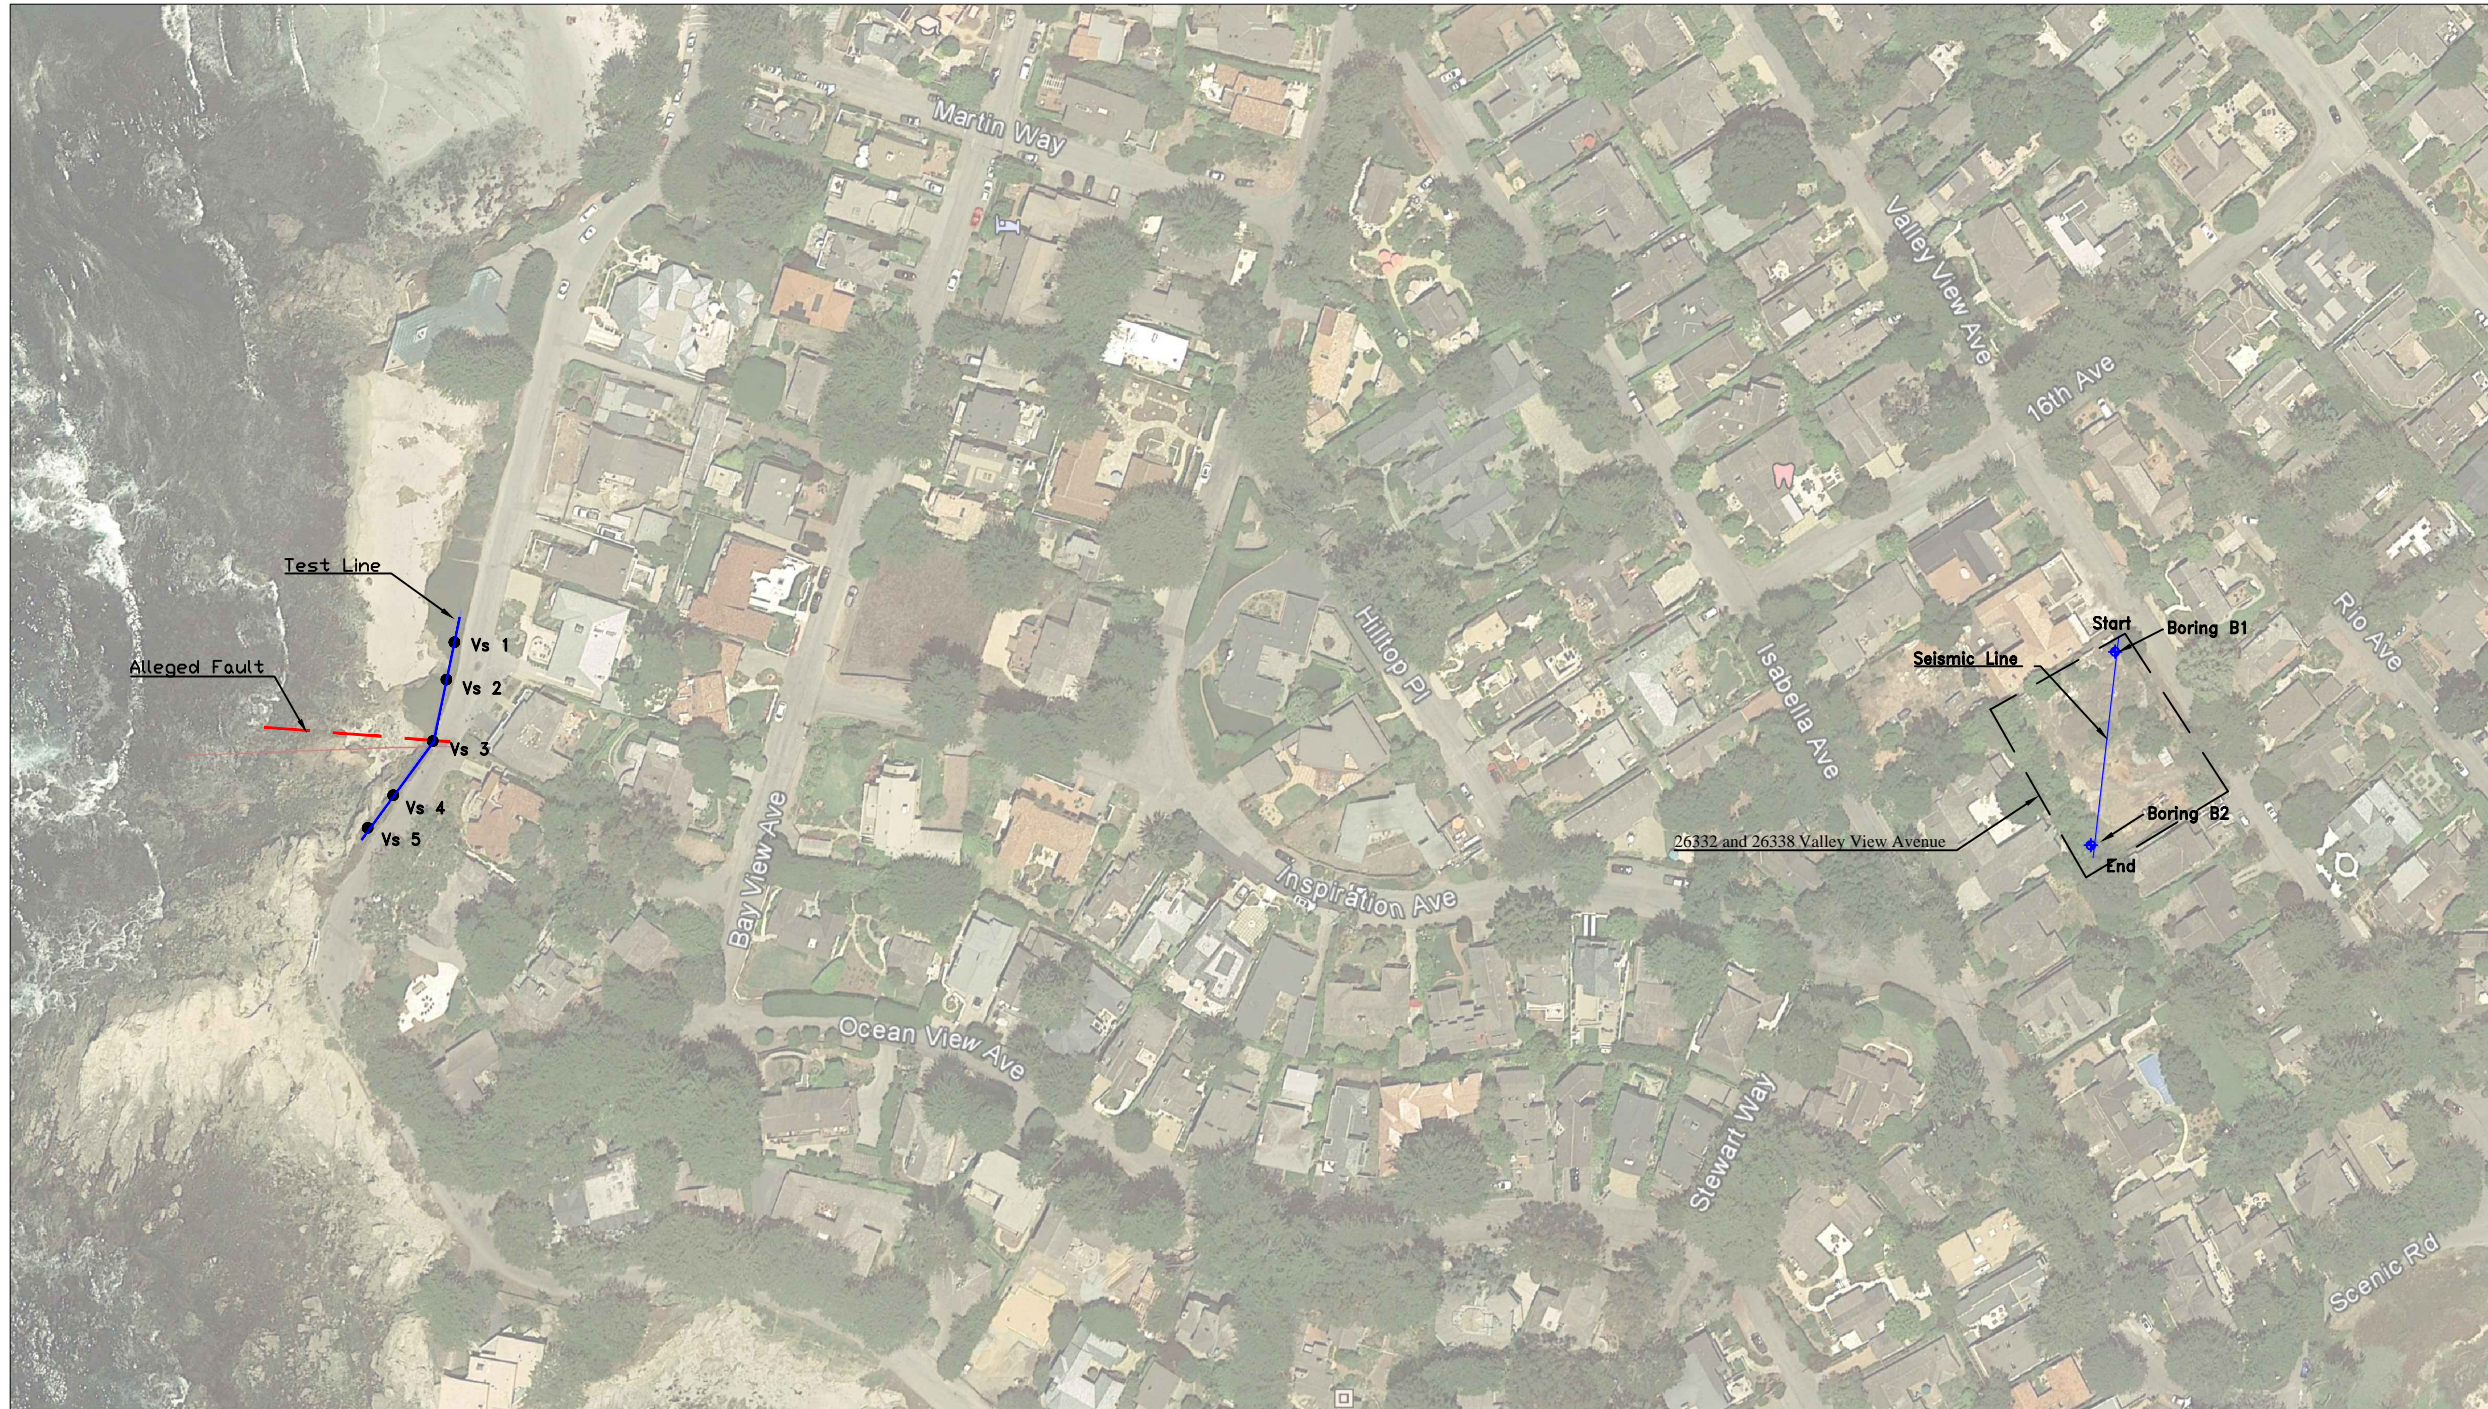
<b>Site Map</b> Valley View Drive Carmel, California		
SCALE: No Scale		DRAWN BY: J.J.R.
DATE: 10-13-2017	JOB NUMBER: 170-291-17	REVISED:
<b>J R Associates</b> Civil and Environmental Geophysics 17040 Oakleaf Drive Moraga Hill, CA (408) 293-7390		
DRAWING NUMBER: 3 of 4

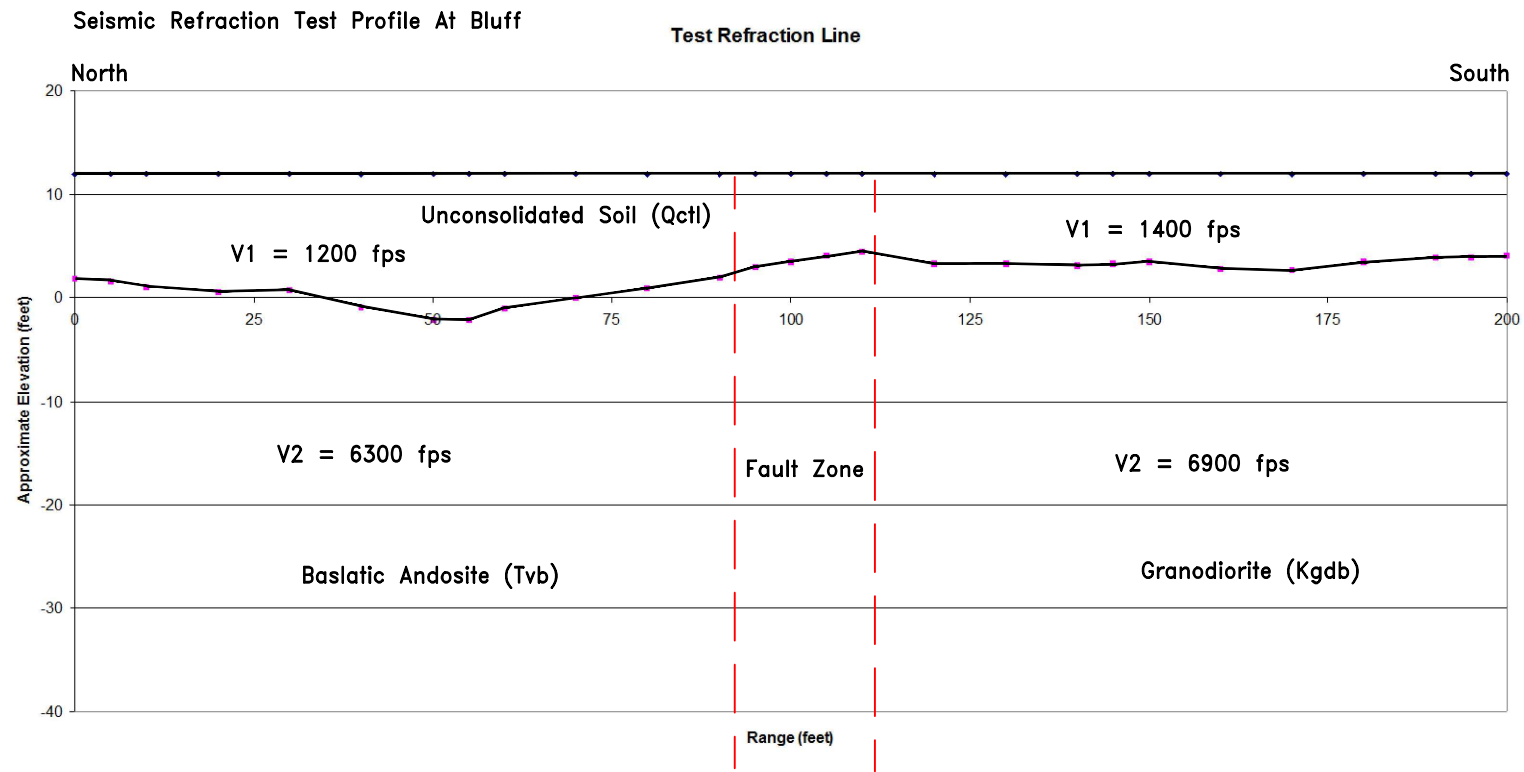
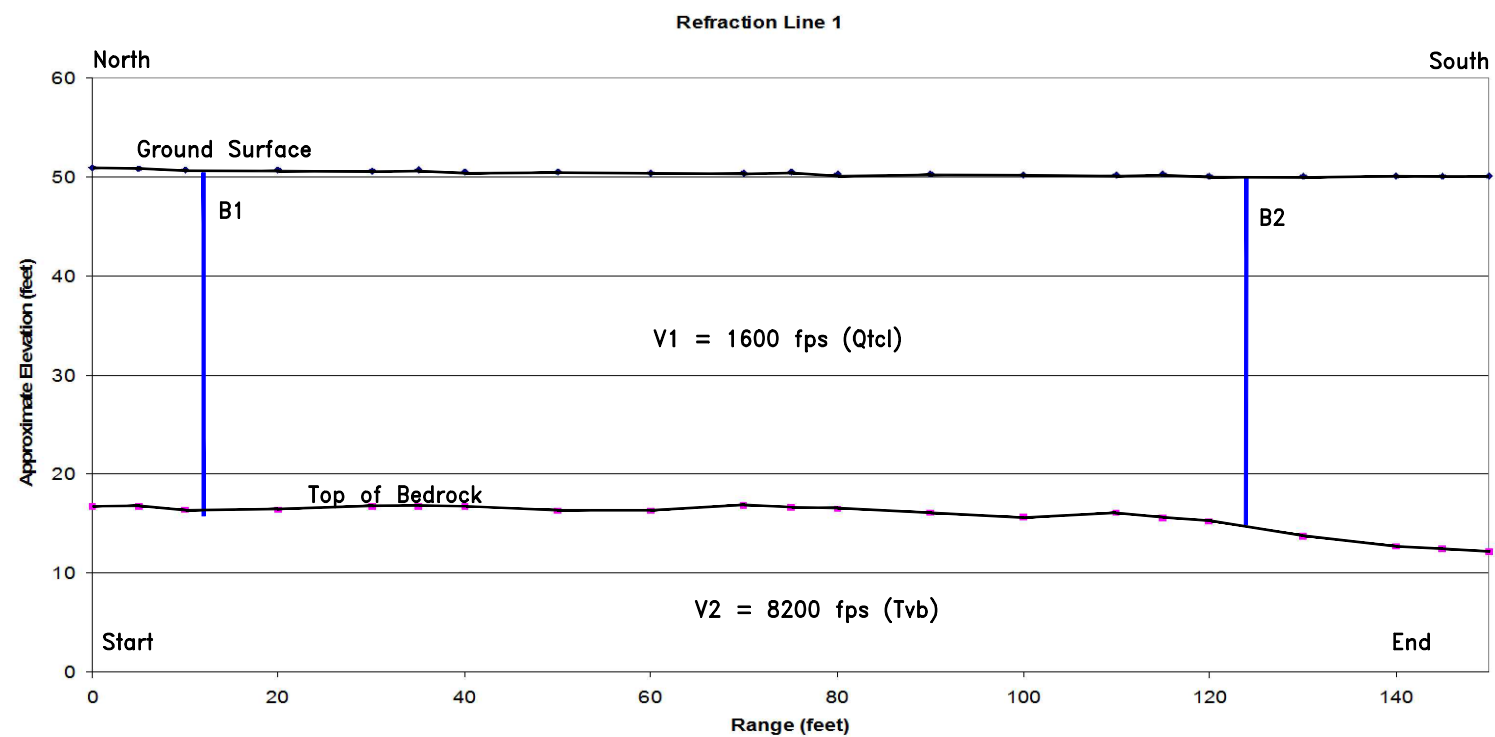
<b>Seismic Refraction Profiles</b> Valley View Drive Carmel, California		
SCALE: See Diagrams		DRAWN BY: J.J.R.
DATE: 10-13-2017	JOB NUMBER: 170-291-17	REVISED:
<b>J R Associates</b> Civil and Environmental Geophysics 17040 Oakleaf Drive Moraga Hill, CA (408) 293-7390

Seismic layers do not always correspond directly to lithologic changes that might be found in borehole or trenching data. A seismic layer is an interface between materials with different P- or S-wave velocities. Factors such as weathering, cementation, induration, and saturation as well as lithologic changes can create changes in seismic velocities. Also, there can be lithologic changes without velocity changes. However, our field experience indicates that seismic layers often correspond to major changes in lithology or saturation to within  $\pm 20\%$  of the depth to the interface. In order to detect a fault there must be a change in the physical rock properties across the fault. If there is no change in physical properties across a fault then it will not be detected. Our data should be compared with available geologic and other data before conclusions are drawn.

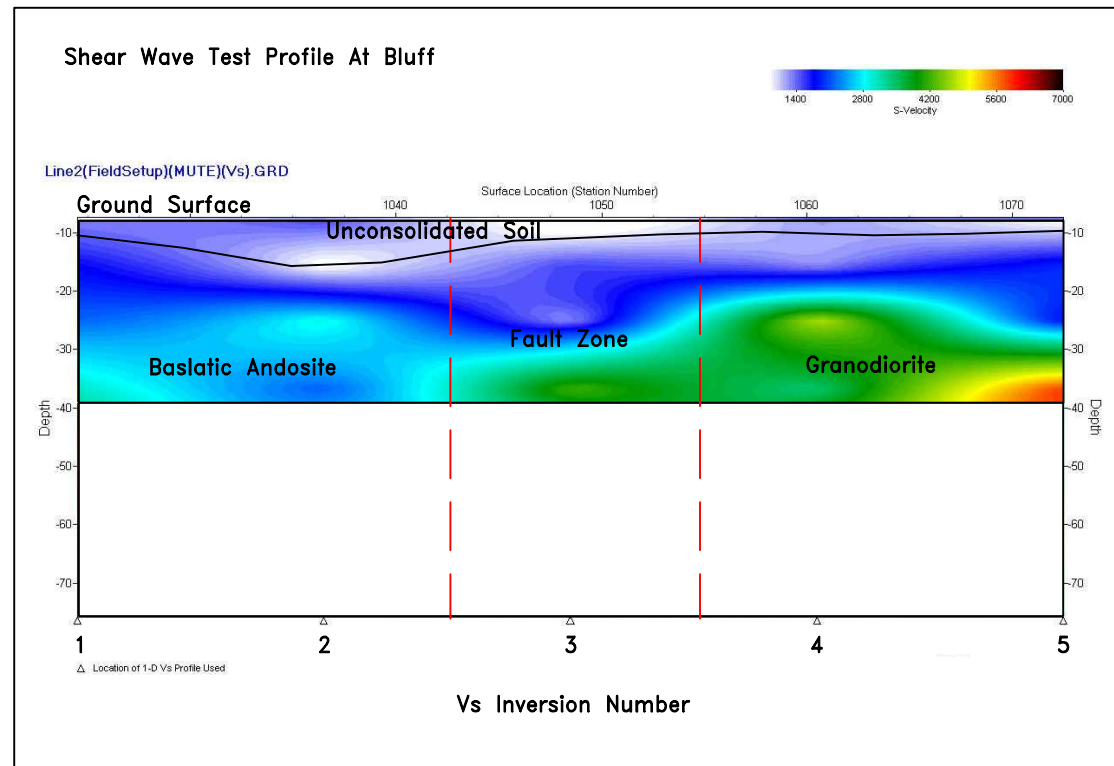
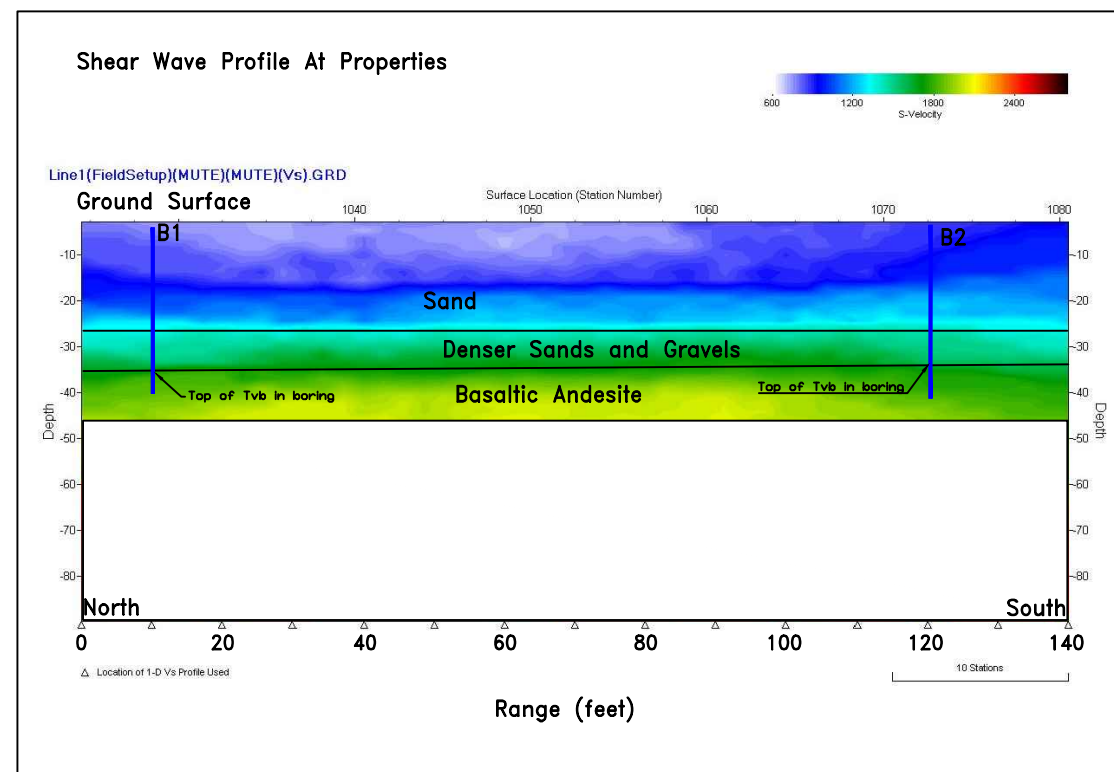
<b>Shear Wave Profiles</b> Valley View Drive Carmel, California		
SCALE: See Diagrams		DRAWN BY: J.J.R.
DATE: 10-13-2017	JOB NUMBER: 170-291-17	REVISED:
<b>J R Associates</b> Civil and Environmental Geophysics 17040 Oakleaf Drive Moraga Hill, CA (408) 293-7390
